**MINERALS PROGRAM INSPECTION REPORT**  
**PHONE: (303) 866-3567**

<b>MINE NAME:</b> Sunday Mine	<b>MINE/PROSPECTING ID#:</b> M-1977-285	<b>MINERAL:</b> Uranium and vanadium	<b>COUNTY:</b> San Miguel
<b>INSPECTION TYPE:</b> Monitoring	<b>INSPECTOR(S):</b> Lucas J. West	<b>INSP. DATE:</b> September 20, 2016	<b>INSP. TIME:</b> 09:46
<b>OPERATOR:</b> Pinon Ridge Mining LLC	<b>OPERATOR REPRESENTATIVE:</b> Patrick Siglin, Michael Rutter	<b>TYPE OF OPERATION:</b> 112d-2 - Designated Mining Operation	
<b>REASON FOR INSPECTION:</b> Normal I&E Program	<b>BOND CALCULATION TYPE:</b> None	<b>BOND AMOUNT:</b> \$297,926.00	
<b>DATE OF COMPLAINT:</b> NA	<b>POST INSP. CONTACTS:</b> None	<b>JOINT INSP. AGENCY:</b> None	
<b>WEATHER:</b> Clear	<b>INSPECTOR'S SIGNATURE:</b>

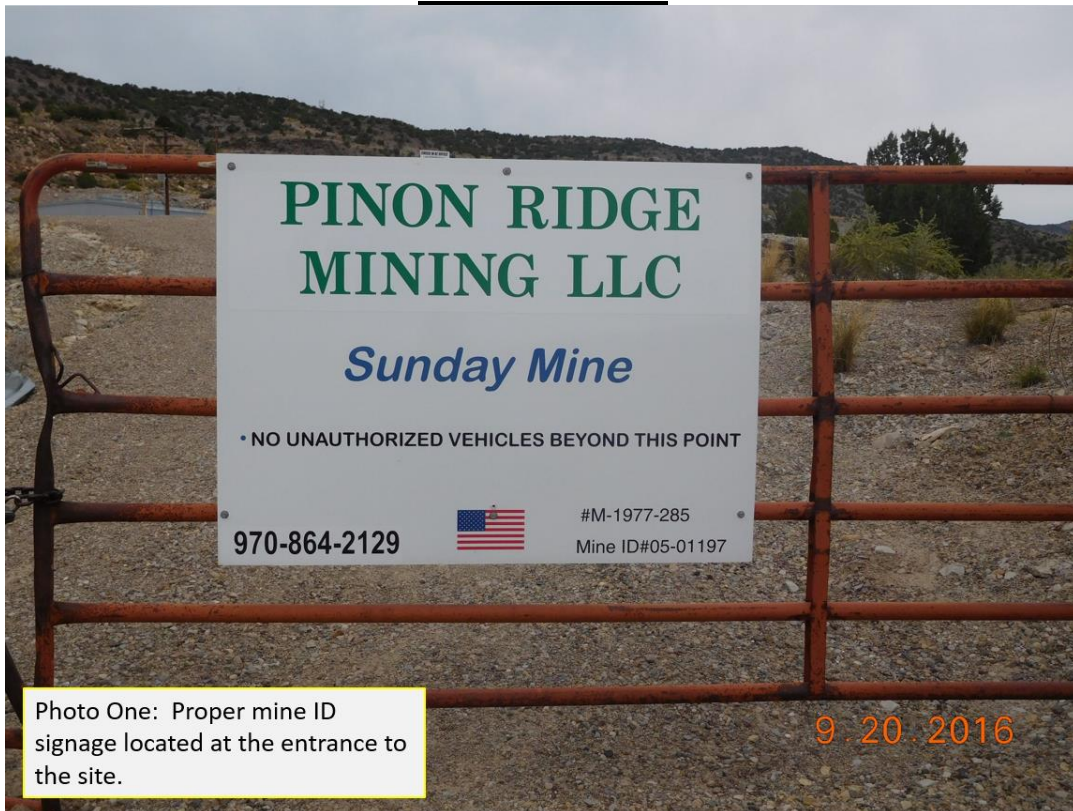
As seen in Photo One, the permit ID sign was observed at the entrance to the site. The permit boundary markers were also observed. Photo Two show the Sediment catchments that are in good condition and appear to be functioning as designed. All diversion ditches appear to be functioning as designed and no significant erosion was observed throughout most of the site. An example of one of the diversion ditches located on site can be seen in Photo Three. The low grade ore pile located on site appears to be stable and in good condition. A large pile of development rock exists on site which appears to be stable and in good condition.

Photo One: Proper mine ID signage located at the entrance to the site.

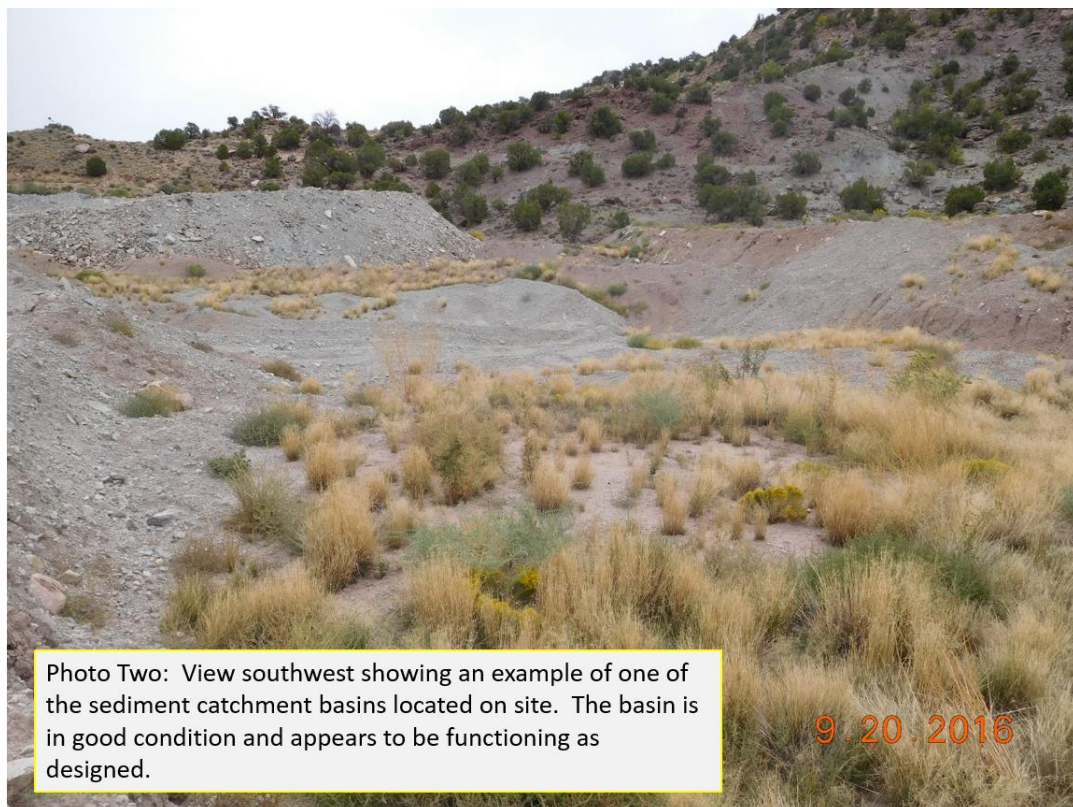
Photo Two: View southwest showing an example of one of the sediment catchment basins located on site. The basin is in good condition and appears to be functioning as designed.

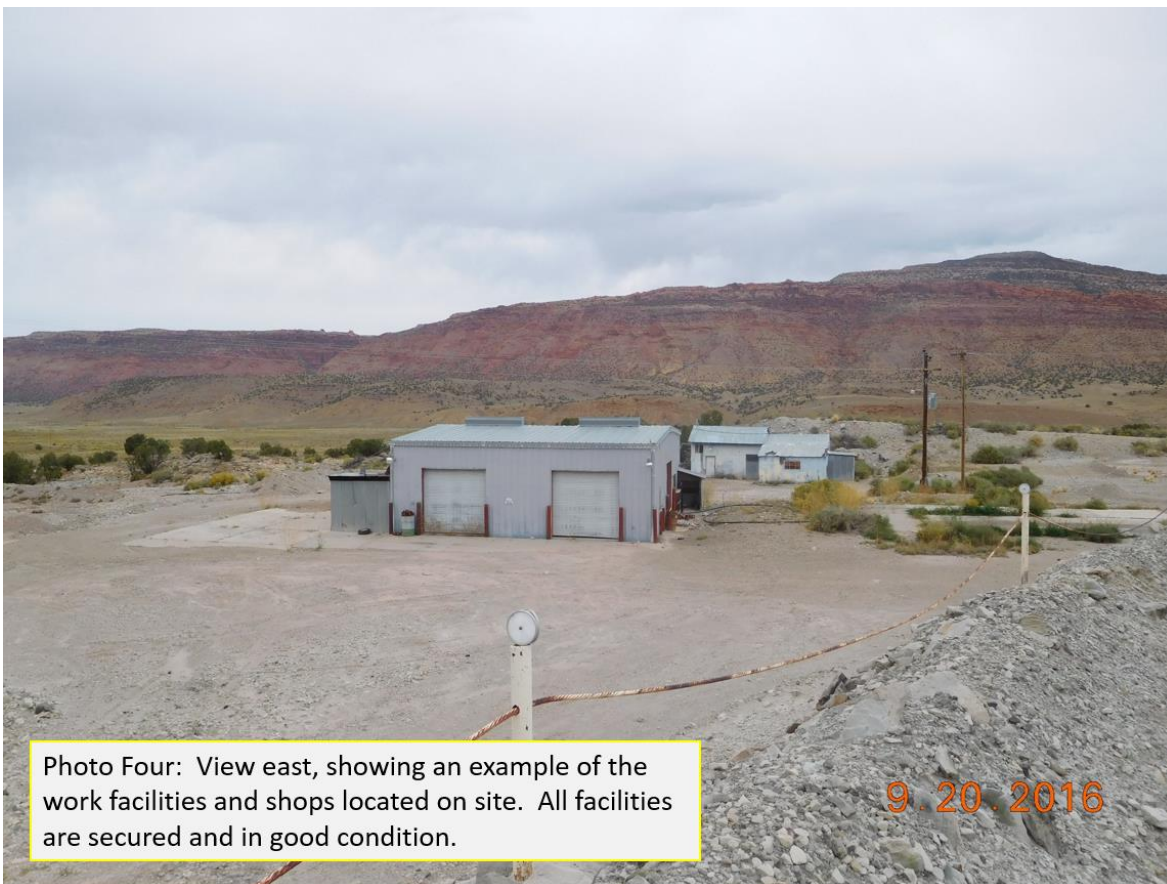
All work facilities were secure and seemed to be in good condition during the time of the inspection. No signs of vandalism or general site degradation were noted. Examples of the work facilities can be seen in Photo Four. The portal located on site was also secured, it has been backfilled and closed off with steel grates that are in good condition as seen in Photo Five. Vent shaft S-2, located to the Northwest of the shop facilities is covered with a steel grate and has been secured in response to the previous Inspection Report. All loadouts, roads and pad areas that exist on site were observed and in good condition. Evidence of chemical weed treatment was observed and the operator expressed that weed management is ongoing throughout the whole Sunday Mine Complex. The site exhibits positive drainage and no erosional features were observed.
