MINERALS PROGRAM INSPECTION REPORT
PHONE: (303) 866-3567

MINE NAME: Carnation Mine	MINE/PROSPECTING ID#: M-1977-416	MINERAL: Uranium and vanadium	COUNTY: San Miguel
INSPECTION TYPE: Monitoring	INSPECTOR(S): Lucas J. West	INSP. DATE: September 20, 2016	INSP. TIME: 12:05
OPERATOR: Pinon Ridge Mining LLC	OPERATOR REPRESENTATIVE: Patrick Siglin, Michael Rutter	TYPE OF OPERATION: 110d - Designated Limited Impact	
REASON FOR INSPECTION: Normal I&E Program	BOND CALCULATION TYPE: None	BOND AMOUNT: \$22,468.00	
DATE OF COMPLAINT: NA	POST INSP. CONTACTS: None	JOINT INSP. AGENCY: None	
WEATHER: Clear	INSPECTOR'S SIGNATURE:

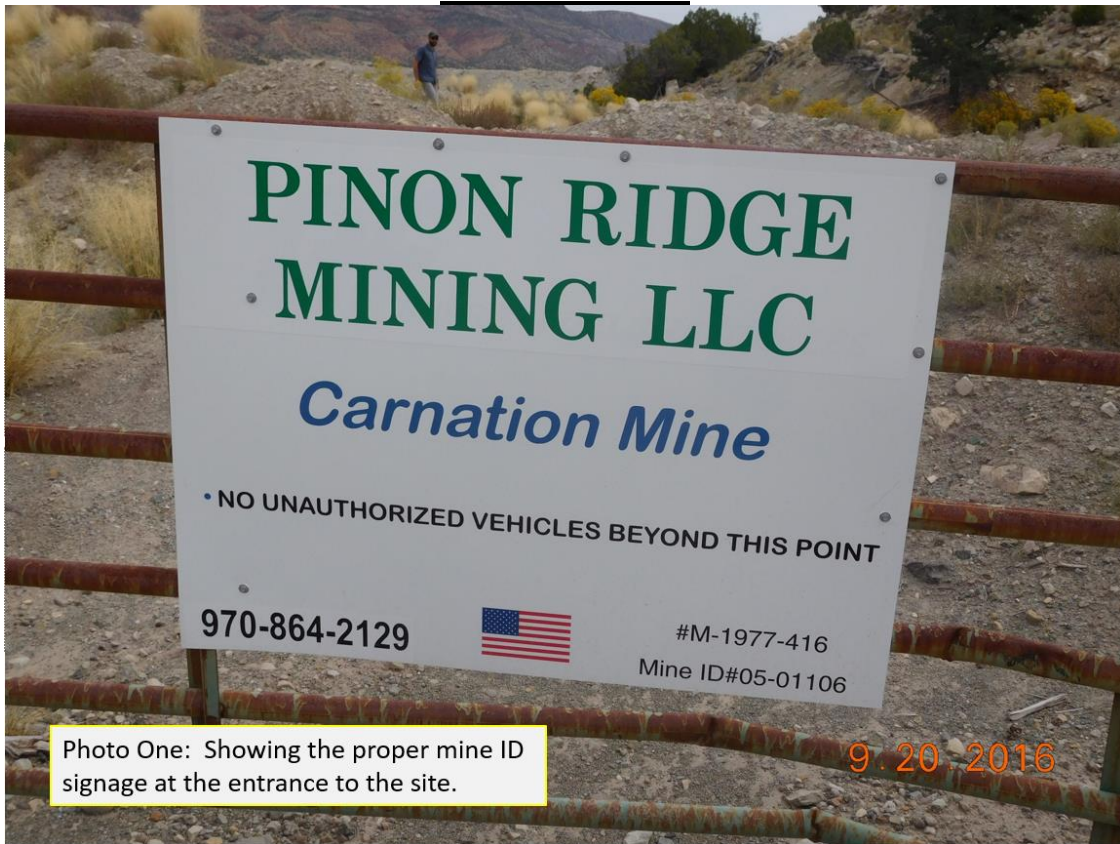
As seen in Photo One, the permit ID sign was observed at the entrance to the site. The permit boundary markers were also observed and all disturbances were confined within the permitted area. The remote vent shaft sites were inspected and found to be in good condition. All vent shaft sites were secured with a steel grate to prevent unauthorized access and showed no signs of vandalism. Evidence that the diversion ditches and storm water control devices are functioning as designed and no significant erosion was observed throughout the site. The lower permit area was also in good condition with no signs of significant erosion. The lower area has begun to revegetate itself and appears to be in good condition.

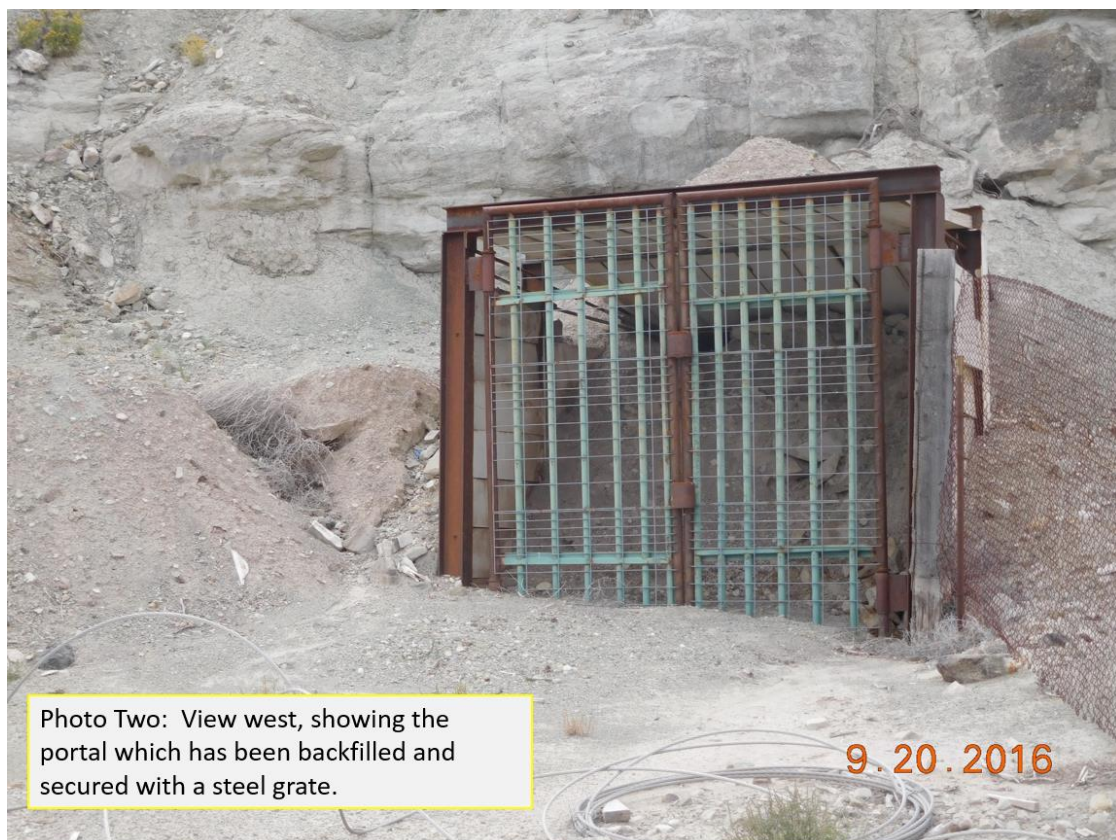
The portal located on site was also secured, it has been backfilled, closed off with steel grates as well as encompassed by a small berm as seen in Photo Two. No fuel storage containers were observed on site. Various other debris was observed on site however it was stored in an orderly fashion and was not a concern at this time.

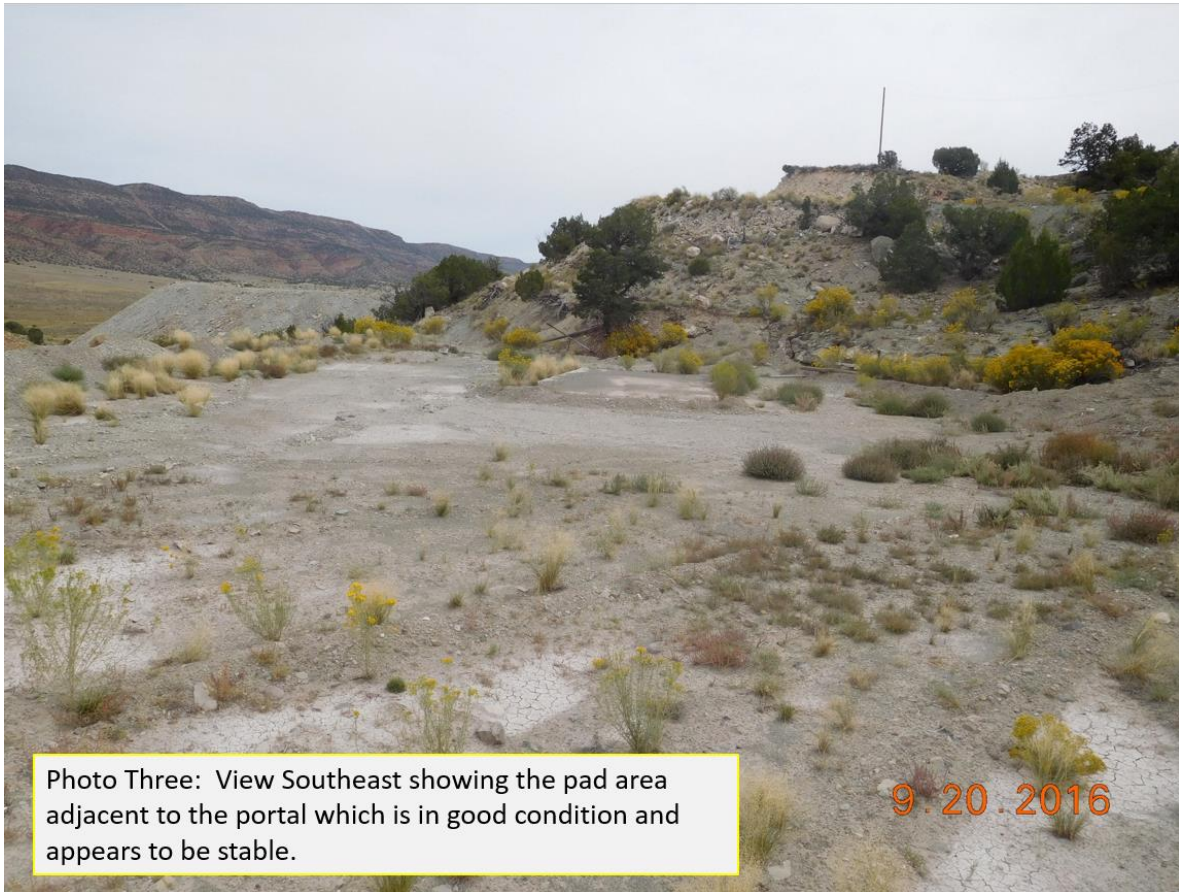
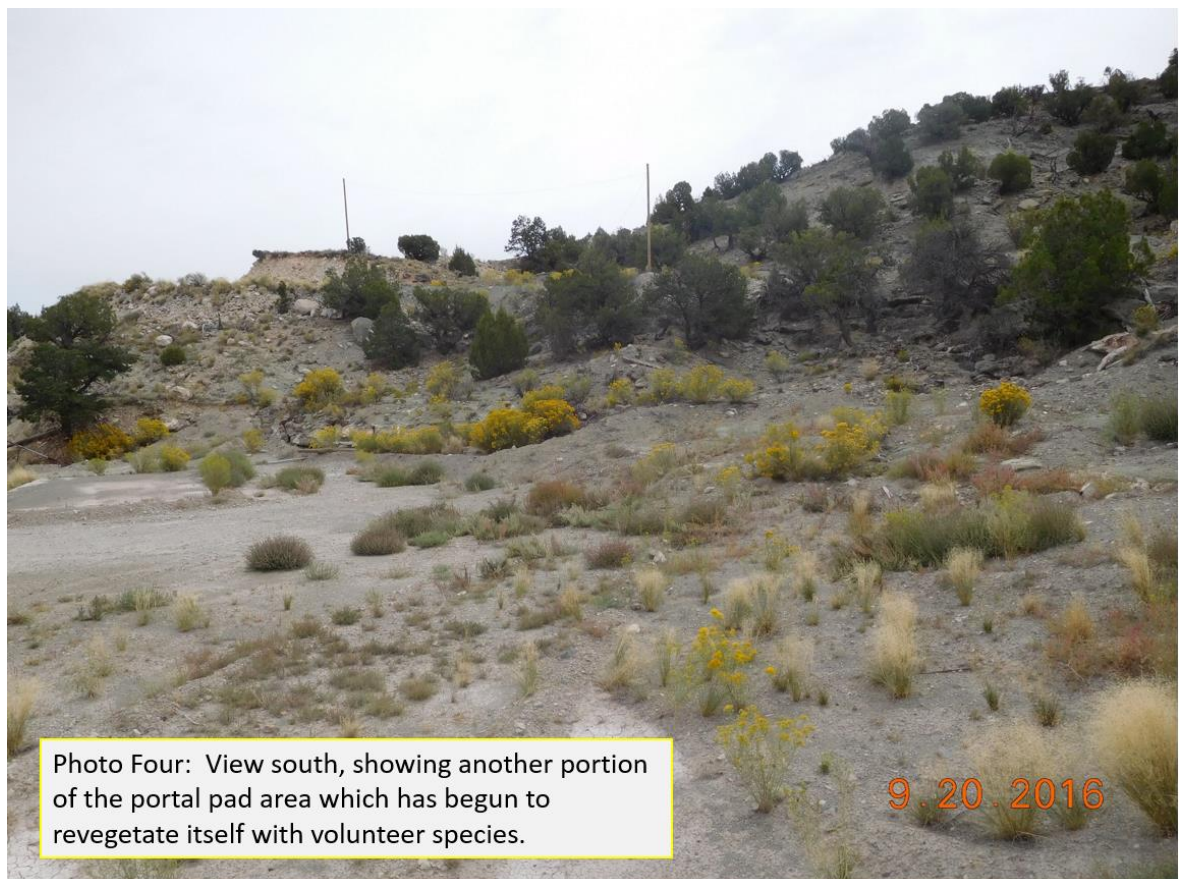
The main pad and work area was in good condition as seen in Photos Three and Four, evidence of weed management during the growing season was observed. The whole site exhibits positive drainage and no erosional issues were observed at this time. The overall footprint of the site was in good condition and free from excessive trash and debris. No problems or possible violations were noted during this inspection.
