MINERALS PROGRAM INSPECTION REPORT
PHONE: (303) 866-3567

MINE NAME: St Jude Mine	MINE/PROSPECTING ID#: M-1978-039-HR	MINERAL: Uranium and vanadium	COUNTY: San Miguel
INSPECTION TYPE: Monitoring	INSPECTOR(S): Lucas J. West	INSP. DATE: September 20, 2016	INSP. TIME: 16:05
OPERATOR: Pinon Ridge Mining LLC	OPERATOR REPRESENTATIVE: None	TYPE OF OPERATION: 110d - Designated Limited Impact	
REASON FOR INSPECTION: Normal I&E Program	BOND CALCULATION TYPE: None	BOND AMOUNT: \$47,700.00	
DATE OF COMPLAINT: NA	POST INSP. CONTACTS: None	JOINT INSP. AGENCY: None	
WEATHER: Clear	INSPECTOR'S SIGNATURE:

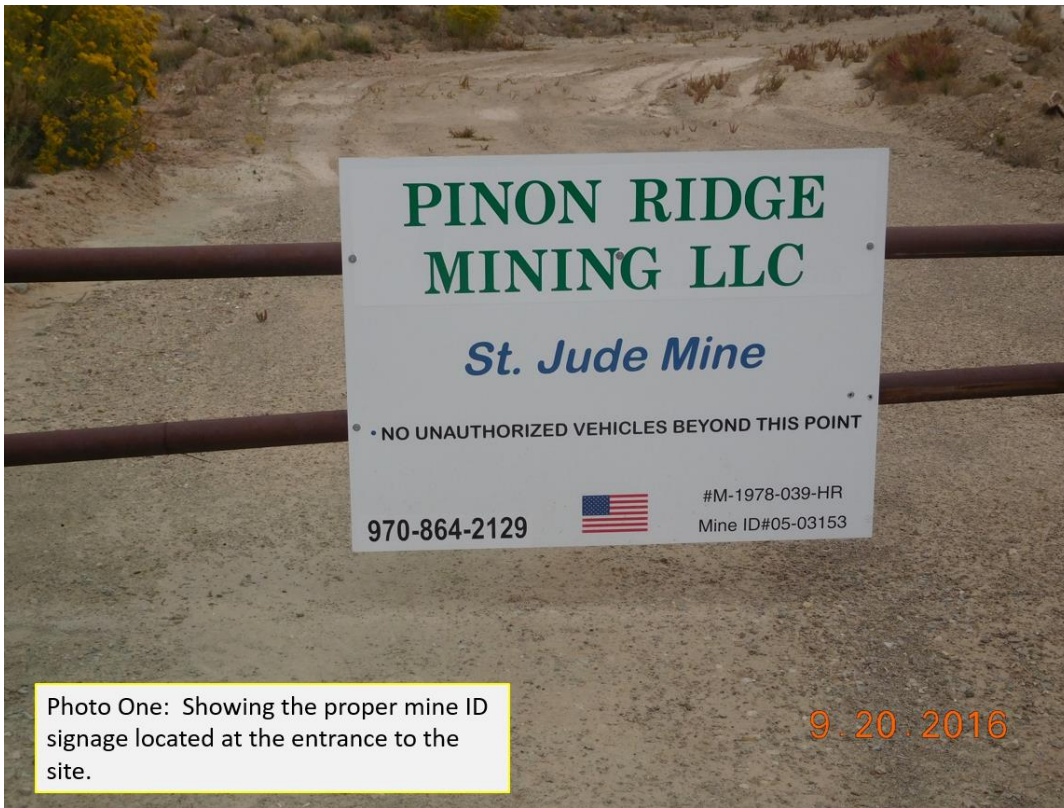
As seen in Photo One, the permit ID sign was observed at the entrance to the site. The permit boundary markers were also observed. All disturbances are contained within the permitted areas. The remote vent shaft sites were inspected at this time. All vent shafts are in good condition and show no signs of vandalism or unauthorized entry. The vents were all secured with a steel grate cover. The diversion ditches and storm water control devices are functioning as designed and no significant erosion was observed throughout the site. The main work area, adjacent to the portal and shops, appeared to be stable and in good condition. Photos Two and Three show the pad area. The portal located on this site has been backfilled and secured. Photo Four shows the earthen cover placed over the portal. No evidence of vandalism or attempted unauthorized entry to the portal was observed during the inspection.

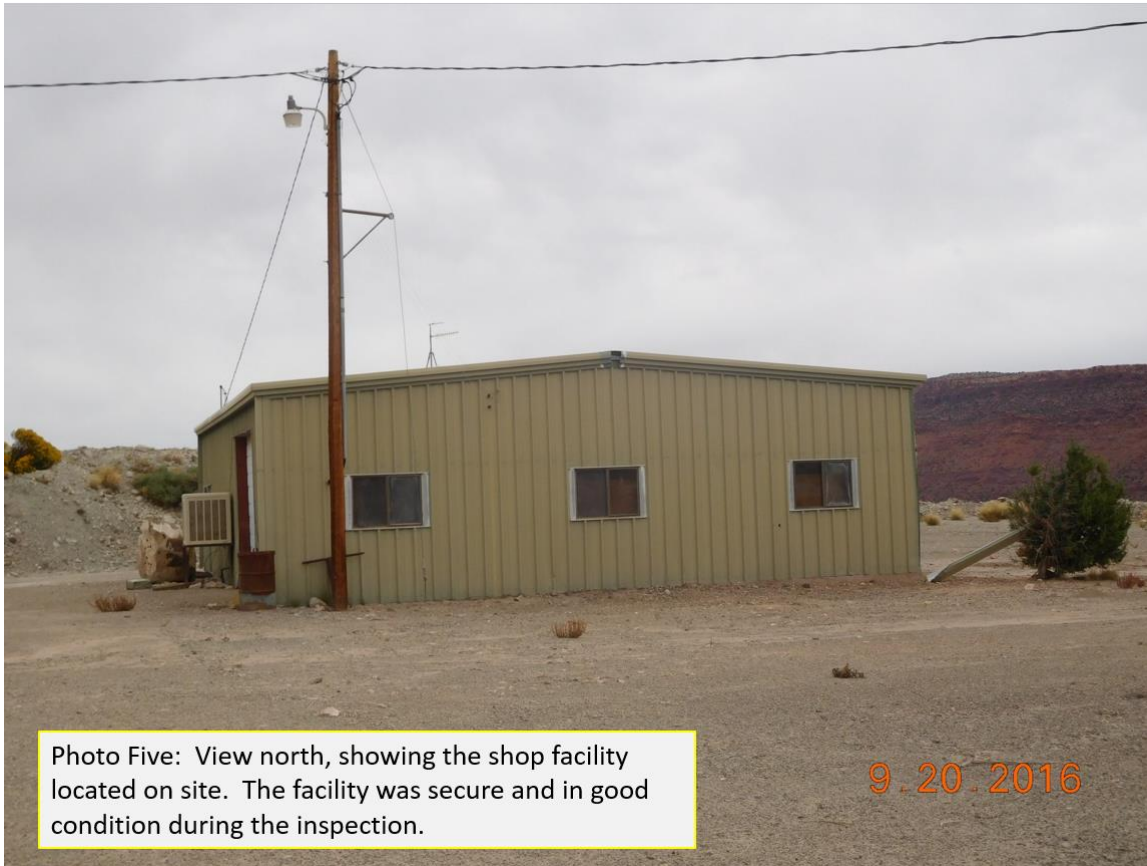
All work and shop facilities onsite were secured and appeared to be in good condition as seen in Photo Five. No fuel storage containers were observed on site. Various other debris was observed on site however it was stored in an orderly fashion and was not a concern at this time.
