MINERALS PROGRAM INSPECTION REPORT

MINE NAME: Topaz Mine	MINE/PROSPECTING ID#: M-1980-055-HR	MINERAL: Uranium and vanadium	COUNTY: San Miguel
INSPECTION TYPE: Monitoring	INSPECTOR(S): Lucas J. West	INSP. DATE: September 20, 2016	INSP. TIME: 15:35
OPERATOR: Pinon Ridge Mining LLC	OPERATOR REPRESENTATIVE: None	TYPE OF OPERATION: 112d-3 - Designated Mining Operation	
REASON FOR INSPECTION: Normal I&E Program	BOND CALCULATION TYPE: None	BOND AMOUNT: \$94,791.00	
DATE OF COMPLAINT: NA	POST INSP. CONTACTS: None	JOINT INSP. AGENCY: None	
WEATHER: Clear	INSPECTOR'S SIGNATURE:

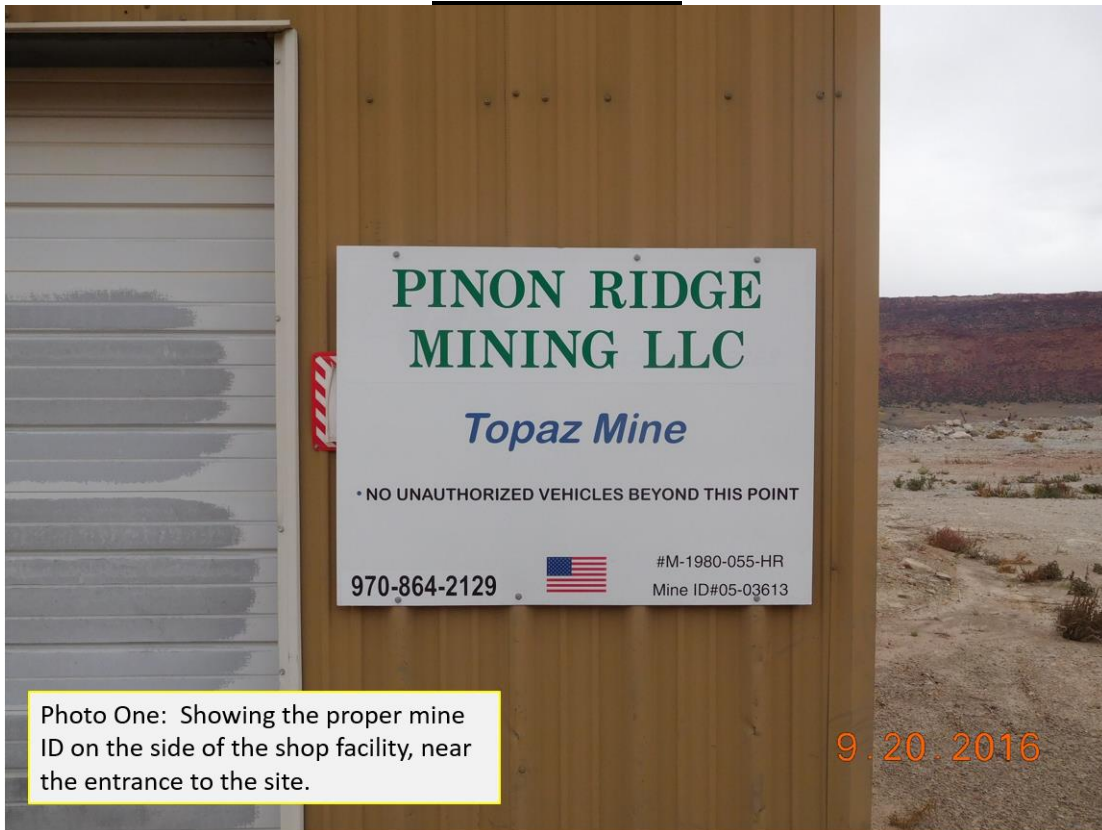
As seen in Photo One, the permit ID sign was observed near the entrance to the site. The permit boundary markers were also observed. The remote vent shaft sites were inspected and found to be in good condition. All vent sites are secured with a metal grate closure to prevent unauthorized entry and show no signs of vandalism. Evidence that the diversion ditches and storm water control devices are functioning as designed and no significant erosion was observed throughout the site.

Photo One: Showing the proper mine ID on the side of the shop facility, near the entrance to the site.

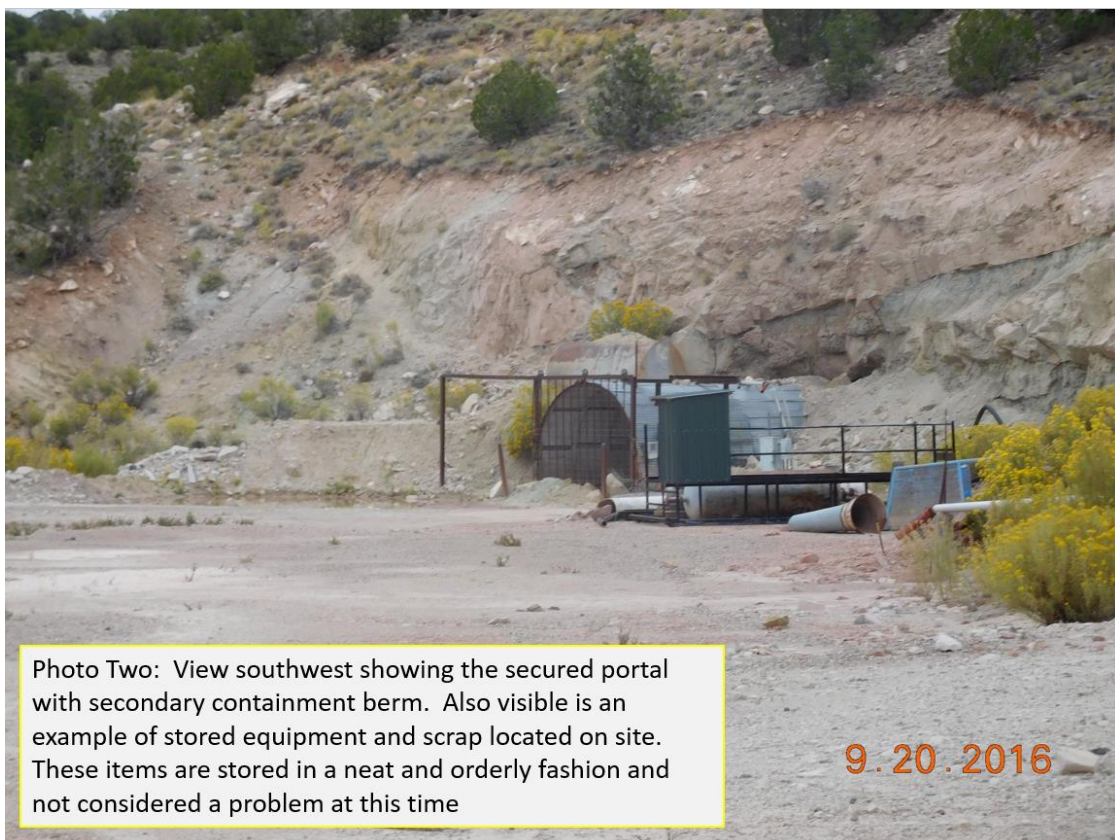
All work and shop facilities onsite were secured and appeared to be in good condition. The portal located on site was also secured, it has been backfilled, closed off with steel grates as well as encompassed by a small berm as seen in Photo Two. No fuel storage containers were observed on site. Various other debris was observed on site however it was stored in an orderly fashion and was not a concern at this time.

Photo Two: View southwest showing the secured portal with secondary containment berm. Also visible is an example of stored equipment and scrap located on site. These items are stored in a neat and orderly fashion and not considered a problem at this time

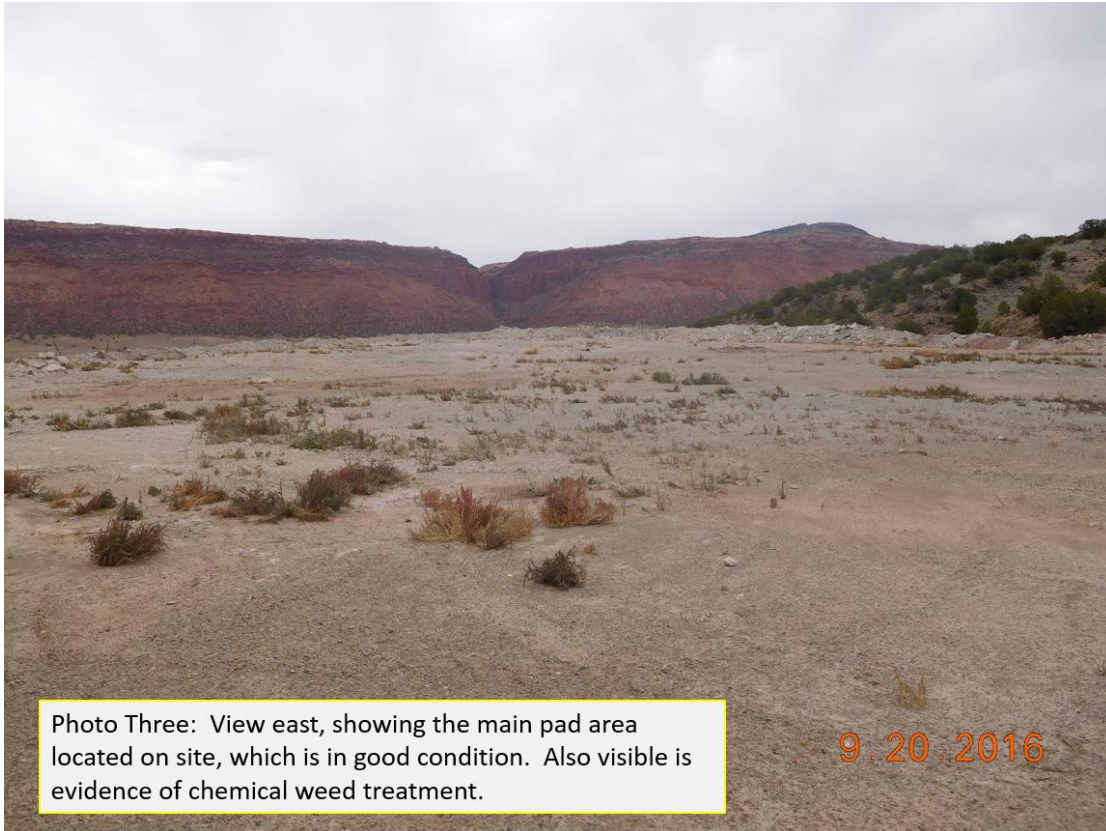
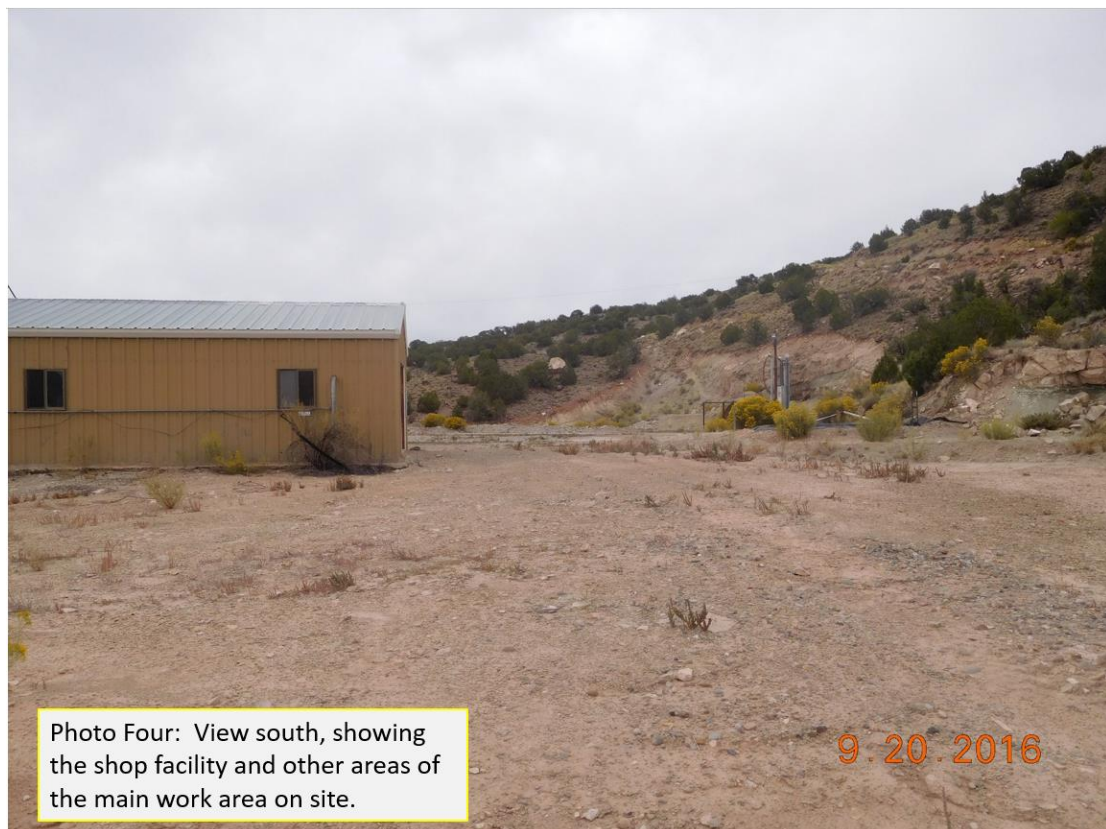
The main pad and work area was in good condition as seen in Photos Three and Four, evidence of weed management during the growing season was observed. Some areas around the perimeter of the pad area have begun to revegetate themselves with volunteer species. The whole site exhibits positive drainage and no erosional issues were observed at this time. The overall footprint of the site was in good condition and free from excessive trash and debris. The condition of the site remains largely unchanged from the previous inspection. No problems or possible violations were noted at this time.
