**MINERALS PROGRAM INSPECTION REPORT**  
**PHONE: (303) 866-3567**

<b>MINE NAME:</b> West Sunday	<b>MINE/PROSPECTING ID#:</b> M-1981-021	<b>MINERAL:</b> Uranium and vanadium	<b>COUNTY:</b> San Miguel
<b>INSPECTION TYPE:</b> Monitoring	<b>INSPECTOR(S):</b> Lucas J. West	<b>INSP. DATE:</b> September 20, 2016	<b>INSP. TIME:</b> 15:45
<b>OPERATOR:</b> Pinon Ridge Mining LLC	<b>OPERATOR REPRESENTATIVE:</b> None	<b>TYPE OF OPERATION:</b> 112d-3 - Designated Mining Operation	
<b>REASON FOR INSPECTION:</b> Normal I&E Program	<b>BOND CALCULATION TYPE:</b> None	<b>BOND AMOUNT:</b> \$85,036.00	
<b>DATE OF COMPLAINT:</b> NA	<b>POST INSP. CONTACTS:</b> None	<b>JOINT INSP. AGENCY:</b> U.S.BLM	
<b>WEATHER:</b> Clear	<b>INSPECTOR'S SIGNATURE:</b>

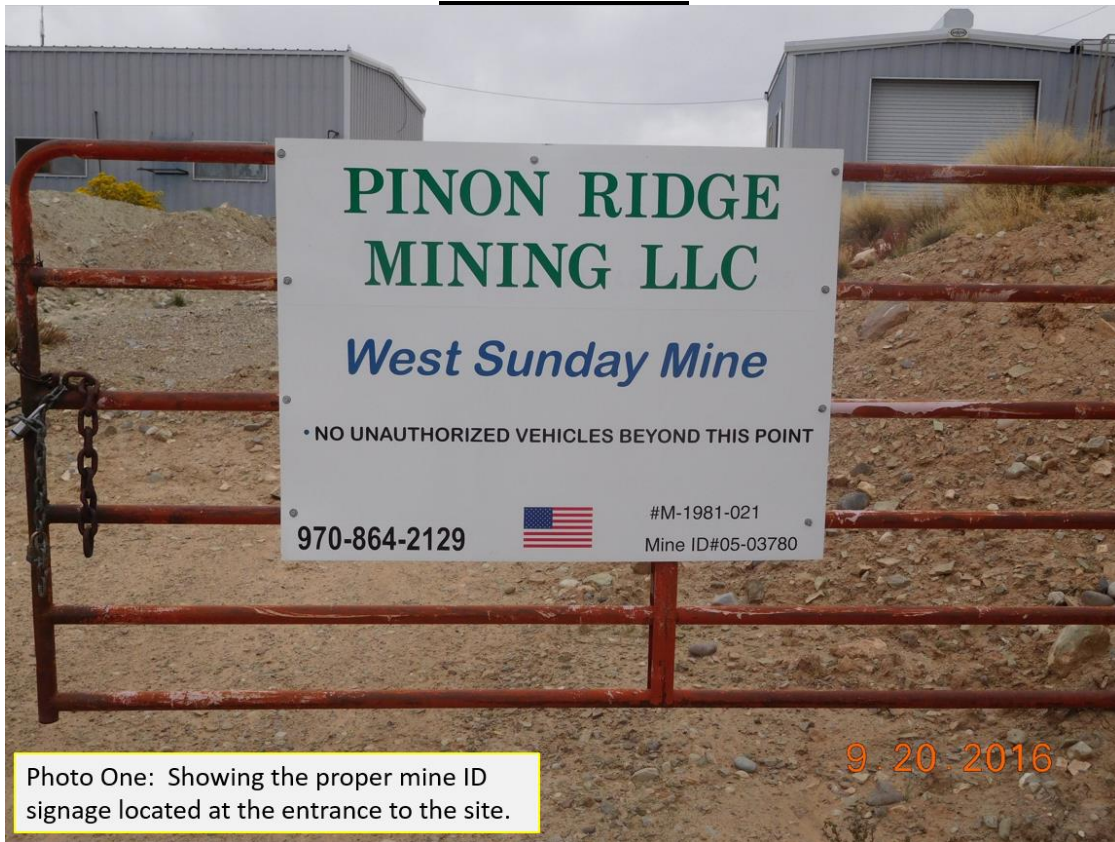
As seen in Photo One, the permit ID sign was observed at the entrance to the site. The permit boundary markers were also observed. The remote vent shaft sites were inspected and found to be in good condition. All vent sites are secured with a metal grate closure to prevent unauthorized entry and show no signs of vandalism. Evidence that the diversion ditches and storm water control devices are functioning as designed was observed and no significant erosion was observed throughout the site.

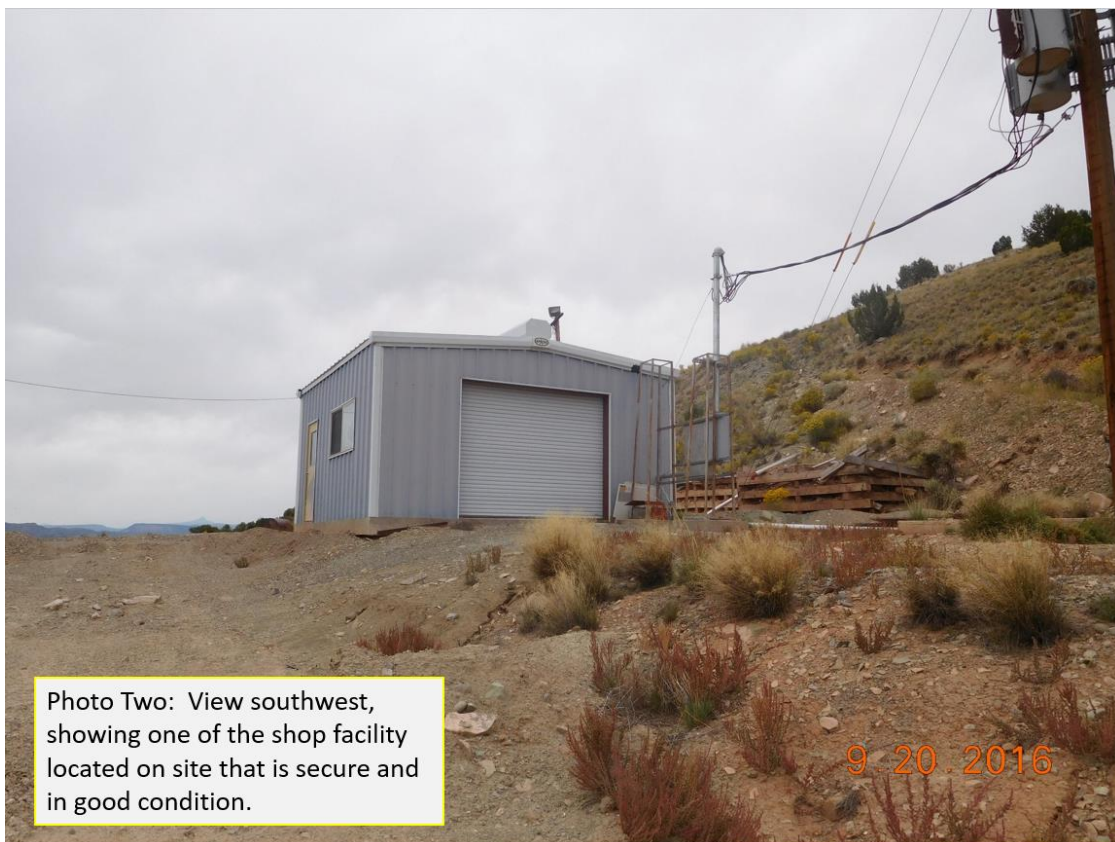
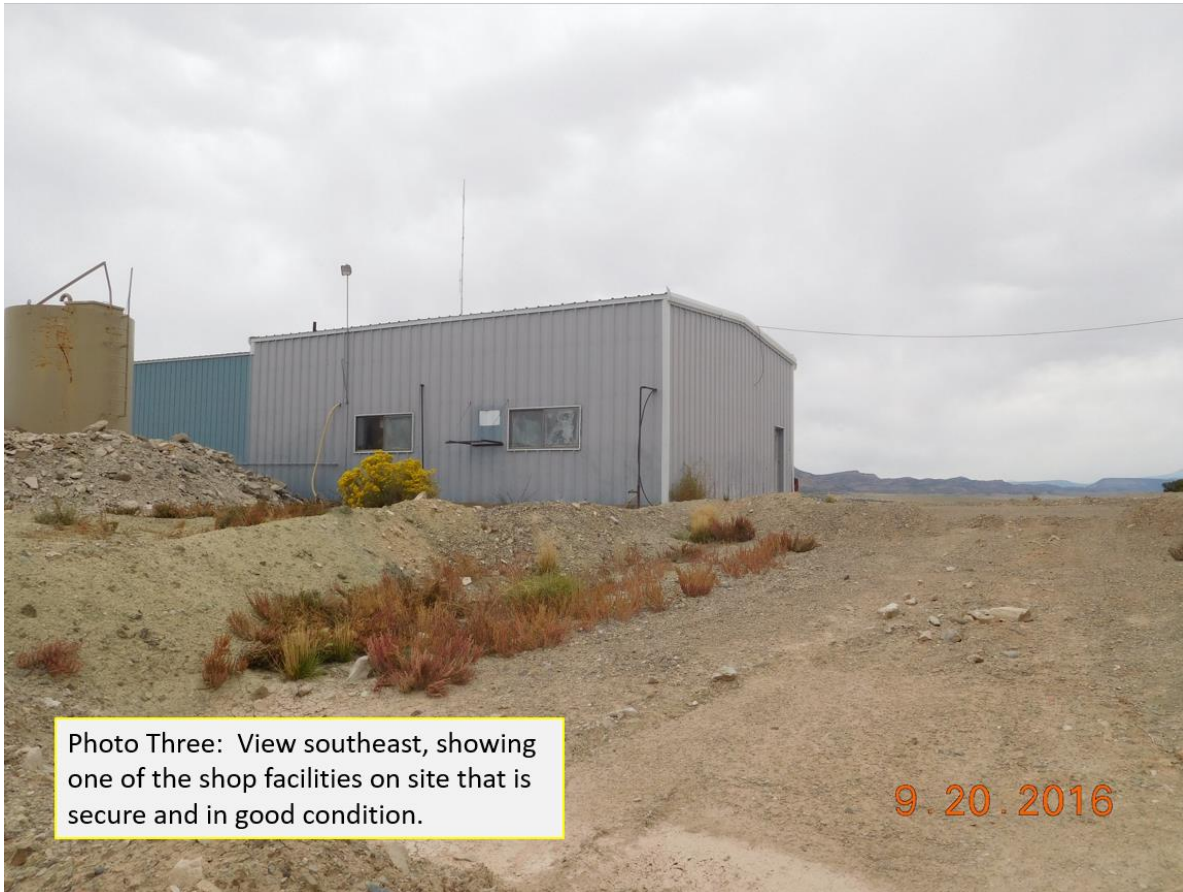
All work and shop facilities onsite were secured and appeared to be in good condition as seen in Photos Two and Three. The portal located on site was also secured, it has been backfilled, closed off with steel grates as well as encompassed by a small berm as seen in Photo Four. Two fuel storage containers were observed on site but were empty and appear to have not been utilized in some time. Various other debris was observed on site however it was stored in an orderly fashion and was not a concern at this time.
