MINERALS PROGRAM INSPECTION REPORT
PHONE: (303) 866-3567

MINE NAME: White Banks Mine	MINE/PROSPECTING ID#: M-1999-042	MINERAL: Marble	COUNTY: Pitkin
INSPECTION TYPE: Monitoring	INSPECTOR(S): Dustin M. Czaplá	INSP. DATE: October 12, 2016	INSP. TIME: 10:00
OPERATOR: Avalanche Creek Marble & Alabaster LLC	OPERATOR REPRESENTATIVE: None	TYPE OF OPERATION: 110c - Construction Limited Impact	
REASON FOR INSPECTION: Normal I&E Program	BOND CALCULATION TYPE: None	BOND AMOUNT: \$41,927.00	
DATE OF COMPLAINT: NA	POST INSP. CONTACTS: None	JOINT INSP. AGENCY: None	
WEATHER: Clear	INSPECTOR'S SIGNATURE:

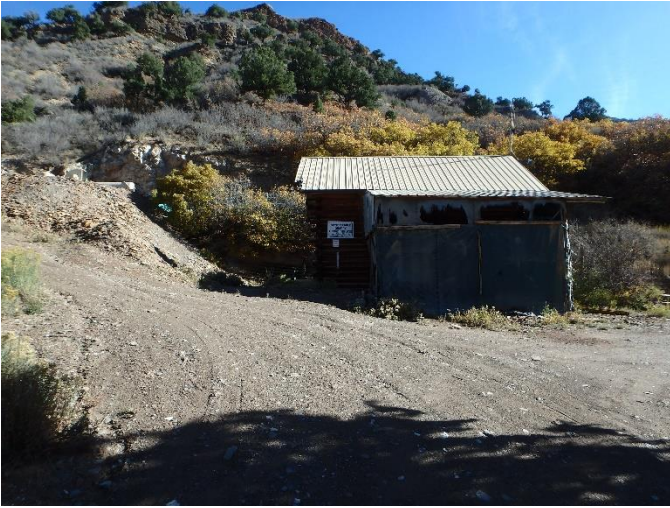
Figure 1: Mine building

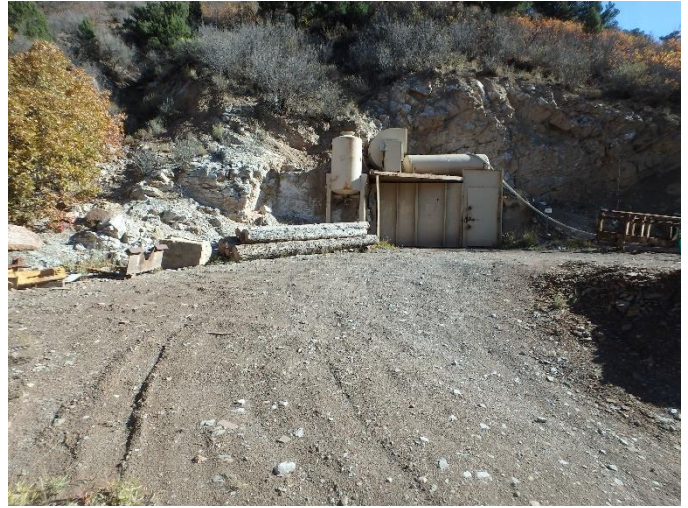
Figure 2: Portal area

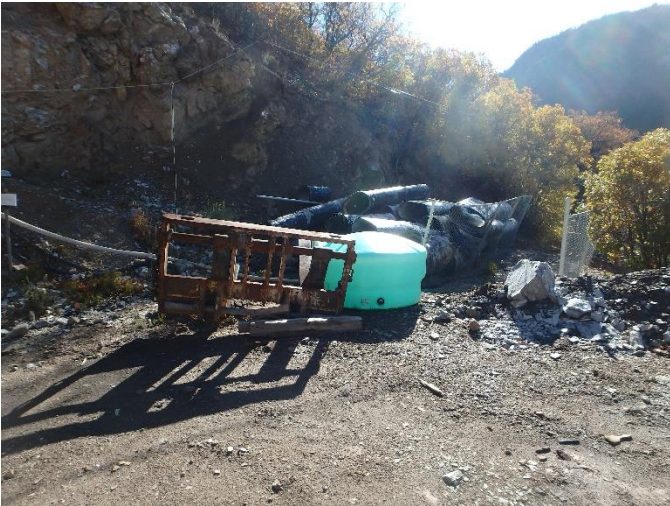
Figure 3: Portal area

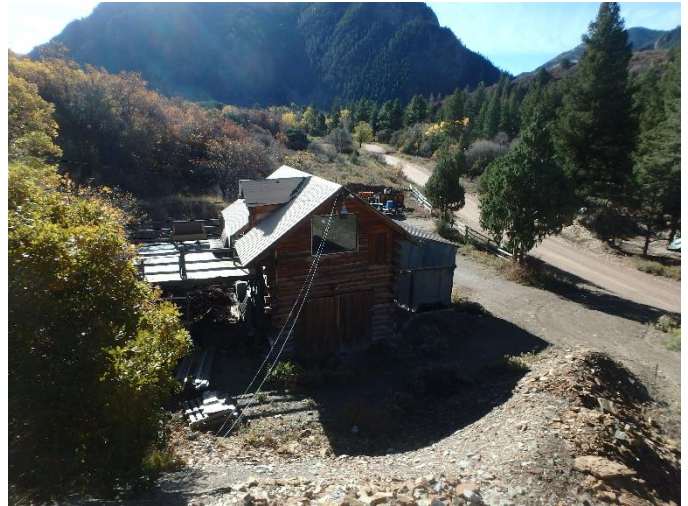
Figure 4: Mine building viewed from portal bench

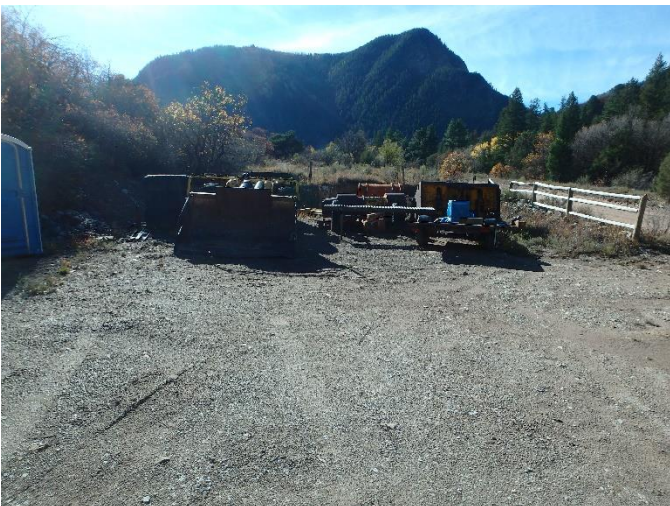
Figure 5: Equipment storage on east side of building

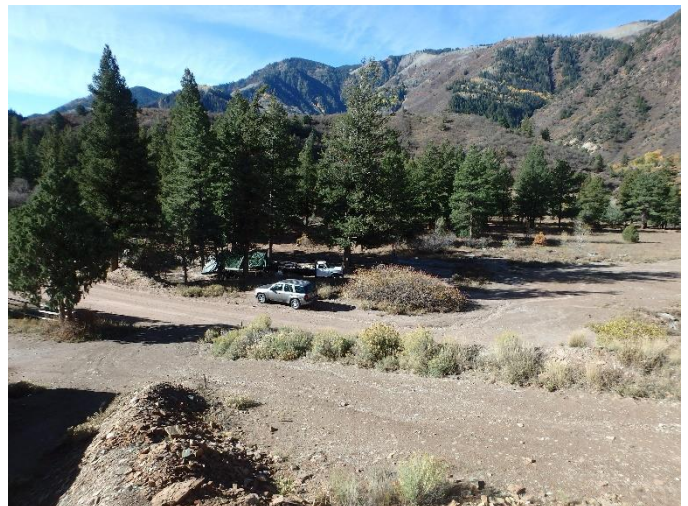
Figure 6: Parking area viewed from portal bench
