**COLORADO**Division of Reclamation,  
Mining and Safety

**MINERALS PROGRAM INSPECTION REPORT****PHONE: (303) 866-3567**

<b>MINE NAME:</b> The Pride of America Mine	<b>MINE/PROSPECTING ID#:</b> M-1999-058	<b>MINERAL:</b> Marble	<b>COUNTY:</b> Gunnison
<b>INSPECTION TYPE:</b> Preoperation Inspection	<b>INSPECTOR(S):</b> Dustin M. Czapla	<b>INSP. DATE:</b> October 12, 2016	<b>INSP. TIME:</b> 11:00
<b>OPERATOR:</b> Colorado Stone Quarries, Inc.	<b>OPERATOR REPRESENTATIVE:</b> Ben Miller	<b>TYPE OF OPERATION:</b> 112c - Construction Regular Operation	
<b>REASON FOR INSPECTION:</b> Normal I&E Program	<b>BOND CALCULATION TYPE:</b> None	<b>BOND AMOUNT:</b> \$404,857.00	
<b>DATE OF COMPLAINT:</b> NA	<b>POST INSP. CONTACTS:</b> None	<b>JOINT INSP. AGENCY:</b> None	
<b>WEATHER:</b> Clear	<b>INSPECTOR'S SIGNATURE:</b>

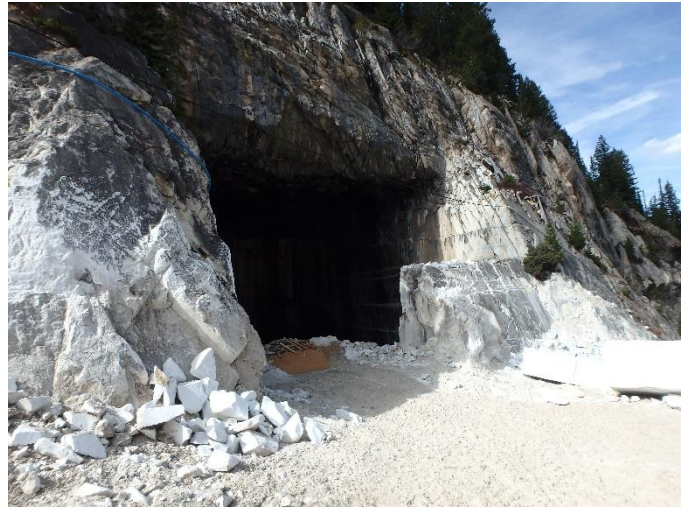
Portals 2 and 3 were barricaded with waste blocks. Portal 4 was still open during the inspection. Stormwater and process water are now directed to the lower part of the Washington Gallery through the utility portal.

Figure 4: Portal 3

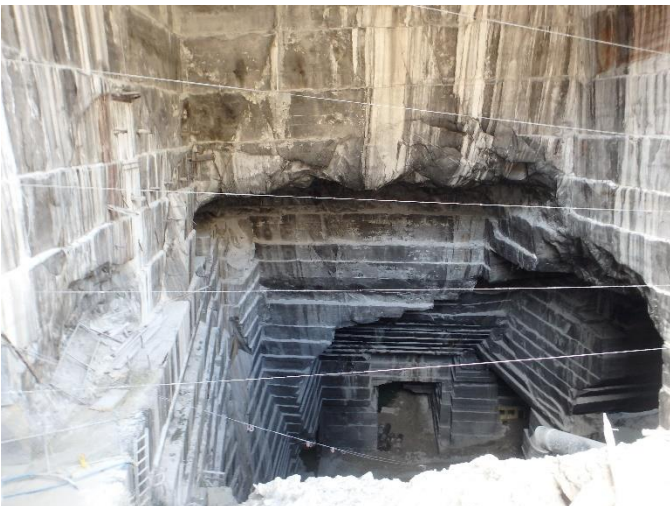
Figure 5: Portal 3

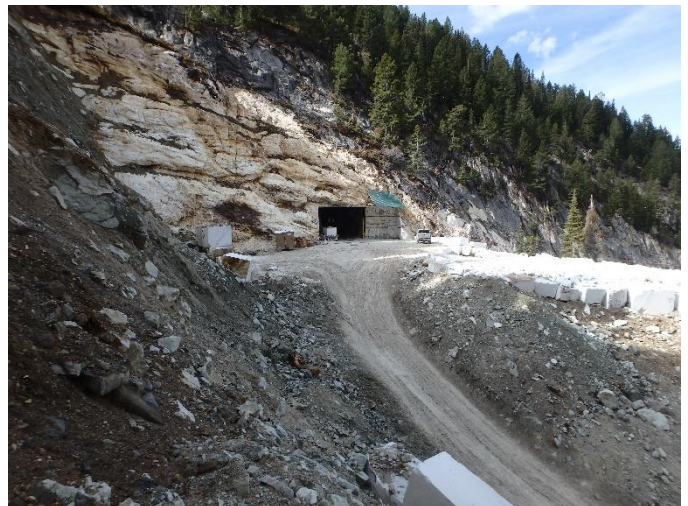
Portals 5, 6 and 7 are currently utilized for access to the active mining areas. Portal 7 was opened in June 2015. The portals appeared stable. Mining was occurring during this inspection. The office trailer and support facilities are located near Portals 5 and 6.

Figure 6: Portal 7 bench

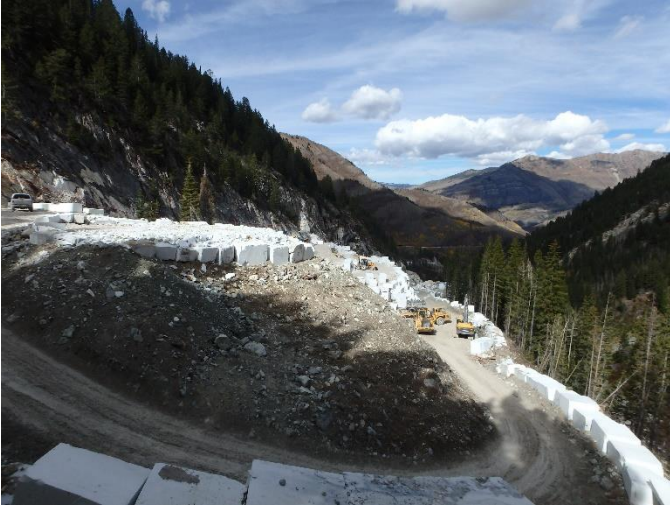
Figure 7: Overview from near Portal 7 bench

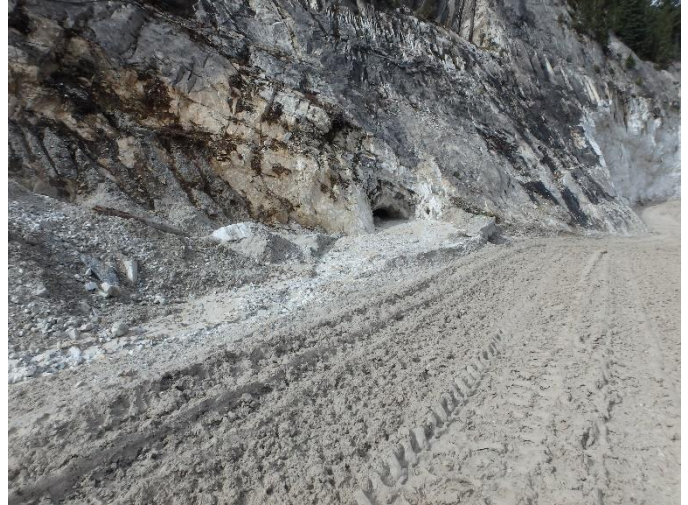
Figure 8: Stormwater directed into utility portal

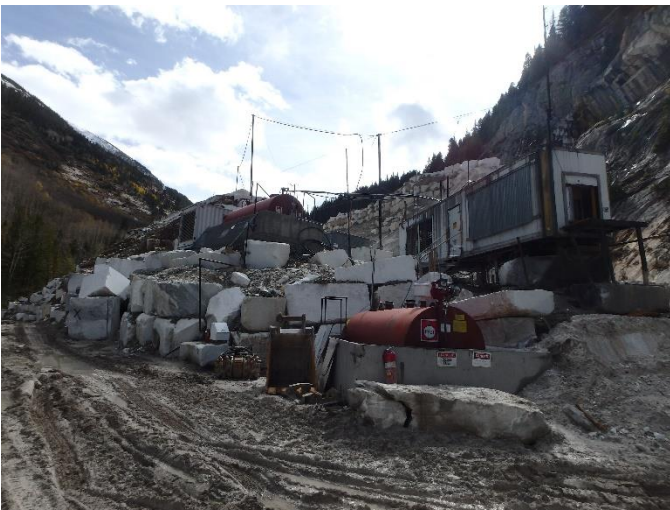
Figure 9: Generator area

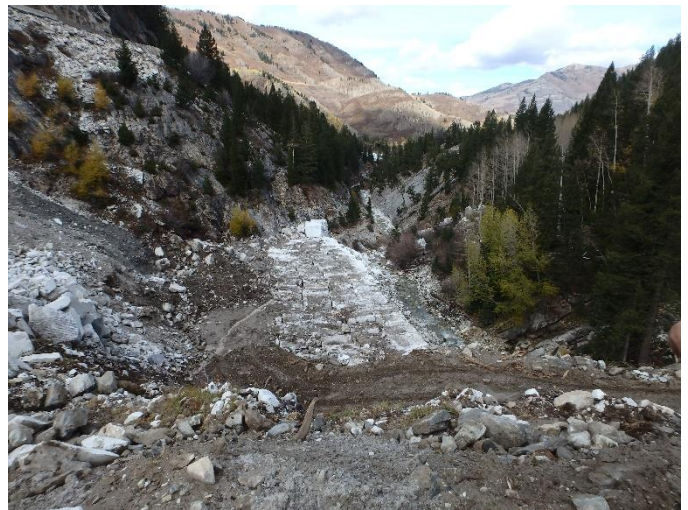
The mine is currently operating under the 110c footprint. Reconstruction of the Washington wasterock wall has commenced. The bottom layers of waste blocks are in place and a culvert crossing the creek has been installed.

Figure 10: Lower rows of Washington Wasterock Landform in place

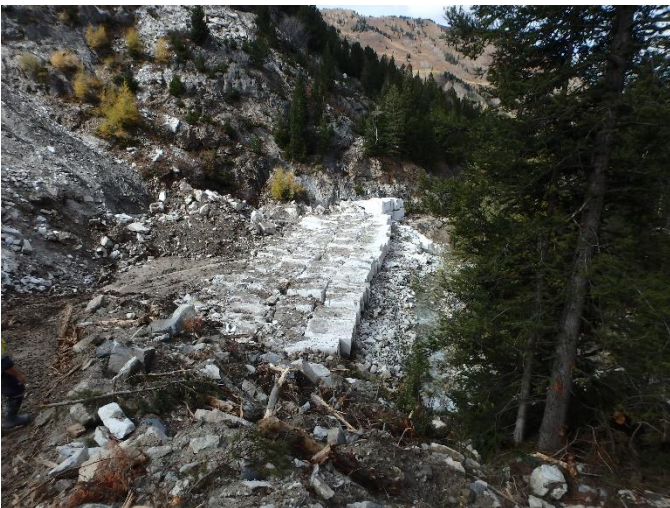
Figure 11: Lower rows of Washington Wasterock Landform in place

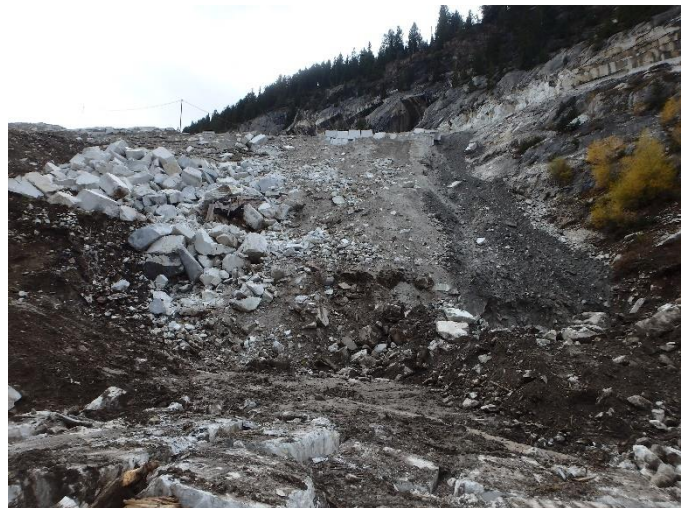
Figure 12: Existing Washington wasterock
