MINERALS PROGRAM INSPECTION REPORT
PHONE: (303) 866-3567

MINE NAME: Alamosa Pit No. 2	MINE/PROSPECTING ID#: M-1983-175	MINERAL: Sand and gravel	COUNTY: Alamosa
INSPECTION TYPE: Monitoring	INSPECTOR(S): Amy C. Yeldell	INSP. DATE: October 5, 2016	INSP. TIME: 10:00
OPERATOR: Southwest Ready-Mix, Inc.	OPERATOR REPRESENTATIVE: Ralph Martinez	TYPE OF OPERATION: 112c - Construction Regular Operation	
REASON FOR INSPECTION: Normal I&E Program	BOND CALCULATION TYPE: Complete Bond	BOND AMOUNT: \$736,602.55	
DATE OF COMPLAINT: NA	POST INSP. CONTACTS: None	JOINT INSP. AGENCY: None	
WEATHER: Clear	INSPECTOR'S SIGNATURE:

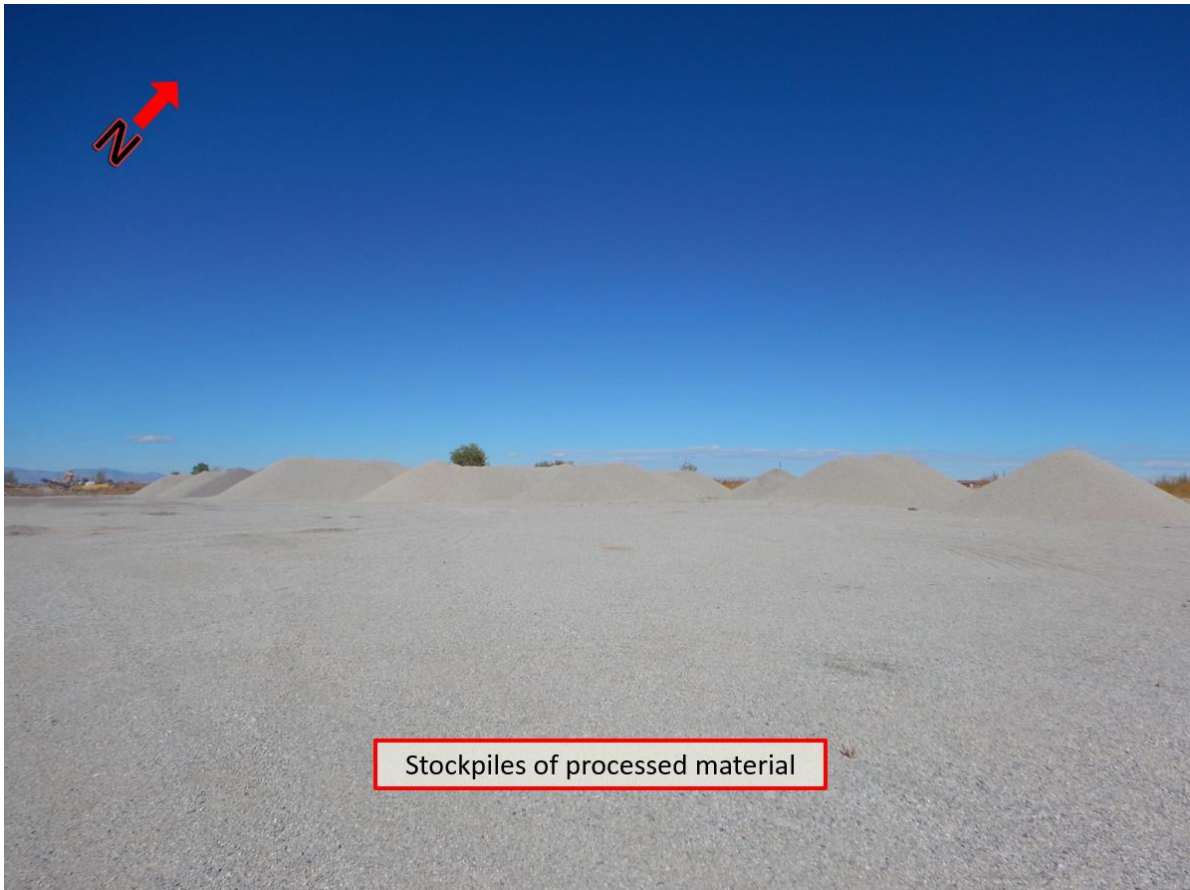
Stockpiles of processed material

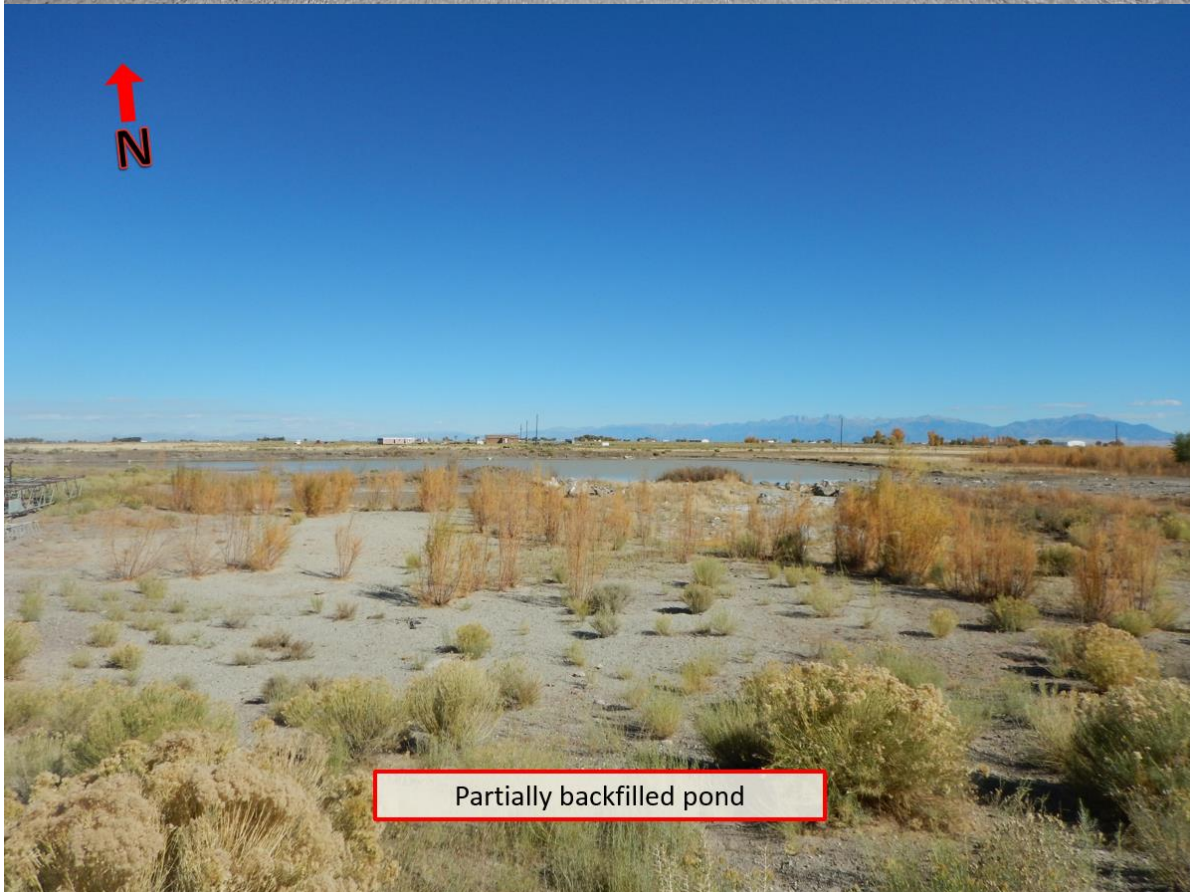
The eastern ~13 acres has been mined out and partially reclaimed. One of the pit ponds has been backfilled and has some vegetation growing on it. There is a good amount of volunteer willows growing in these areas since the water table is so close to the surface. Excess material is stockpiled adjacent to the mine entrance. Stockpiles are stable and generally sloped 2:1. They are up to 20' tall and organized into several piles based on material class. Areas under the stockpiles and the road will need to be ripped if not mined out to prevent excessive compaction.

Partially backfilled pond
