MINERALS PROGRAM INSPECTION REPORT
PHONE: (303) 866-3567

MINE NAME: Swede Corners Pit	MINE/PROSPECTING ID#: M-1988-087	MINERAL: Sand and gravel	COUNTY: Saguache
INSPECTION TYPE: Surety Release Inspection	INSPECTOR(S): Amy C. Yeldell	INSP. DATE: October 6, 2016	INSP. TIME: 09:00
OPERATOR: Southway Construction Company, Inc.	OPERATOR REPRESENTATIVE: Ralph Martinez	TYPE OF OPERATION: 110c - Construction Limited Impact	
REASON FOR INSPECTION: Surety Release Requested	BOND CALCULATION TYPE: None	BOND AMOUNT: \$11,270.00	
DATE OF COMPLAINT: NA	POST INSP. CONTACTS: U.S.BLM	JOINT INSP. AGENCY: None	
WEATHER: Windy	INSPECTOR'S SIGNATURE:

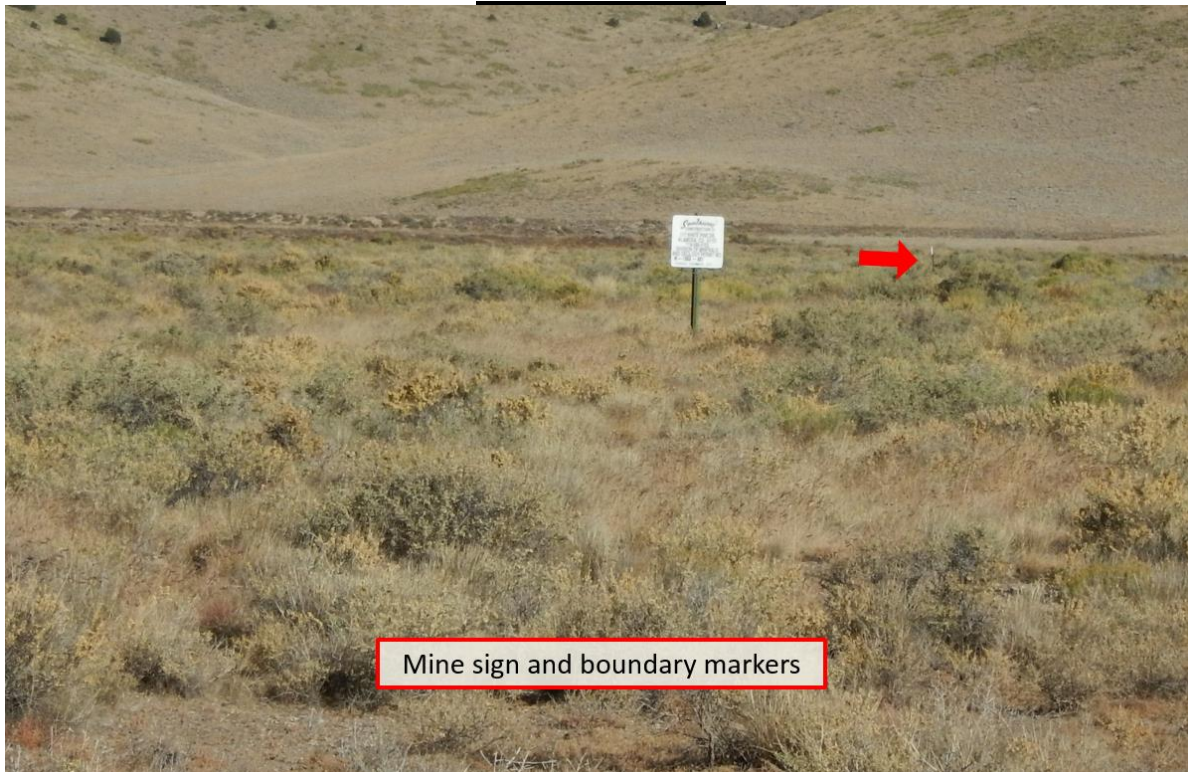
The mine identification sign and affected area boundary markers are in place and in compliance with Rule 3.1.12. The permit boundary is delineated by t-posts. The mine sign was posted along the reclaimed access road.

Mine sign and boundary markers

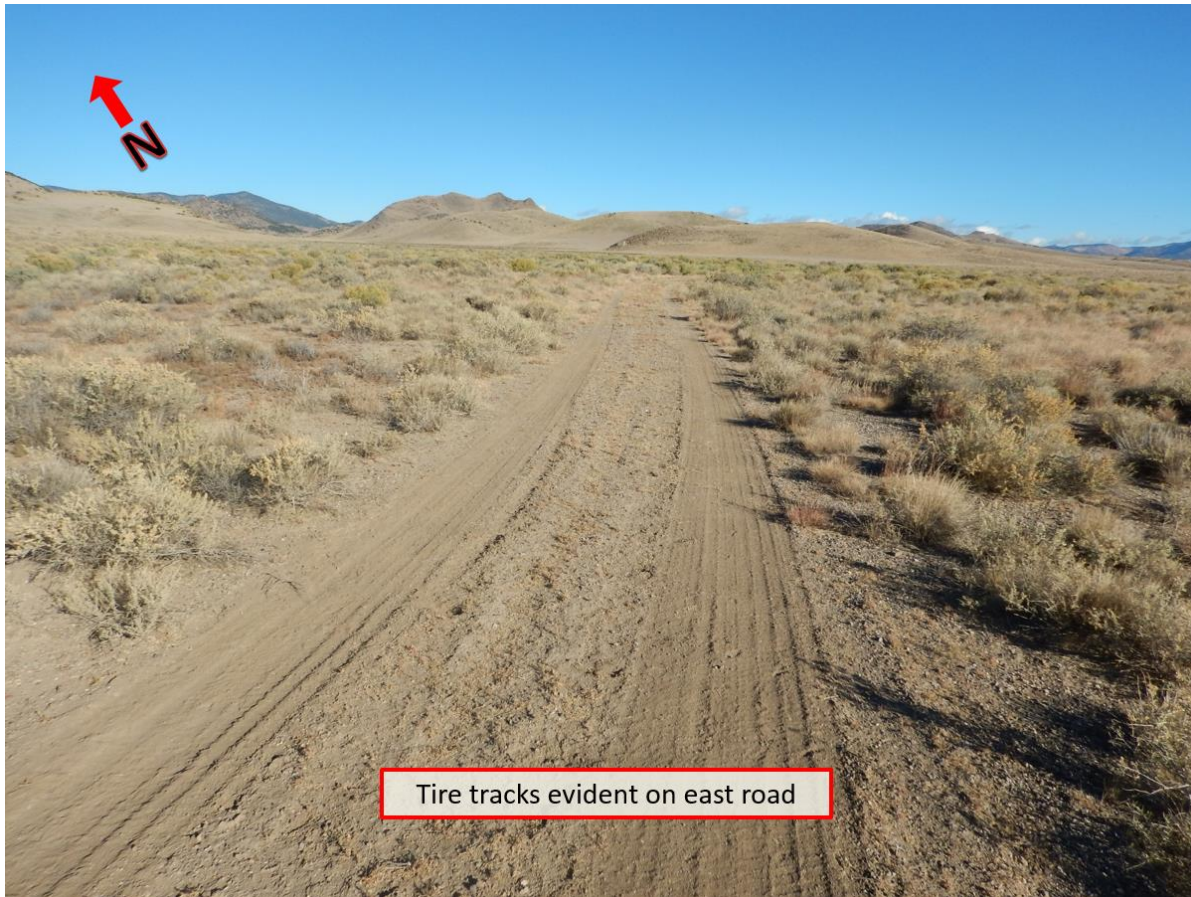
The mine access road does not meet the requirements of the approved reclamation plan. There appears to be two road that lead from County Road T to the pit. Mr. Martinez indicated that the mining road was the more westerly one which is where the mine sign is located. Based on satellite imagery both roads appear to be to have been in existence prior to 1999, however based on the imagery quality the Division is unable to determine the extent of these disturbances. Based on the map submitted with the permit application the western road more closely resembles the road indicated on the map. The western road appears to have been reclaimed however the vegetation is not dense enough in some areas. Also there is large amount of Russian Thistle, especially as you move towards the county road. The eastern road is a two track road with very little vegetation. Vegetation on the eastern road may be the result of volunteer establishment rather than actual reclamation. Neither road is releasable.

Tire tracks evident on east road

For areas requiring additional reclamation the Division recommends that work is done this fall. Compacted areas such as roads with visible vehicle traffic would likely benefit from additional tillage. Also the operator should explore methods to preclude unwanted vehicle traffic through reclaimed areas. This may be achieved by placing a temporary fence along the access road, placing large boulders or adding additional signage. Please get approval from BLM prior to implementing any of the above mentioned suggestions or other methods. Additional noxious weed treatments, specifically to control annuals such as Russian thistle (tumbleweed) will greatly benefit this site. Newly established plants can easily be choked out by quick growing noxious weeds. Please be advised that a Pesticide Use Permit (PUP) is required to use chemical herbicides on federal lands. Please ensure that you or your contractor has all the necessary requirements prior to beginning applications.

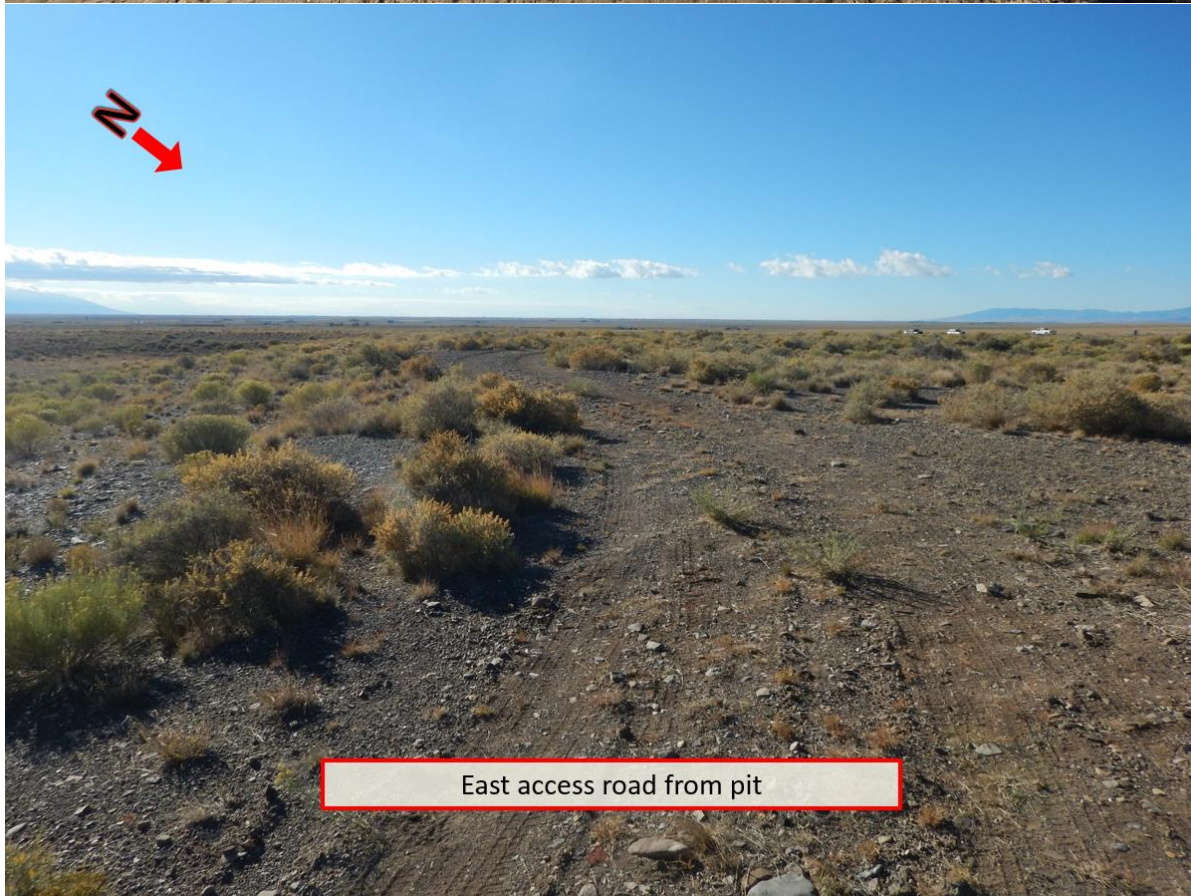
East access road from pit

The Division recommends that the operator submits an acreage release for the pit slopes and floor. The access road which was permitted but is not depicted on recent annual report maps should not be requested for release as it needs additional reclamation work. Approximate half an acre will need to remain permitted. If the operator submits an acreage release request within 60-days of this report, the Division will consider this a release inspection for that area. Please note that in order to release any permitted acreage on Federal lands, DRMS must first get concurrence from the BLM prior to final approval.
