**MINERALS PROGRAM INSPECTION REPORT**  
**PHONE: (303) 866-3567**

<b>MINE NAME:</b> Rancho Rosado	<b>MINE/PROSPECTING ID#:</b> M-1985-085	<b>MINERAL:</b> Sand and gravel	<b>COUNTY:</b> Saguache
<b>INSPECTION TYPE:</b> Monitoring	<b>INSPECTOR(S):</b> Amy C. Yeldell	<b>INSP. DATE:</b> October 5, 2016	<b>INSP. TIME:</b> 13:20
<b>OPERATOR:</b> Gary C Boyce	<b>OPERATOR REPRESENTATIVE:</b> Benito Rascon	<b>TYPE OF OPERATION:</b> 112c - Construction Regular Operation	
<b>REASON FOR INSPECTION:</b> Normal I&E Program	<b>BOND CALCULATION TYPE:</b> Complete Bond	<b>BOND AMOUNT:</b> \$15,001.00	
<b>DATE OF COMPLAINT:</b> NA	<b>POST INSP. CONTACTS:</b> None	<b>JOINT INSP. AGENCY:</b> None	
<b>WEATHER:</b> Windy	<b>INSPECTOR'S SIGNATURE:</b>

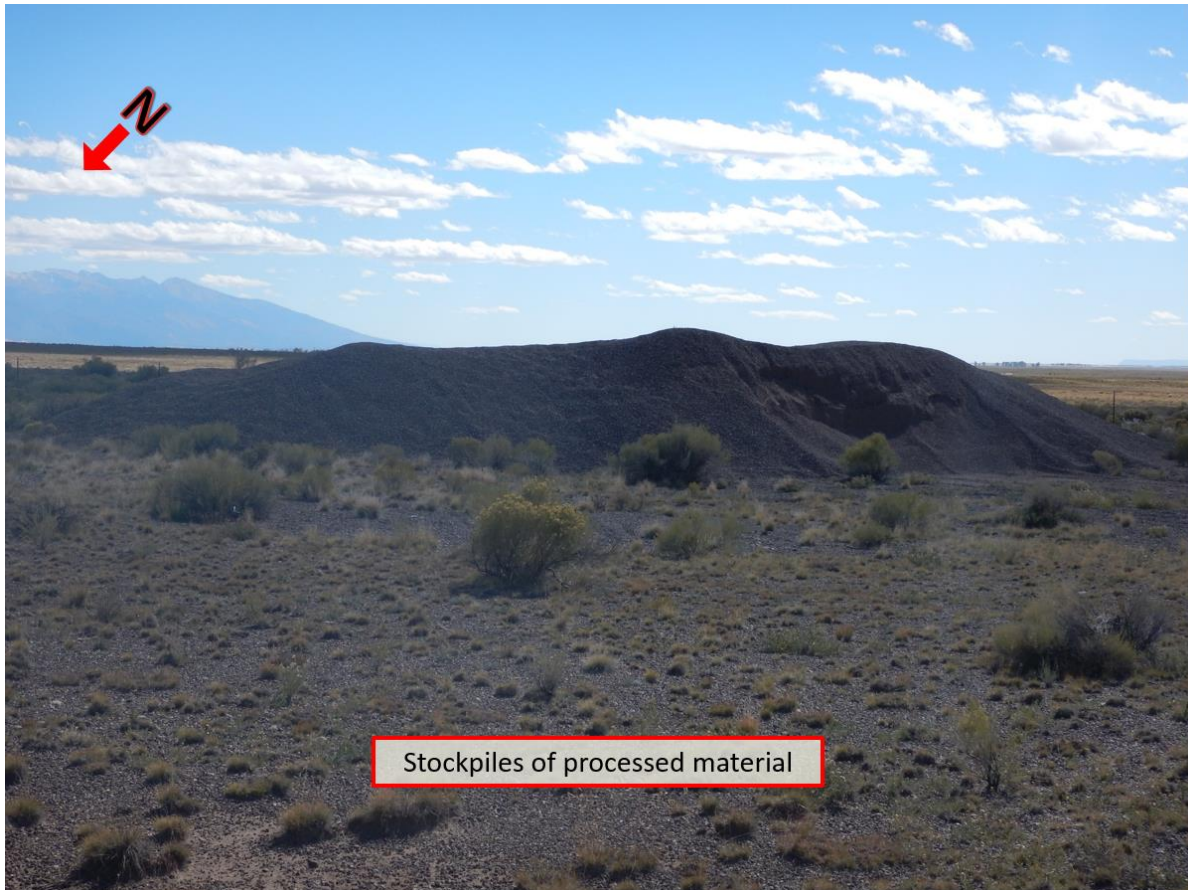
Stockpiles of processed material

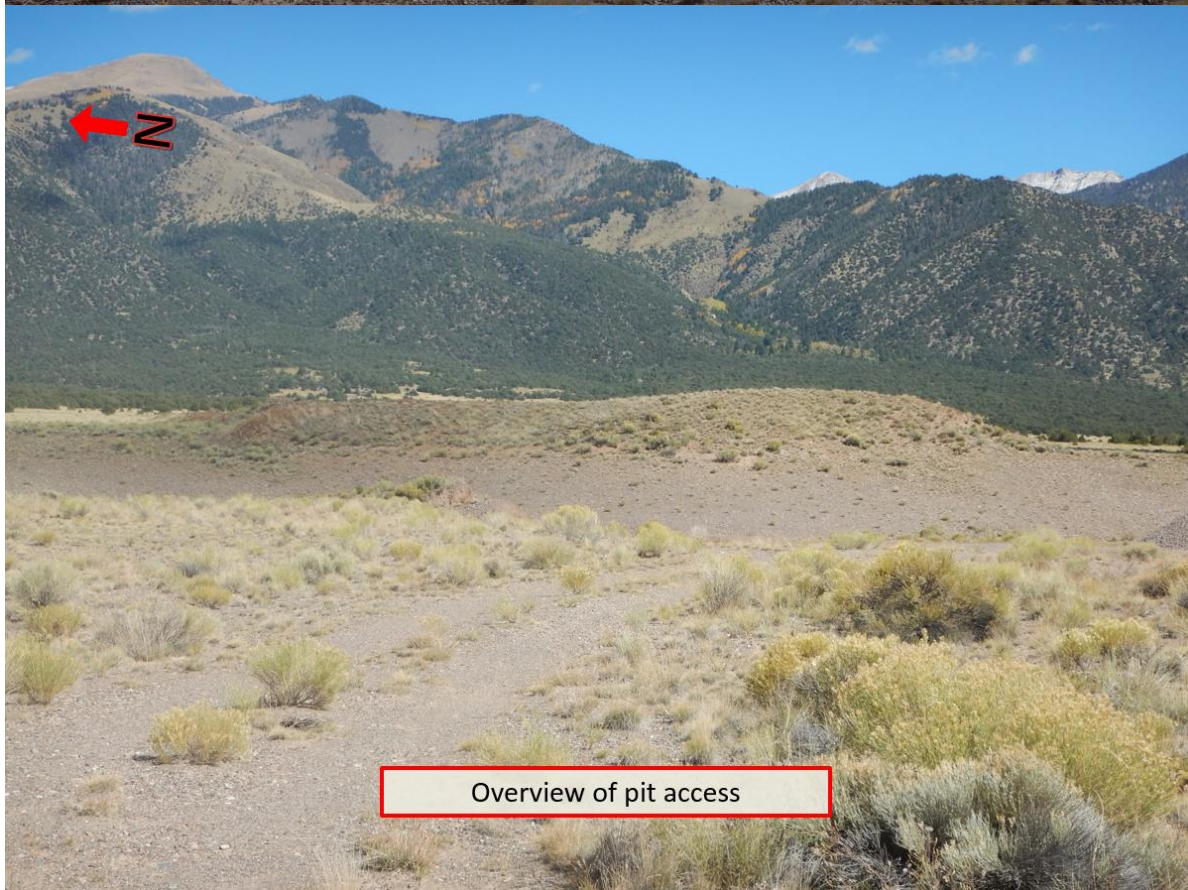
Overview of pit access
