Bowie No. 2, 3Q Gob & Pond Inspection Report

Re: Bowie Resources, LLC, Bowie No. 2 Mine
Coal Mine Waste Banks & Instrumentation Monitoring
Pond Quarterly Inspections
Permit C-1996-083

Coal Mine Waste Bank Nos. 1, 2, & 3 Inspections - 3rd Quarter 2016

Subject: Summary of Instrumentation Monitoring
3rd Quarter 2016
Bowie Coal Waste Disposal Area No. 2
Paonia, Colorado

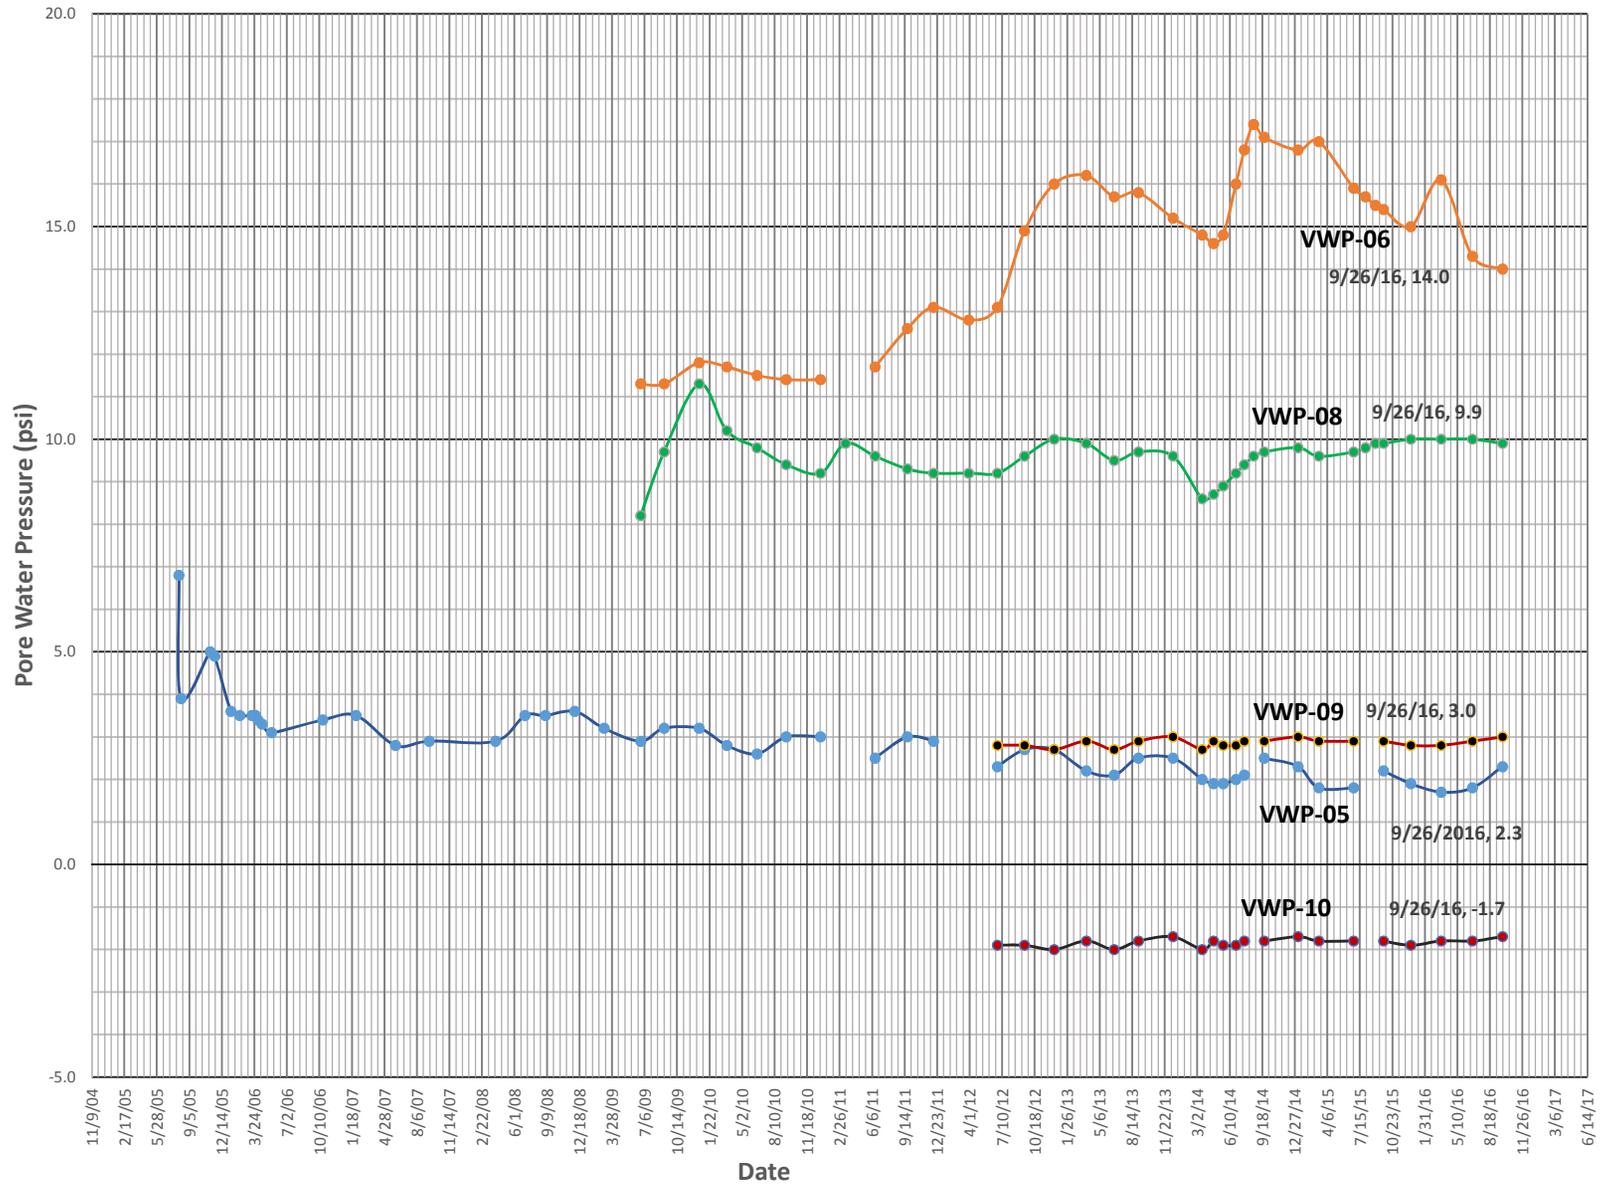
FIGURE 2

The latest inclinometer readings indicate no major movements since the last quarterly reading. As indicated in the DOWL report, the movements noted in BGO5-05 and BGO5-07 during the previous two quarters have reversed and/or stabilized. It is possible that the previously reported movements were due to an instrument error or other error which did not reflect actual movement of the gob. In general, the 3rd Quarter 2016 monitoring data does not provide any indication of instability in CWDA No. 2.

The current pore pressure reflects a piezometric surface elevation of approximately 6098 feet which is much less than the critical elevation of 6113 feet. As a result, HBET does not believe that the measured pore pressures in VWP-08 are any indication of instability in CWDA No. 2.

In general, based upon the results of the recent VWP and inclinometer monitoring data, and upon our observations at the site, HBET does not believe that there is any reduction in the stability of CWDA No. 2. Continued quarterly monitoring of piezometers and inclinometers is recommended.

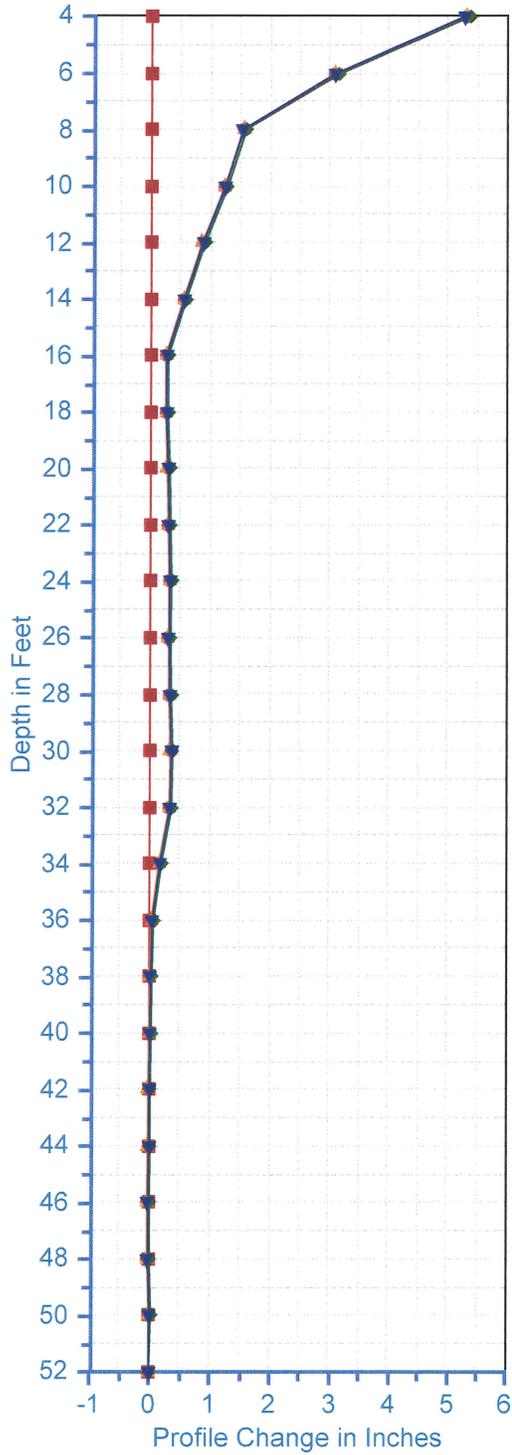
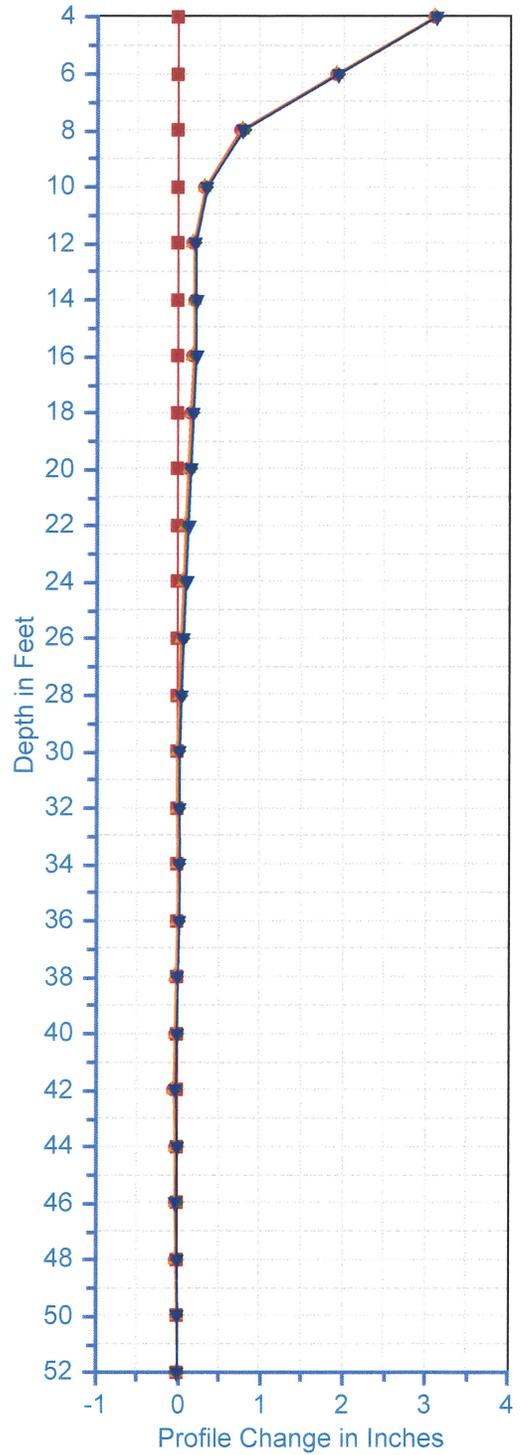
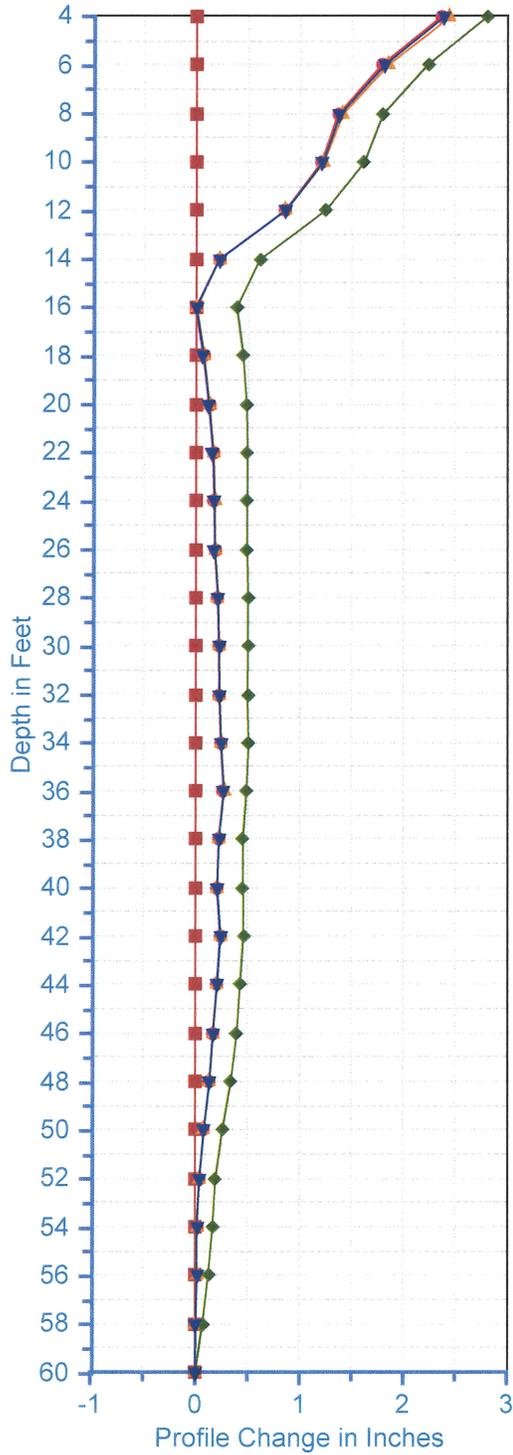
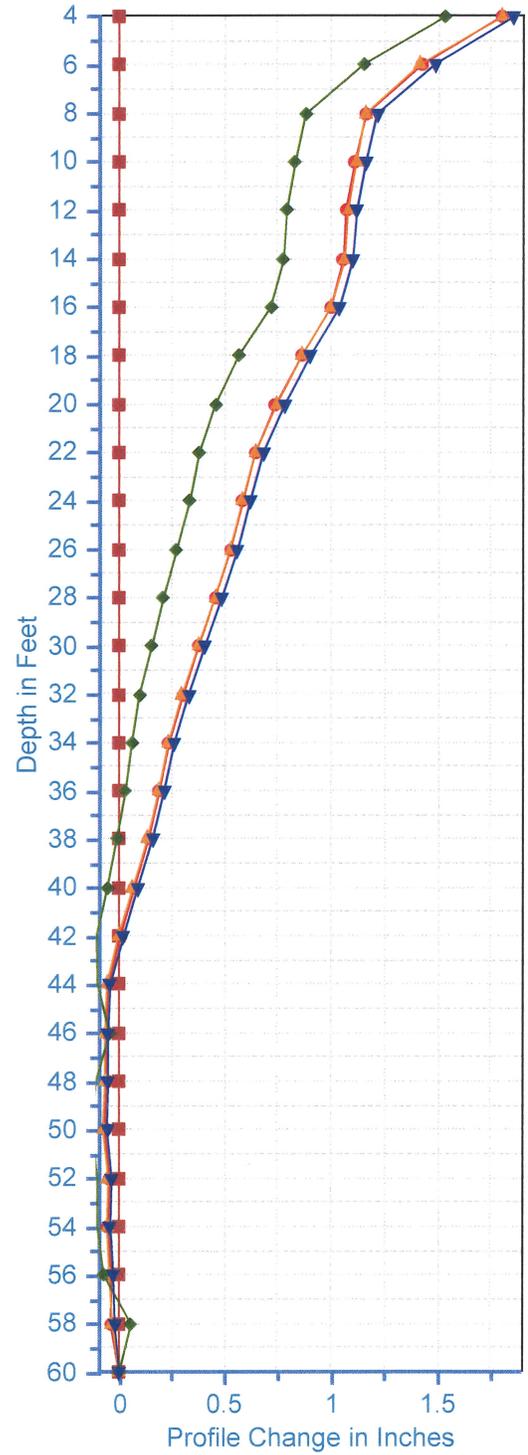
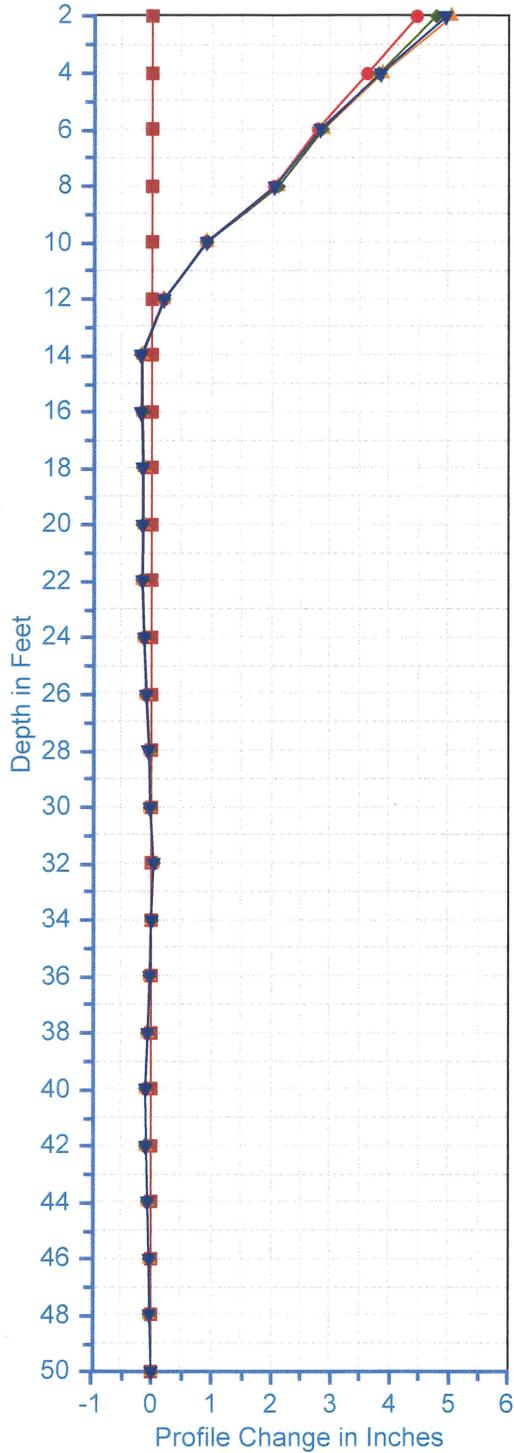
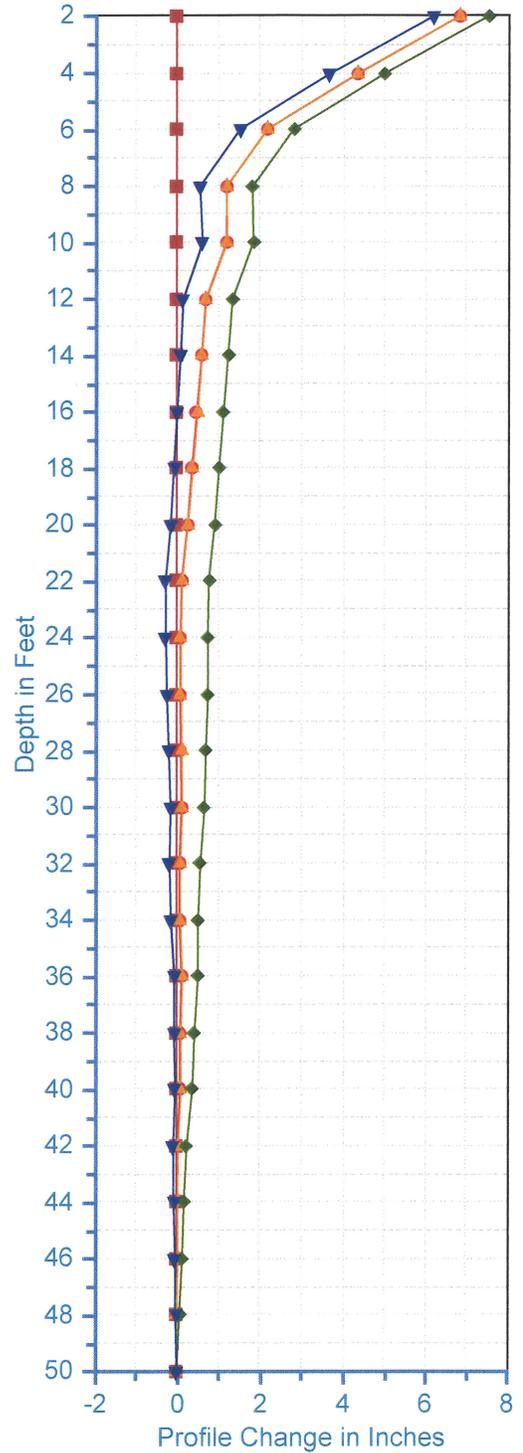
reversed or stabilized, which would seem to indicate that the movements are within the accuracy tolerance of the equipment. As described in previous reports, we are of the opinion that historic displacements indicated on the plots for the approximate upper ten feet of the inclinometers are likely due to placement of cover soil on the face of the waste bank during normal operations.

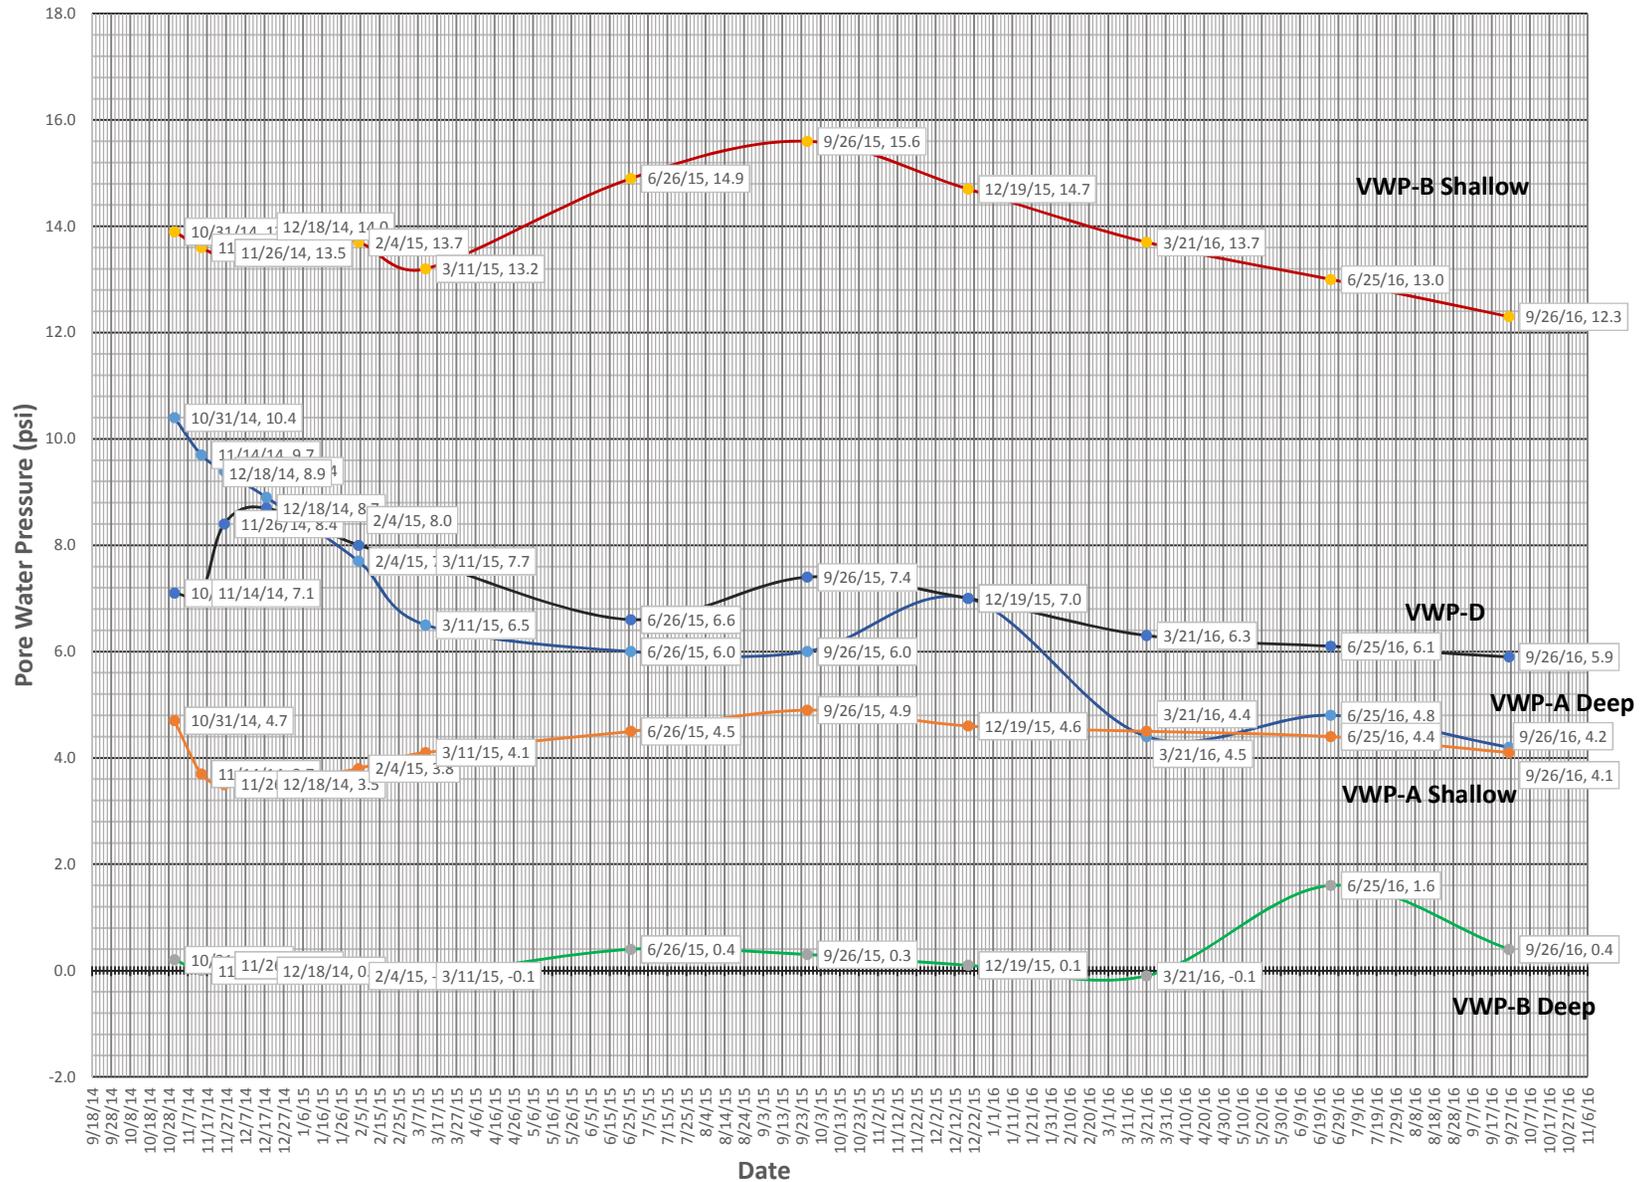
FIGURE 1

VWP-A Deep was installed on October 6, 2014 near the northern edge of CWDA No. 3. VWP-A Deep was installed in the foundation soil approximately eight feet below the bottom of the gob. The pore pressures recorded at VWP-A Deep generally decreased since installation until September 2015. Between September and December 2015, the pore pressures increased slightly. However, the pore pressures dropped significantly between December 2015 and March 2016. A slight increase was recorded since March; however, the pore pressures again dropped between June and September 2016. In general, HBET does not believe that the pore pressure changes in VWP-A Deep are cause for concern regarding stability of the gob pile.

VWP-B Deep was installed on October 6, 2014 in the west-central portion of CWDA No. 3. VWP-B Deep was installed in the foundation soil approximately ten feet below the bottom of the gob. Since installation, the pore pressures recorded at VWP-B Deep were fairly constant through March 2016. A slight increase was recorded between March and June 2016; however, the pore pressures dropped between June and September 2016. In general, HBET does not believe that the pore pressure changes in VWP-B Deep are an indication of instability in CWDA No. 3.

Based upon the results of the most recent VWP monitoring data and upon our observations at the site, HBET does not believe that there is any reduction in the stability of CWDA No. 3. Continued quarterly monitoring of piezometers and inclinometers is recommended.
