**COLORADO**Division of Reclamation,
Mining and Safety

MINERALS PROGRAM INSPECTION REPORT**PHONE: (303) 866-3567**

MINE NAME: Sunnyside Gold Mine	MINE/PROSPECTING ID#: M-1977-378	MINERAL: Lead, zinc, copper, iron	COUNTY: San Juan
INSPECTION TYPE: Multi Person Inspection	INSPECTOR(S): Lucas J. West, Russ Means	INSP. DATE: October 3, 2016	INSP. TIME: 12:00
OPERATOR: Sunnyside Gold Corp	OPERATOR REPRESENTATIVE: Larry Perino	TYPE OF OPERATION: 112 - Hard Rock Regular Operation	
REASON FOR INSPECTION: Normal I&E Program	BOND CALCULATION TYPE: None	BOND AMOUNT: \$60,534.00	
DATE OF COMPLAINT: NA	POST INSP. CONTACTS: None	JOINT INSP. AGENCY: None	
WEATHER: Cloudy	INSPECTOR'S SIGNATURE:

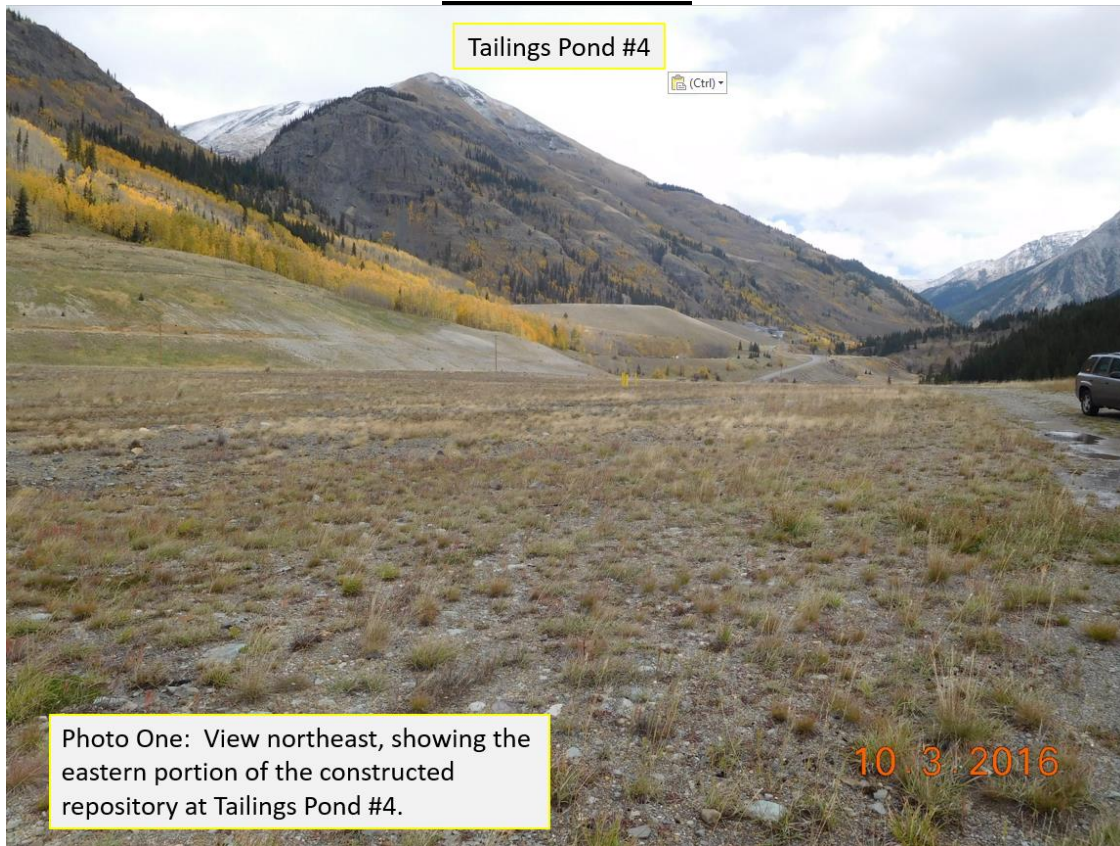
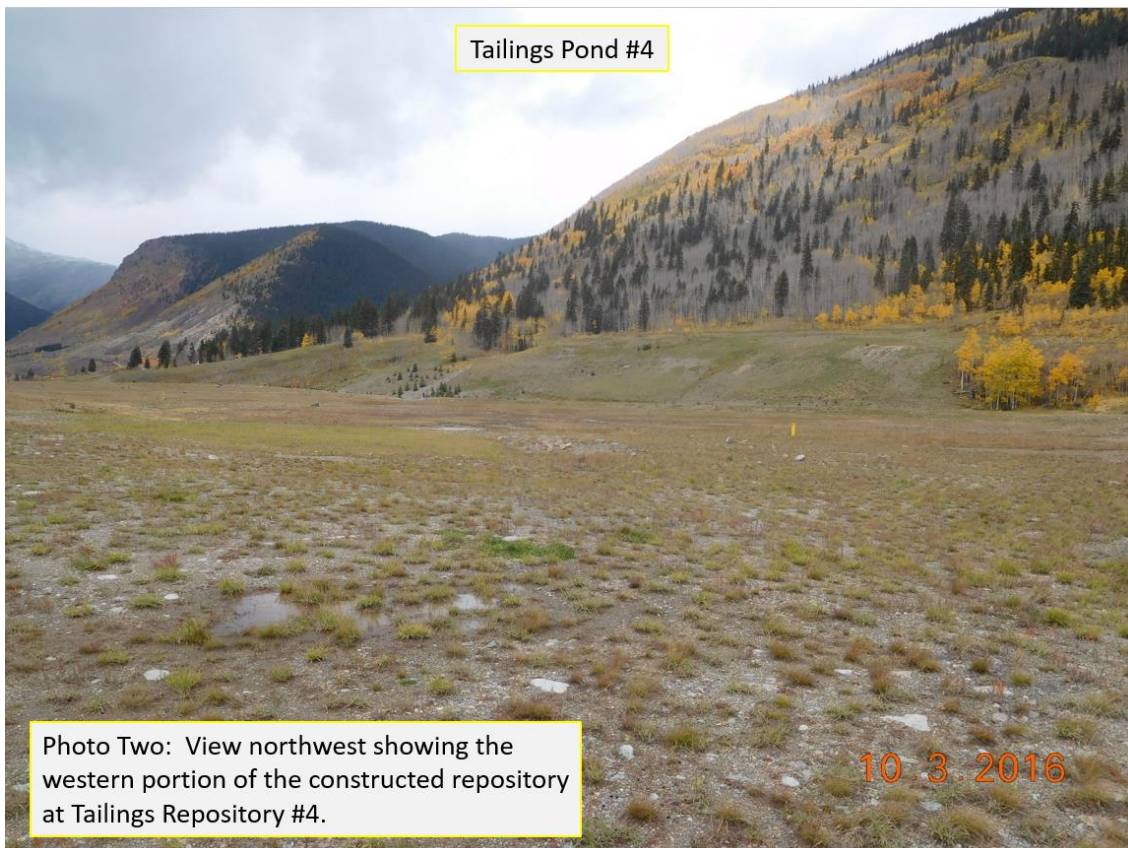
The side slopes and top of the constructed repository appear to be stable and are in good condition. Photos One and Two show the top of the repository which is well vegetated and showing signs of self-sustainment with previous years biomass observed. The operator expressed that vegetation management is ongoing and continuous, and evidence of chemical weed treatment was observed on site. 8 monitoring wells were observed on the top of the repository, all of which were properly collared and secured. Photo Three shows an example of the covers on the wells. The repository exhibits positive drainage and no impounded storm water or erosional issues were noted. The upland diversion ditch was inspected and appeared to be functioning as designed. The ditch is well vegetated, appears to be stable and can be seen in Photo Four.

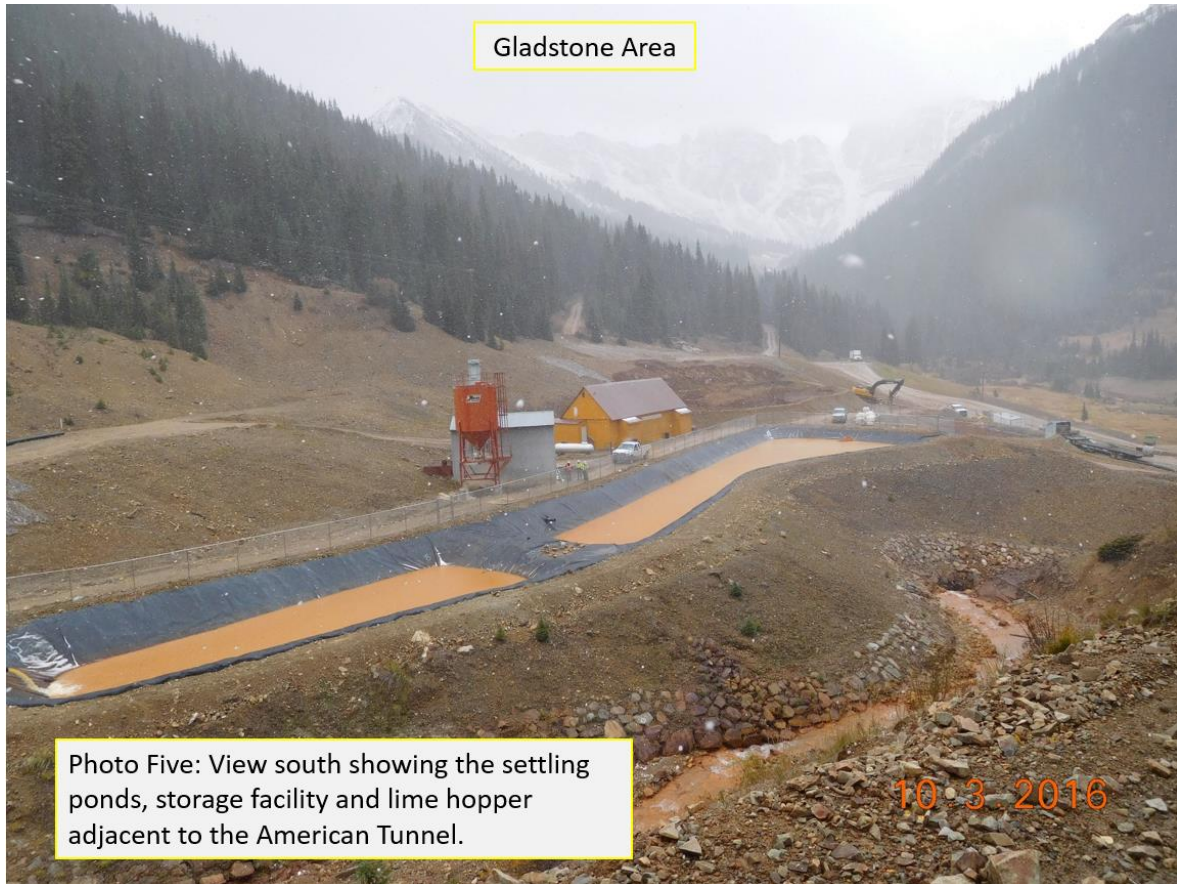
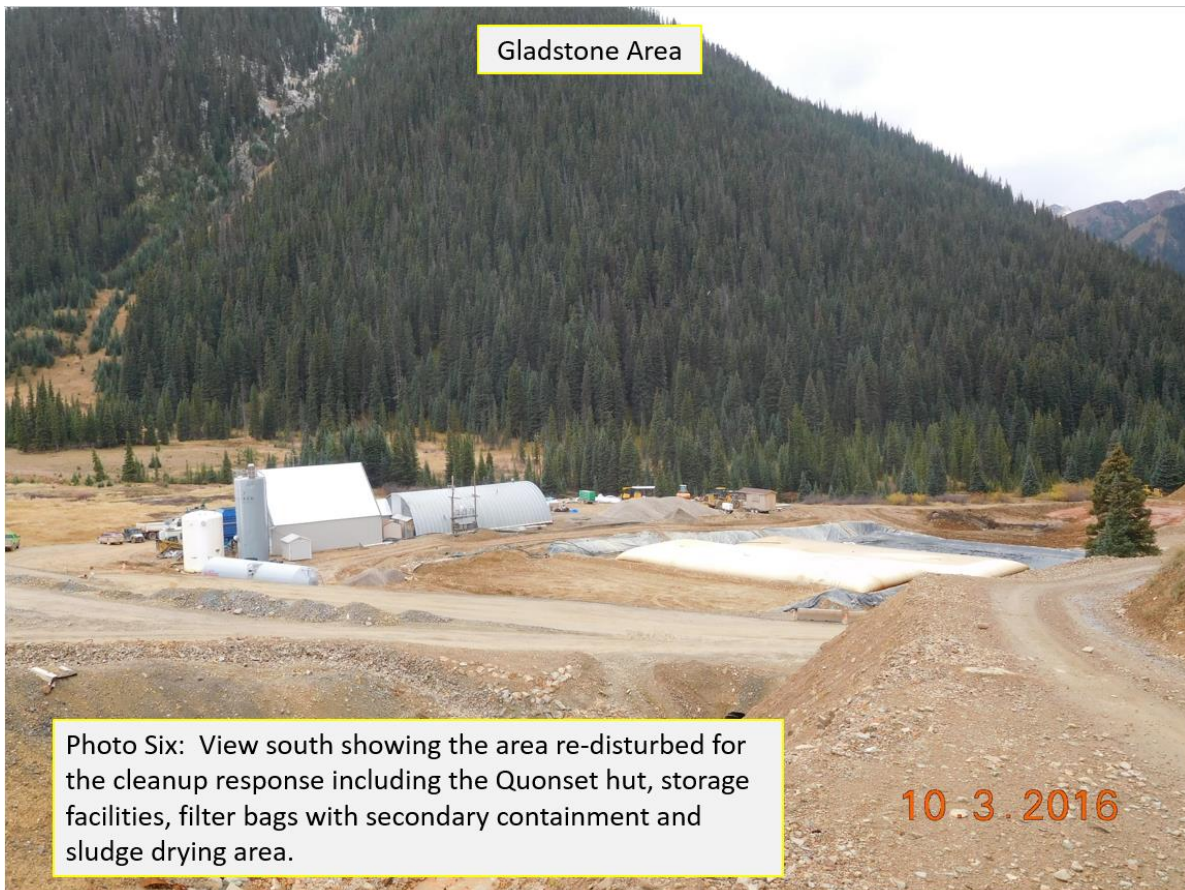
The majority of the Gladstone area has been re-disturbed for use in the EPA cleanup efforts in response to the Gold King spill. Photos Five and Six show the recently constructed facilities that include settling ponds, storage facilities, large Quonset hut, filter bags with secondary containment, as well as a sludge drying area. Approximately 80% of the permitted lands at the Gladstone area have been disturbed. A small area of the permitted lands adjacent to the Quonset hut was left undisturbed the EPA shown in Photo Seven. This area appears to be stable and in good condition. The vegetation in the area is in similar, if not better, condition than the adjacent undisturbed lands and appears to be well established, diverse and capable of regeneration. There were no noxious weeds, or significant erosion noted in this area.
