MINERALS PROGRAM INSPECTION REPORT

MINE NAME: Flying Horse Pit	MINE/PROSPECTING ID#: M-2013-012	MINERAL: Borrow material	COUNTY: Park
INSPECTION TYPE: Monitoring	INSPECTOR(S): Michael A. Cunningham	INSP. DATE: October 13, 2016	INSP. TIME: 10:00
OPERATOR: Kirkland Construction, R.L.L.P.	OPERATOR REPRESENTATIVE: None	TYPE OF OPERATION: 111 - Construction by Government Agency

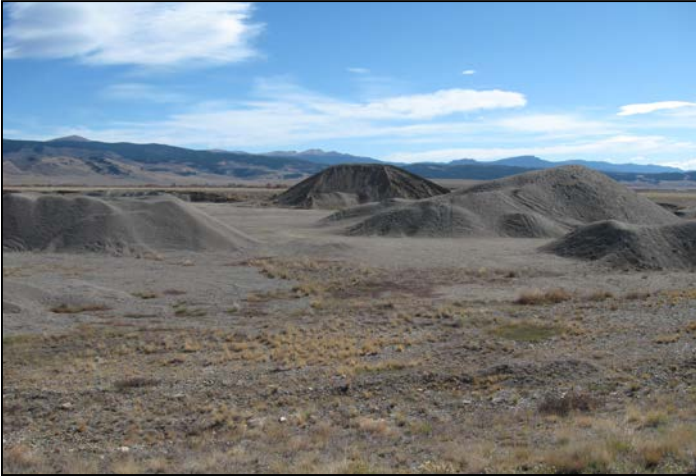
A scale and scale house are located at the site entrance, no equipment was observed within the pit. There were numerous product stockpiles remaining on the pit floor. The product stockpiles will either need to be hauled from the site or graded into the pit floor and pit walls. The pit walls along the western boundary and portions of the southern boundary were not disturbed and are at a 3H:1V angle and are vegetated. The pit walls around the remainder of the site are nearly vertical at the natural angle of repose. The Division estimates there are 1,400 ft. of highwall which will need to be graded. The pit floor lies approximately 10 ft. below the natural ground surface.

1. Product stockpiles on pit floor.

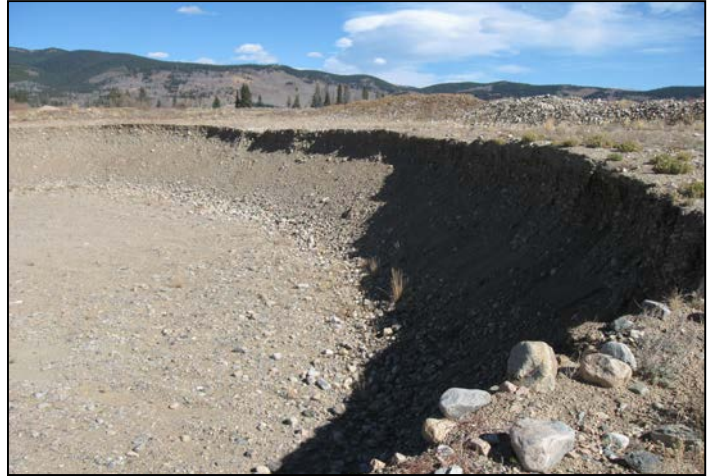
Based on observations made during the inspection and the information provided in the Annual Report, no reclamation has been performed to date. As required by Rule 3.1.3, all reclamation must be carried to completion within five years from the date the Operator informs the Division that mining is complete and reclamation has commenced. Since mining ceased in 2013, reclamation of the site should be carried to completion with all reasonable diligence by 2018. The Division encourages the Operator to commence reclamation as soon as is practical. The earthwork which must be completed at the site can be done within a single construction season. However, establishing vegetation at the site could take considerably longer.

2. Unreclaimed pit walls.

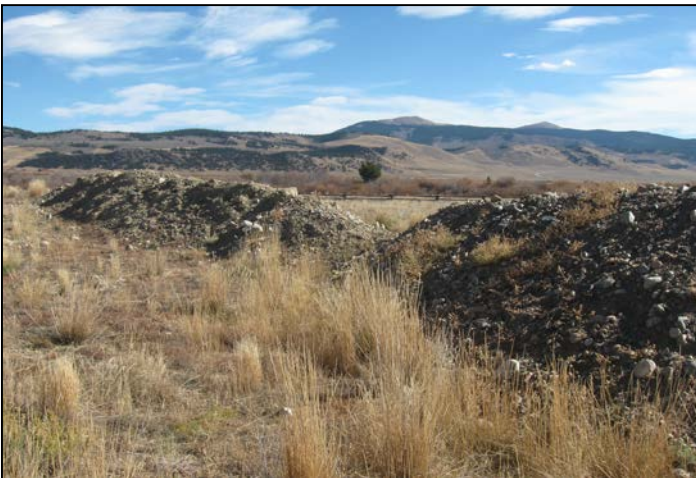
The Division observed topsoil stockpiles along the top of the pit walls. The stockpiles were stable and did not show any signs of erosion.

3. Topsoil stockpiles.

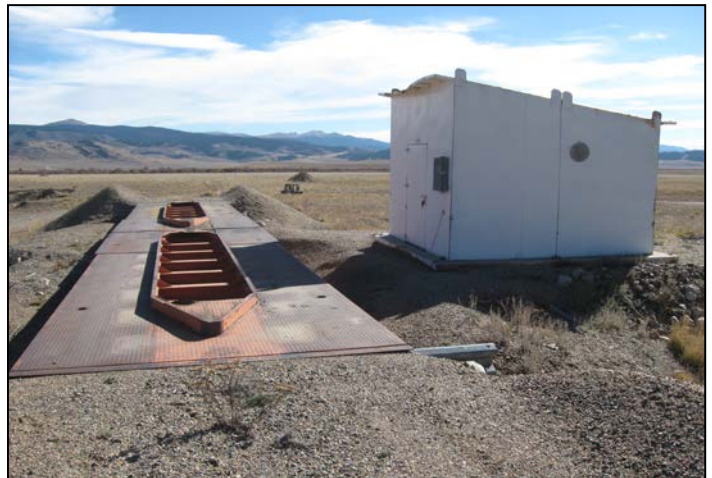
4. Scale house and scale.
