MINERALS PROGRAM INSPECTION REPORT
PHONE: (303) 866-3567

MINE NAME: Pueblo County Aggregate Project	MINE/PROSPECTING ID#: M-2016-009	MINERAL: Gravel	COUNTY: Pueblo
INSPECTION TYPE: Pre-operation Inspection	INSPECTOR(S): Elliott R. Russell	INSP. DATE: September 22, 2016	INSP. TIME: 10:30
OPERATOR: Fremont Paving & Redi-Mix, Inc.	OPERATOR REPRESENTATIVE: John Paul Ary	TYPE OF OPERATION: 112c - Construction Regular Operation	
REASON FOR INSPECTION: Pre-operation Inspection	BOND CALCULATION TYPE: None	BOND AMOUNT: No Bond Held	
DATE OF COMPLAINT: NA	POST INSP. CONTACTS: None	JOINT INSP. AGENCY: None	
WEATHER: Clear	INSPECTOR'S SIGNATURE:

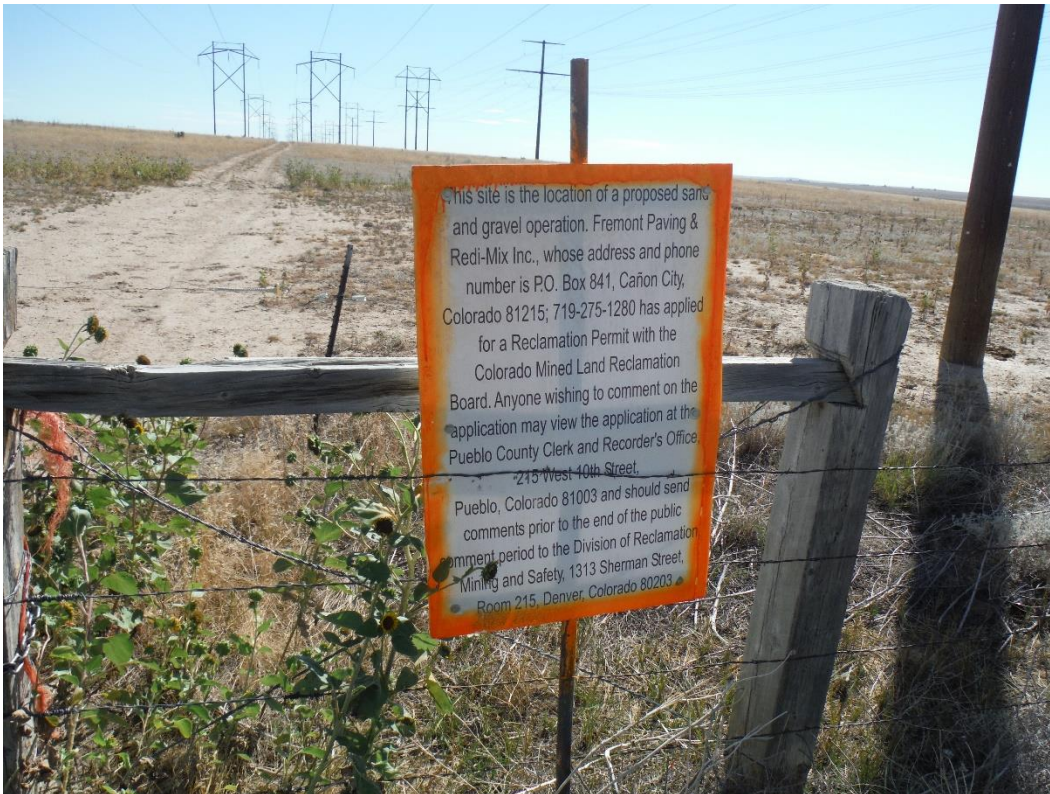
Photo 1. Site notice posted along 36th Lane; looking east.

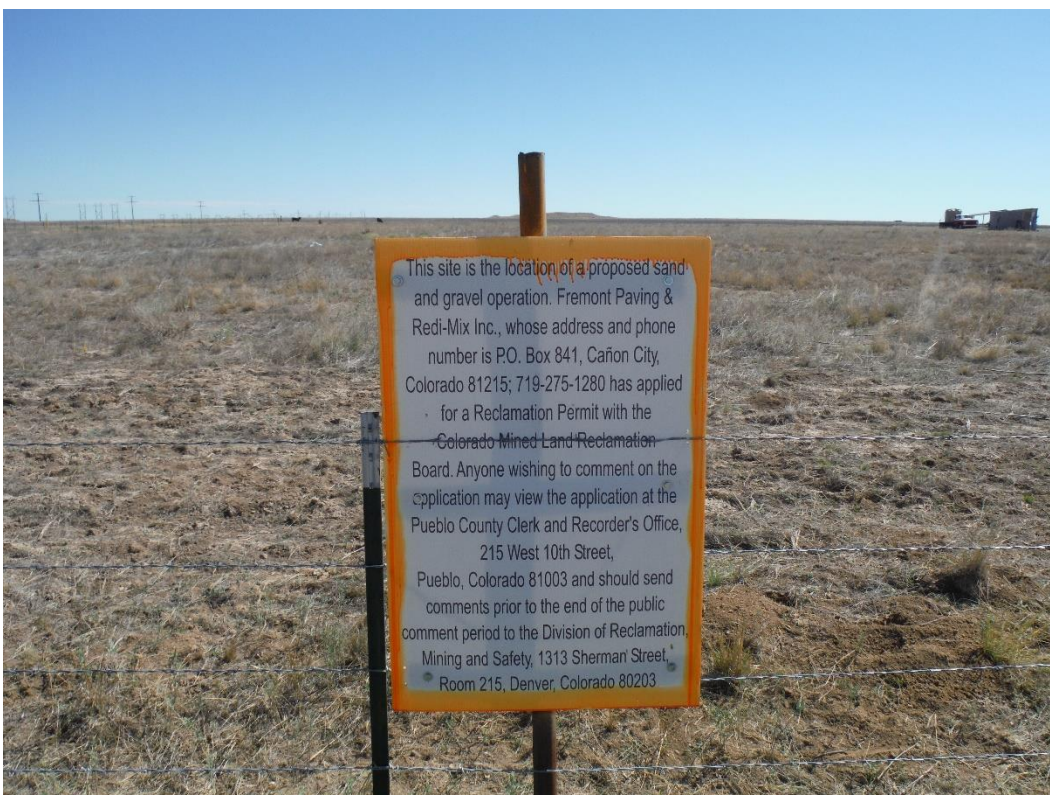
Photo 2. Site notice posted along 40th Lane; looking east.

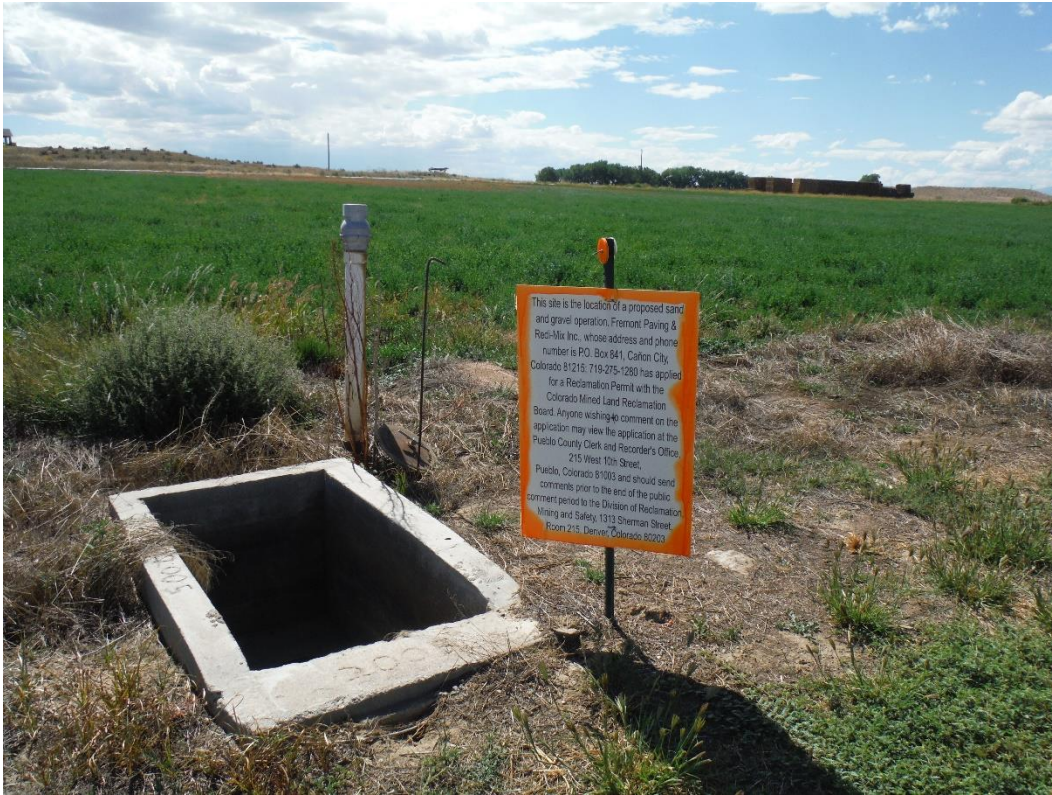
Photo 3. Site notice posted along Olsen Road; looking southwest.

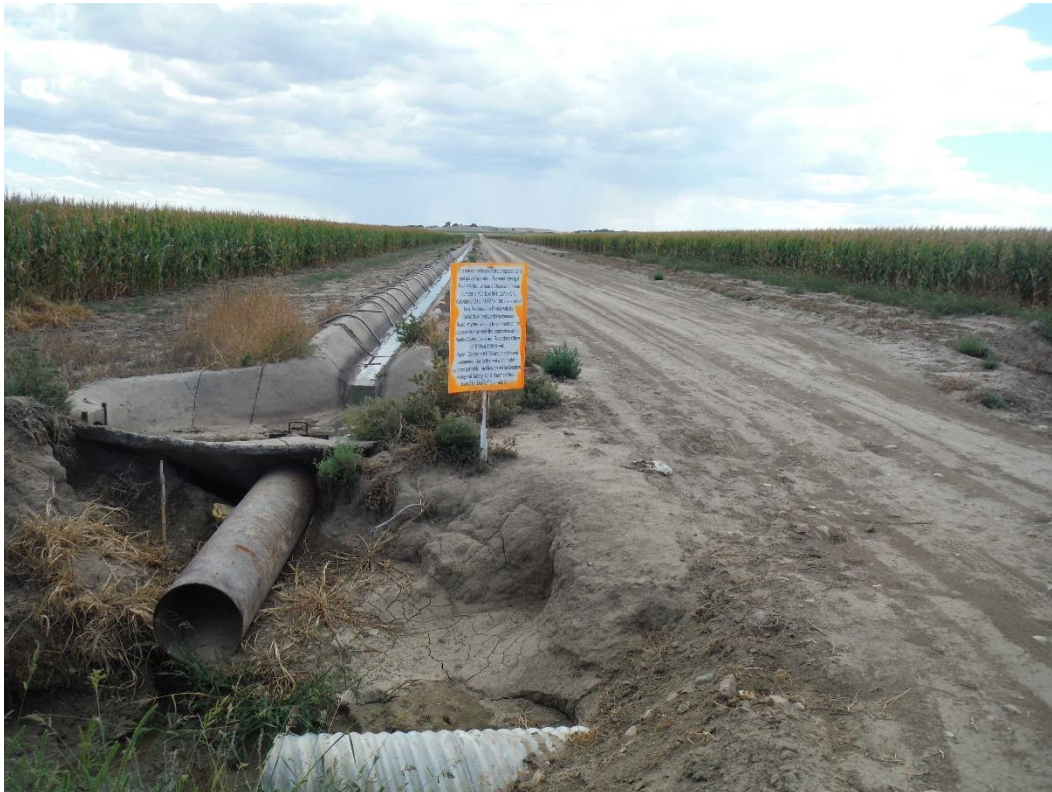
Photos 4. Site notice posted along Highway 50; looking south.

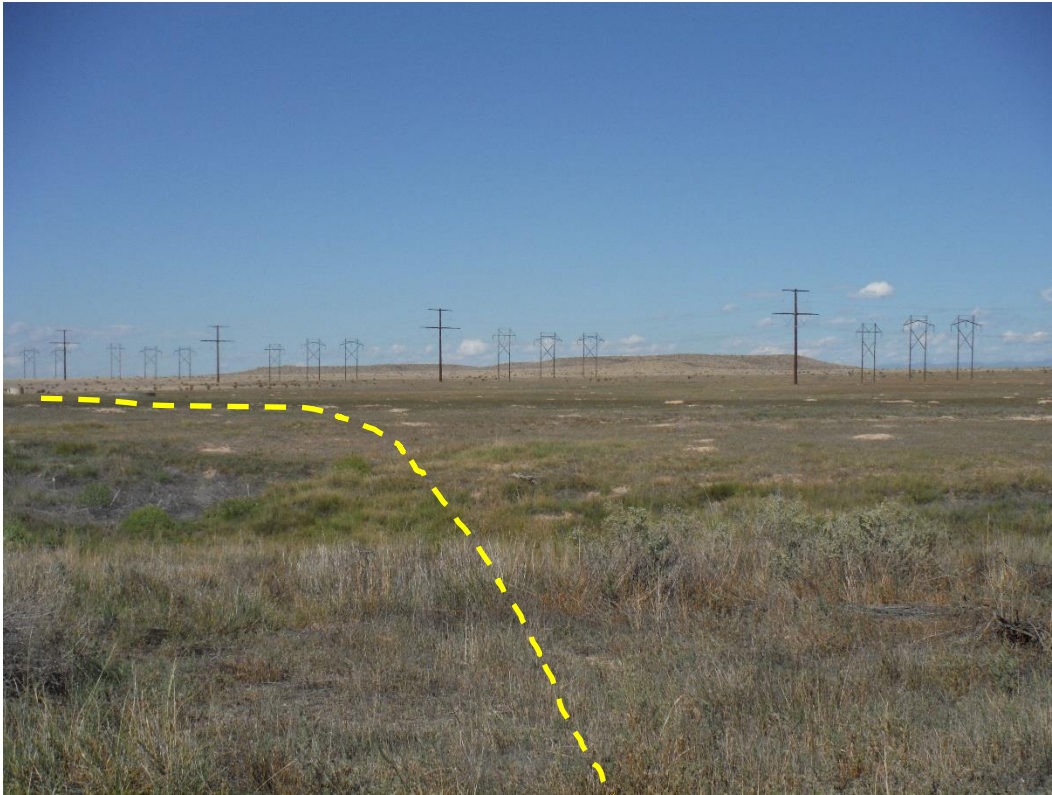
Photo 5. Approximate location of a segment of the Southwest Haul Road on the Thacker parcel; looking northwest.

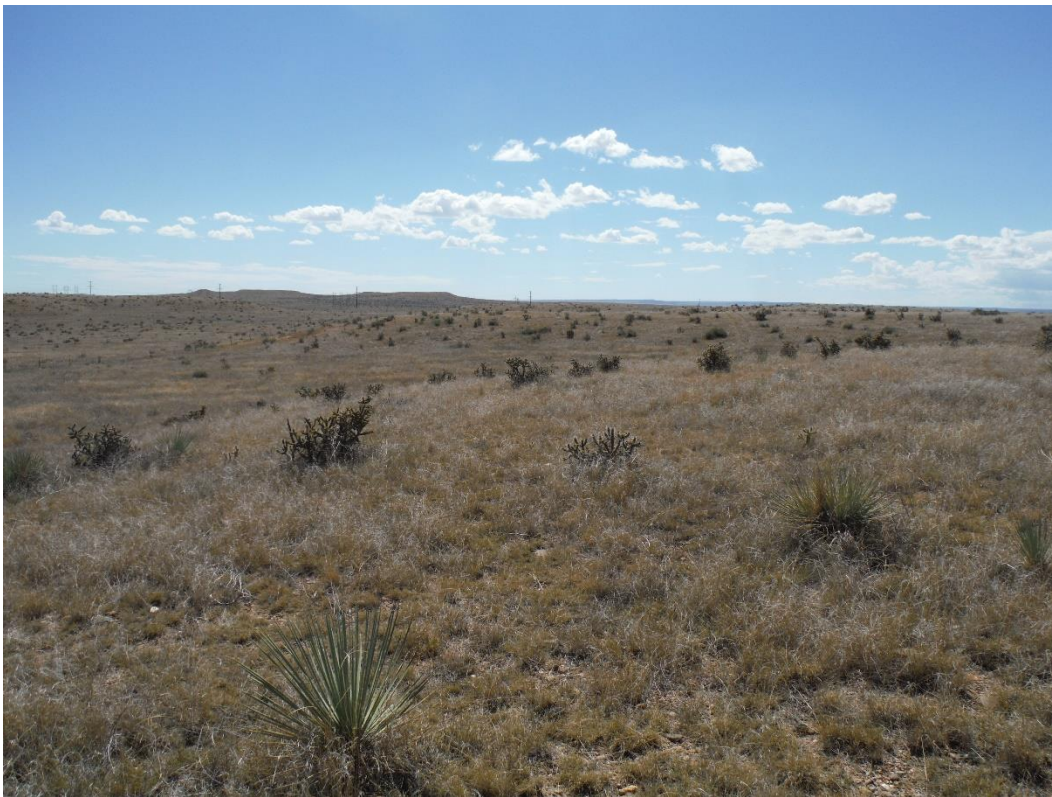
Photo 6. Sample photo of the existing vegetative cover on top of the gravel terrace in Phase I; looking south.

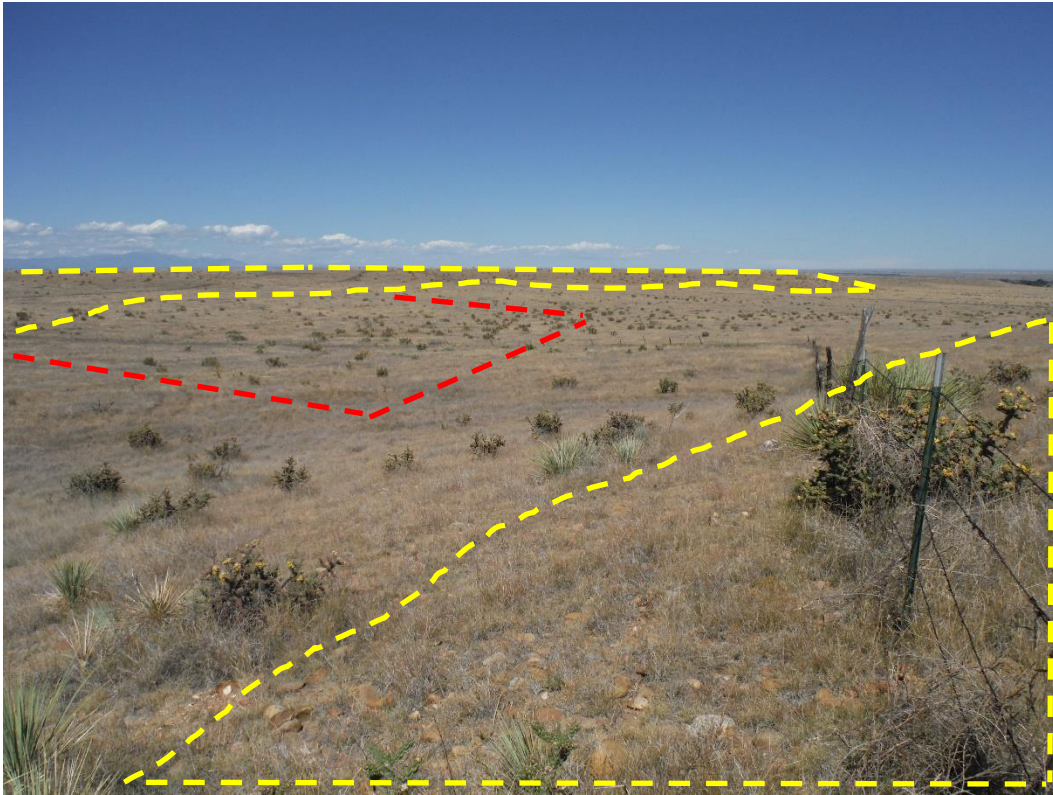
Photo 7. Approximation of Phase I activities, mining areas (yellow) and processing area (red); looking north.

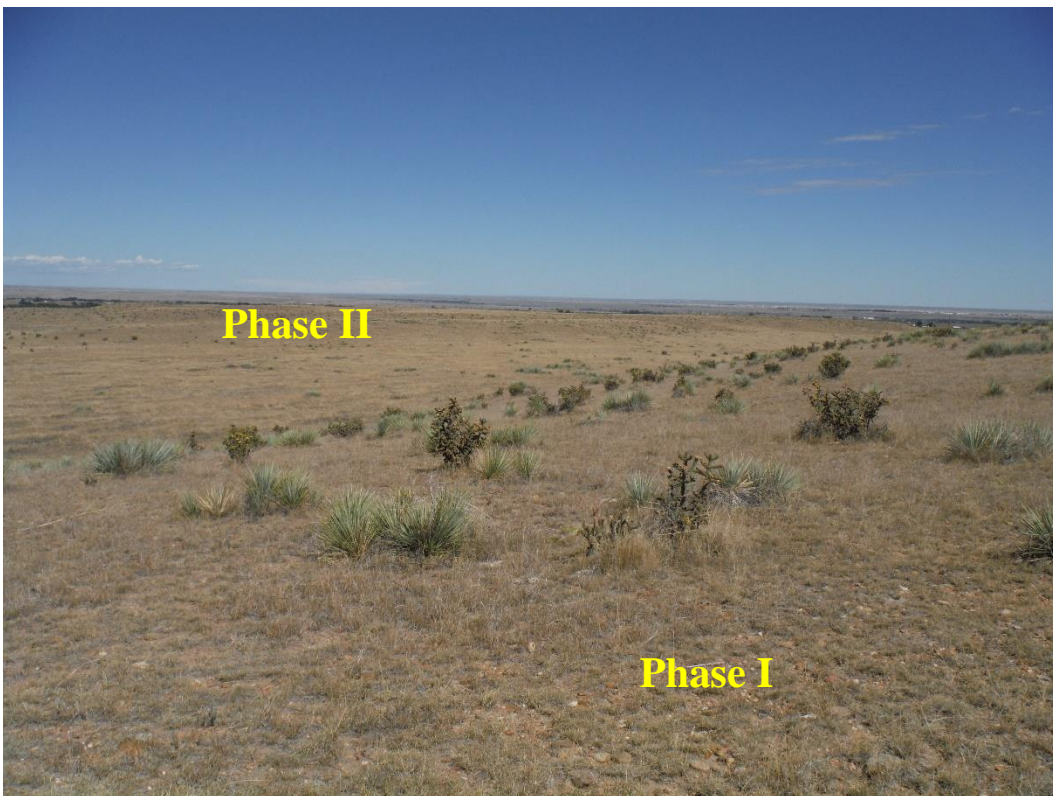
Photo 8. Phase II; looking north from Phase I area.

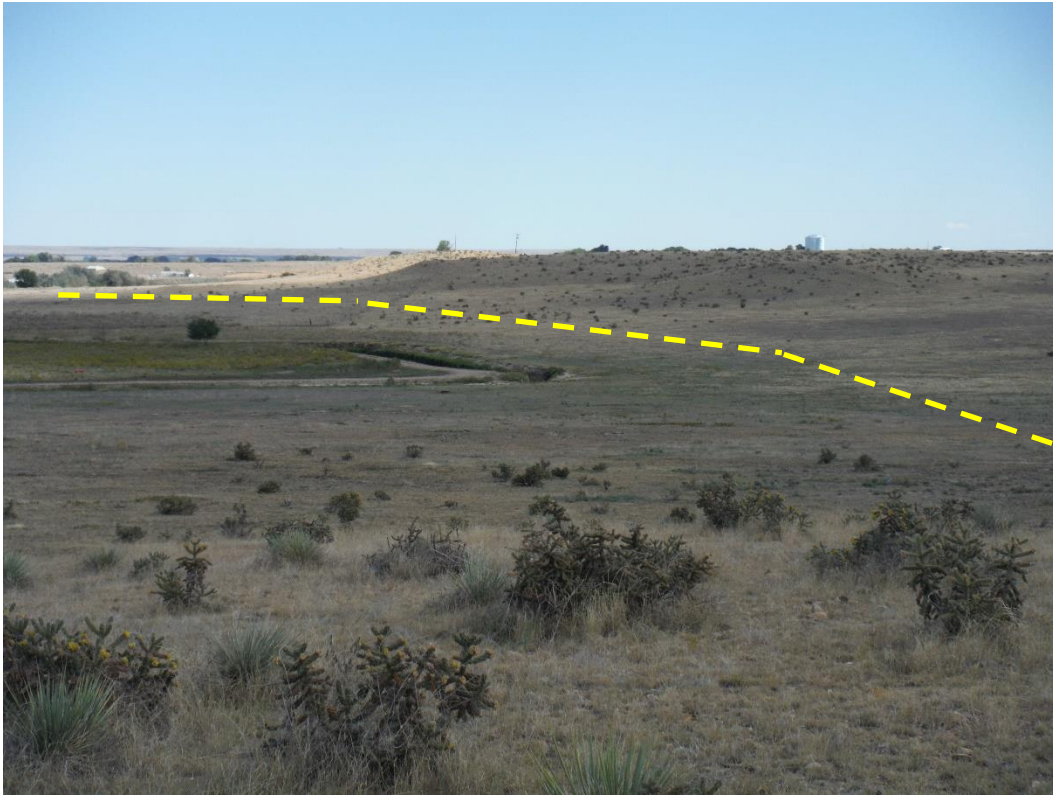
Photo 9. Approximation of the portion of the North Haul Road with 200 feet of the Bessemer Ditch; looking east.

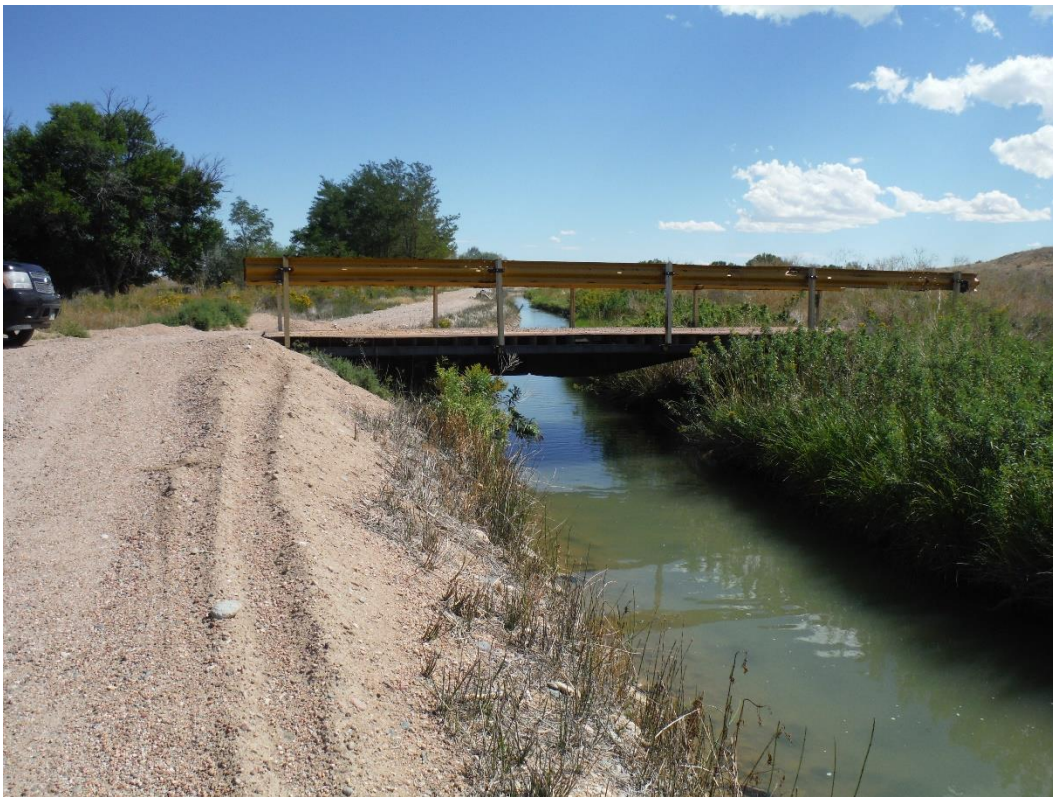
Photo 10. Existing bridge, which is the Applicant proposes to be improved/replaced for the North Haul Road, across the Bessemer Ditch; looking east (downstream).

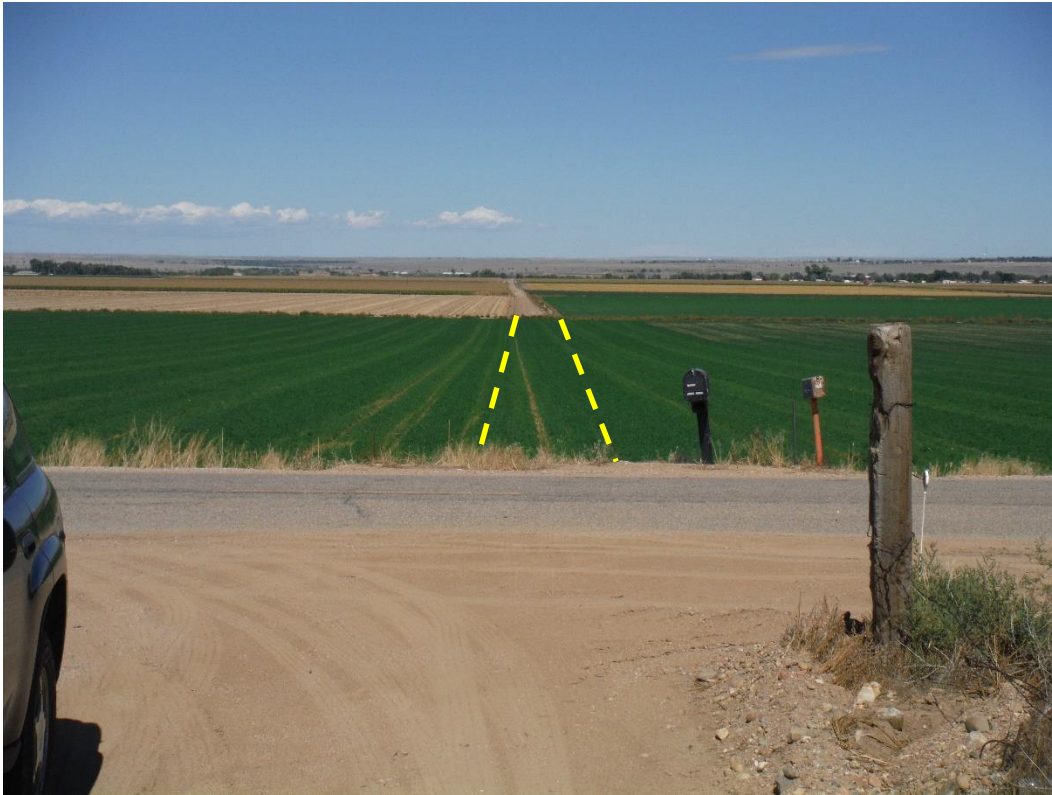
Photo 11. Portion of the North Haul Road that will be constructed north of Olsen Road and south of the existing agricultural access road; looking north.
