MINERALS PROGRAM INSPECTION REPORT**PHONE: (303) 866-3567**

MINE NAME: Hillyer Pit	MINE/PROSPECTING ID#: M-1982-011	MINERAL: Sand and gravel	COUNTY: San Juan
INSPECTION TYPE: Multi Person Inspection	INSPECTOR(S): Lucas J. West	INSP. DATE: October 4, 2016	INSP. TIME: 10:00
OPERATOR: Jo Ann Vota	OPERATOR REPRESENTATIVE: None	TYPE OF OPERATION: 110c - Construction Limited Impact

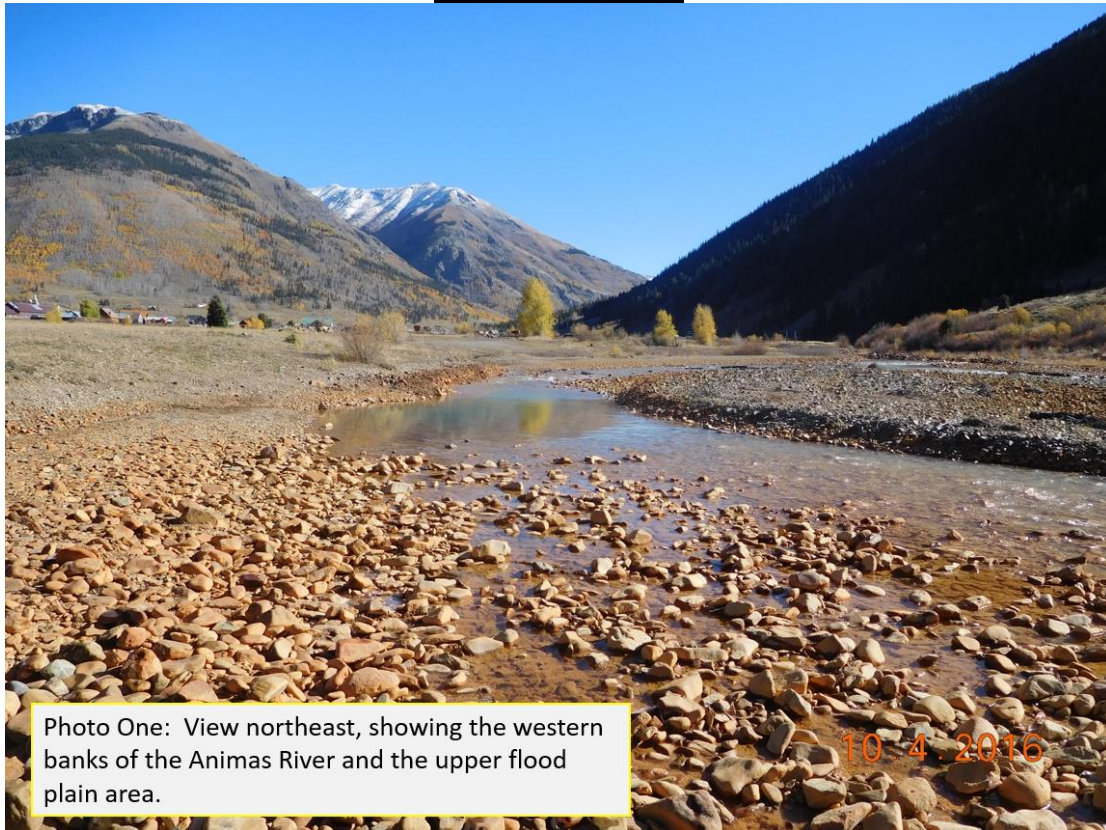
According to records kept by the Division all mining activity was concentrated to the areas of the west bank of the Animas River. The area now shows little signs of disturbance, shown in Photos One and Two. One small area of excavation was observed. The upper floodplain area appears to be stable and in good condition and erosion was noted during the inspection. The area has begun to revegetate itself with volunteer grasses however the vegetation is very sparse shown in Photo Three. Despite that lack of vegetation throughout the site, the affected lands appear to be stable and no signs of erosion were noted during the inspection. Two stockpiles of materials as well as one stockpile of recycled concrete remain on site. The stockpiles will need to be removed along with a general site clean-up during final reclamation of the site. Very little other reclamation tasks remain to be completed. Photo Four shows the stockpiles, as well as the area requiring cleanup of scrap metal within the permitted areas. The area on the west bank of the Animas River no longer needs to be regraded. Evidence of public use of the land included fire rings and vehicle tracks.
