## MINERALS PROGRAM INSPECTION REPORT

| <b>MINE NAME:</b><br>Schwartzwalder Mine | <b>MINE/PROSPECTING ID#:</b><br>M-1977-300 | <b>MINERAL:</b><br>Uranium | <b>COUNTY:</b><br>Jefferson |
| <b>INSPECTION TYPE:</b><br>Monitoring | <b>INSPECTOR(S):</b><br>Michael A. Cunningham | <b>INSP. DATE:</b><br>June 28, 2016 | <b>INSP. TIME:</b><br>09:00 |

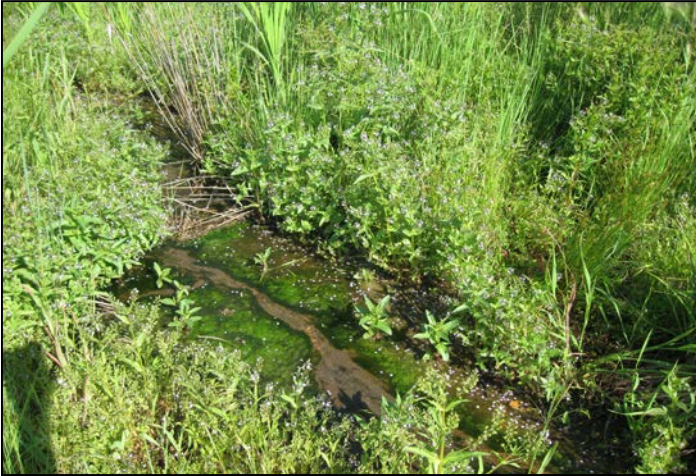
The inspection started with a tour of the north and south waste rock piles. The waste rock piles have been in a reclaimed state for a number of years. Both of the waste rock piles lie outside of the 100-year floodplain and held up remarkably well during the regional flooding that occurred in 2013. The Operator is proposing to excavate between 32,000 to 54,000 cubic yards of alluvial valley fill which will be placed onto both of the existing waste rock piles. The alluvial valley fill is comprised of mine waste rock as well as naturally occurring soils, sands and gravels. The waste rock piles have a remaining capacity of 603,000 cubic yards. Both of the waste rock piles were found to be stable and adequately vegetated. The Division did observe a small seep on top of the north waste rock pile. The seep was flowing at an estimated rate of 2 gpm. The water was found to be flowing across a portion of the top of waste rock pile. The Division observed hydrophytic vegetation around the seep, which indicates the seep has been present long enough for plants such as cattails to establish. The water was not flowing down the face of the waste rock pile and no erosion was associated with the seep. The presence of the seep will need to be addressed through the review of Technical Revision No. 23. The Operator will be required to address the long term stability of the waste rock pile and will need to provide a plan for diverting the seep so that it does not come into contact with any of the waste rock.

**1. Seep on top of north waste rock pile.**

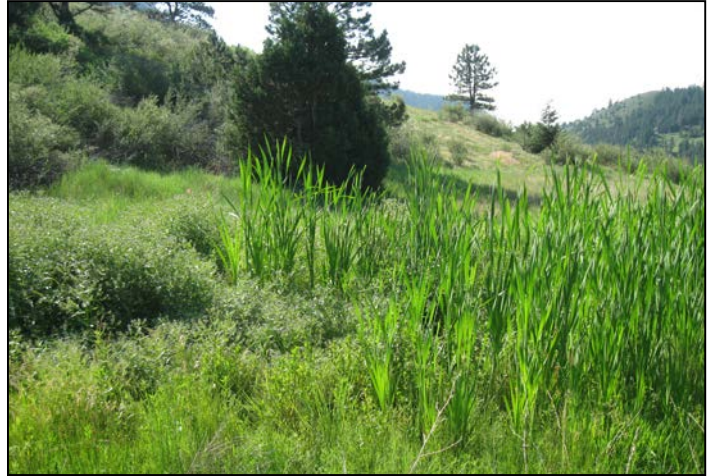
**2. Cattails growing around seep on north waste rock pile.**

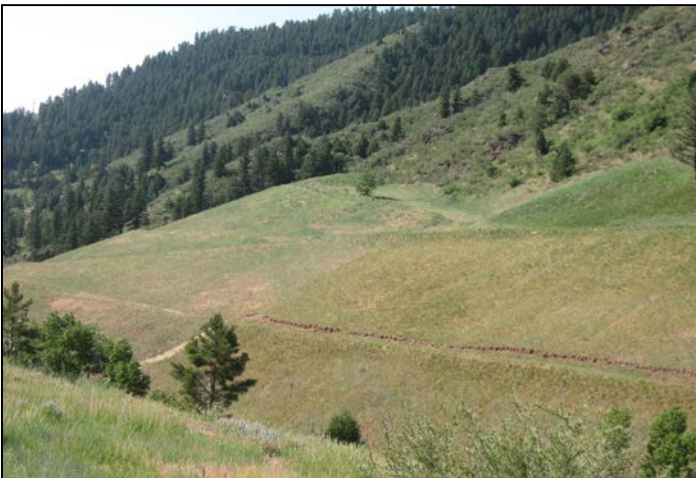
**3. South waste rock pile.**

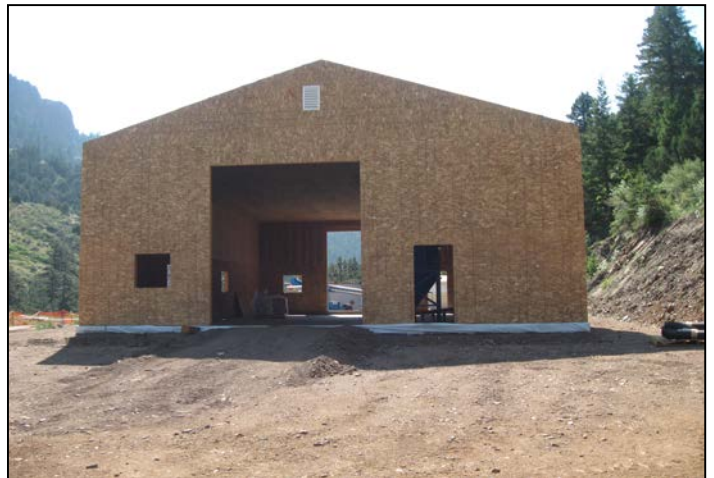
Following the tour of the waste rock piles, the Division inspected the new water treatment building. The new water treatment building is currently under construction and will be located adjacent to the Steve Level Adit. The foundation of the new water treatment building was in place and the roof and walls had been framed. In addition, clarifier tanks were in place. The next steps planned for the water treatment building include installing electrical and plumbing infrastructure, as well as adding sheet metal to the outside of the building. The Operator informed the Division the electrical substation, which provides power for the water treatment building, will be moved from its current location and will be situated next to the new water treatment building. The Operator will also install a back-up generator to ensure the water treatment plant can continue to operate in the event there are power shortages.

**4. New water treatment building.**

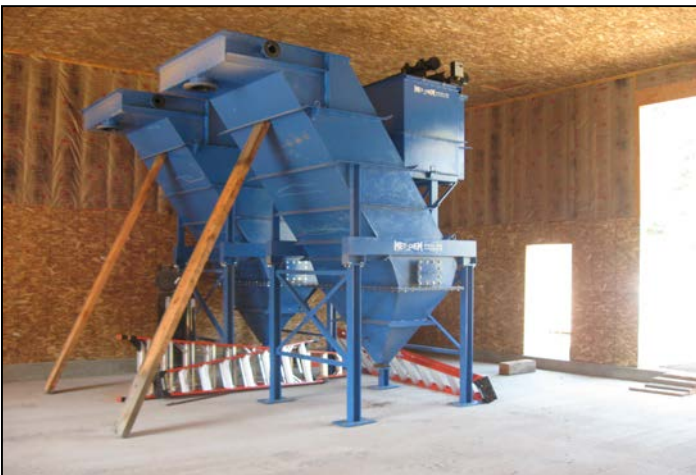
**5. Clarifiers.**

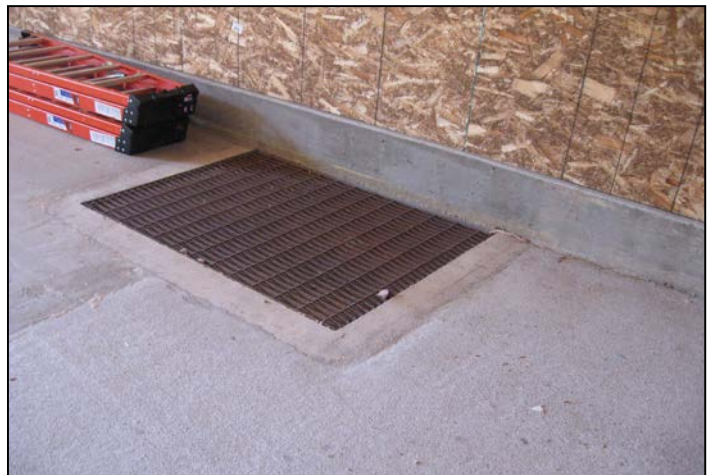
**6. Sump in water treatment building.**
