**COLORADO**Division of Reclamation,
Mining and Safety

MINERALS PROGRAM INSPECTION REPORT**PHONE: (303) 866-3567**

| MINE NAME: Sierra Grande Site | MINE/PROSPECTING ID#: M-1994-103 | MINERAL: Sand and gravel | COUNTY: Costilla |
| INSPECTION TYPE: Monitoring | INSPECTOR(S): Lucas J. West | INSP. DATE: October 6, 2016 | INSP. TIME: 08:00 |

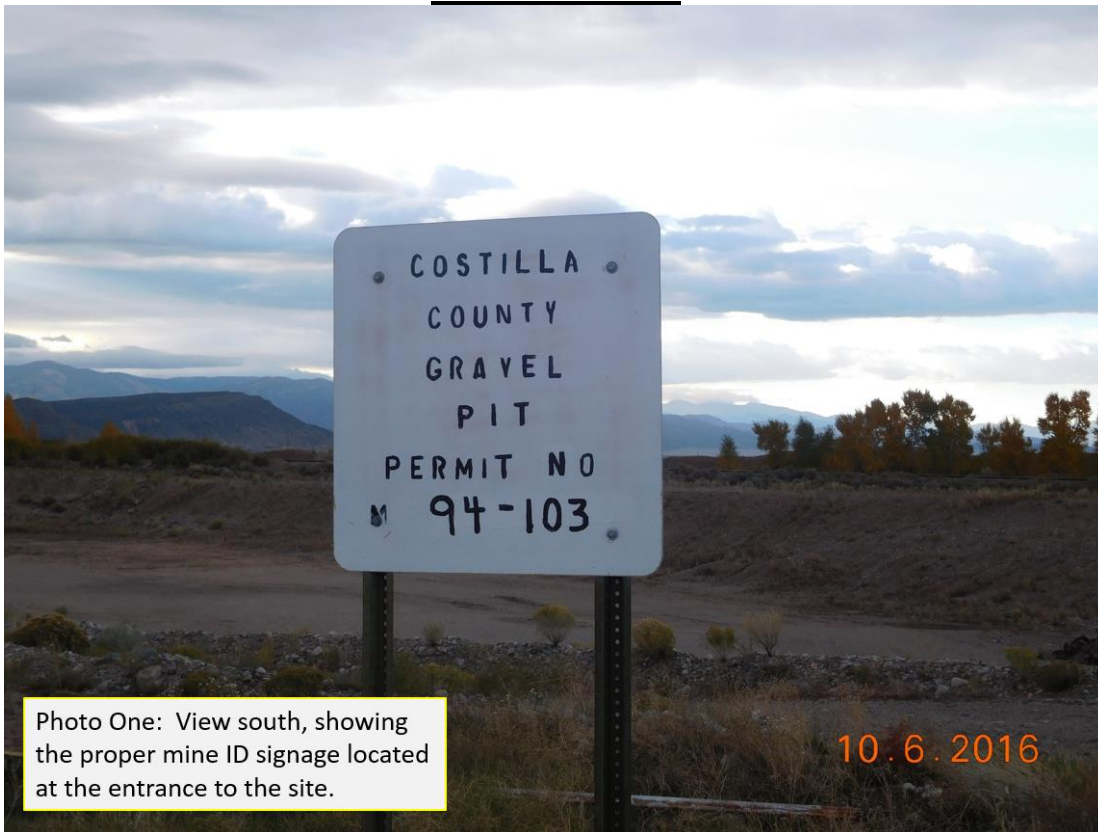
Photo One: View south, showing the proper mine ID signage located at the entrance to the site.

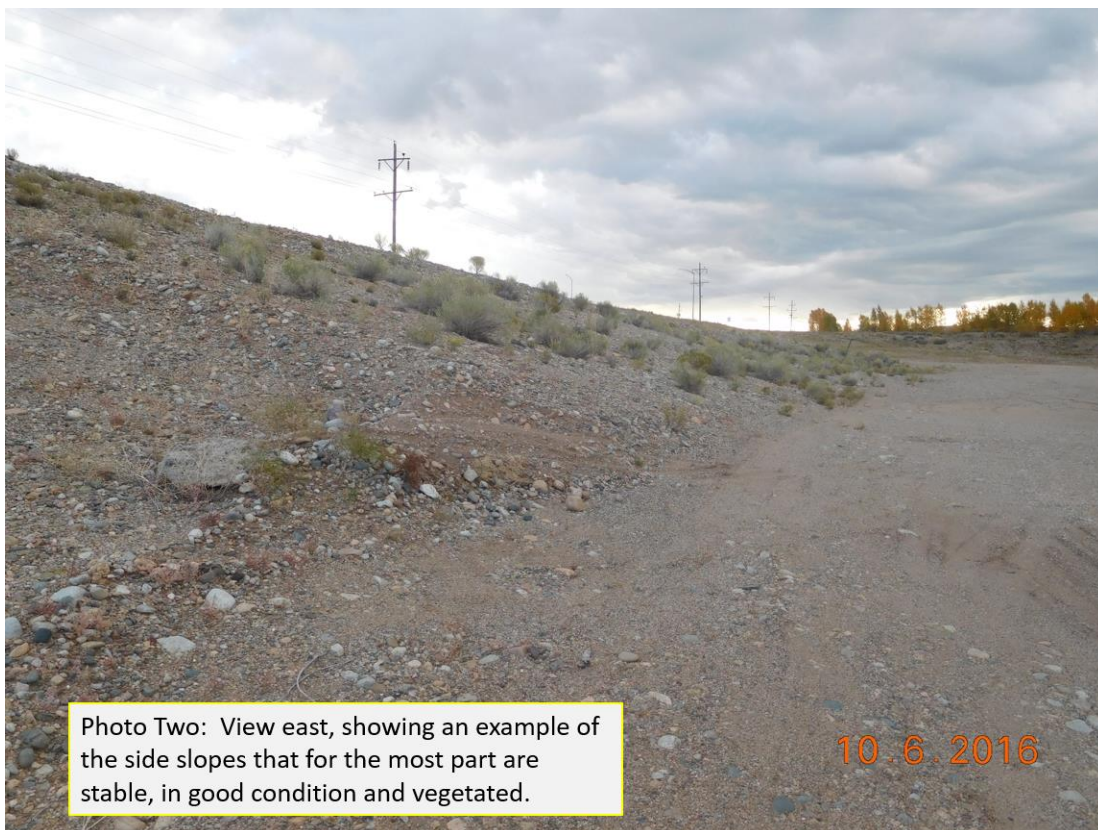
Photo Two: View east, showing an example of the side slopes that for the most part are stable, in good condition and vegetated.

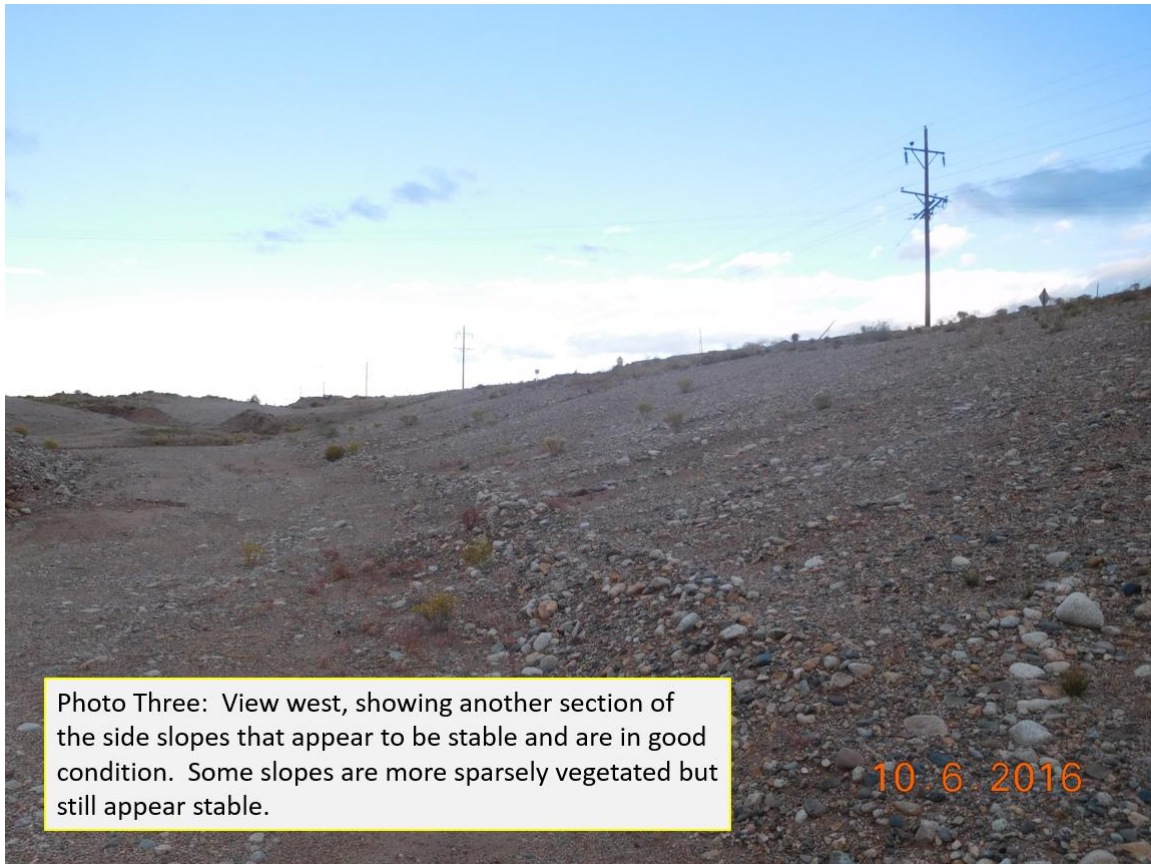
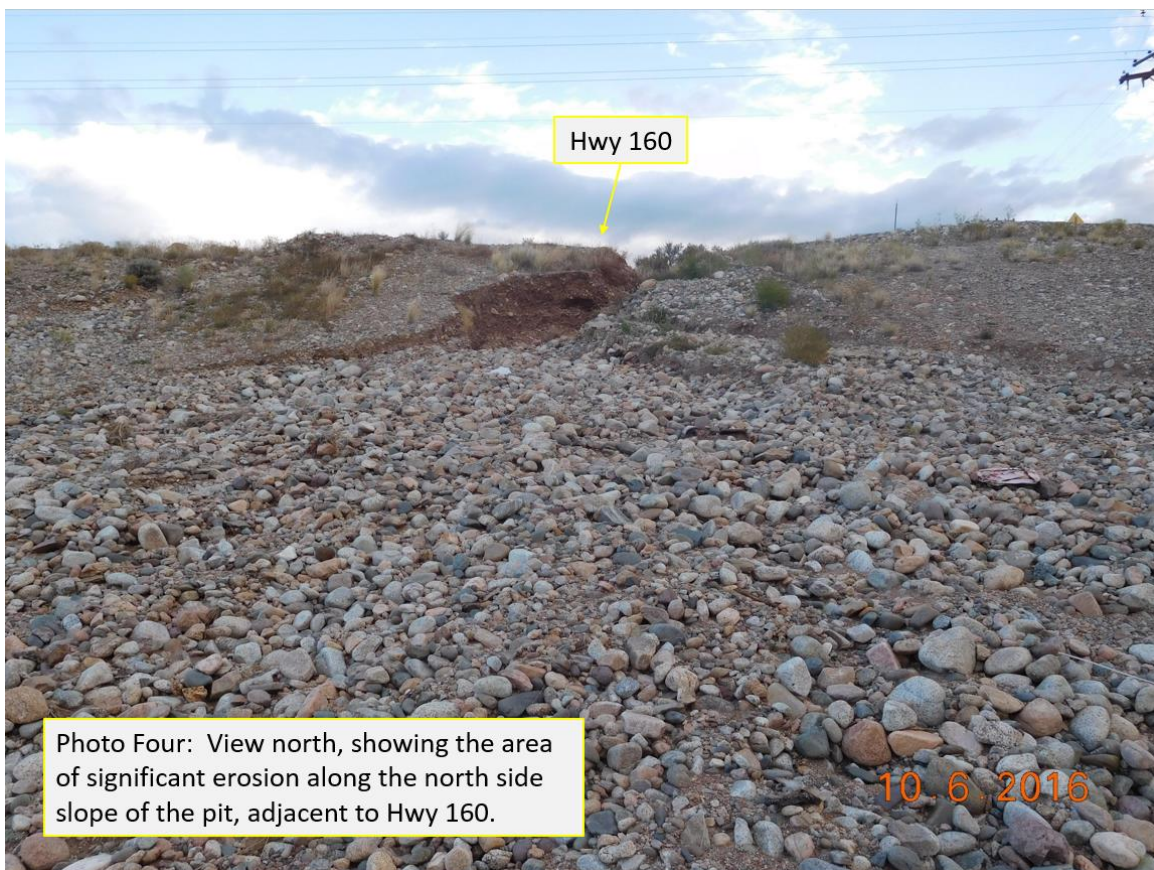
INSPECTION TOPIC: Sediment Control**PROBLEM/POSSIBLE VIOLATION:** Problem: Significant erosion was observed at the outfall of a storm water drain from Highway 160. This is a problem at this time for failure to protect the affected land from erosion pursuant to C.R.S. 34-32.5-116 (4) (j).**CORRECTIVE ACTIONS:** The operator shall provide photo documentation to the Division verifying erosion gullies and ruts have been repaired, and that the site has have been reconstructed and stabilized to prevent erosion damage by the corrective action date. The Division recommends backfilling the gully and armoring it with rip rap to effectively convey storm water without causing significant erosion. Documentation of compliance must be received within **60 days**.**CORRECTIVE ACTION DUE DATE: 12/23/16**

Proper mine identification signage and permit boundary markers were observed on site. The sign was posted at the entrance and can be seen in Photo One. The site was not active during the day of the inspection, and no equipment was on site. The site has not been active in some time, however the operator indicated that the pit floor is often used for temporary storage. When active, the slopes are mine to a stable configuration at approximately 3H: 1V. The side slopes can be seen in Photos Two and Three, appear to be stable and in good condition. Most of the slopes have begun to revegetate themselves with volunteer species such as range grasses as well as Sage and Rabbit brush. One area of the side slopes however demonstrates significant erosion shown in Photos Four and Five. This is a problem at this time for failure to protect the affected land from erosion pursuant to C.R.S. 34-32.5-116 (4) (j). The operator shall provide photo documentation to the Division verifying erosion gullies and ruts have been repaired, and that the site has have been reconstructed and stabilized to prevent erosion damage by the corrective action date. On site discussions with the operator, as well as records kept by the Division indicate that this is not the first time significant erosion has been a problem in this specific location. The operator explained that the erosion has been repaired before but with little success. The Division recommends backfilling the gulley and armoring it with rip rap to effectively convey storm water without causing significant erosion. Documentation of compliance must be received by the Division's Denver Office within **60 days** of the date of this letter. The corrective action must be completed by **Friday December 23, 2016**.

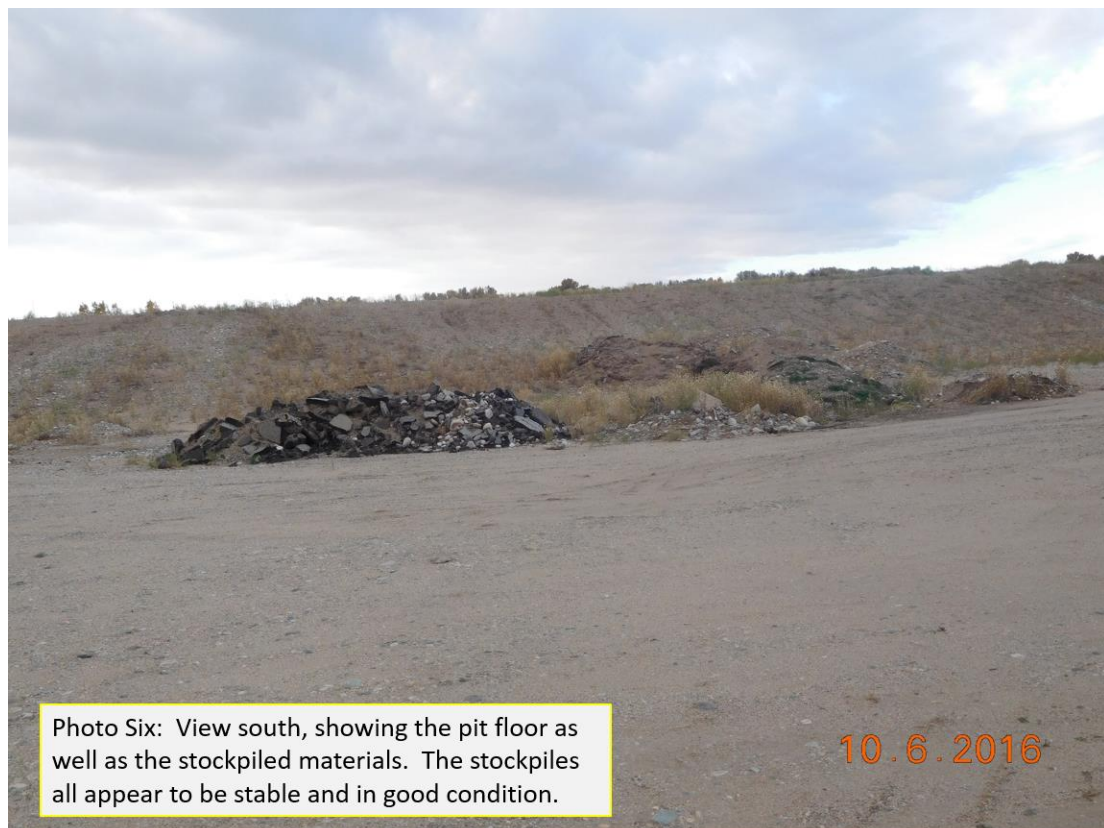
Several stockpiles were noted on site, including several on the pit floor. All stockpiles were in good condition and appeared to be stable. Examples of the stockpiles can be seen in Photo Six. The pit floor itself exhibits positive drainage and impounded storm water was observed on site. Evidence of chemical weed treatment was observed and discussions with the operator indicate that weed management is continuous at all pits operated by the County.
