MINERALS PROGRAM INSPECTION REPORT
PHONE: (303) 866-3567

MINE NAME: San Acacio Gravel Pit	MINE/PROSPECTING ID#: M-1999-024	MINERAL: Gravel	COUNTY: Costilla
INSPECTION TYPE: Monitoring	INSPECTOR(S): Lucas J. West	INSP. DATE: October 6, 2016	INSP. TIME: 09:24
OPERATOR: Costilla County	OPERATOR REPRESENTATIVE: Trinidad Martinez	TYPE OF OPERATION: 112c - Construction Regular Operation	
REASON FOR INSPECTION: Normal I&E Program	BOND CALCULATION TYPE: IT.Bondcalculationtype.CD.Desc	BOND AMOUNT: \$0.00	
DATE OF COMPLAINT: NA	POST INSP. CONTACTS: None	JOINT INSP. AGENCY: None	
WEATHER: Clear	INSPECTOR'S SIGNATURE:

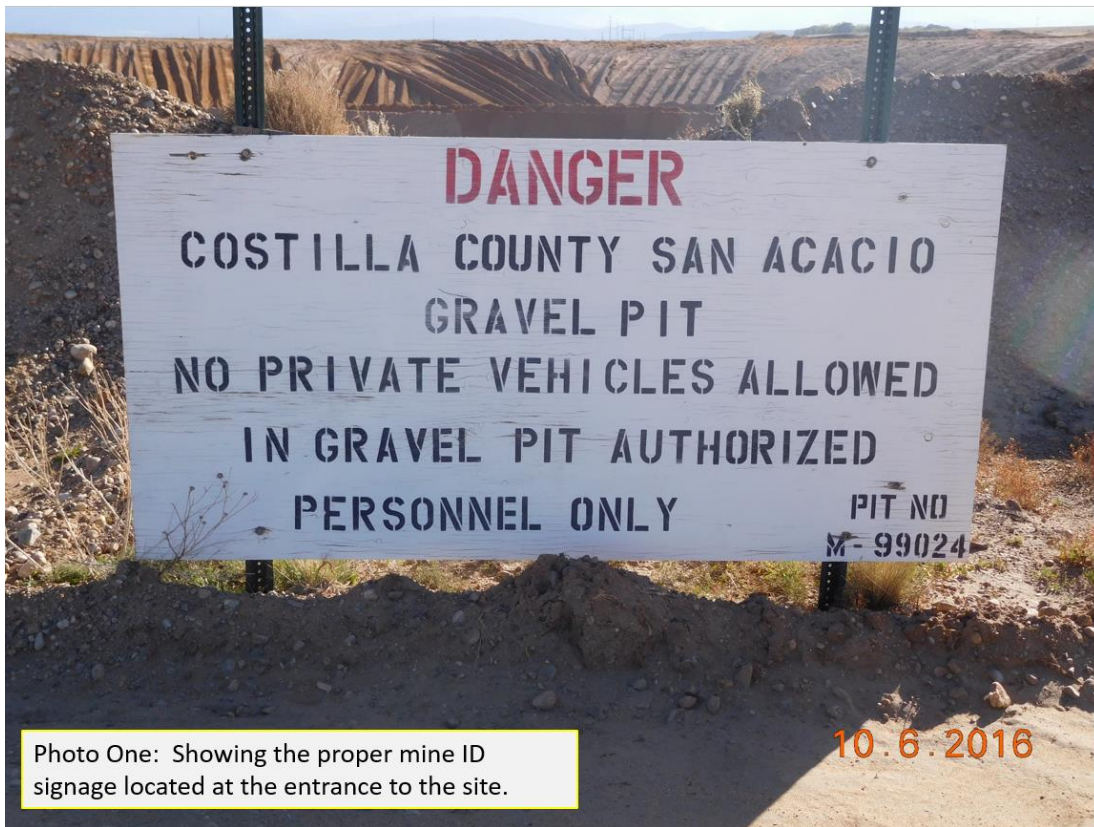
Proper mine identification signage was posted at the entrance to the site, shown in Photo One. The site was active during the inspection and a dozer and front end loader were engaged in stripping activities at the time of the inspection. There are currently approximately 15 Acres of the 76 Acre permitted area disturbed by mining activities. The stripping activities can be seen in Photo Two. The inactive side slopes have been relaxed to approximately a 3H: 1V slope, appear to be stable and are in good condition. Photo Three shows an example of the side slopes that show no evidence of slumping, settling or erosion. Several stockpiles of material and overburden were located on the pit floor. All stockpiles observed appeared to be stable and in good condition. The pit floor is exhibiting positive drainage and shows no signs of significant erosion, settling or slumping. The pit floor and stockpiles can be seen in Photo Four.

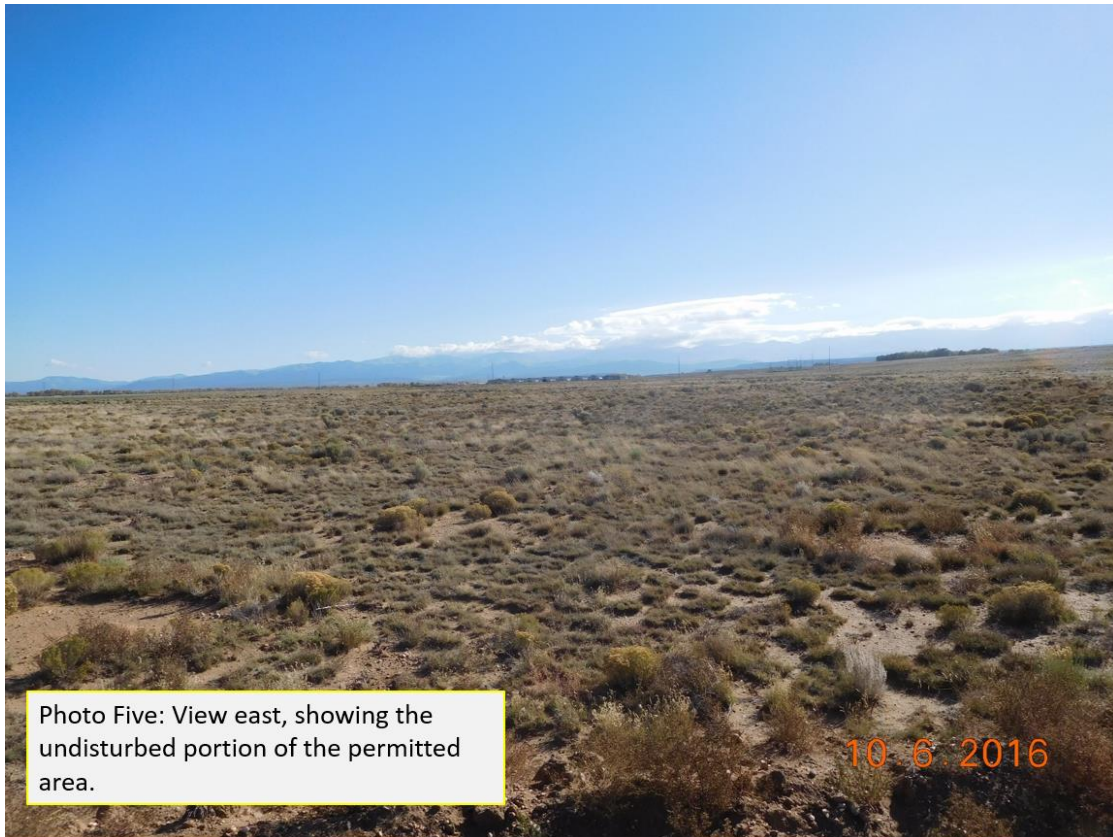
The remaining undisturbed areas totaling approximately 61 acres remains undisturbed. The undisturbed area can be seen in Photo Five. The undisturbed area is well vegetated and is at a near flat grade with minor rolling hills. In the southeast corner of the permitted area is the topsoil stockpiles which have been stripped for reclamation purposes. The stockpiles are in good condition and stabilized with vegetation to prevent erosion. Photo Six shows the stockpiles which are located in that area.
