MINERALS PROGRAM INSPECTION REPORT

MINE NAME: Mesita Hill Pit	MINE/PROSPECTING ID#: M-1977-227	MINERAL: Volcanics (Ash, Cind	COUNTY: Costilla
INSPECTION TYPE: Monitoring	INSPECTOR(S): Lucas J. West	INSP. DATE: October 6, 2016	INSP. TIME: 12:30
OPERATOR: Super Ex. LLC.	OPERATOR REPRESENTATIVE: Bill Tezak	TYPE OF OPERATION: 112c - Construction Regular Operation

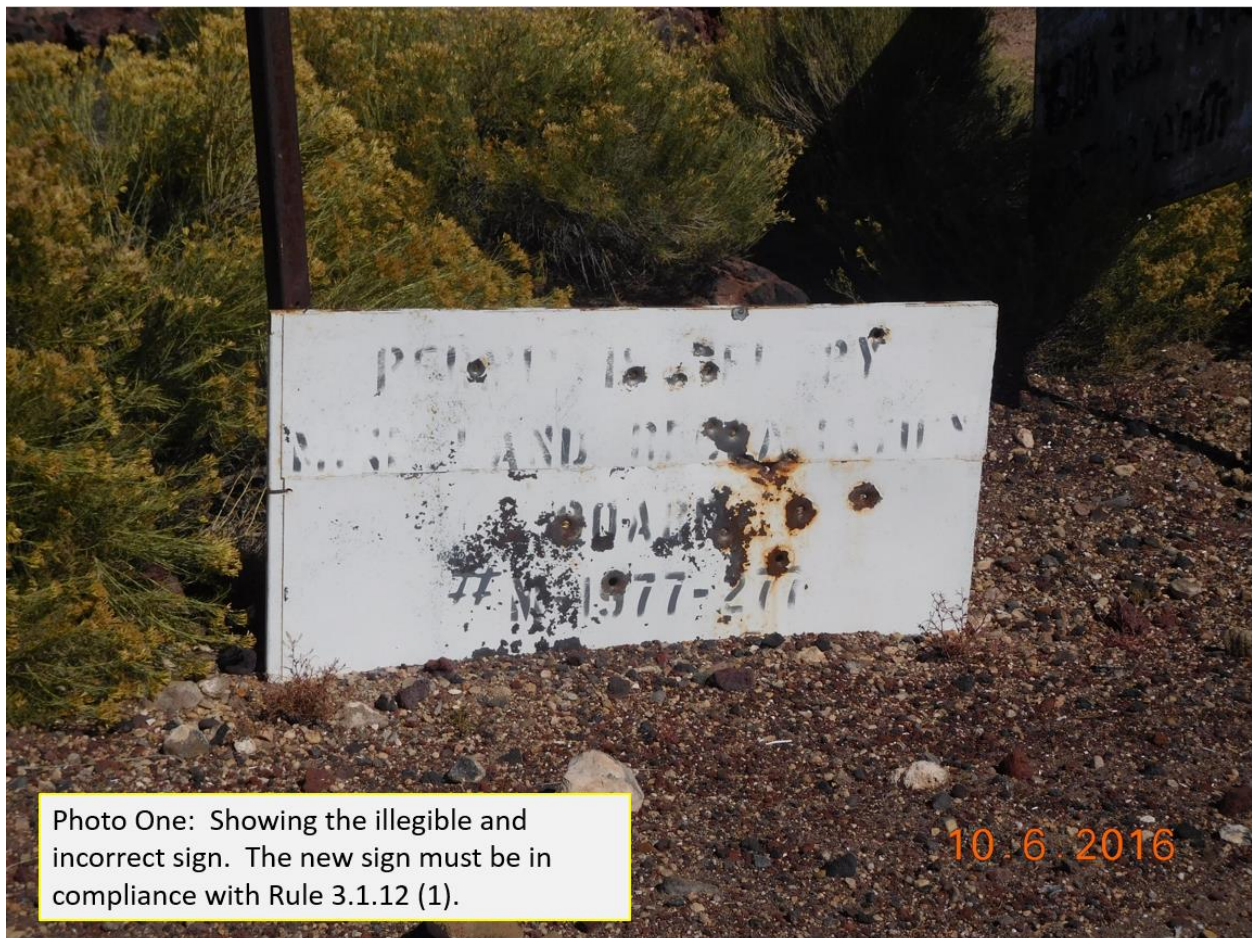
PROBLEM/POSSIBLE VIOLATION: Problem: The mine identification sign posted at the entrance of the mine site however was not updated with the current operator's information. This is a problem for failure to post a mine identification sign as required by Section 3.1.12(1) of the rule.

The mine identification signage was posted at the entrance however it was severely sun-faded and was not updated when the permit was transferred with the recently completed Succession of Operator. The sign that is currently posted can be seen in Photo One. The operator shall, within **60 days** of the date of this report, post a sign which shall be clearly visible from the access road with the following: the name of the operator, a statement that a reclamation permit for the operation has been issued by the Colorado Mined Land Reclamation Board; and the permit number. The operator shall submit photo documentation that the sign has been posted no later than **December 23, 2016**.

CORRECTIVE ACTIONS: The operator shall, at the entrance of the mine site, post a sign which shall be clearly visible from the access road with the following: the name of the operator, a statement that a reclamation permit for the operation has been issued by the Colorado Mined Land Reclamation Board; and the permit number. The operator shall submit photo documentation that a proper sign has been posted within 60 days of the date of this report, December 23, 2016.

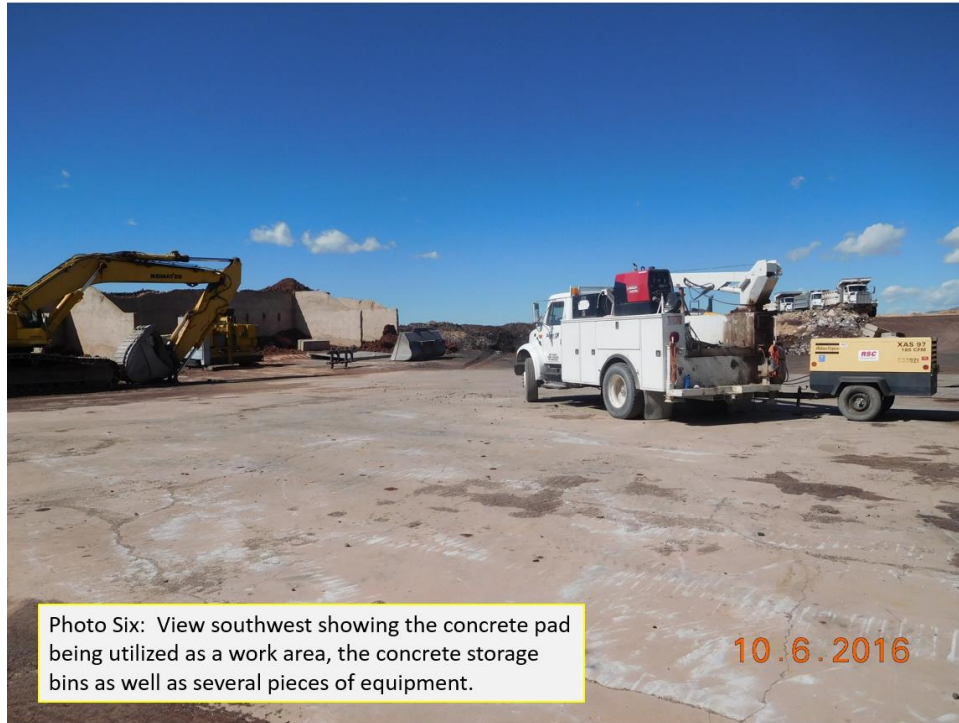
The site contains a large concrete pad with containment bins which is currently being utilized as a work area. The work area is in good condition and appears to be stable Shown in Photo Six. Adjacent to the work area are two van trailers being used as tool storage as well as hazardous materials storage. The hazardous materials being stored on site includes engine oil, diesel fuel, hydraulic fluids and other greases related to the operation of the heavy equipment. The van trailer provides proper secondary containment as well as security for the materials.
