MINERALS PROGRAM INSPECTION REPORT
PHONE: (303) 866-3567

MINE NAME: Riveras Excavation Gravel Pit	MINE/PROSPECTING ID#: M-2004-053	MINERAL: Gravel	COUNTY: Costilla
INSPECTION TYPE: Monitoring	INSPECTOR(S): Lucas J. West	INSP. DATE: October 6, 2016	INSP. TIME: 14:05
OPERATOR: Rivera's Excavation	OPERATOR REPRESENTATIVE: Joe Rivera	TYPE OF OPERATION: 110c - Construction Limited Impact	
REASON FOR INSPECTION: Normal I&E Program	BOND CALCULATION TYPE: Complete Bond	BOND AMOUNT: \$8,226.22	
DATE OF COMPLAINT: NA	POST INSP. CONTACTS: None	JOINT INSP. AGENCY: None	
WEATHER: Clear	INSPECTOR'S SIGNATURE:

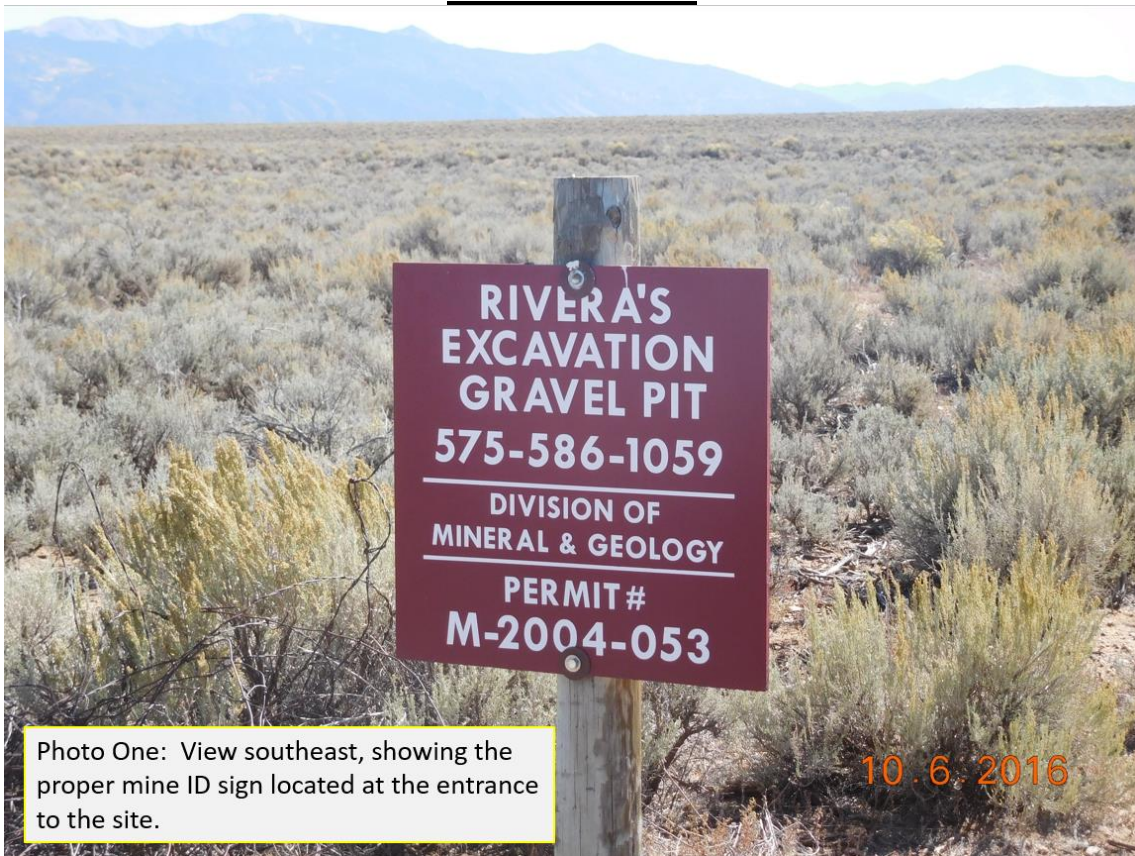
Proper mine identification signage was posted at the entrance to the site, shown in Photo One. The site consists of a small pit totaling approximately 1 acre. Some equipment including a small loader was on site however the site was not active during the inspection. Conversations with the operator indicate the pit is used on an as needed basis as projects arise. The active mining area consists of a high wall approximately 10 feet tall and approximately 30 feet long. The active mining area can be seen in Photo Two, appeared to be stable and in good condition. Several small stockpiles of various sized materials were located on the pit floor shown in Photo Three. One stockpile of recycled asphalt was located outside of the pit floor. Discussions with the operator indicate the material was being stored there temporarily until it can properly be recycled.

Photo One: View southeast, showing the proper mine ID sign located at the entrance to the site.

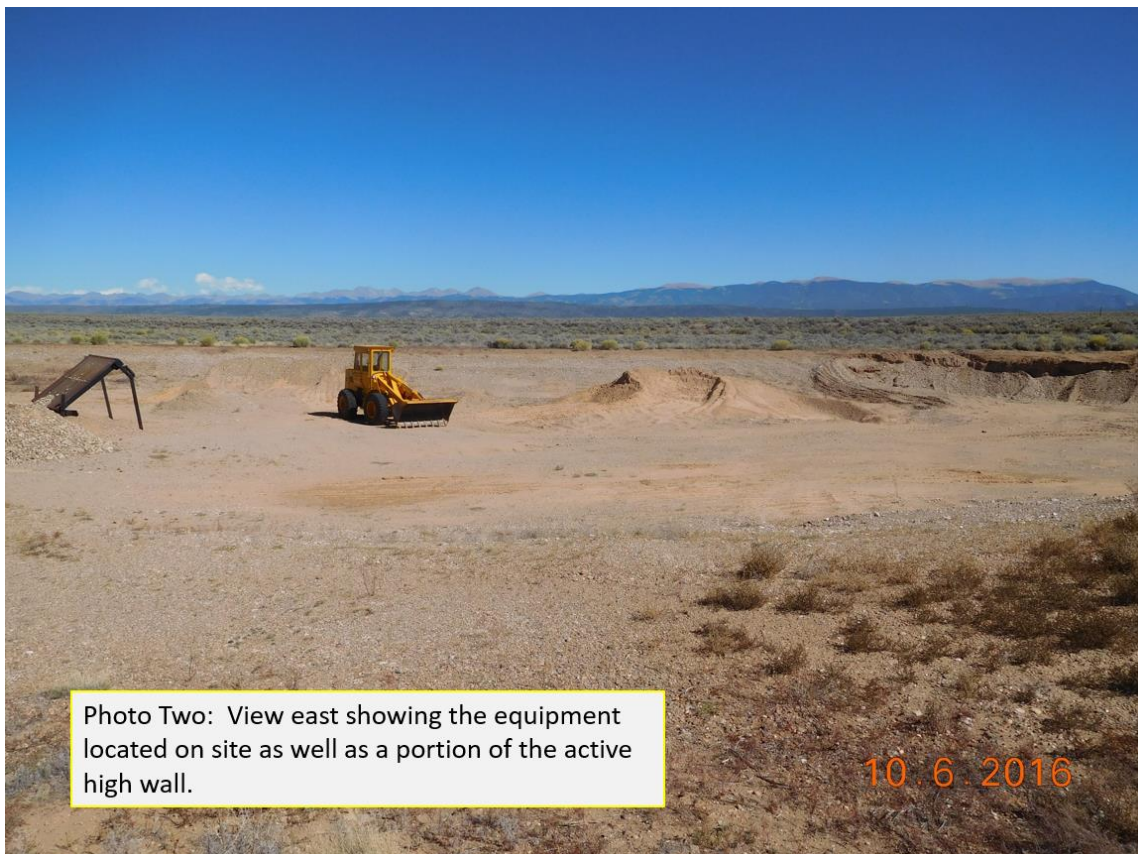
Photo Two: View east showing the equipment located on site as well as a portion of the active high wall.
