MINERALS PROGRAM INSPECTION REPORT
PHONE: (303) 866-3567

MINE NAME: Pit 1	MINE/PROSPECTING ID#: M-1999-073	MINERAL: Sand	COUNTY: Costilla
INSPECTION TYPE: Monitoring	INSPECTOR(S): Lucas J. West	INSP. DATE: October 6, 2016	INSP. TIME: 15:30
OPERATOR: Evan L. Melby, Inc.	OPERATOR REPRESENTATIVE: Sam	TYPE OF OPERATION: 110c - Construction Limited Impact	
REASON FOR INSPECTION: Normal I&E Program	BOND CALCULATION TYPE: Complete Bond	BOND AMOUNT: \$8,500.00	
DATE OF COMPLAINT: NA	POST INSP. CONTACTS: None	JOINT INSP. AGENCY: None	
WEATHER: Clear	INSPECTOR'S SIGNATURE:

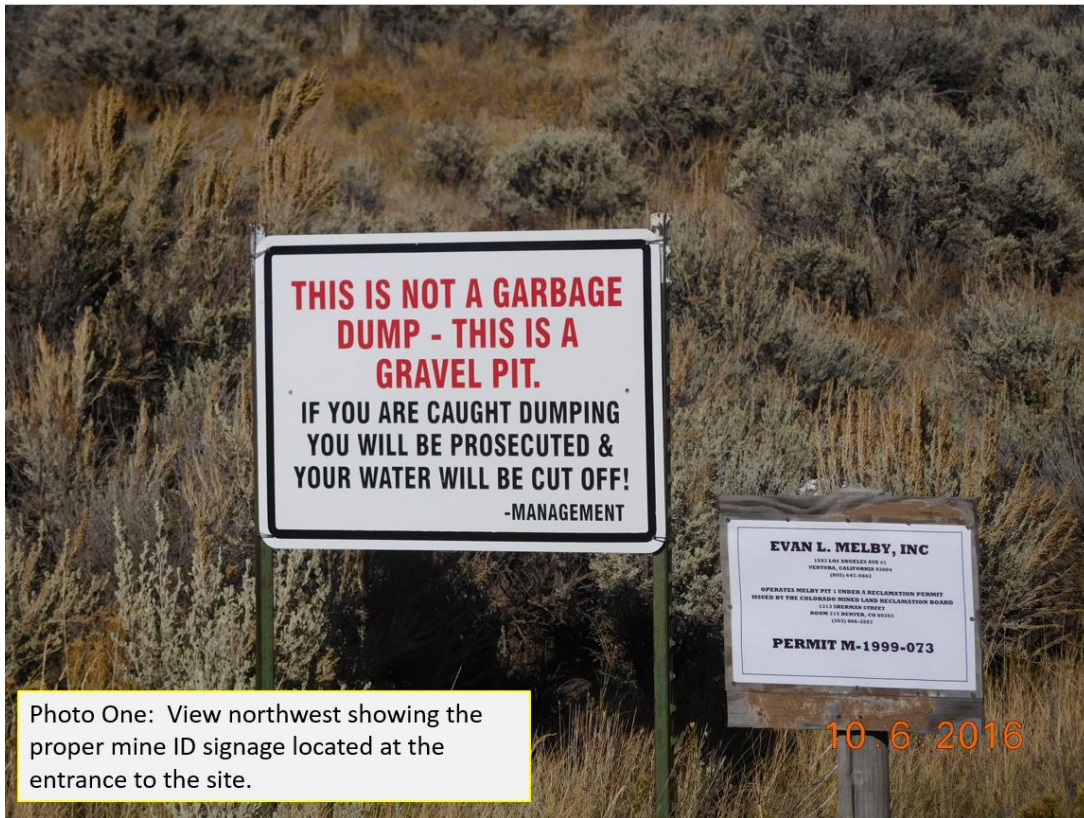
Proper mine identification signage was posted at the entrance to the site, shown in Photo One. Some equipment including a small loader and dozer were on site however the site was not active during the inspection. Conversations with the ranch manager indicate the pit is used on an as needed basis as projects arise on the ranch properties. A small stockpile of material is located on the pit floor shown in Photo Two. The main area of excavation, shown in Photo Three, has previously consisted of a highwall operation. Since the Division's previous inspection the highwall has been removed and material is being mined at a near reclamation grade. The excavation area appears to be stable and in good condition.

Photo One: View northwest showing the proper mine ID signage located at the entrance to the site.

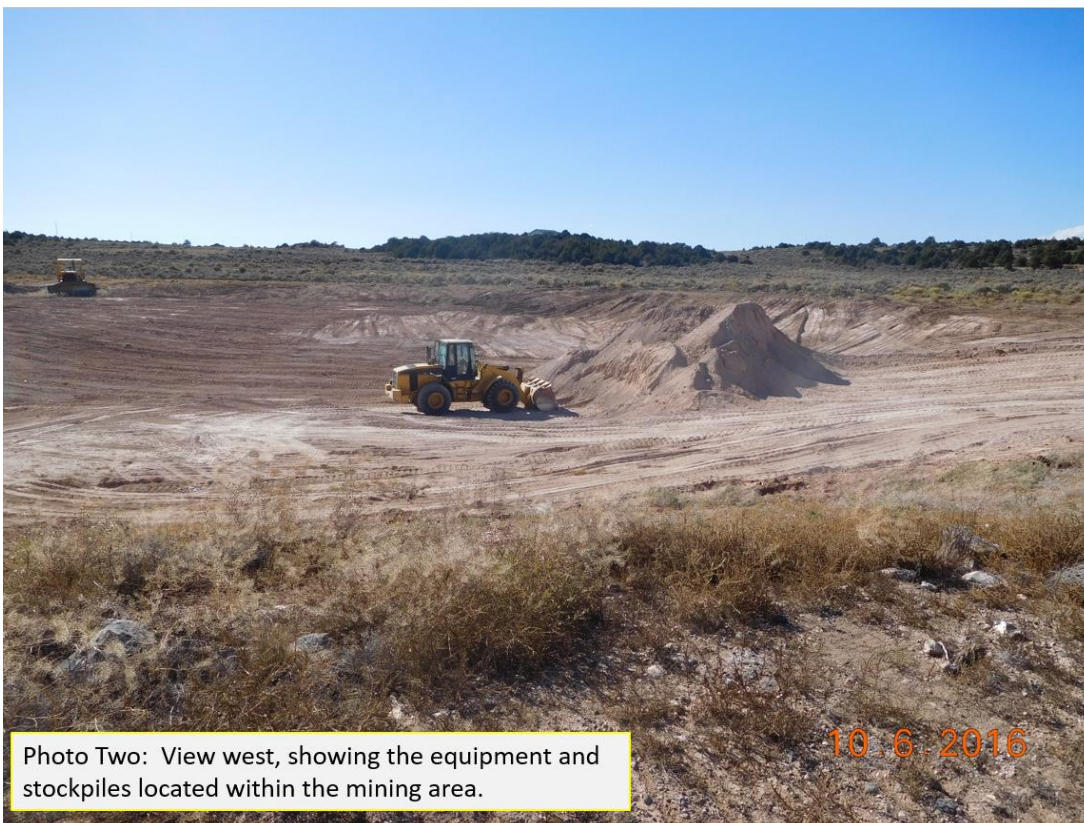
Photo Two: View west, showing the equipment and stockpiles located within the mining area.
