MINERALS PROGRAM INSPECTION REPORT
PHONE: (303) 866-3567

MINE NAME: Costilla Pit	MINE/PROSPECTING ID#: M-1987-040	MINERAL: Sand and gravel	COUNTY: Costilla
INSPECTION TYPE: Monitoring	INSPECTOR(S): Lucas J. West	INSP. DATE: October 7, 2016	INSP. TIME: 08:00
OPERATOR: Southway Construction Company, Inc.	OPERATOR REPRESENTATIVE: None	TYPE OF OPERATION: 110c - Construction Limited Impact	
REASON FOR INSPECTION: Normal I&E Program	BOND CALCULATION TYPE: Complete Bond	BOND AMOUNT: \$40,354.07	
DATE OF COMPLAINT: NA	POST INSP. CONTACTS: None	JOINT INSP. AGENCY: None	
WEATHER: Clear	INSPECTOR'S SIGNATURE:

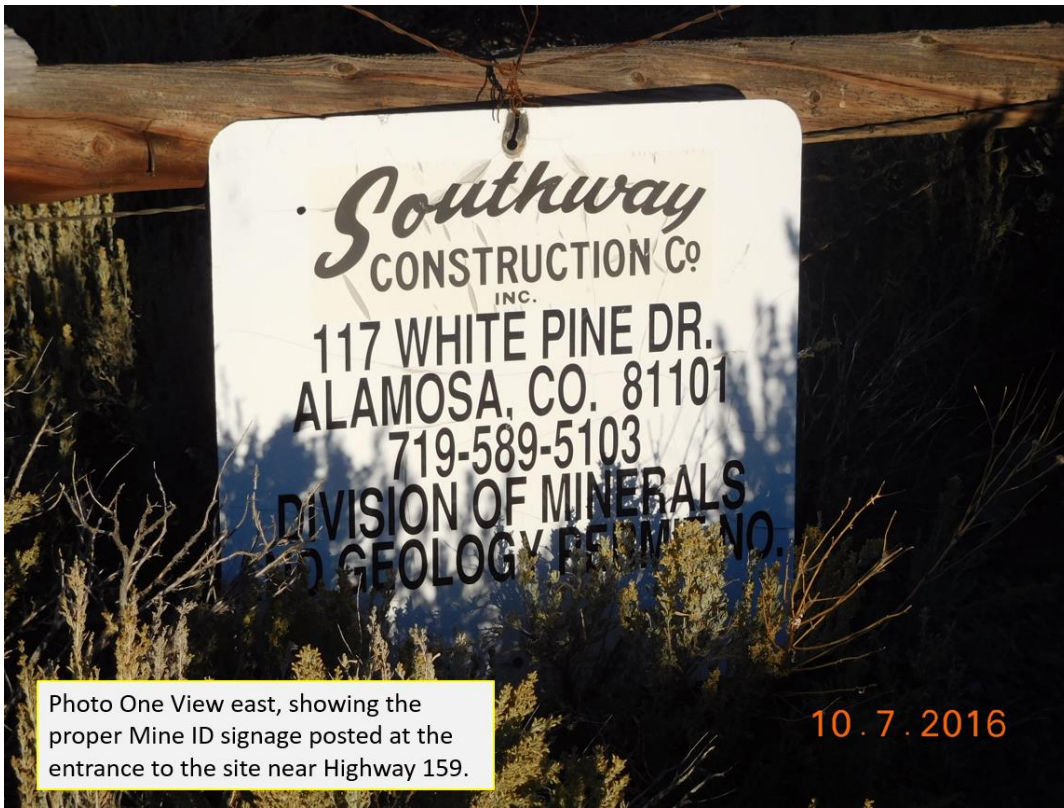
Proper mine identification signage was posted at the entrance to the site, shown in Photo One. The site is approved for 9.7 Acres of affected lands, and is adjacent to other, historic, unpermitted disturbances. T-Posts were found identifying the permit boundary. The site consists of an active pit totaling approximately 2.5 acres. No equipment was on site and the site was not active during the inspection. The active mining area consists of a high wall approximately 20 feet tall and approximately 200 feet long. The active mining area can be seen in Photo Two, appeared to be stable and in good condition. Several stockpiles of various sized materials were located on site, examples of the stockpiles are shown in Photo Three. The stockpiles ranged from overburden and topsoil to various sized material for removal. The stockpiles have clearly not been hauled from for quite some time as most of them are vegetated with volunteer species.
