## MINERALS PROGRAM INSPECTION REPORT

<b>MINE NAME:</b> Fedinec Pit	<b>MINE/PROSPECTING ID#:</b> M-1977-057	<b>MINERAL:</b> Crushed stone mater	<b>COUNTY:</b> Moffat
<b>INSPECTION TYPE:</b> Monitoring	<b>INSPECTOR(S):</b> Amy C. Yeldell	<b>INSP. DATE:</b> October 27, 2016	<b>INSP. TIME:</b> 12:00
<b>OPERATOR:</b> Pioneer Sand Company, Inc.	<b>OPERATOR REPRESENTATIVE:</b> None	<b>TYPE OF OPERATION:</b> 110c - Construction Limited Impact	
<b>REASON FOR INSPECTION:</b> Priority	<b>BOND CALCULATION TYPE:</b> None	<b>BOND AMOUNT:</b> \$19,300.00	
<b>DATE OF COMPLAINT:</b> NA	<b>POST INSP. CONTACTS:</b> None	<b>JOINT INSP. AGENCY:</b> None	
<b>WEATHER:</b> Clear	<b>INSPECTOR'S SIGNATURE:</b>

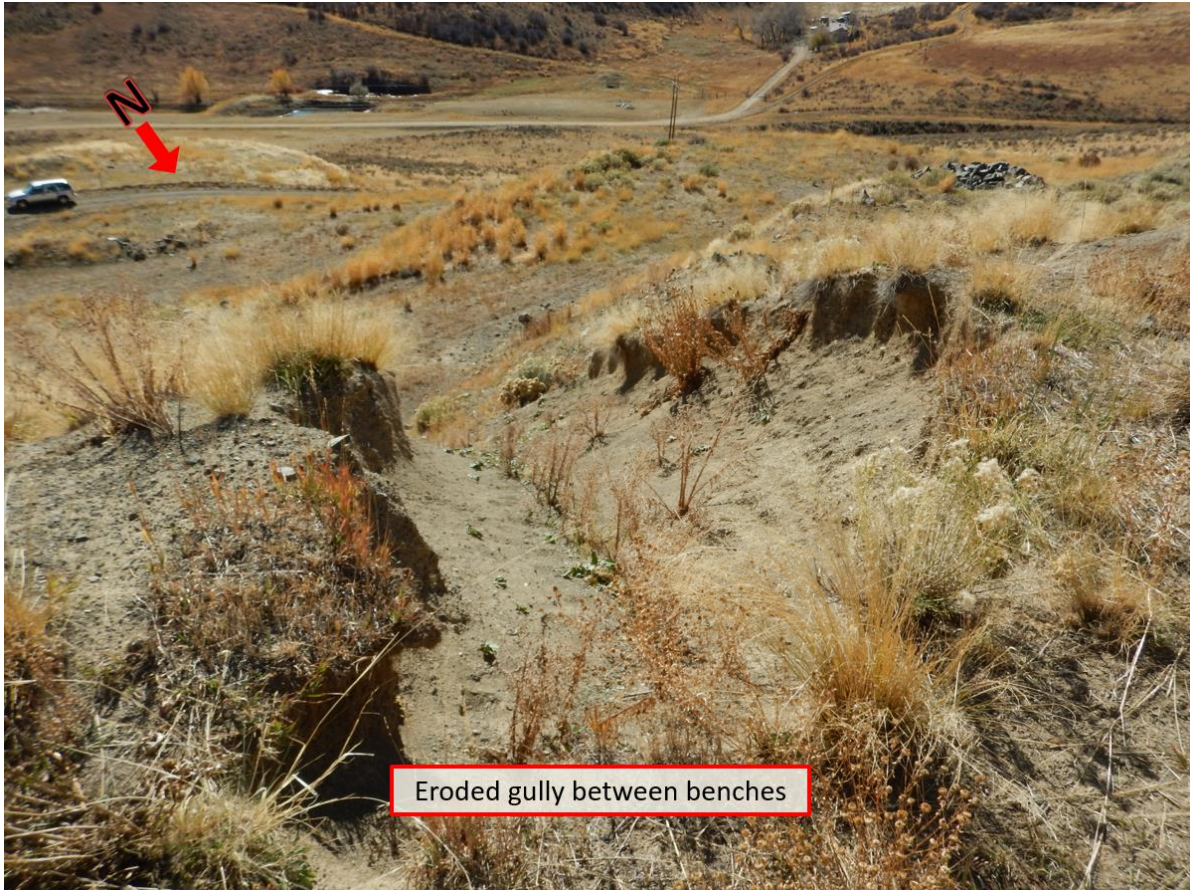
Eroded gully between benches

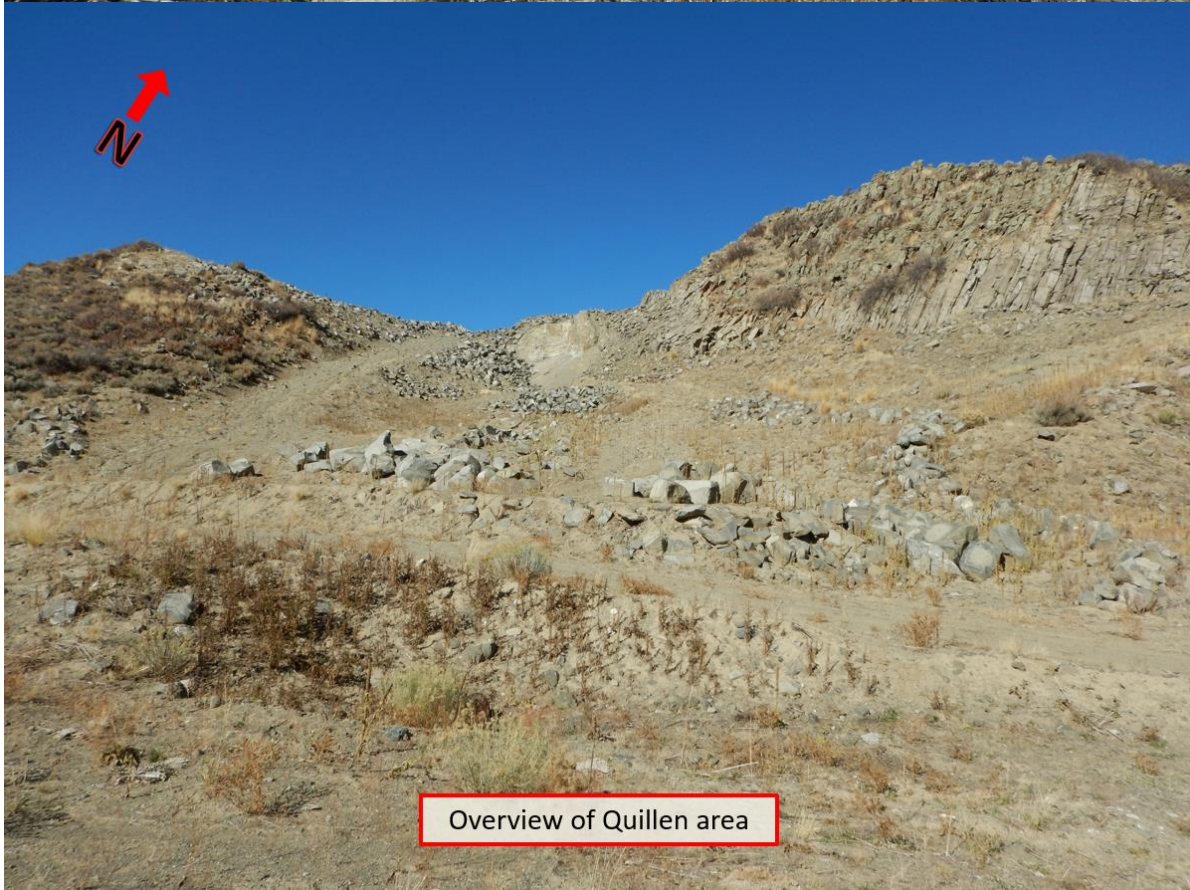
The Quillen permit area is the source of the rock material. A natural rock outcrop has been mined and subsequent rock highwalls have been created. It is unclear if this rock material is competent and could be left near vertical upon final reclamation or if the highwall would need to be relaxed. There is no evidence of blasting which further suggests that the rock breaks off in blocks and may not be competent. The only vegetation in this area are weeds (mullen, knapweed, thistle, hounds tongue, and cheat grass). It appears that the weeds were sprayed late this summer. Due to the amount of dead vegetation present aggressive weed management over the next few years will necessary to keep populations in check. Above the rock wall in the undisturbed portions is sagebrush and native grasses. There are several rock stockpiles throughout this area. One stockpile is located along the northern boundary and may be topsoil based on the amount of grass growing. It is not sufficient in volume to cover the 5 acres of the original permit area 6-12". However this is to be expected if this site was originally a rock outcrop. This site will likely be topsoil deficient.

Overview of Quillen area

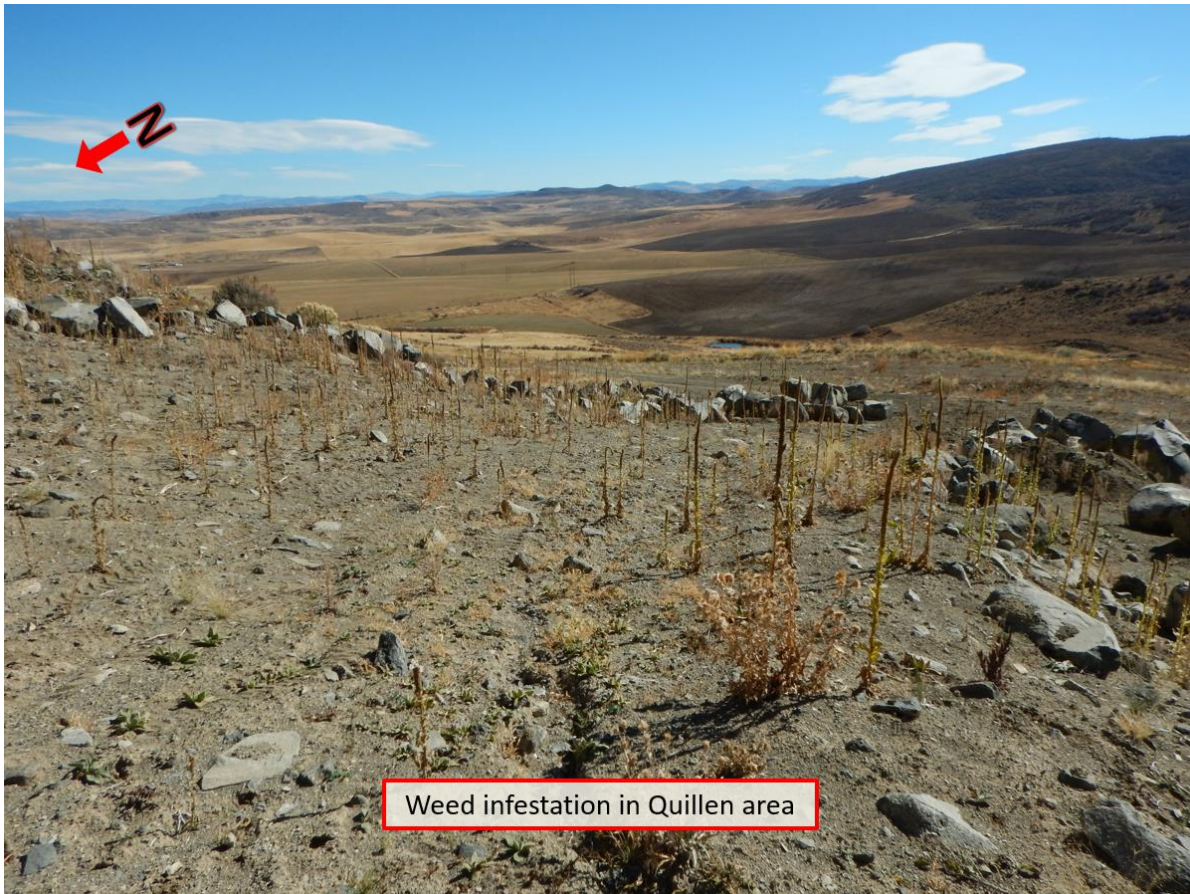
Weed infestation in Quillen area

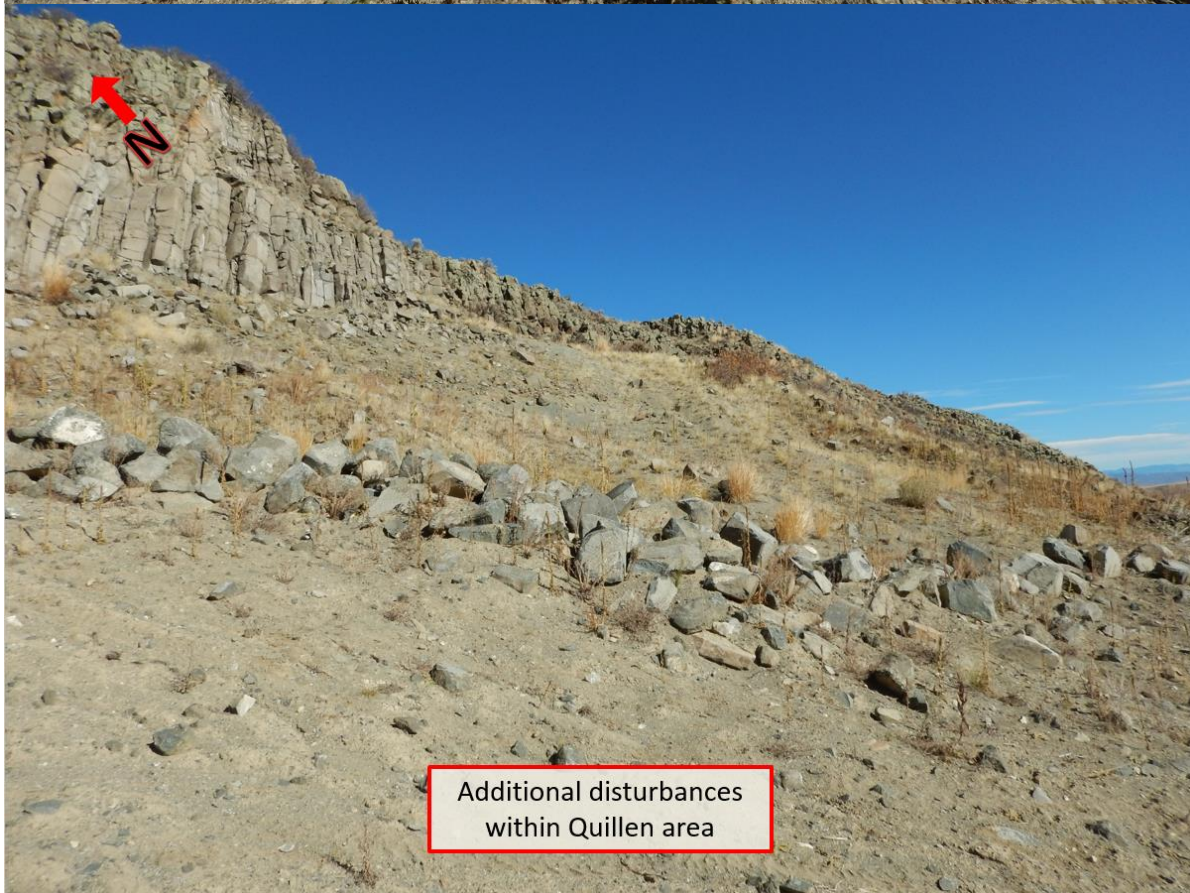
Additional disturbances  
within Quillen area
