MINERALS PROGRAM INSPECTION REPORT
PHONE: (303) 866-3567

MINE NAME: May Day Idaho Mine Complex	MINE/PROSPECTING ID#: M-1981-185	MINERAL: Gold and silver	COUNTY: La Plata
INSPECTION TYPE: Multi Person Inspection	INSPECTOR(S): Lucas J. West	INSP. DATE: October 18, 2016	INSP. TIME: 08:00
OPERATOR: Wildcat Mining Corporation	OPERATOR REPRESENTATIVE: Ray Ferguson	TYPE OF OPERATION: 112d-1 - Designated Mining Operation	
REASON FOR INSPECTION: High Priority	BOND CALCULATION TYPE: None	BOND AMOUNT: \$204,562.00	
DATE OF COMPLAINT: NA	POST INSP. CONTACTS: None	JOINT INSP. AGENCY: None	
WEATHER: Clear	INSPECTOR'S SIGNATURE:

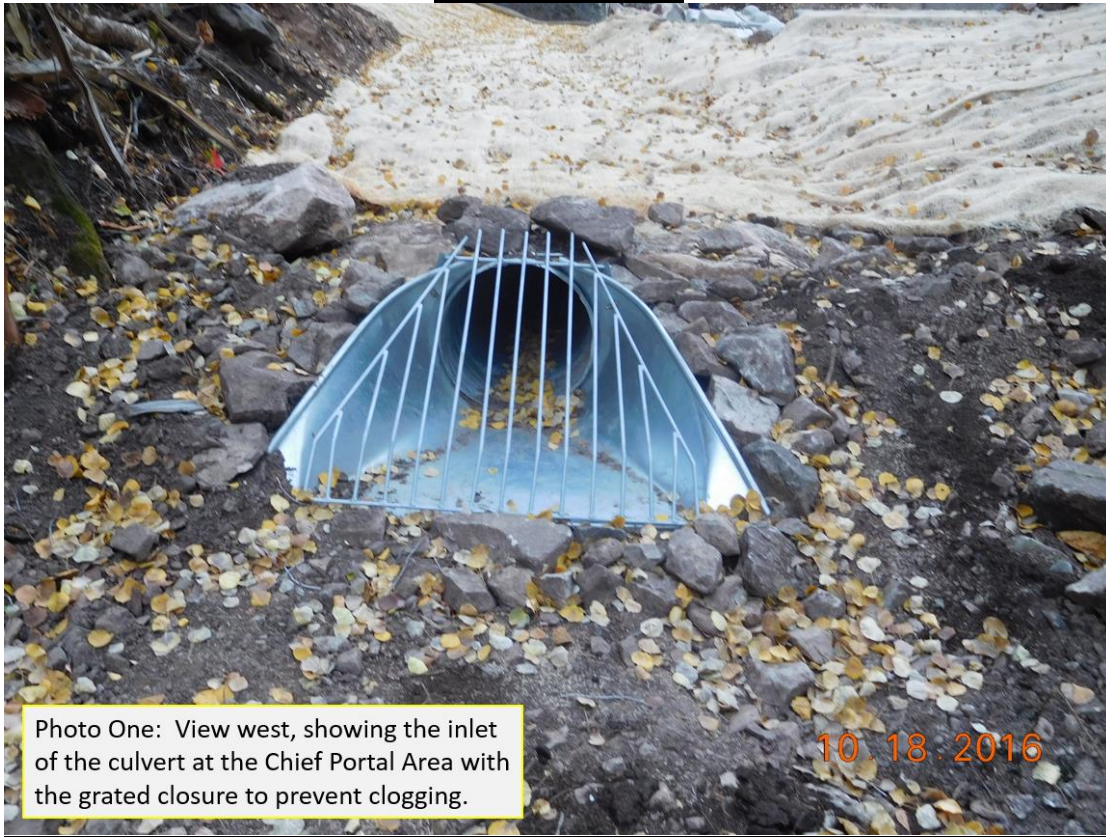
The restoration activities at the Chief Portal Area appears to have been completed. As seen in Photo One, the culvert has been installed with a grated closure on the inlet to prevent plugging. The outfall of the culvert has been armored with rip rap to prevent down cutting shown in Photo Two. The area has been backfilled, mulched and secured / seeded with the vegetated matting. All backfilled areas appear to be stable and in good condition, no evidence of settling, slumping or subsidence was observed. The matting extends from the access road down to the bottom of the gulch as well as up the other side. Photo Three shows the area with the vegetative matting as seen from the access road above. The secondary escape / emergency access has been further buttressed with the restoration of Little Deadwood Gulch. The portal was not secured with a grated closure, however discussions with the operator indicate that the closure will be installed soon. Approximately 12-14 precast concrete blocks have been installed to buttress the installed culvert and backfilled area of the gulch. Photo Four shows the blocks and area that has been buttressed. A secondary drain has been installed to allow any water generated from the portal to be conveyed into Little Deadwood Gulch. The slope above the secondary access which had been backfilled as of the previous inspection by Division staff appears to be in good condition. The areas that were identified to be revegetated or secured with the vegetative matting have been addressed. No evidence of erosion, slumping or subsidence was noted. The area at the top of the slope, adjacent to the road was identified to need a safety barrier which has been installed.

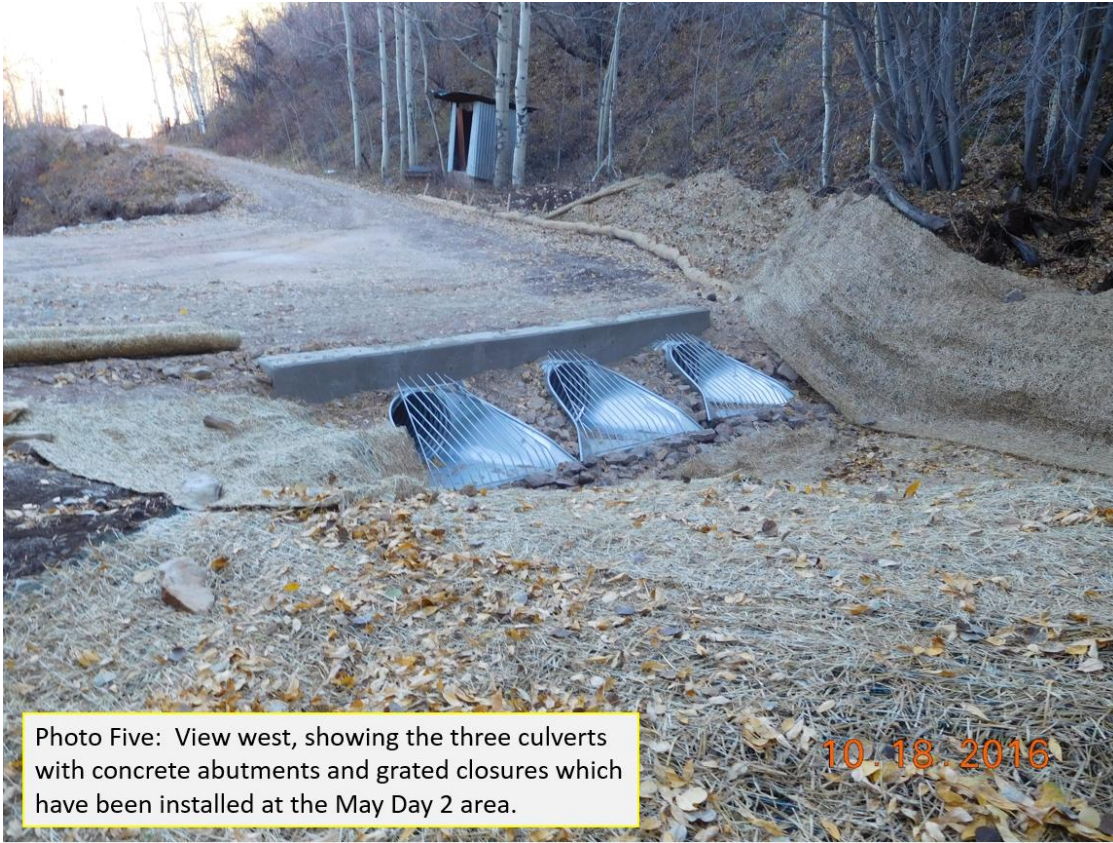
The required work at the May Day 2 area was the installation of a series of culverts where the access road crosses Little Deadwood Gulch. Photo Five shows where the access road crosses the gulch, and that the culverts have been installed. Three culverts, with grated closures at their inlets to prevent clogging, as well as concrete abutments to prevent degradation of the surrounding material has been installed. The outfall of the culverts has been armored to prevent down cutting of the channel immediately downstream of the culverts. The armoring can be seen in Photo Six. Within the channel immediately upstream of the culverts, two water bars have been installed to help dissipate the energy as the stream flow approaches the crossing. The portal at the May Day 2 Area remains partially collapsed. A small waste rock pile was located adjacent to the closure,

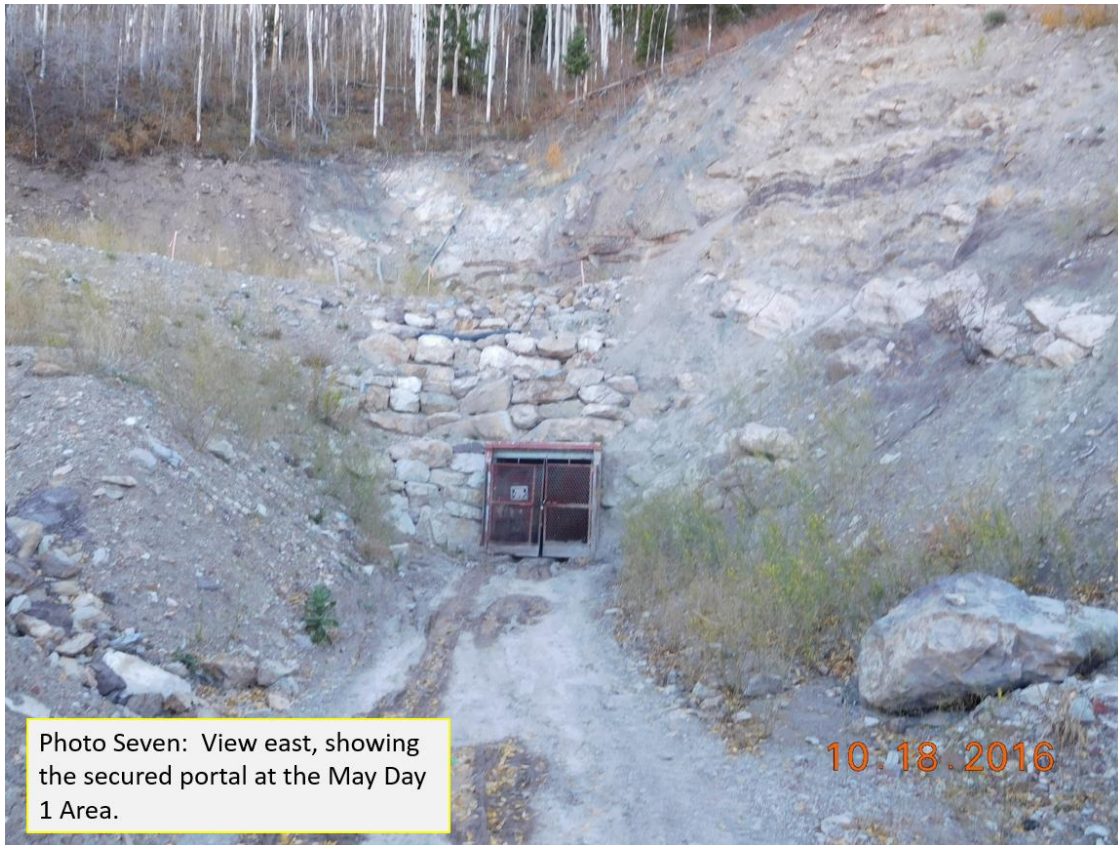
There has been some minimal activity at the May Day 1 area. The portal remains closed with a locked gate, and the surrounding slopes buttressed with the placement of large boulders. The area above the portal has been stabilized with wire mesh and rock bolts. Photo Seven shows the portal with the locked gate and buttressed slopes as well as the rock bolts and wire mesh. The Mill building was not inspected at this time. A variety of equipment was observed throughout the May Day 1 area. The surface conditions of the area are largely unchanged from the October 2015 Inspection.
