**MINERALS PROGRAM INSPECTION REPORT**  
**PHONE: (303) 866-3567**

<b>MINE NAME:</b> Southway Pit	<b>MINE/PROSPECTING ID#:</b> M-1981-153	<b>MINERAL:</b> Sand and gravel	<b>COUNTY:</b> Costilla
<b>INSPECTION TYPE:</b> Monitoring	<b>INSPECTOR(S):</b> Lucas J. West	<b>INSP. DATE:</b> October 7, 2016	<b>INSP. TIME:</b> 09:22
<b>OPERATOR:</b> Southway Construction Company, Inc.	<b>OPERATOR REPRESENTATIVE:</b> None	<b>TYPE OF OPERATION:</b> 112c - Construction Regular Operation	
<b>REASON FOR INSPECTION:</b> Normal I&E Program	<b>BOND CALCULATION TYPE:</b> Complete Bond	<b>BOND AMOUNT:</b> \$56,500.00	
<b>DATE OF COMPLAINT:</b> NA	<b>POST INSP. CONTACTS:</b> None	<b>JOINT INSP. AGENCY:</b> None	
<b>WEATHER:</b> Clear	<b>INSPECTOR'S SIGNATURE:</b>

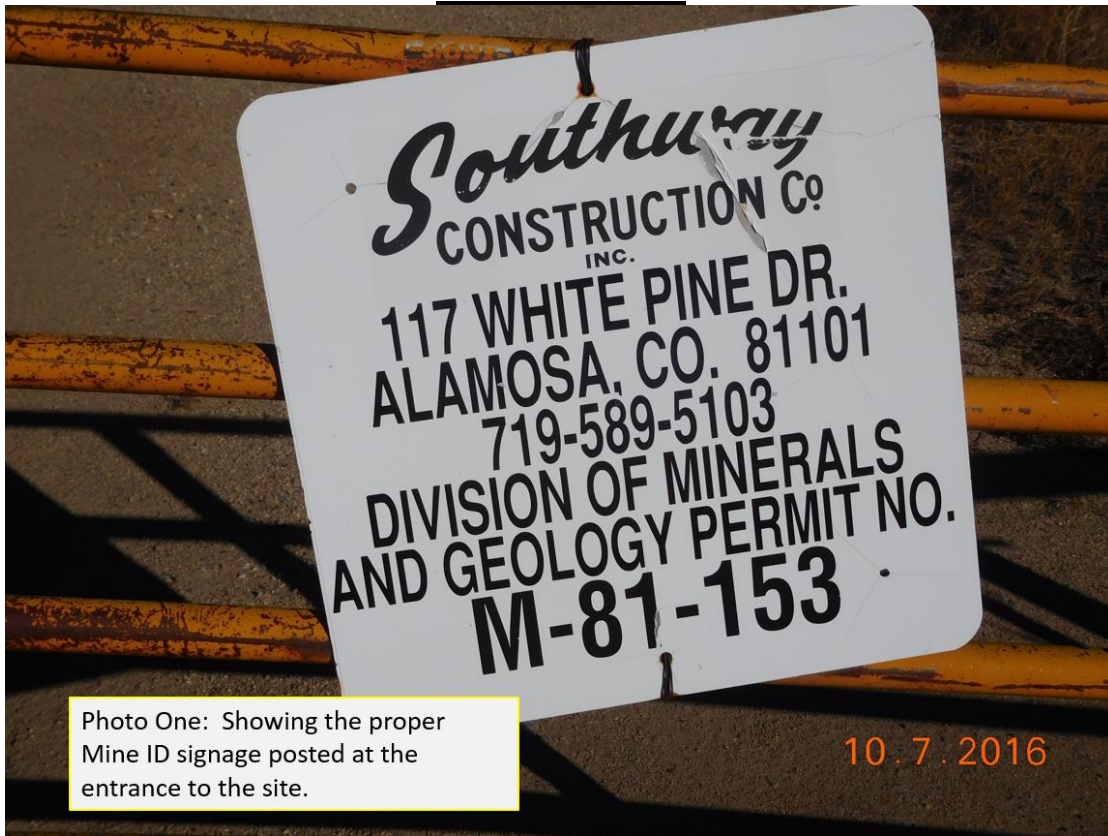
The proper mine Identification signage was posted at the entrance to the site, as seen in Photo One. The permit boundaries were clearly marked with fence lines, T-Posts and a concrete lined irrigation canal on the west side of the site. No equipment was present and the site was not active during the inspection. The mining area consists of a large pit located just north of County Road GG. The access road leading down into the pit is in good condition. On the pit floor several stockpiles of materials were observed. The stockpiles all appear to be stable and in good condition. Examples of the stockpiles can be seen in Photos Two and Three. Most of the pit floor has begun to revegetate itself with volunteer species in areas that are not heavily trafficked. The side slopes of the pit have been mined and or backfilled to a stable configuration, at approximately a 3H: 1V slope that appears to be stable and in good condition. The slopes are well vegetated and show no significant signs of erosion. Examples of the slopes can be seen in Photo Four. The active mining area was observed in the northeast section of the pit. The active mining area is also in good condition and appears to be stable.

Photo One: Showing the proper Mine ID signage posted at the entrance to the site.

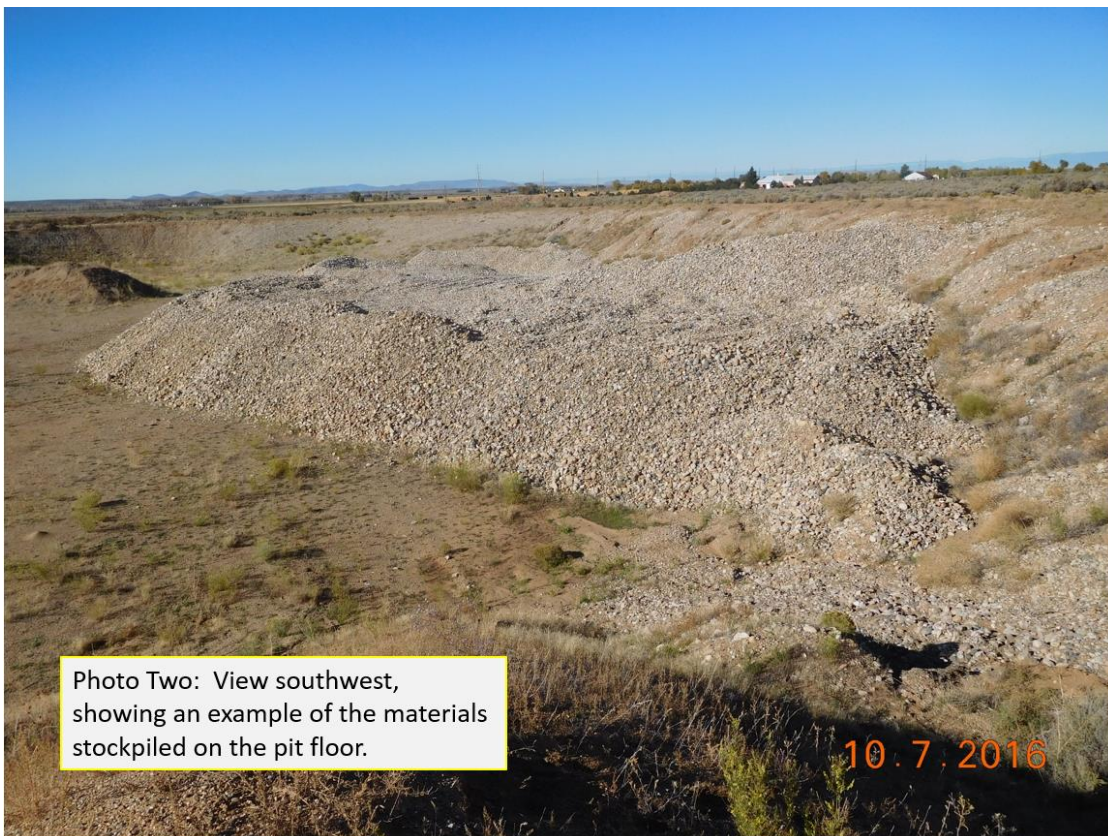
Photo Two: View southwest, showing an example of the materials stockpiled on the pit floor.
