MINERALS PROGRAM INSPECTION REPORT
PHONE: (303) 866-3567

MINE NAME: Lyle Smith Pit	MINE/PROSPECTING ID#: M-1977-053	MINERAL: Sand and gravel	COUNTY: Costilla
INSPECTION TYPE: Monitoring	INSPECTOR(S): Lucas J. West	INSP. DATE: October 7, 2016	INSP. TIME: 10:30
OPERATOR: Asphalt Constructors, Inc.	OPERATOR REPRESENTATIVE: Todd Stockebrand	TYPE OF OPERATION: 112c - Construction Regular Operation	
REASON FOR INSPECTION: Normal I&E Program	BOND CALCULATION TYPE: Complete Bond	BOND AMOUNT: \$128,120.82	
DATE OF COMPLAINT: NA	POST INSP. CONTACTS: None	JOINT INSP. AGENCY: None	
WEATHER: Clear	INSPECTOR'S SIGNATURE:

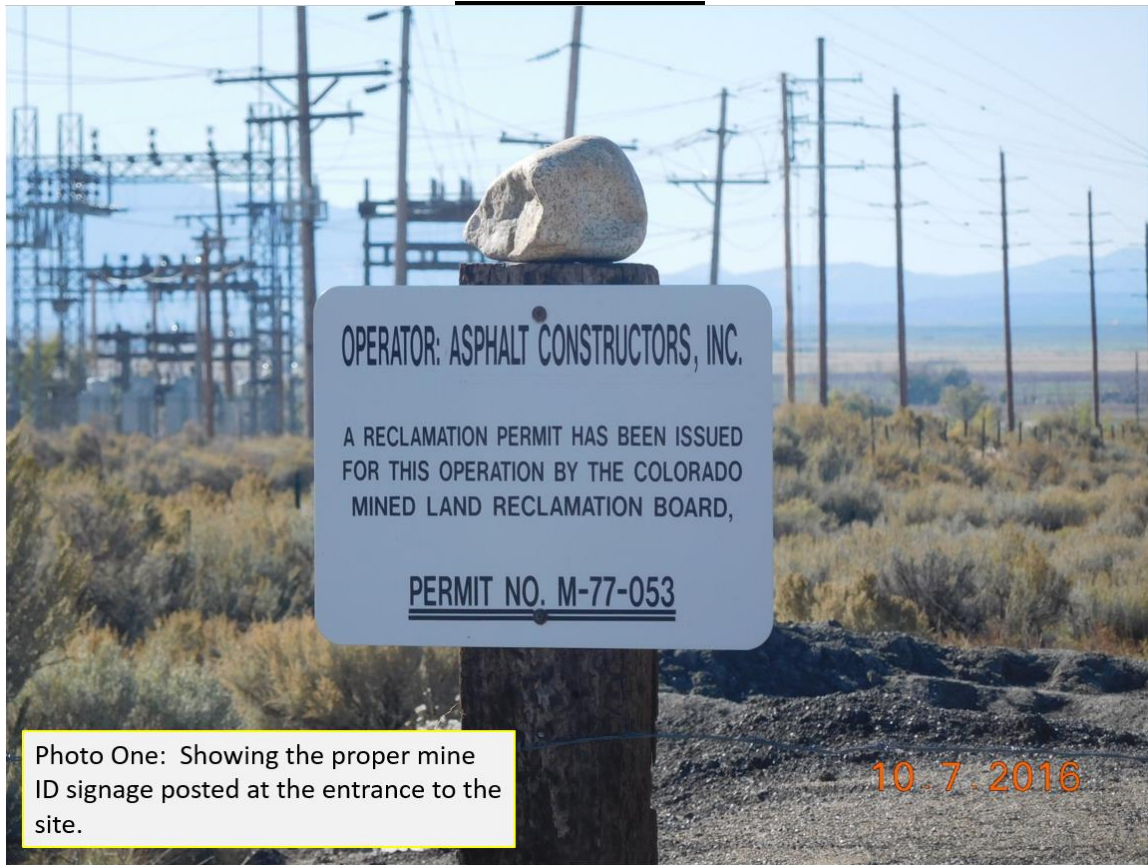
As seen in Photo One, the proper mine identification signage was posted at the entrance to the site. Also observed were the permit boundary markers, which consisted of T-posts, fence lines and earthen berms. Several pieces of equipment were located on site during the inspection including a front end loader, crusher, conveyors and a hot plant. The site was not actively being mined during the inspection however the hot plant was running and material was being hauled off site from the stockpiles. The stockpiles observed on the pit floor included various sized materials, as well as some overburden and asphalt that is to be recycled. Examples of the stockpiles can be seen in Photos two and Three. All of the stockpiles on the pit floor appear to be stable and in good condition with no signs of degradation. The side slopes of the pit have been relaxed to approximately a 3H: 1V or shallower, and also appear to be stable. The side slopes are well vegetated with grasses and shrubs and are in good condition. An example of the side slopes can be seen in Photo Four.
