**COLORADO**Division of Reclamation,
Mining and Safety

MINERALS PROGRAM INSPECTION REPORT**PHONE: (303) 866-3567**

MINE NAME: Neglected Mine	MINE/PROSPECTING ID#: M-1981-165	MINERAL: Gold	COUNTY: La Plata
INSPECTION TYPE: Multi Person Inspection	INSPECTOR(S): Lucas J. West, Russ Means	INSP. DATE: October 17, 2016	INSP. TIME: 14:50
OPERATOR: Mine Development Inc	OPERATOR REPRESENTATIVE: None	TYPE OF OPERATION: 110(2) - Hard Rock Limited Impact

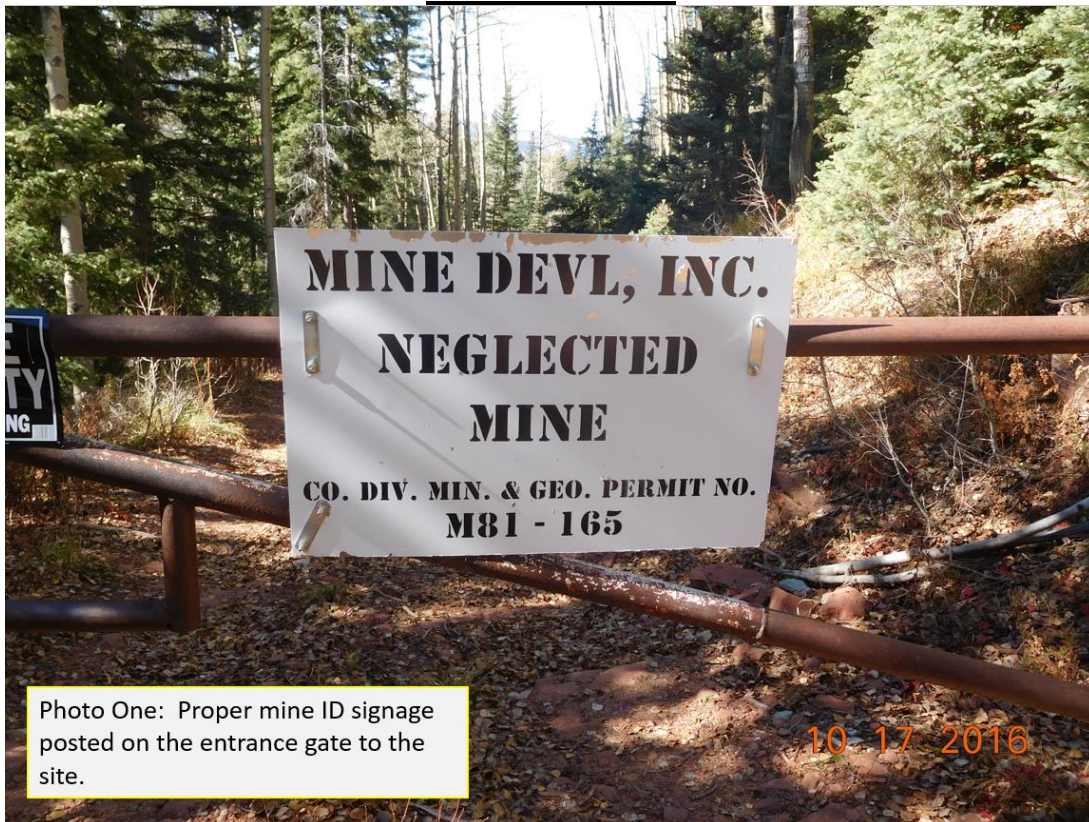
As seen in Photos One and Two, proper signage and Permit Boundary Markers were observed. The interior of the Mill building was not inspected at this time, however the building was secure and in good condition. Photo Three shows the mill building, which is built on a concrete pad with proper drainage structures to contain any processed water generated during operations. All other surface structures and facilities were inspected. The site is currently winterized with minimal activity taking place over the past mining season. The portal was sealed with a locked steel door and small temporary berm pushed up to its base, shown in Photo Four. The portal was not draining water during the inspection. The secondary egress/ vent shaft was observed to be in good condition. The storage yard was in good condition, and well vegetated. Equipment stored includes a box truck, lumber, scrap iron and an explosives magazine. The Explosives magazine is secure and appears to be in good condition. The Operator confirms it is empty and prior to the commencement of mining activities next season he will change the locks to allow for access and use. The lined tailings pond was in good condition, as seen in Photo Five. The area above the water line showed no signs of tearing or compromising of any kind. The pond level is lowered by the assisted evaporation process and is low enough to support the addition of any contributions from precipitation events.

Photo One: Proper mine ID signage posted on the entrance gate to the site.

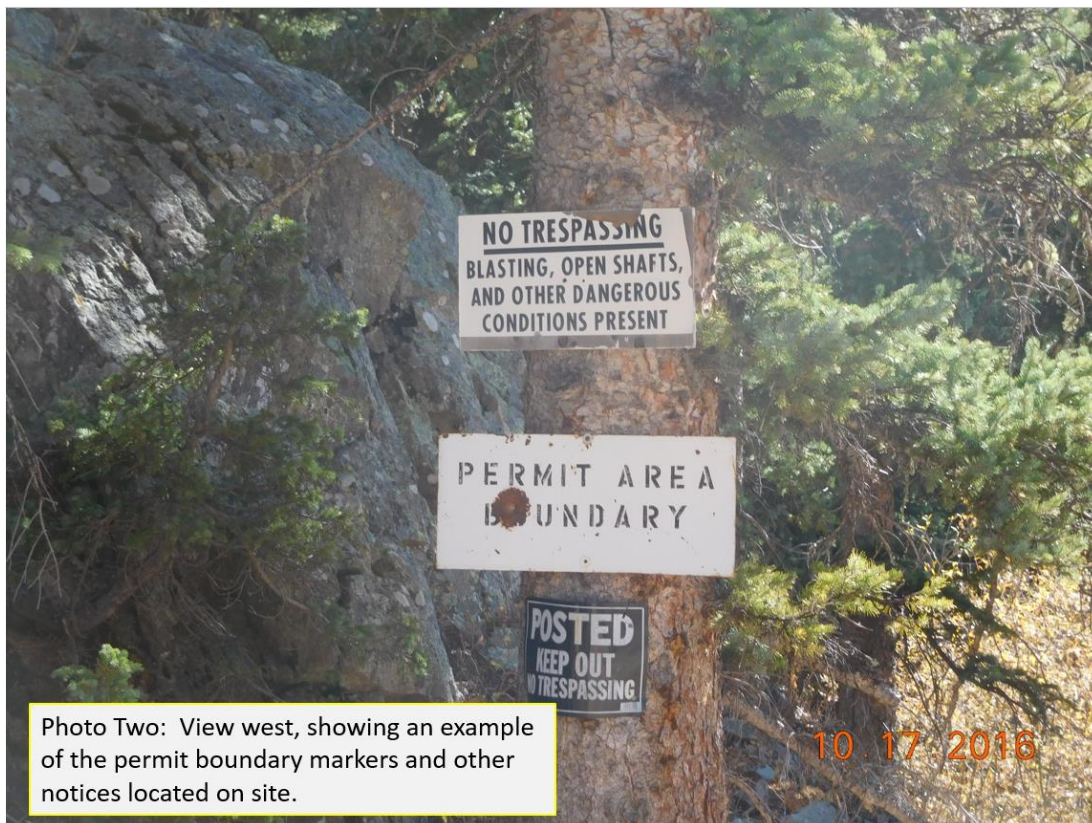
Photo Two: View west, showing an example of the permit boundary markers and other notices located on site.

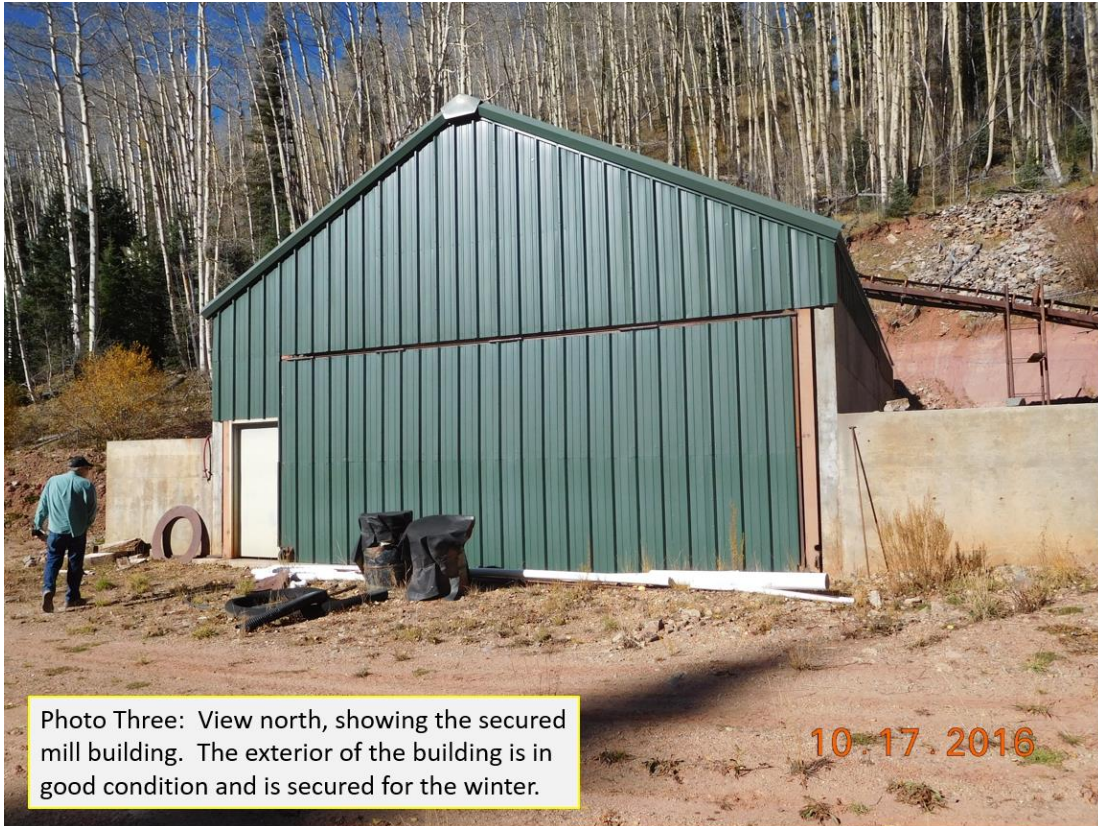
Photo Three: View north, showing the secured mill building. The exterior of the building is in good condition and is secured for the winter.

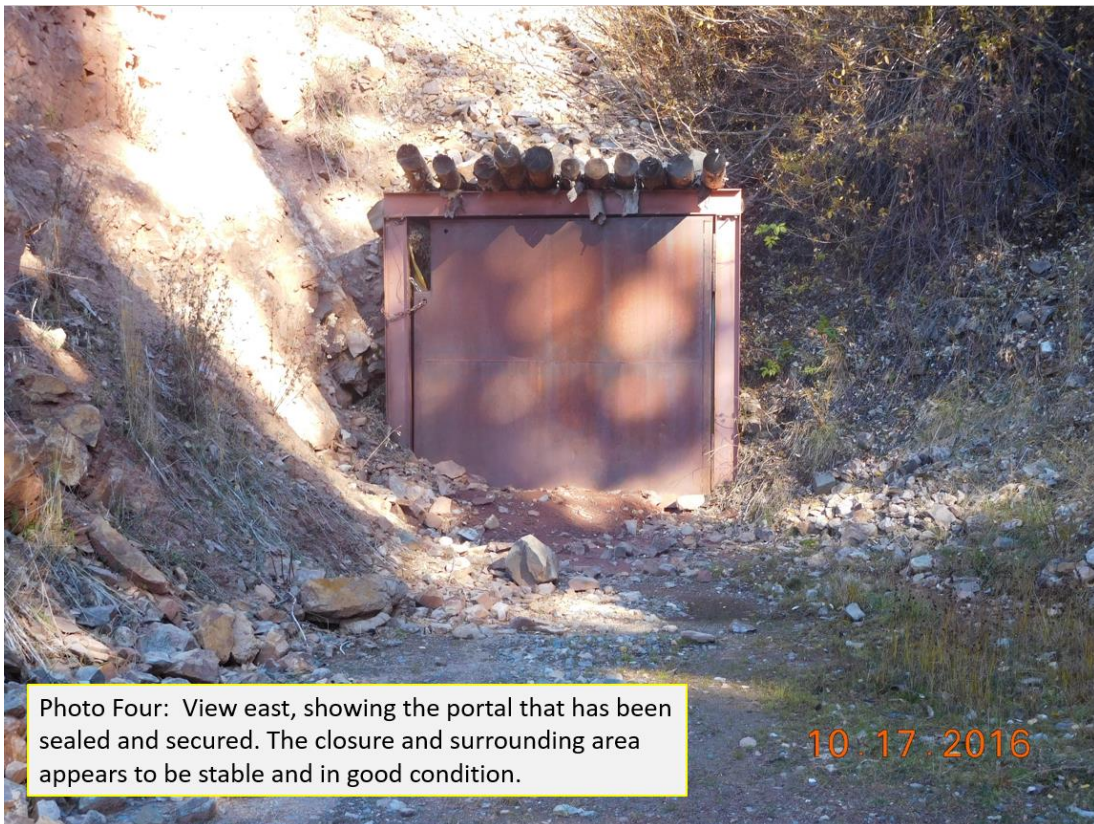
Photo Four: View east, showing the portal that has been sealed and secured. The closure and surrounding area appears to be stable and in good condition.

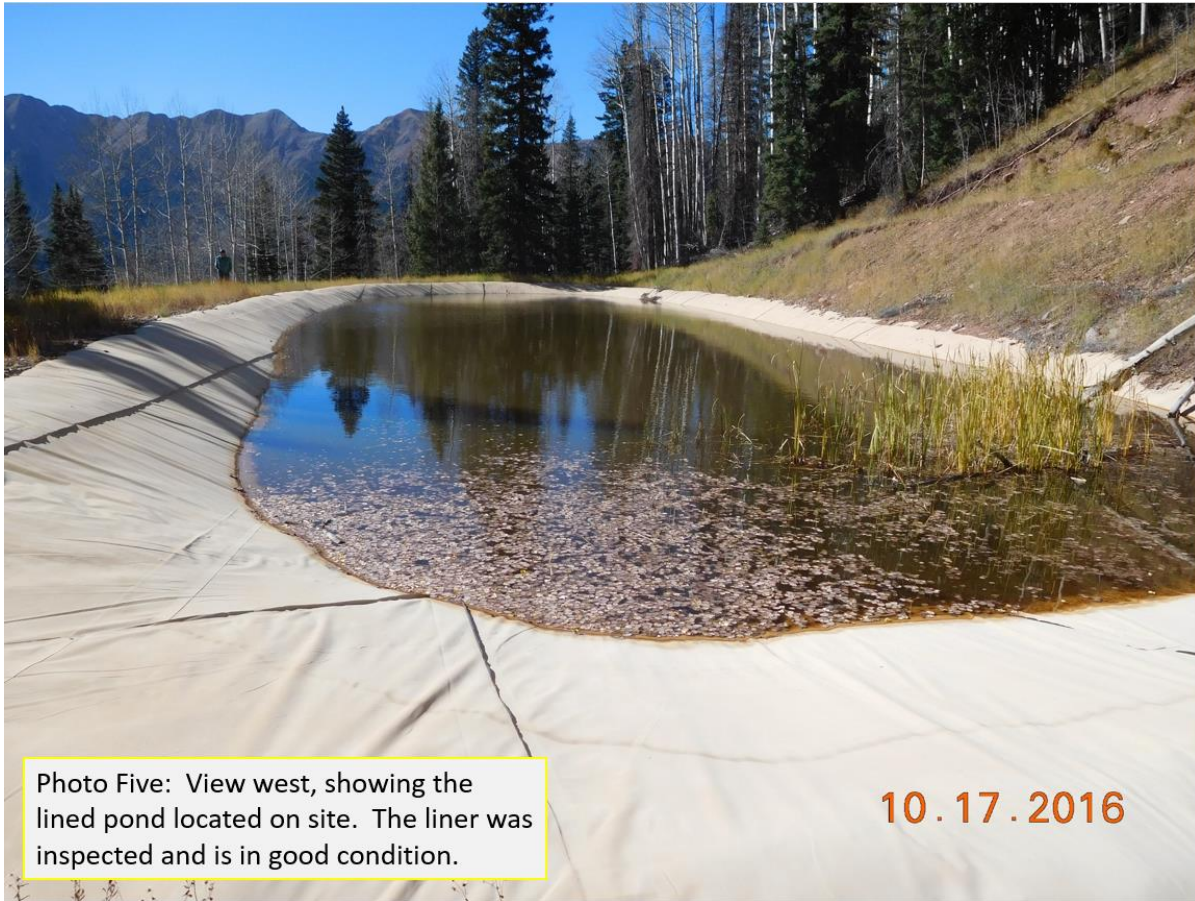
Photo Five: View west, showing the lined pond located on site. The liner was inspected and is in good condition.
