**Re: Restoration Completion Report Board Order Signed-March 3, 2016  
Little Deadwood Gulch and Chief Portal  
May Day Idaho Mine Complex Permit No. M-1981-185  
112d-1 Reclamation Permit**

The following is Wildcat Mining Corporation's (Wildcat) completion request for the restoration of the Little Deadwood Gulch (LDG) adjacent to the Chief Portal.. This completion report summarizes site activities pursuant to the approved Technical Revision (TR-8)<sup>1</sup>. The original drainage plan was designed by Carroll & Lange-Manhard (Manhard) and submitted to the Division on March 18, 2013 and approved on April 1, 2013. (Attachment 1).

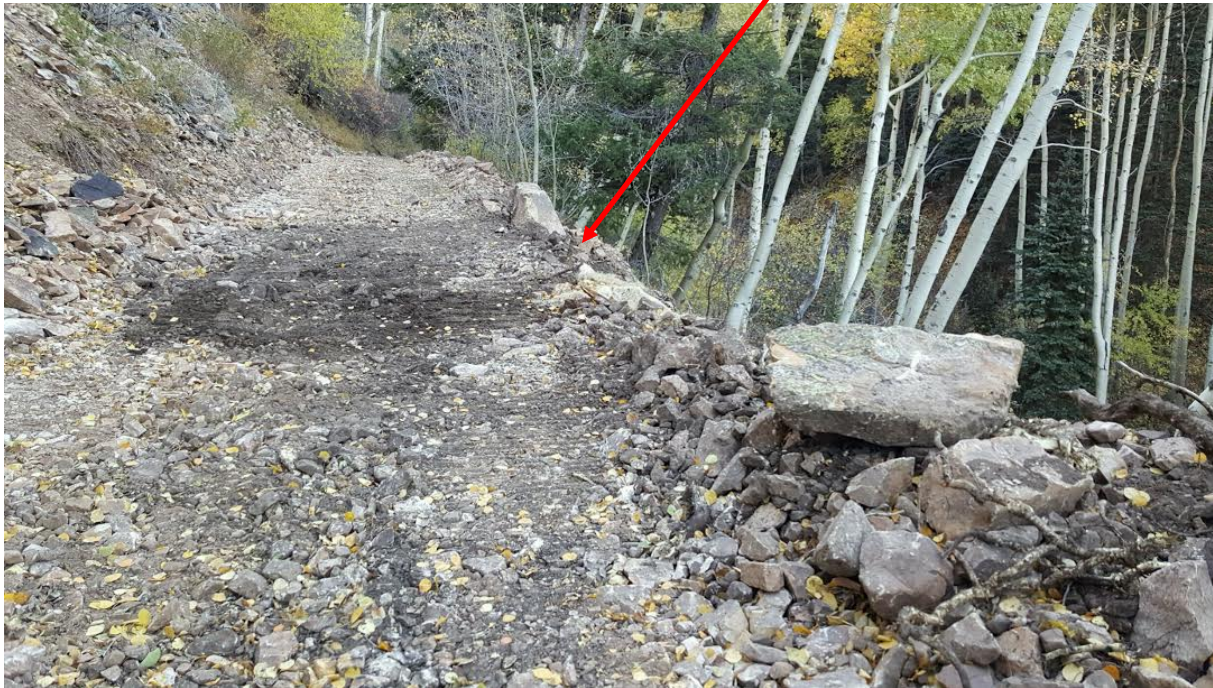
# Repaired Access Road Above Chief Portal

Rock Barrier-above Chief Man Way Head Wall

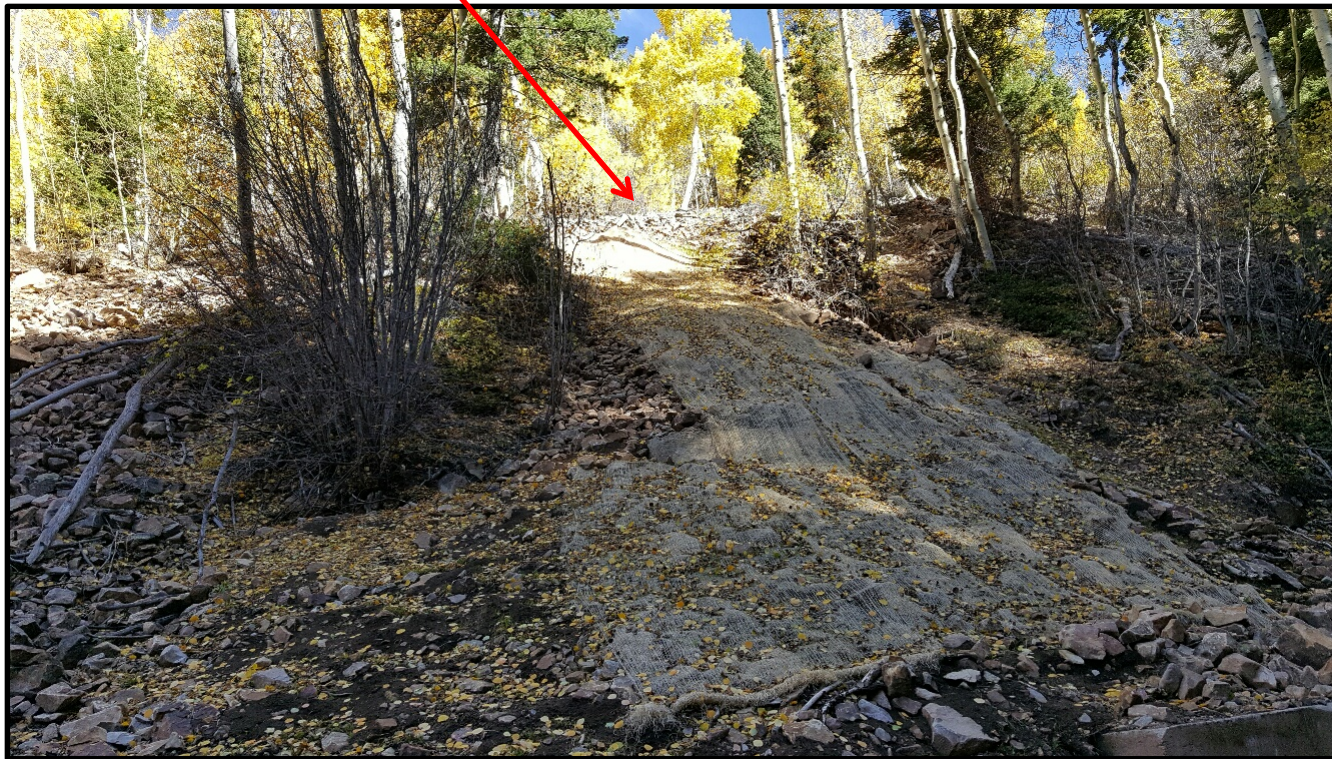
# Restored Chief Headwall

Incas access Road

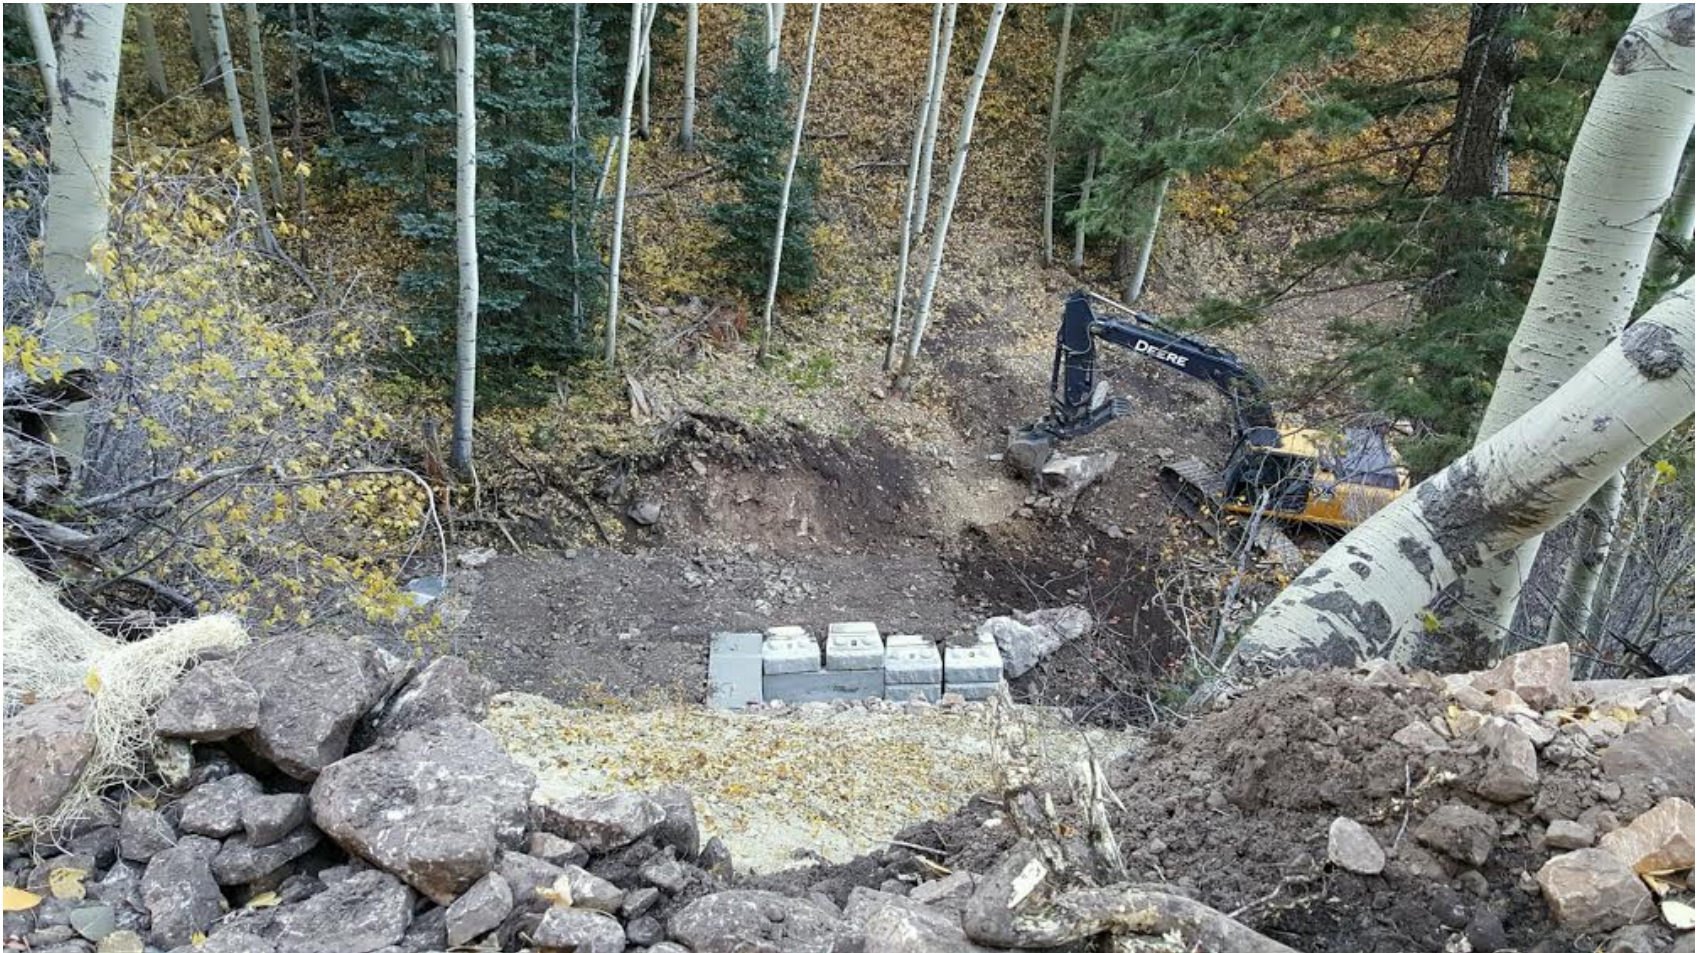
# Manway Barriers Construction

6. To provide stability to site alluvial materials outside of the portal manway, gravity blocks were placed immediately upgradient and parallel to of the manway portal. The upgradient block extension is approximately 4-feet wide and approximately 16-feet long. (See photo). A manway entry ramp was constructed to permit mine rescue crews to gain access to the mine in the event of an emergency.

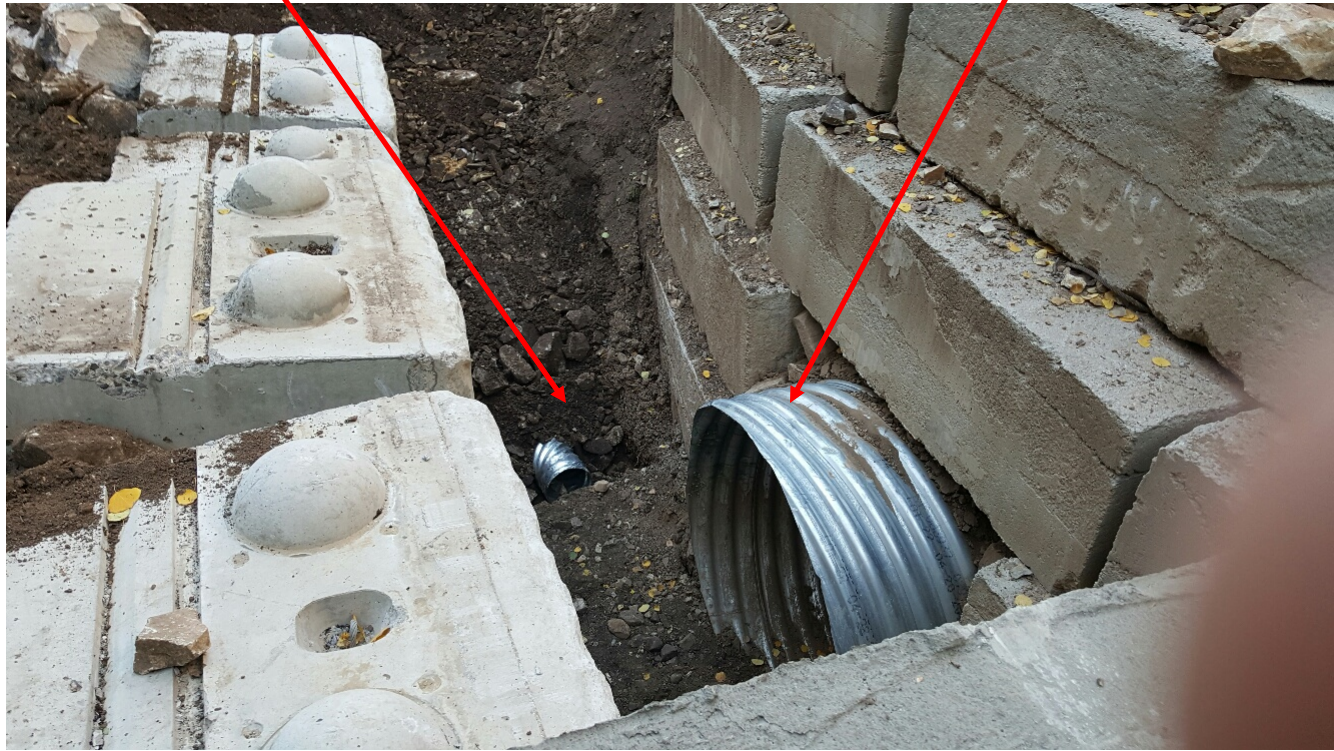
# Chief Manway-with Sub drain

12 inch CMP Sub Drain

66 inch CMP Man Way

7. Installed a 12-inch CMP sub drain (5.5 percent grade) at the entrance of the 66-inch culvert to drain collected water that may collect in front of the manway. (See Photo) Water from the manway entrance will be gravity drained to a downgradient point near the crest of the LDG bench and in close proximity to the LDG-24 inch CMP discharge point. (See Photo)

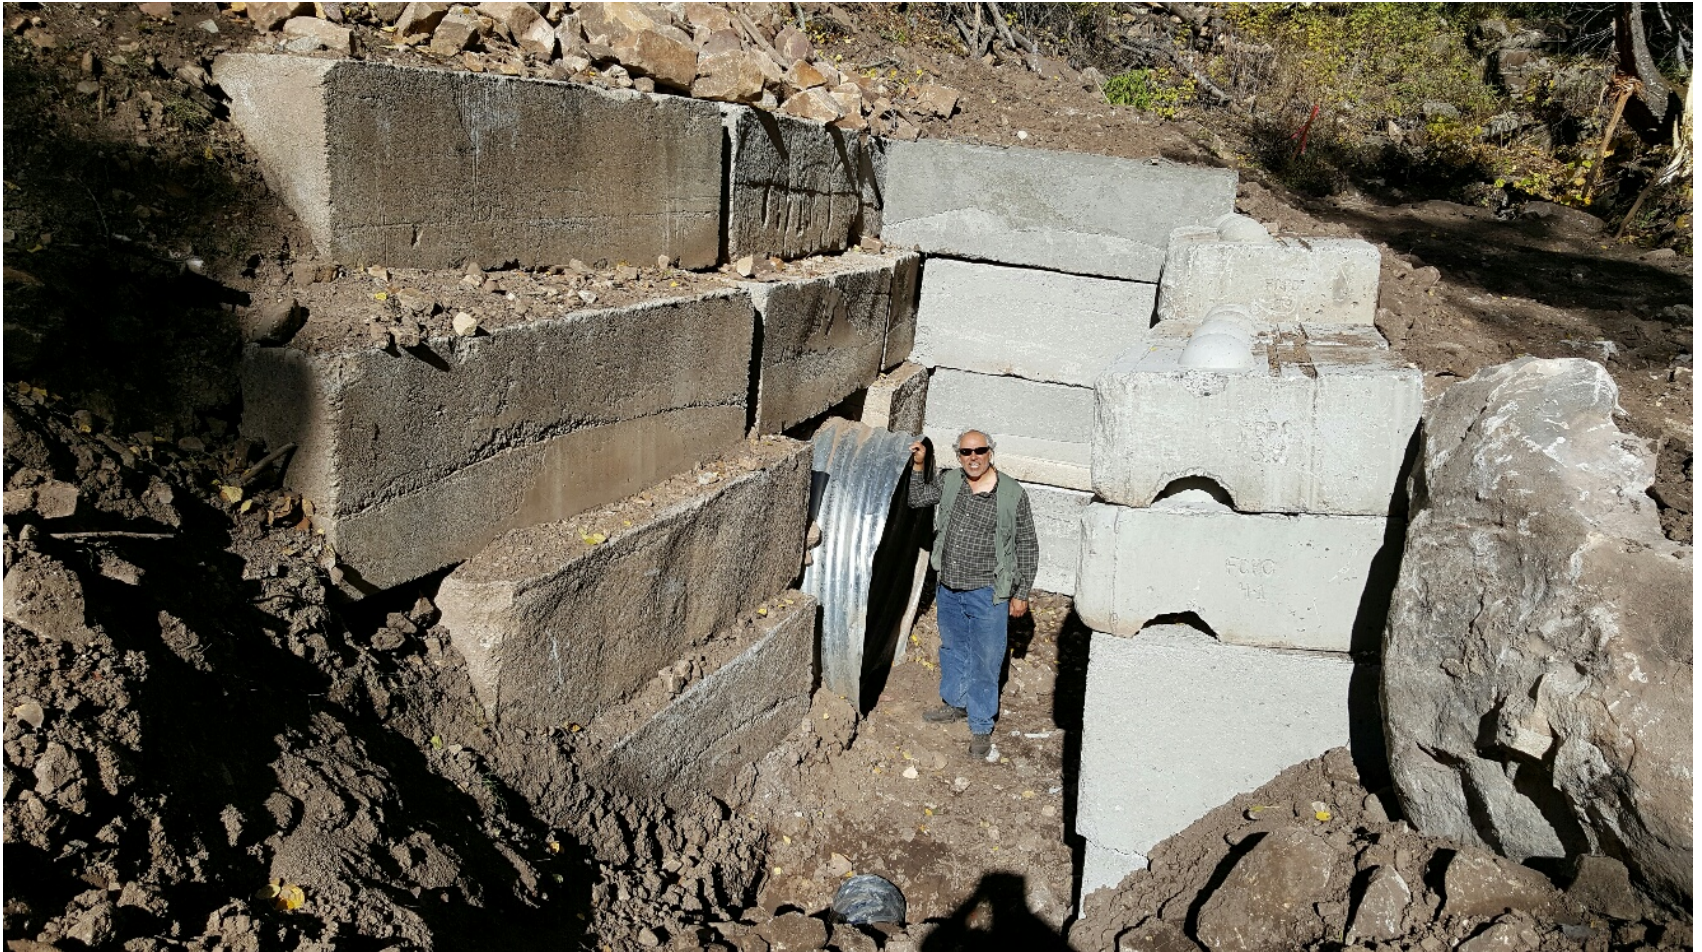
# Manway-Post Construction

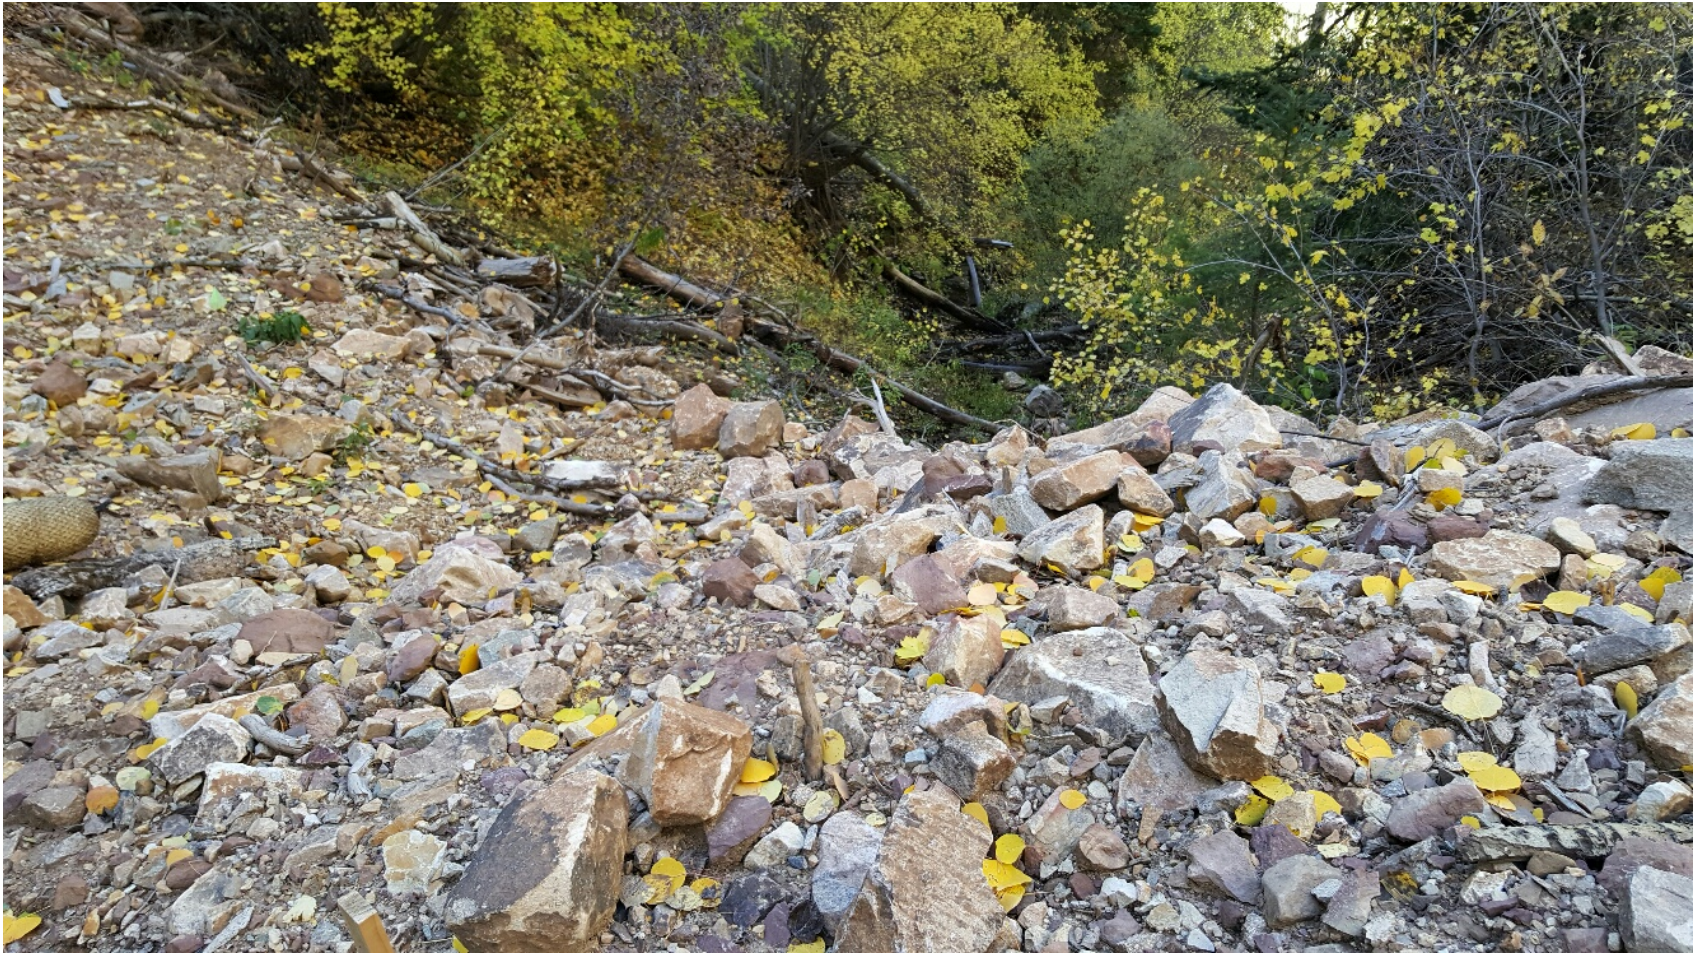
# LDG-Chief Down Gradient Channel Pre-Construction

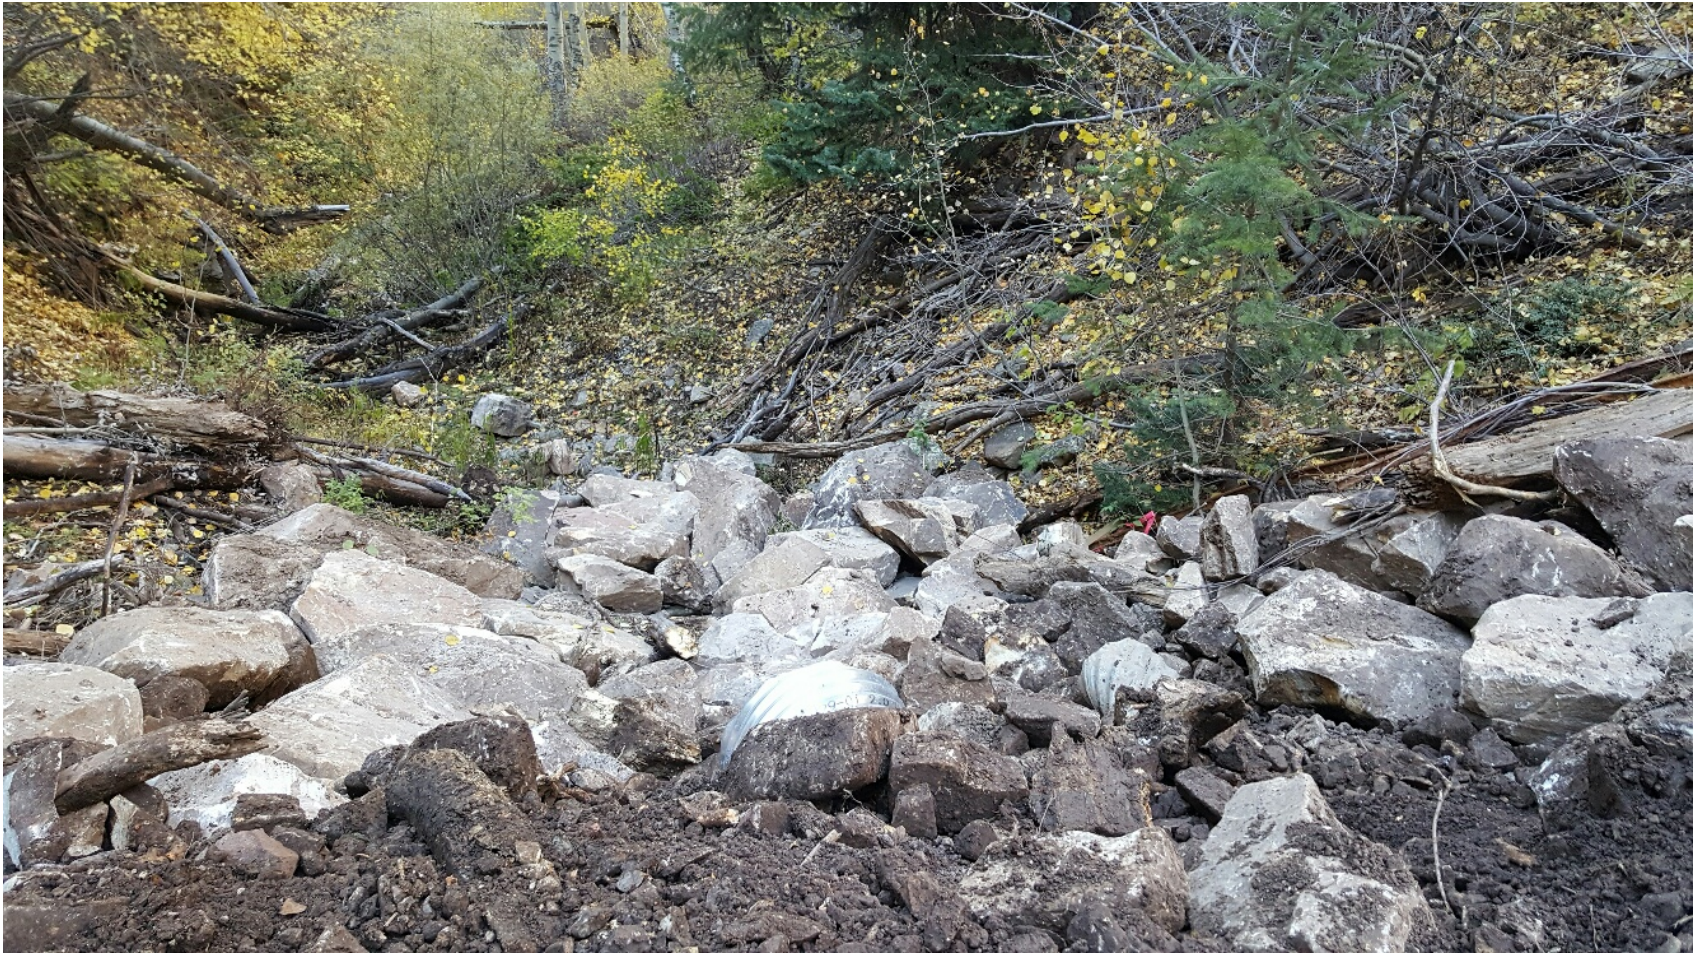
# LDG-Chief Down Gradient Channel Post Construction

8. Constructed a trapezoidal channel. (See Photo-See TR-5 and TR-8 design);
9. The disturbed area was revegetated in accordance with TR-5 approved design;

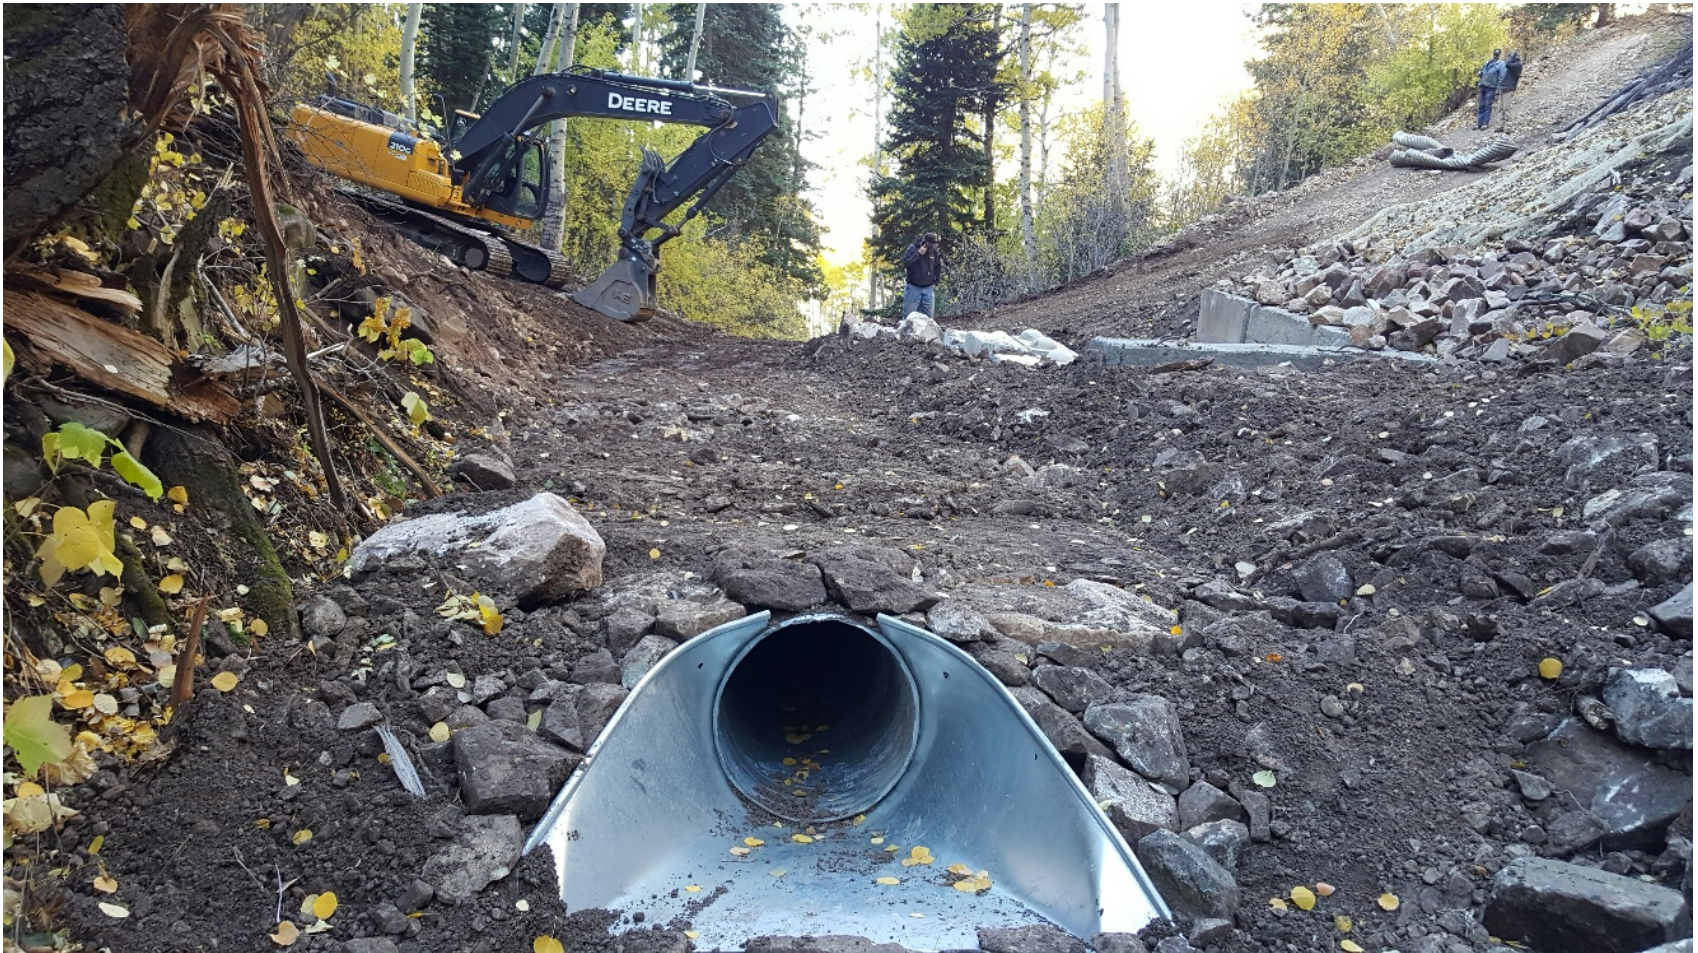
# LDG-Upgradient Culvert End Section w/o Trash Rack

1. Installed 100 foot-24 inch CMP pipe with end sections (11 percent grade) and a trash rack. The CMP is designed to convey the peak flow from a 10-year-24 hour storm (19.5 cubic feet per second (cfs)) (Manhard, 2013)<sup>2</sup> (See Table 1);

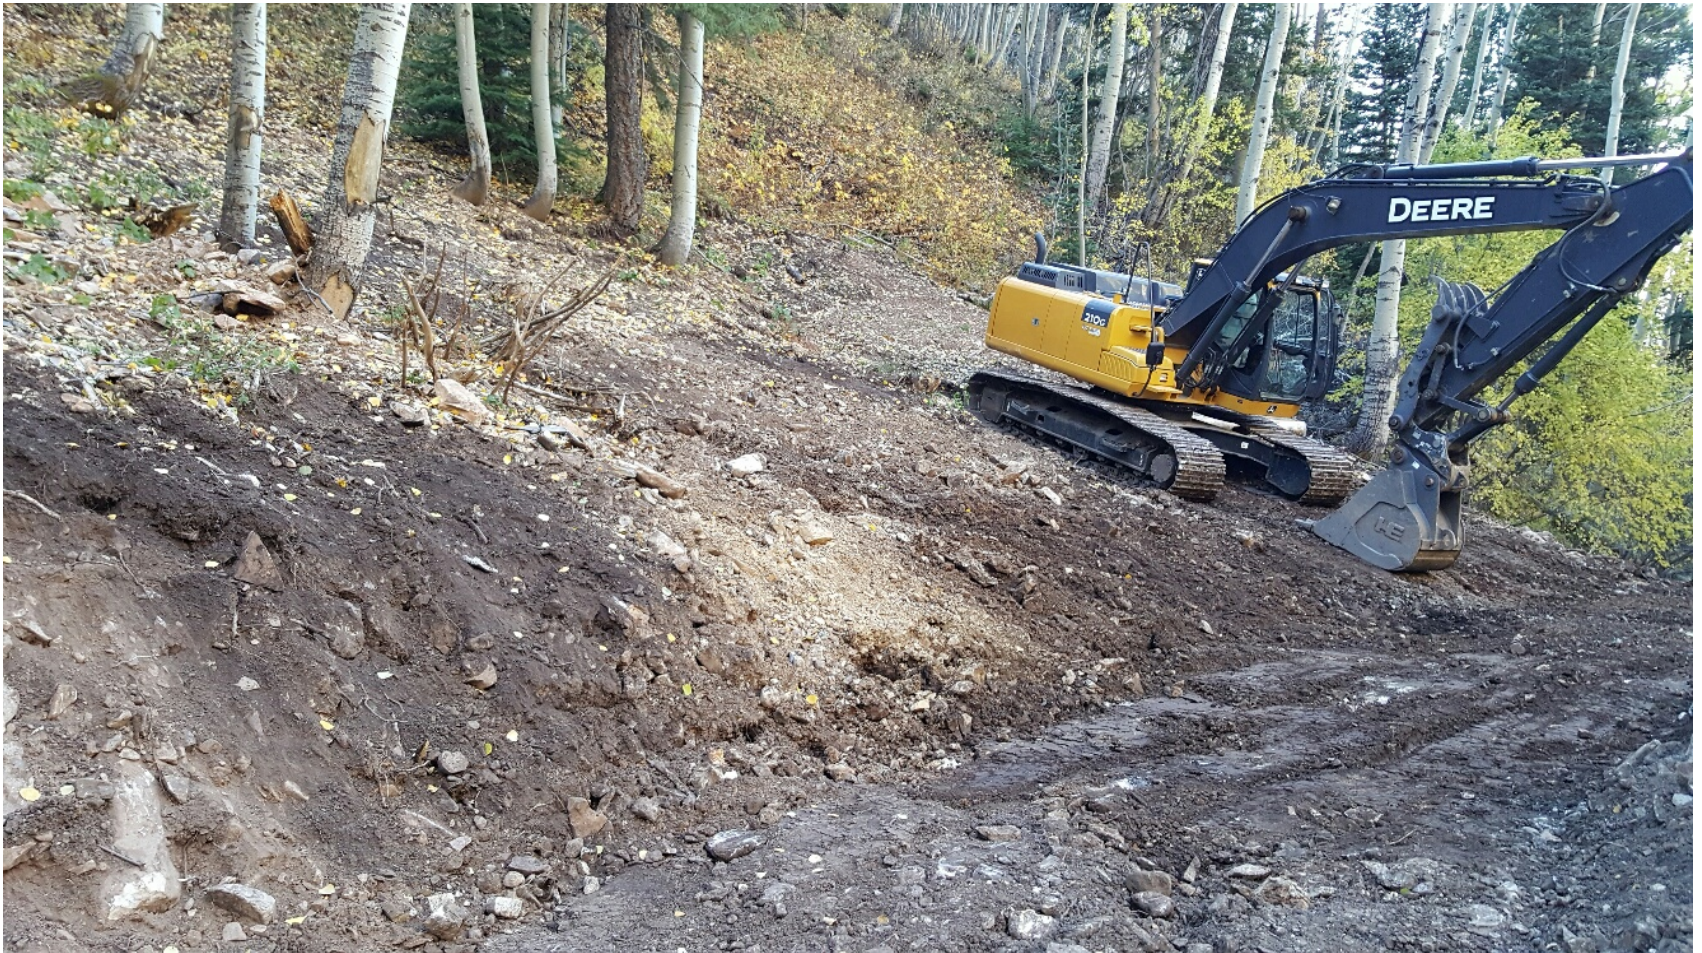
# LDG-Chief Channel Construction

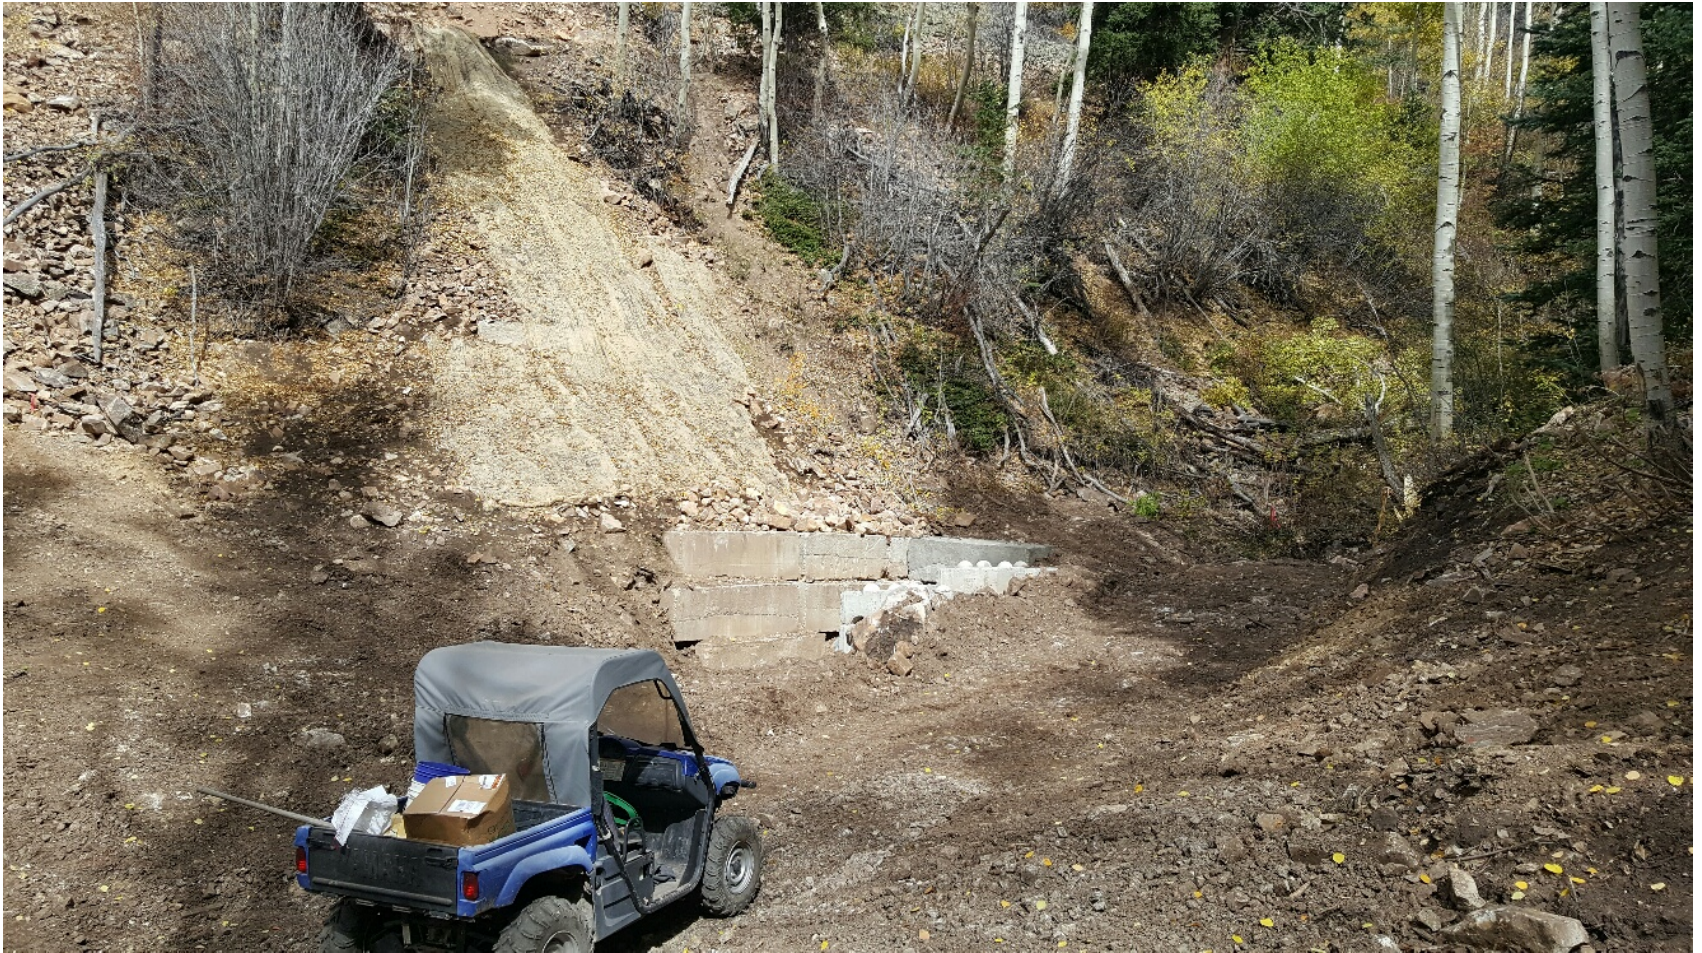
# Chief-LDG Post Construction

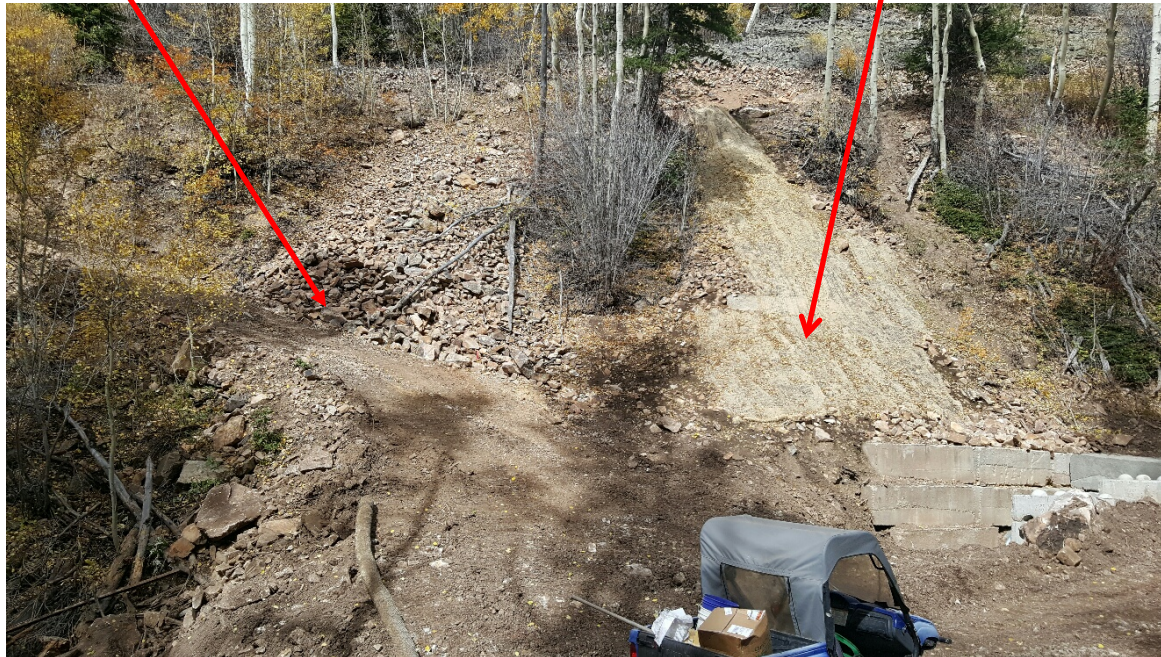
# Chief-LDG Post Construction

Man way access road

Restored Chief Portal

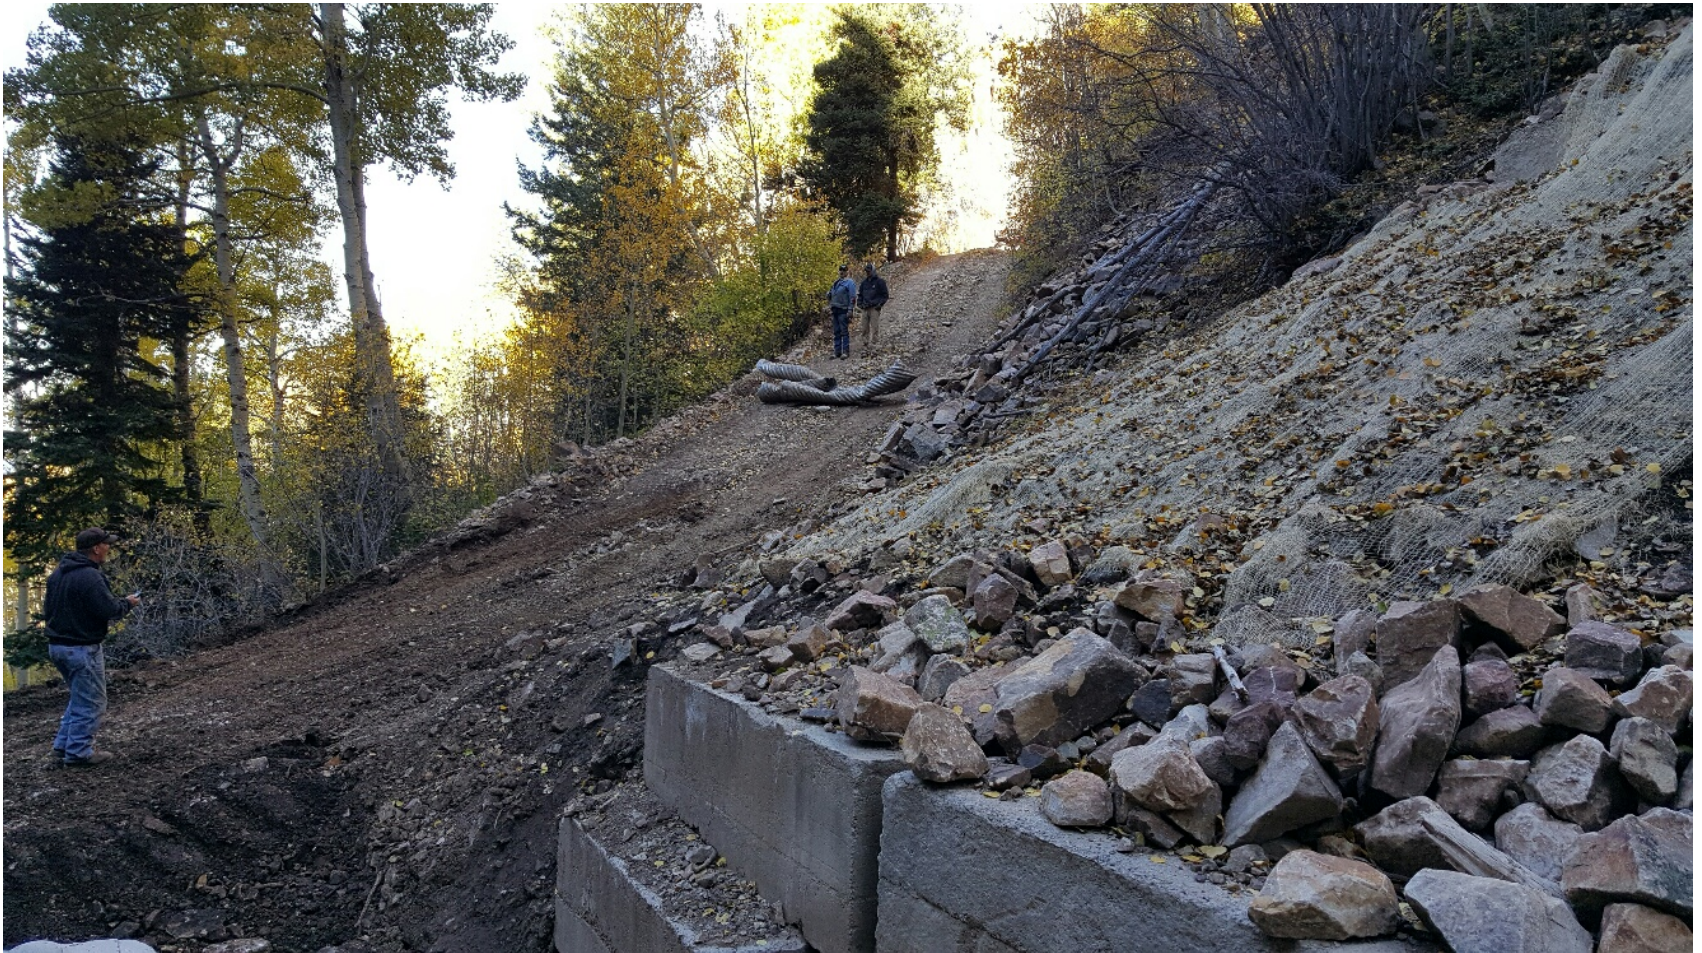
# Chief Manway Access Road

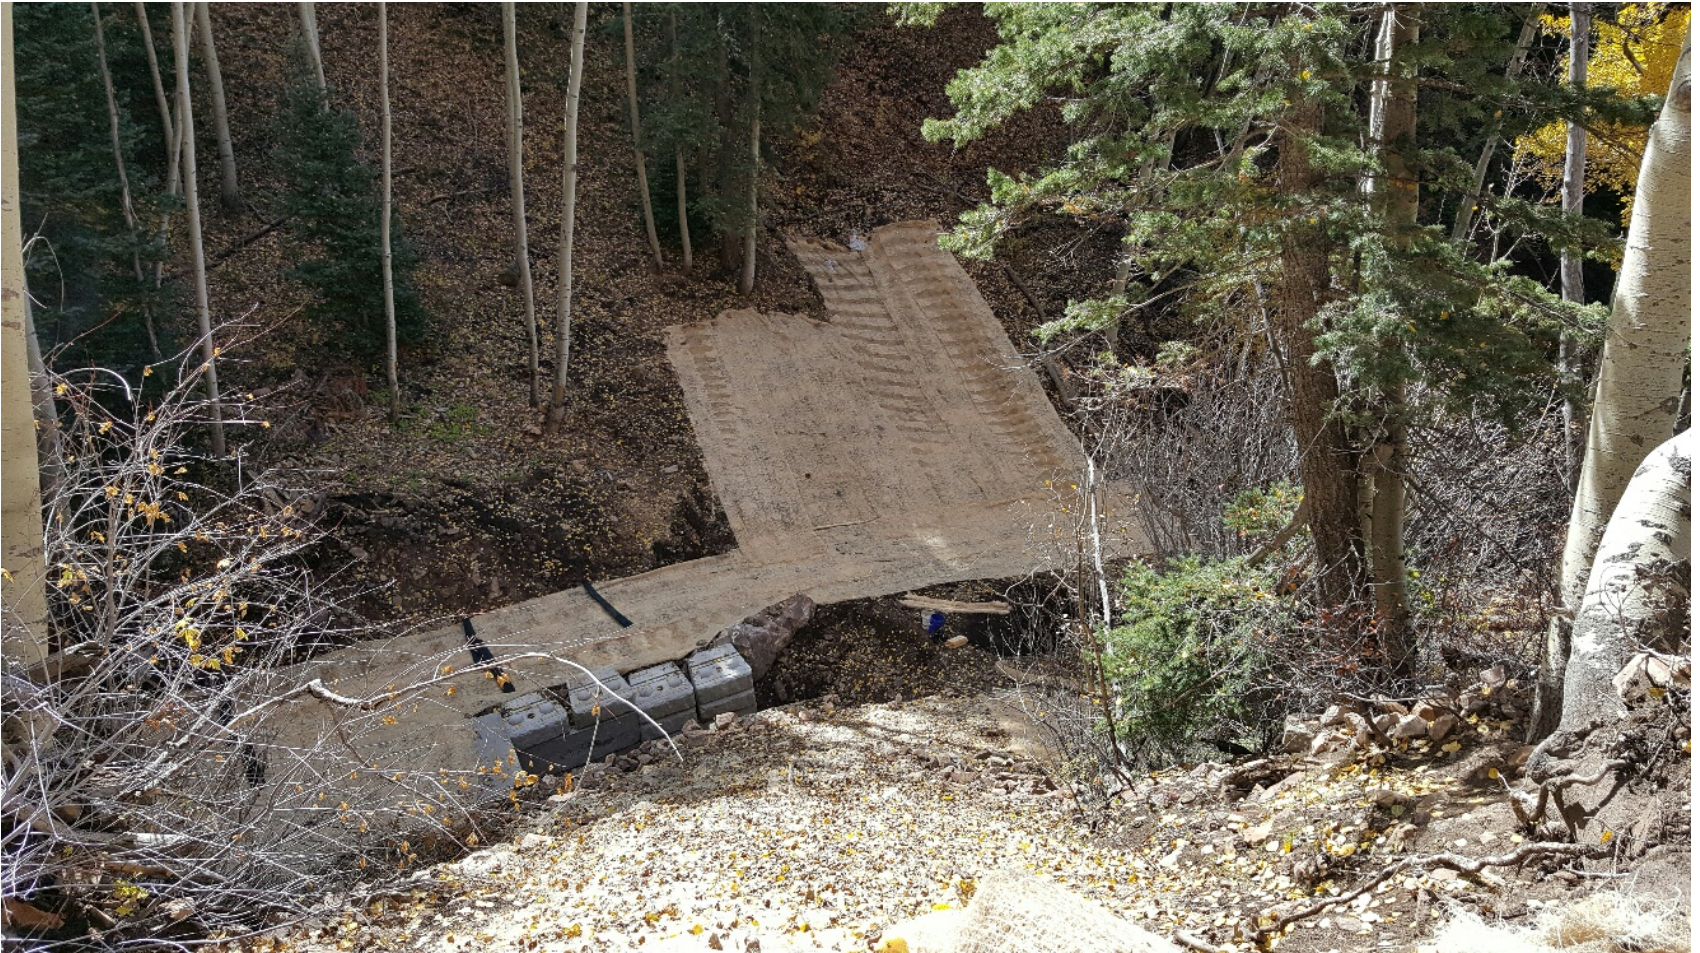
# Chief –LDG Drainage Reclaimed

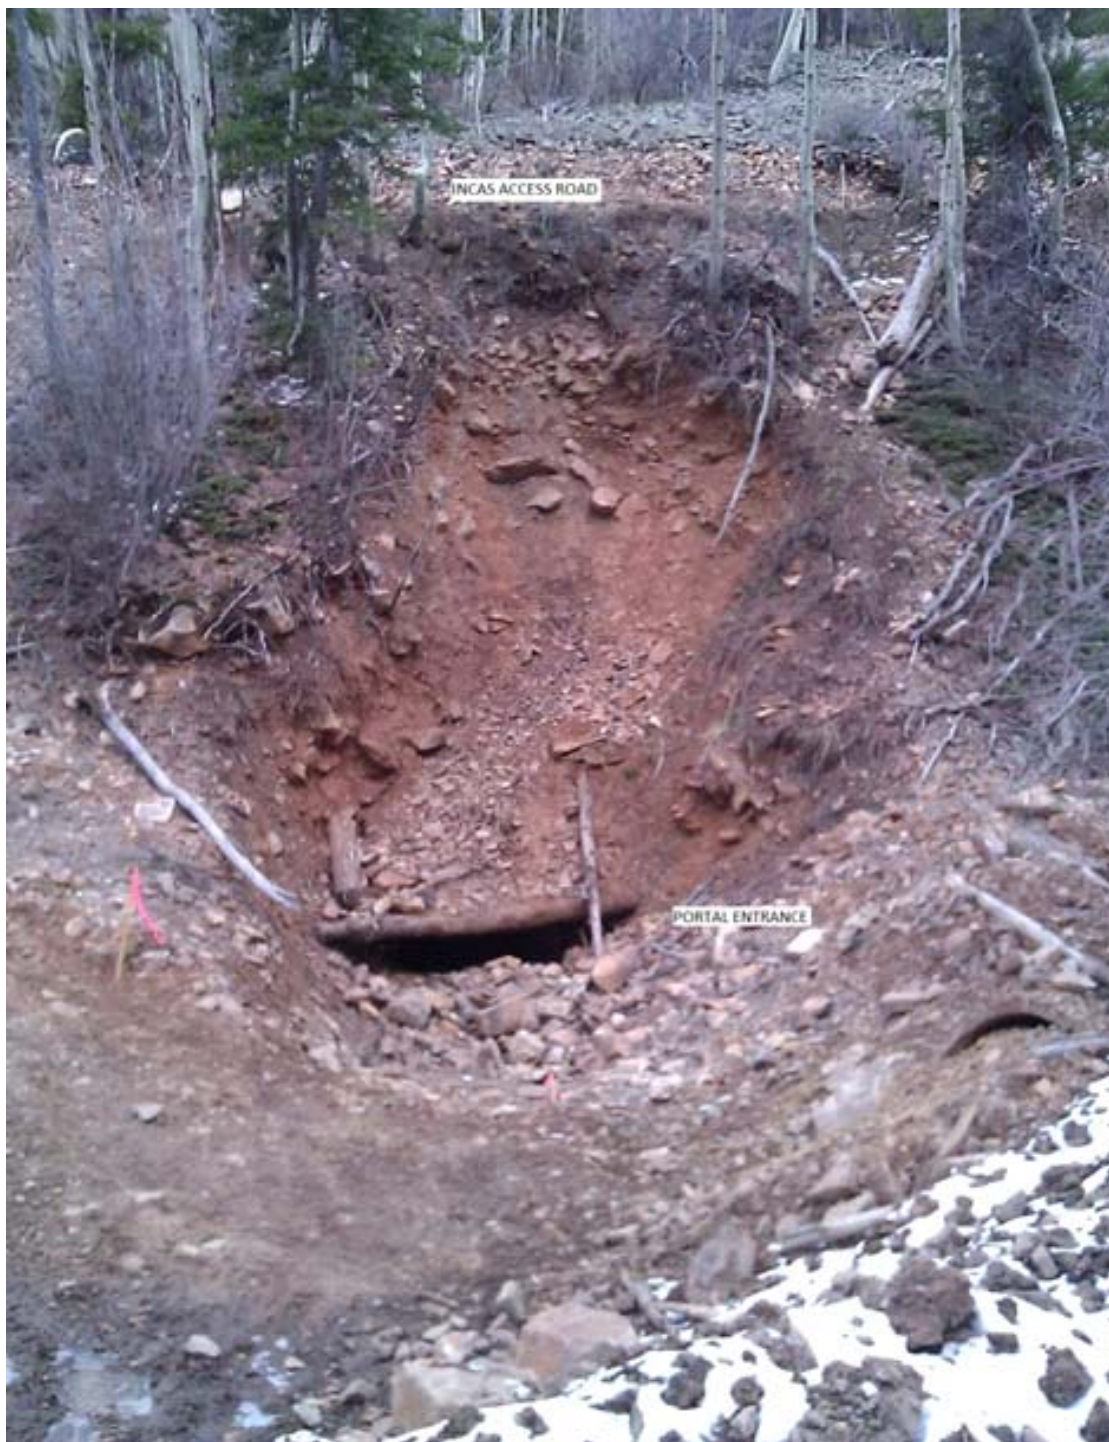
As shown on Figure 3, surface conditions on the slope above the portal consists primarily of colluvium. During the 2009 portal reconstruction, material was removed directly above the portal, causing some of the colluvial material to fall down the slope. The slope above the portal is approximately 50 feet high and has an approximate slope of 1:1 (horizontal:vertical). The portal is partially covered with rock and fill. There is an approximate 1,200 square-foot bench south of the portal. The access road to the portal from the Incas Access Road is approximately 10 to 12 feet wide, and is at an approximate 3:1 downward slope.

As discussed above, some colluvial material has been removed directly above the portal during its 2009 reconstruction which, in turn, undermined the slope and created the unstable condition in Figure 3.

The slope above the Chief Portal. The bedrock geology supports overall stability; however, loose fill and colluvial material creates a potential for slope raveling and rock falls.

Following removal of fill and debris from the drainage channel, a buttress should be constructed to establish a pad on which portal improvements can be supported and the slope above the portal stabilized. Figure 4 presents recommendations for fill over slope (buttress) construction. The buttress should extend at least 10 feet beyond the lateral extent of the portal, and be keyed into stiff colluvium or rock beneath the fill. The buttress width and keyway depth should be observed by the geotechnical engineer to check that suitable bearing materials are exposed. The slope of the buttress fill should be no steeper than 1.5:1 horizontal:vertical.
