MINERALS PROGRAM INSPECTION REPORT

MINE NAME: Mamm Creek Sand & Gravel	MINE/PROSPECTING ID#: M-2000-113	MINERAL: Sand and gravel	COUNTY: Garfield
INSPECTION TYPE: Surety Release Inspection	INSPECTOR(S): Amy C. Yeldell	INSP. DATE: October 27, 2016	INSP. TIME: 09:30
OPERATOR: Oldcastle SW Group, Inc. dba United Compai County	OPERATOR REPRESENTATIVE: Jason Burkey	TYPE OF OPERATION: 112c - Construction Regular Operation	
REASON FOR INSPECTION: Priority	BOND CALCULATION TYPE: None	BOND AMOUNT: \$149,153.00	
DATE OF COMPLAINT: NA	POST INSP. CONTACTS: None	JOINT INSP. AGENCY: None	
WEATHER: Clear	INSPECTOR'S SIGNATURE:

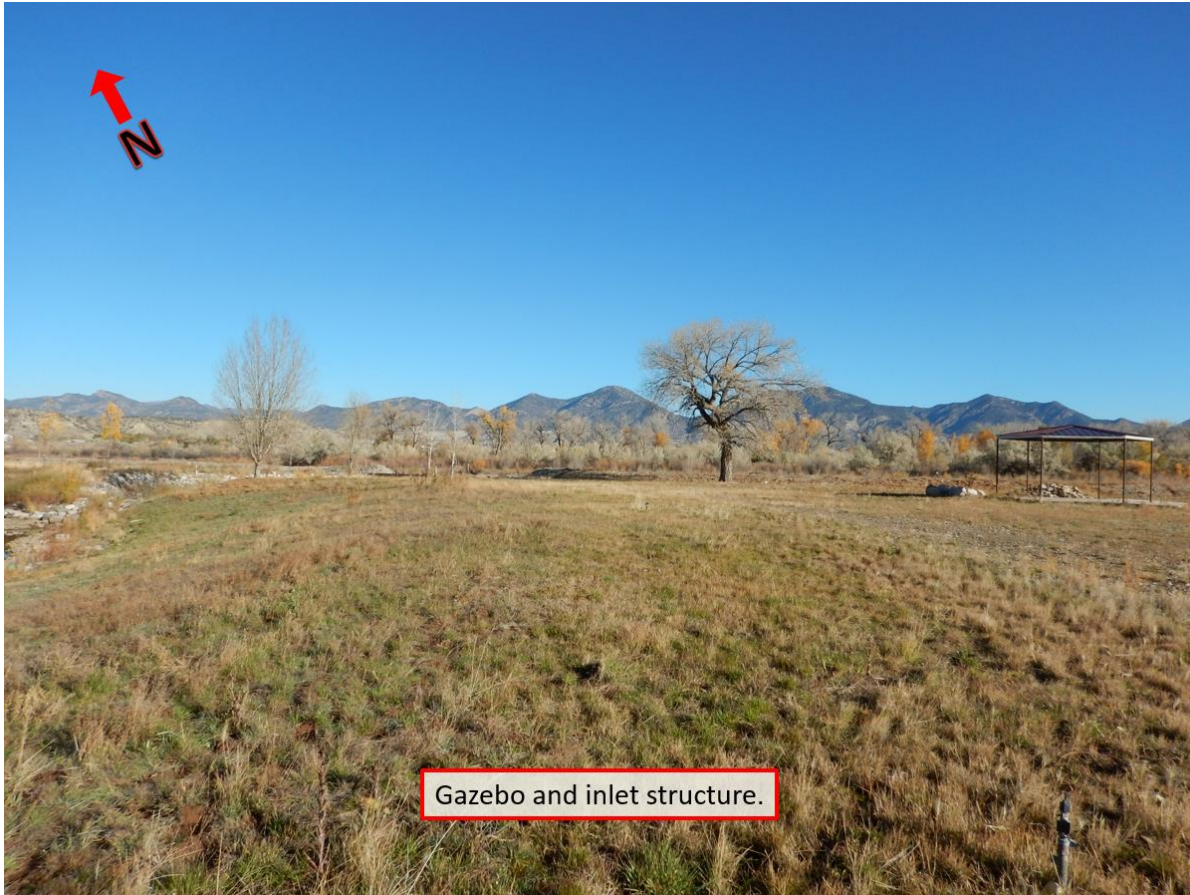
Gazebo and inlet structure.

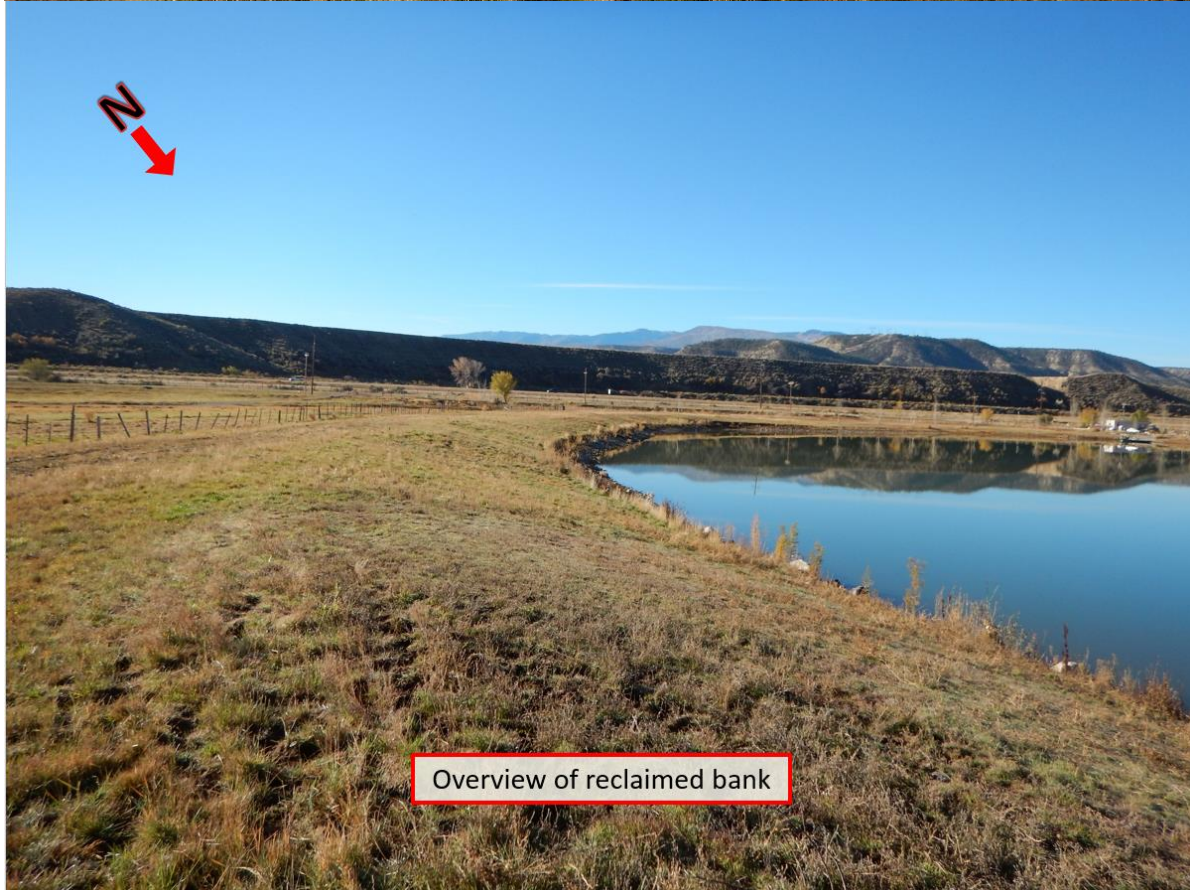
Overview of reclaimed bank
