MINERALS PROGRAM INSPECTION REPORT
PHONE: (303) 866-3567

MINE NAME: West Pit	MINE/PROSPECTING ID#: M-1983-130	MINERAL: Sand and gravel	COUNTY: Elbert
INSPECTION TYPE: Monitoring	INSPECTOR(S): Amy Eschberger	INSP. DATE: February 17, 2016	INSP. TIME: 11:00
OPERATOR: Elbert County	OPERATOR REPRESENTATIVE: Ted Dole	TYPE OF OPERATION: 110c - Construction Limited Impact	
REASON FOR INSPECTION: Normal I&E Program	BOND CALCULATION TYPE: None	BOND AMOUNT: \$0.00	
DATE OF COMPLAINT: NA	POST INSP. CONTACTS: None	JOINT INSP. AGENCY: None	
WEATHER: Clear	INSPECTOR'S SIGNATURE:

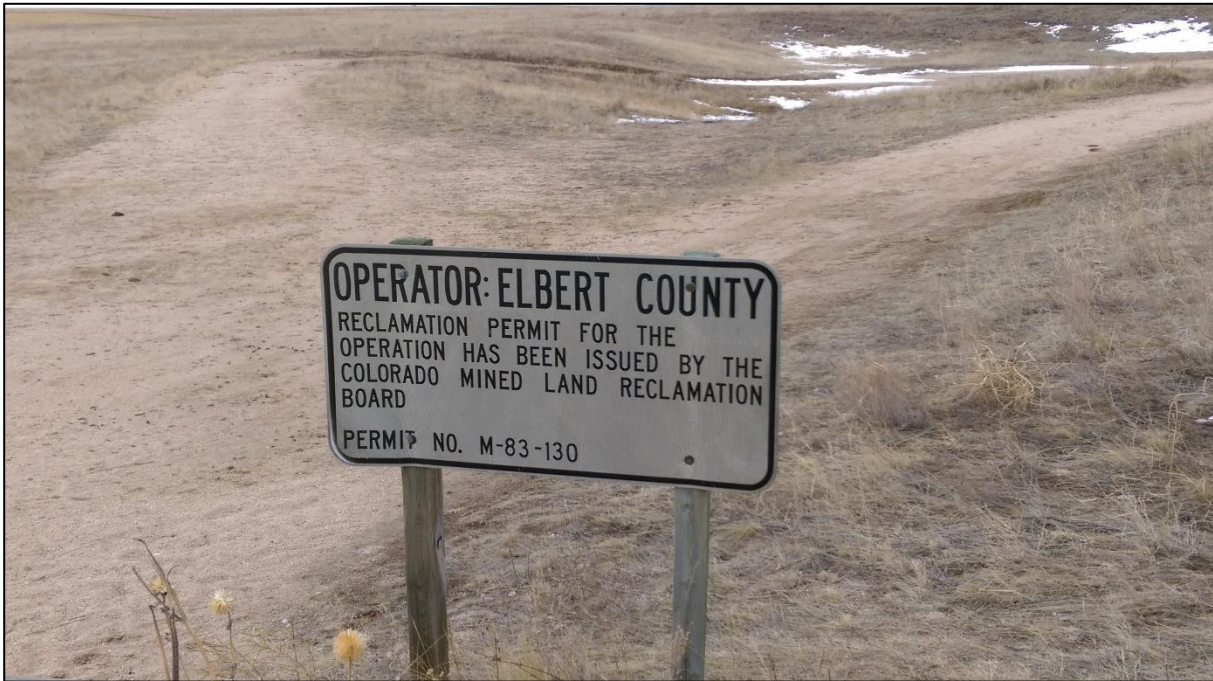
At the time of the inspection, it was partly cloudy and cool, with some snow cover remaining. A permit sign was posted at the main entrance to the site off of Co Rd 137 (**Photo 1**). The permit boundary was delineated by metal stakes. The site was not active during the inspection. However, Mr. Dole stated the county hauls off from the site every year. The pit has a depth below ground surface of approximately 25 feet (**Photo 2**). It appears the operation has two primary working faces, one along the northern edge of the permit area (**Photo 3**), and the other along a portion of the western edge of the permit area (**Photo 4**). Mined walls are maintained at 3H:1V slope gradients or flatter (see **Photos 3 and 4**), in accordance with the approved mining plan. A material stockpile is stored on the pit floor (**Photo 5**). The pit has reached its lateral extent within the permit boundary. Therefore, the operator intends to mine the pit a little deeper before completing final reclamation. The approved mining plan does not indicate a maximum mining depth. However, groundwater shall not be exposed, as this permit was approved as a dry mining operation.

Photo 1. View of permit sign posted at main entrance to site off of Co Rd 137.

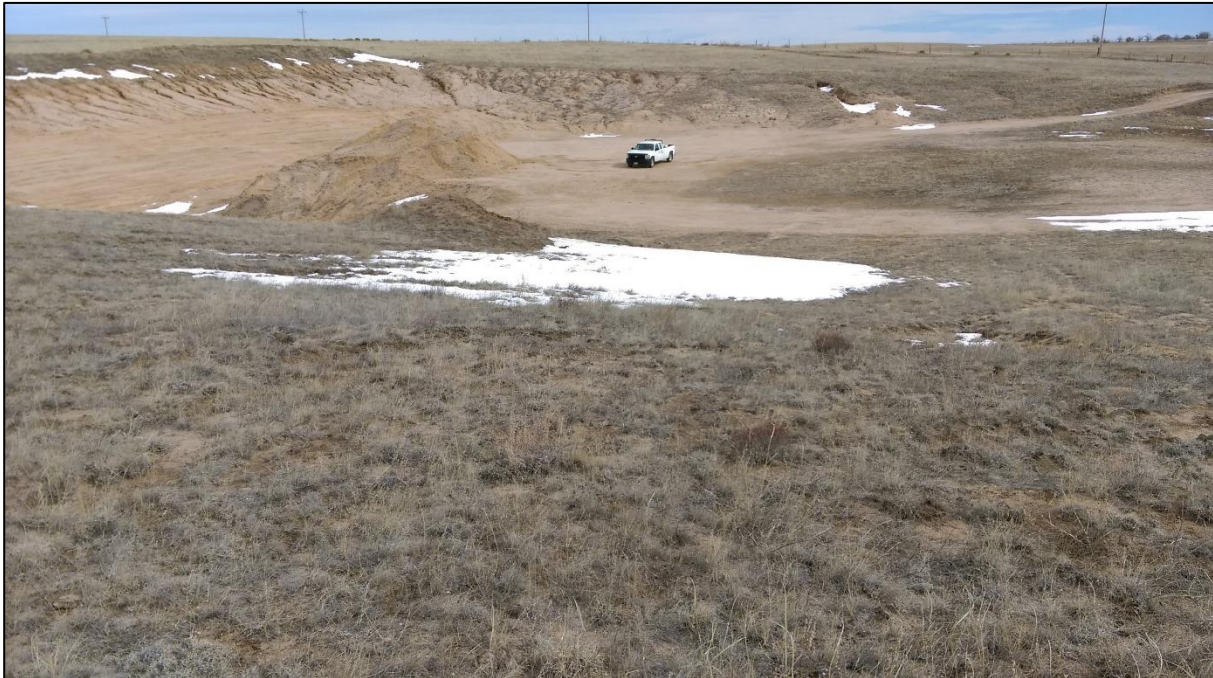
Photo 2. View looking east from western edge of permit area, showing pit approximately 25 feet deep.

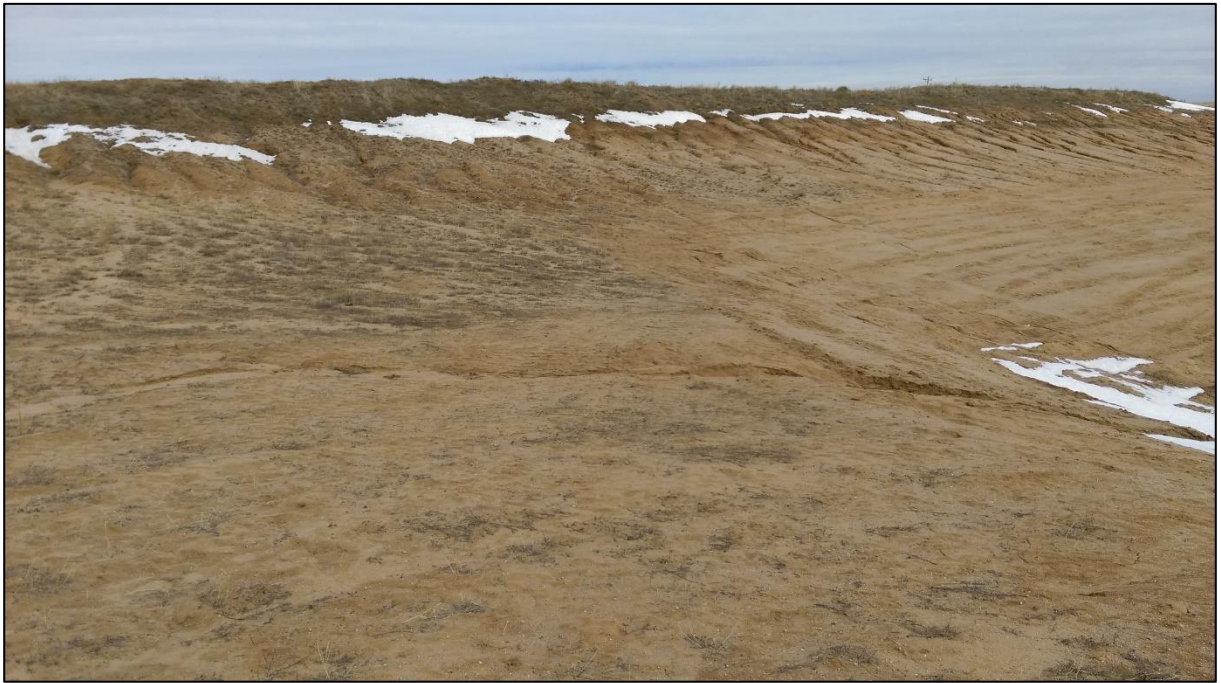
Topsoil stockpiles are stored along the northern and western edges of the unreclaimed pit walls (see **Photos 3 and 4**). The topsoil stockpiles appeared to be stable with vegetative cover. Native grasses are volunteering into the pit. No weeds were observed. The southwestern portion of the pit has been reclaimed, including the southern pit wall and a portion of the western pit wall (**Photos 6-8**). This area was graded to mainly flatter than 3H:1V, retopsoiled, and seeded, and now has a mixture of native grasses establishing across the area.

Photo 3. View of working face along northern edge of pit with slope gradients of 3H:1V or flatter. Note topsoil stockpile stored along top edge of mined wall.

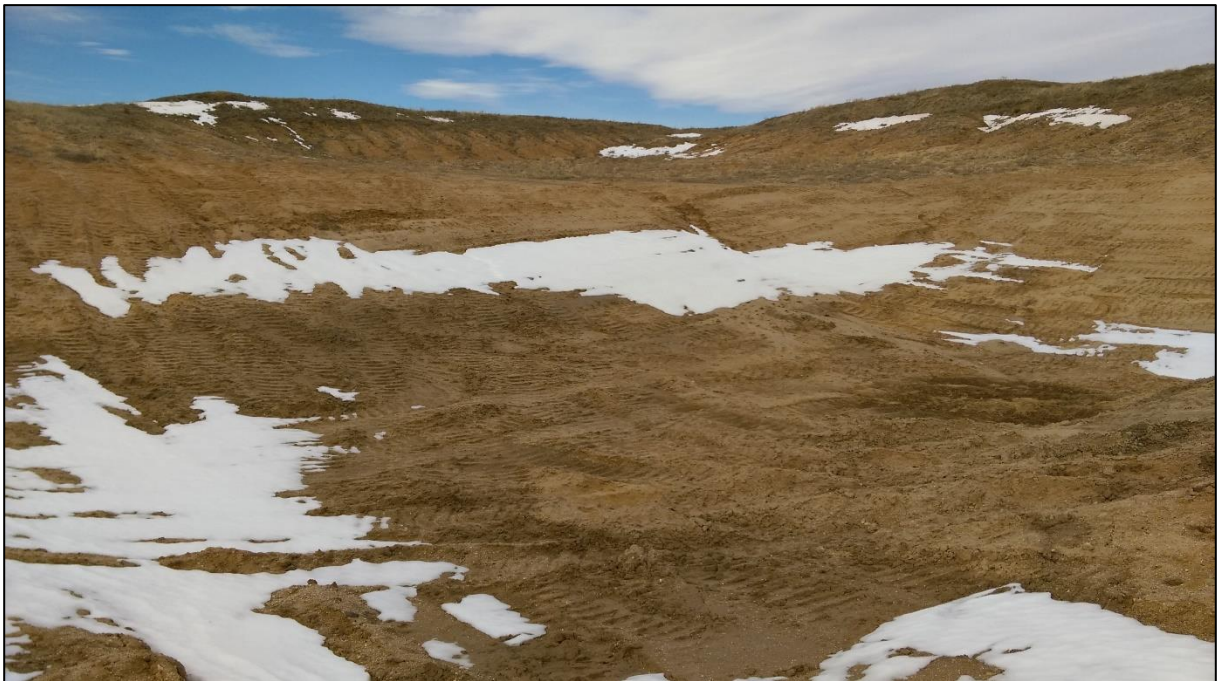
Photo 4. View of working face along western edge of pit with slope gradients of 3H:1V or flatter. Note topsoil stockpile stored along top edge of mined wall.

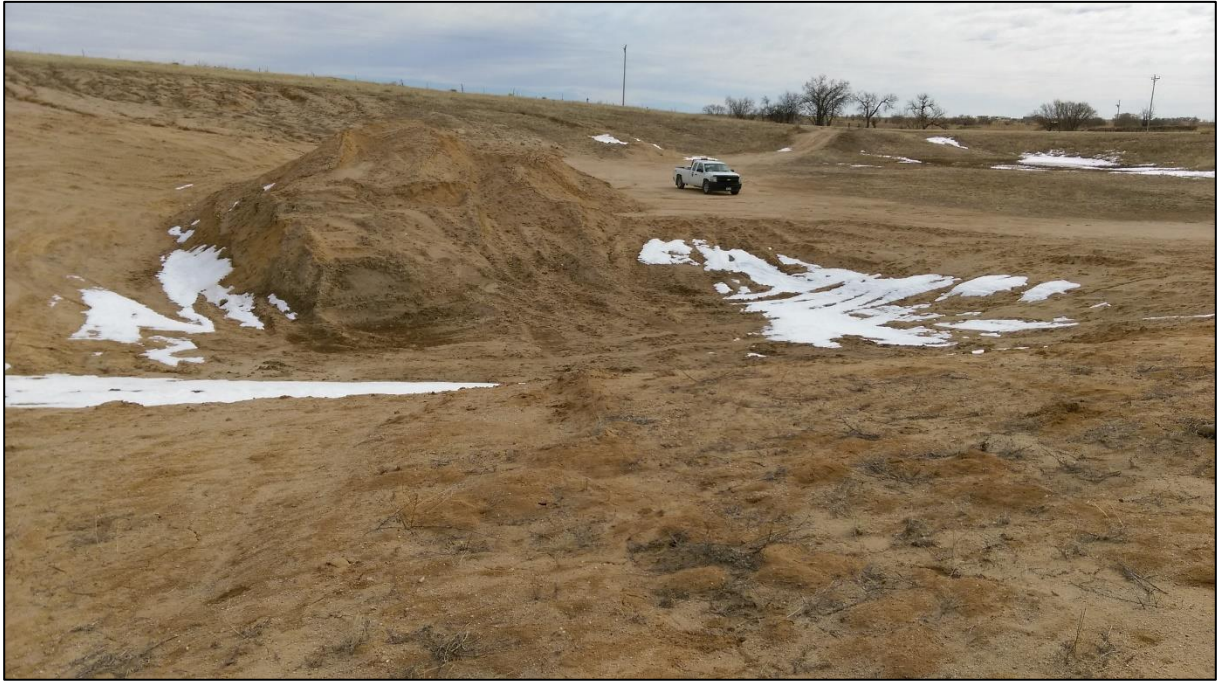
Photo 5. View of small material stockpile stored on pit floor.

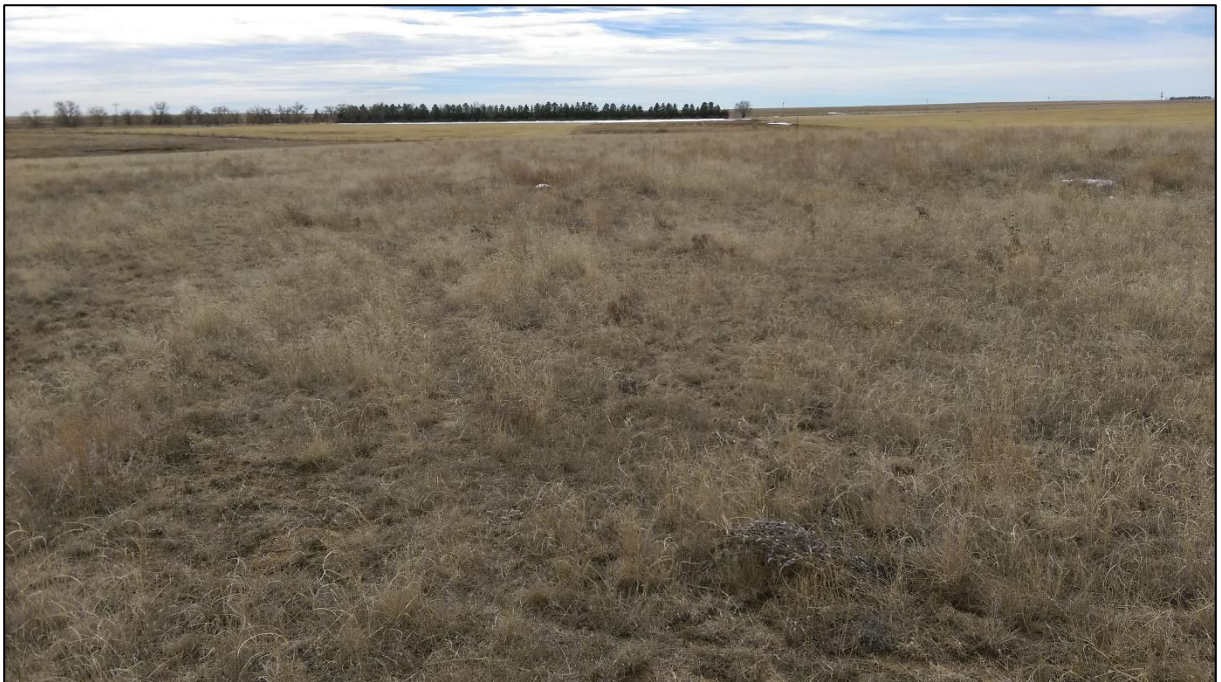
Photo 6. View looking south across reclaimed southwestern portion of permit area. Note native grasses establishing across this area.

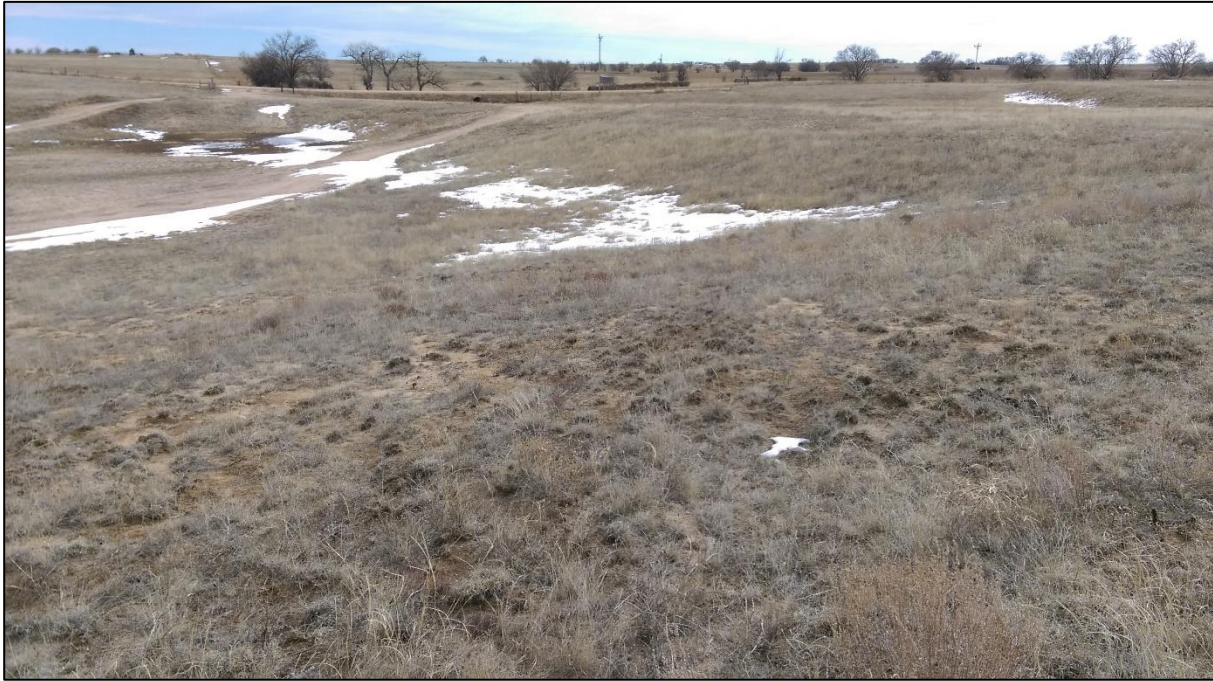
Photo 7. View looking southeast across reclaimed southern pit wall. Note slopes graded to 3H:1V or flatter, and native grasses establishing across this area.

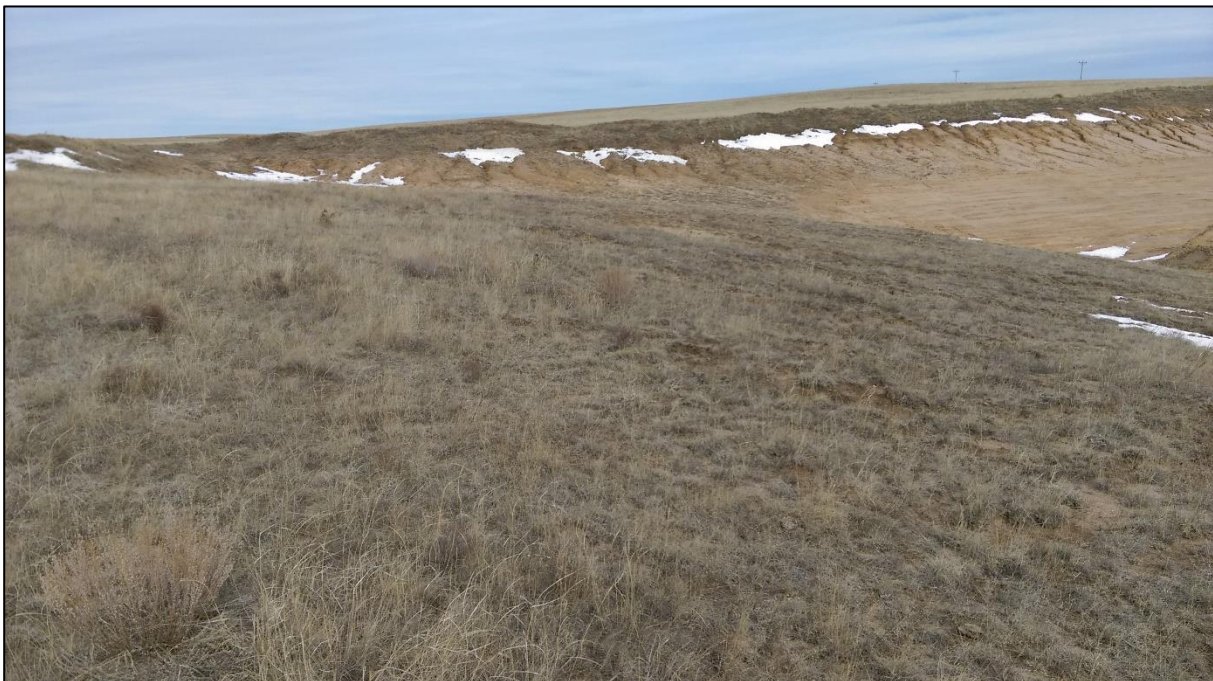
Photo 8. View looking north across reclaimed portion of western pit wall. Note slopes graded to 3H:1V or flatter, and native grasses establishing across this area.
