MINERALS PROGRAM INSPECTION REPORT**PHONE: (303) 866-3567**

MINE NAME: Belveal Gravel Pit	MINE/PROSPECTING ID#: M-2001-056	MINERAL: Gravel	COUNTY: Elbert
INSPECTION TYPE: Monitoring	INSPECTOR(S): Amy Eschberger	INSP. DATE: February 17, 2016	INSP. TIME: 11:45
OPERATOR: Elbert County	OPERATOR REPRESENTATIVE: Ted Dole	TYPE OF OPERATION: 110c - Construction Limited Impact	
REASON FOR INSPECTION: Normal I&E Program	BOND CALCULATION TYPE: None	BOND AMOUNT: \$0.00	
DATE OF COMPLAINT: NA	POST INSP. CONTACTS: None	JOINT INSP. AGENCY: None	
WEATHER: Clear	INSPECTOR'S SIGNATURE:

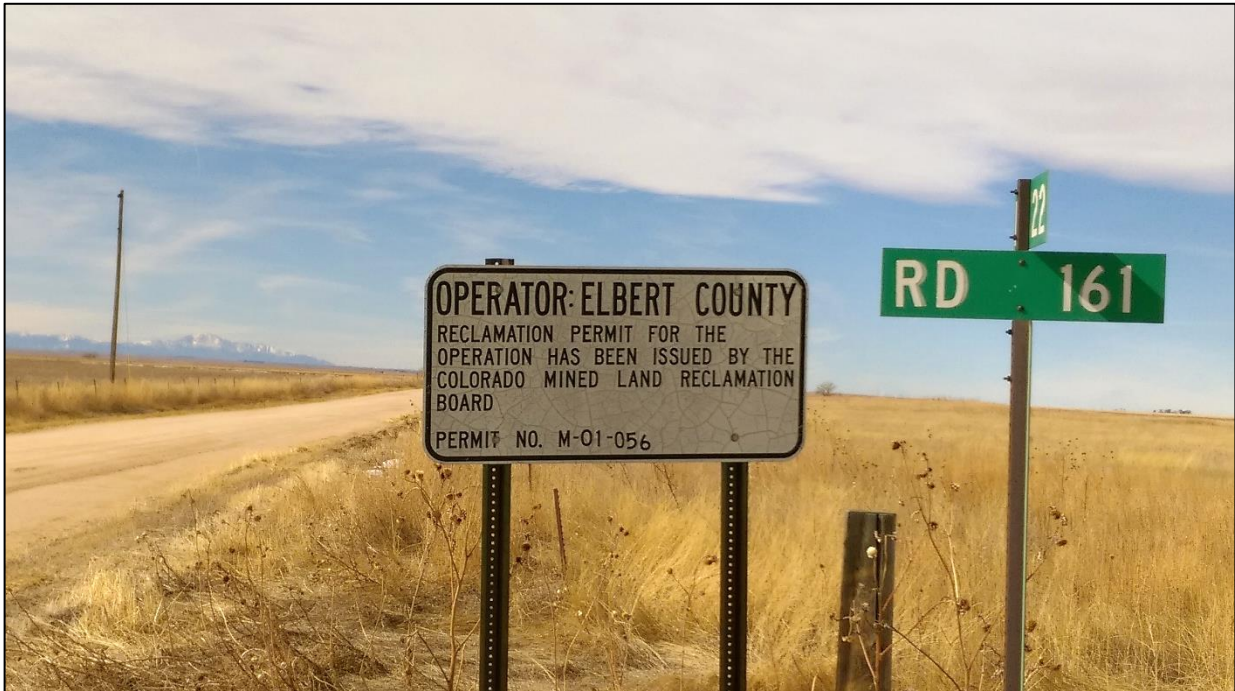
At the time of the inspection, it was partly cloudy and windy, with some snow cover remaining. A permit sign was posted at the main entrance to the site off of Co Rd 22 (**Photo 1**). The permit boundary was delineated with metal stakes. The site was not active during the inspection. However, Mr. Dole stated the county hauls off from the site every year, which is in accordance with the operation's intermittent status. The active pit is located primarily in mining phase A, with a depth of approximately 10-12 feet below ground surface. The excavation is oval in shape, with pit walls graded flatter than 3H:1V (**Photos 2-5**). A material stockpile is stored on the pit floor (**Photo 6**). Topsoil is stored along the edges of the pit, and appear to be stable (**Photo 7**). The current pit has reached its lateral extent within the permit boundary to the north, east, and west. The operation stripped an area south of the active pit in preparation for mining phase B (**Photos 8 and 9**). However, according to Mr. Dole, the gravel is not good quality south of the pit. Therefore, the overburden was replaced, and the topsoil will be replaced in the near future. Currently, the salvaged topsoil is stockpiled along the eastern and western edges of this area (**Photo 10**). The Division estimates the operation has disturbed a total of approximately 4.75 acres (3.75 acre pit area plus ~ 1 acre haul road).

Photo 1. View of permit sign posted at main entrance to site off of Co Rd 22.

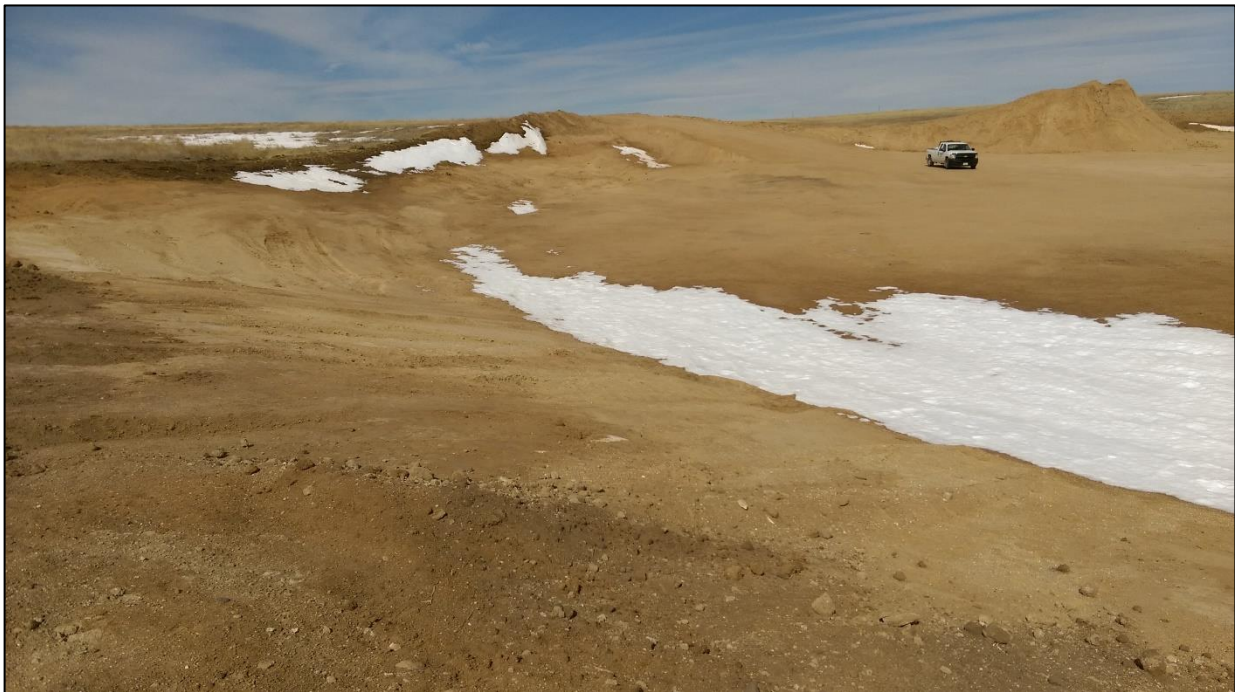
Photo 2. View looking northwest from southern edge of pit, showing western pit wall graded to flatter than 3H:1V slope gradient.

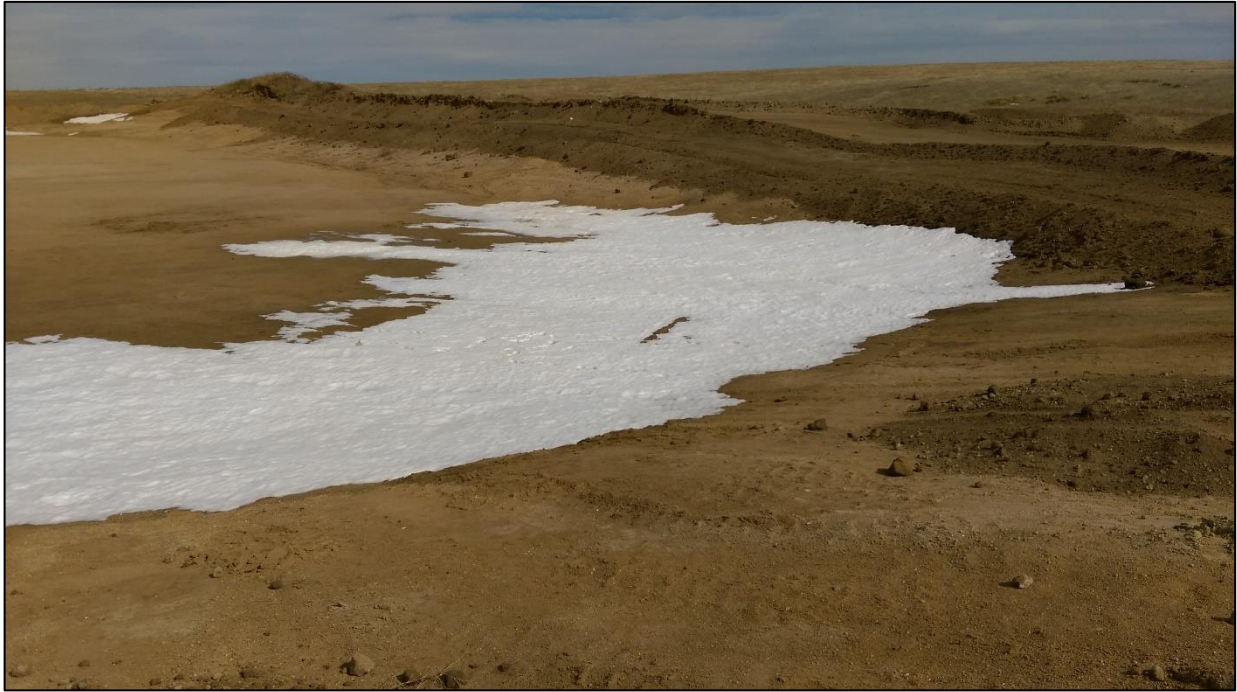
Photo 3. View looking northeast from southern edge of pit, showing eastern pit wall graded to flatter than 3H:1V slope gradient.

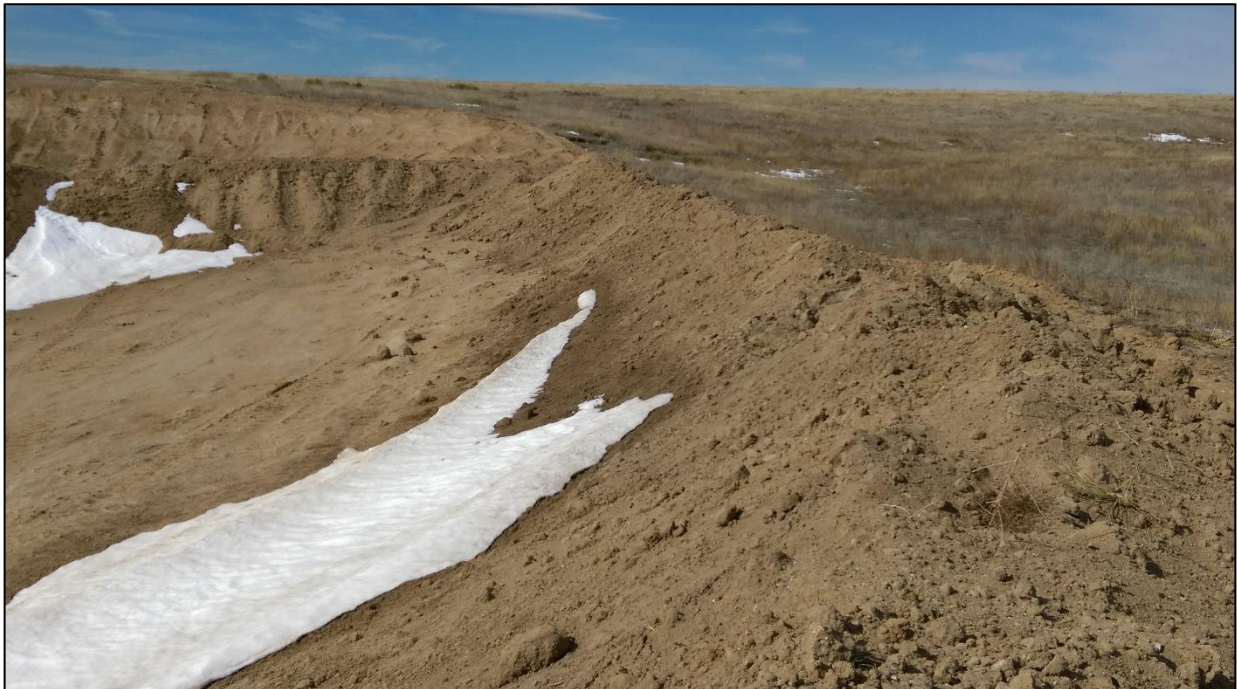
Photo 4. View looking west from northern edge of pit, showing northern pit wall graded to flatter than 3H:1V slope gradient.

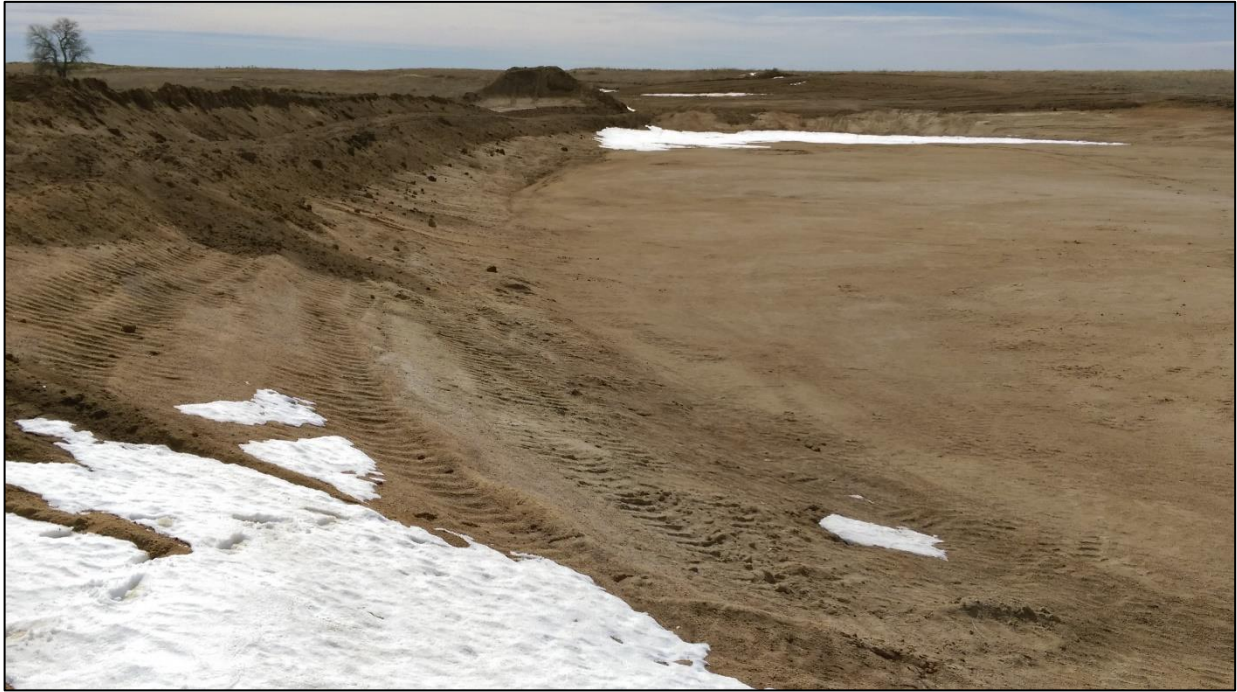
Photo 5. View looking south from northern edge of pit, showing eastern pit wall graded to flatter than 3H:1V slope gradient.

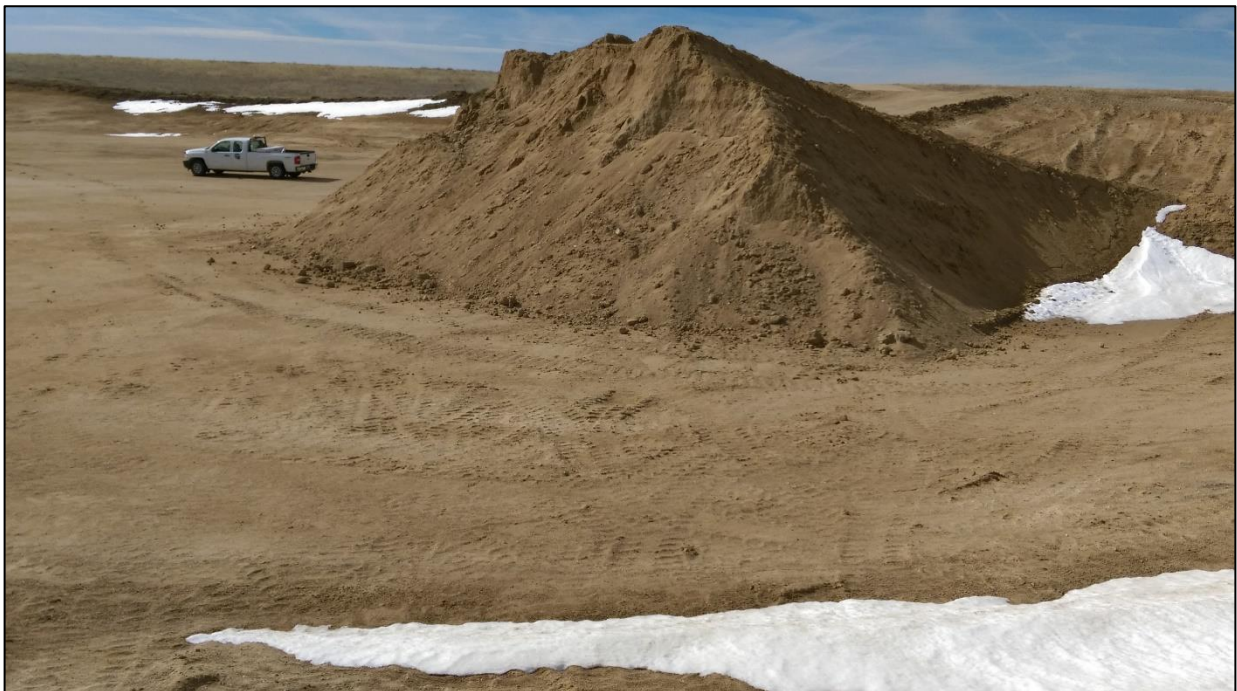
Photo 6. View looking southwest, showing material stockpile stored on pit floor near haul road entrance to pit.

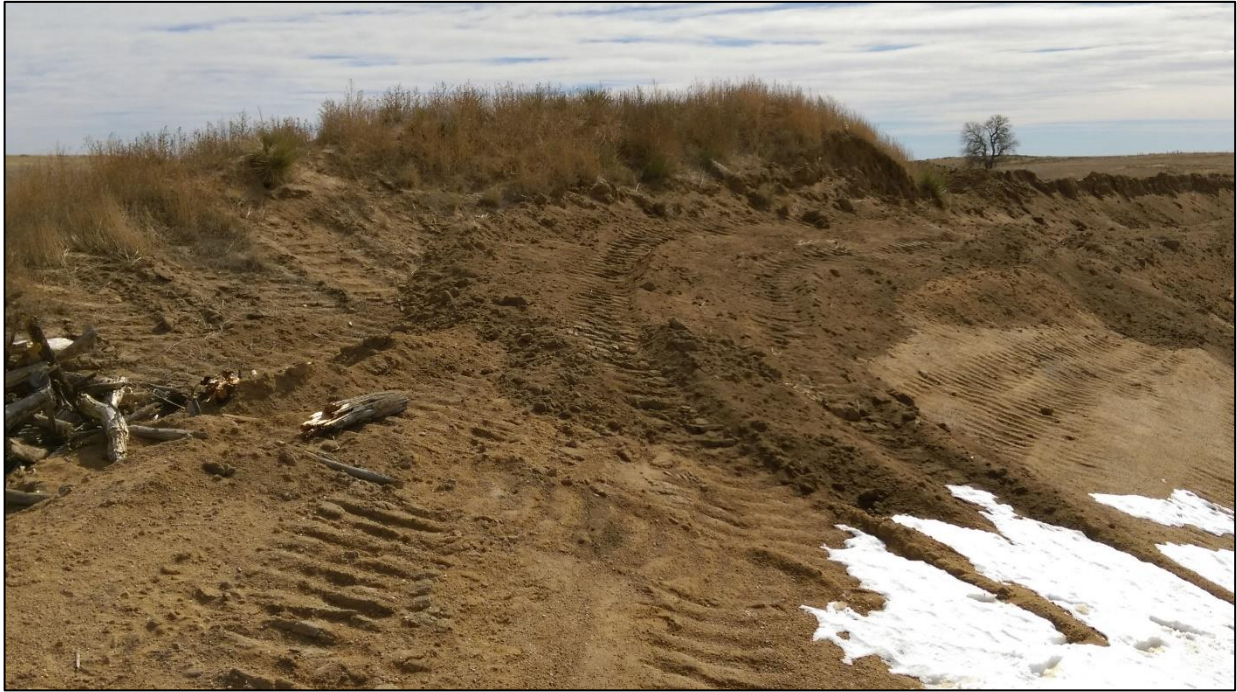
Photo 7. View looking east, showing topsoil stockpile stored at edge of eastern pit wall.

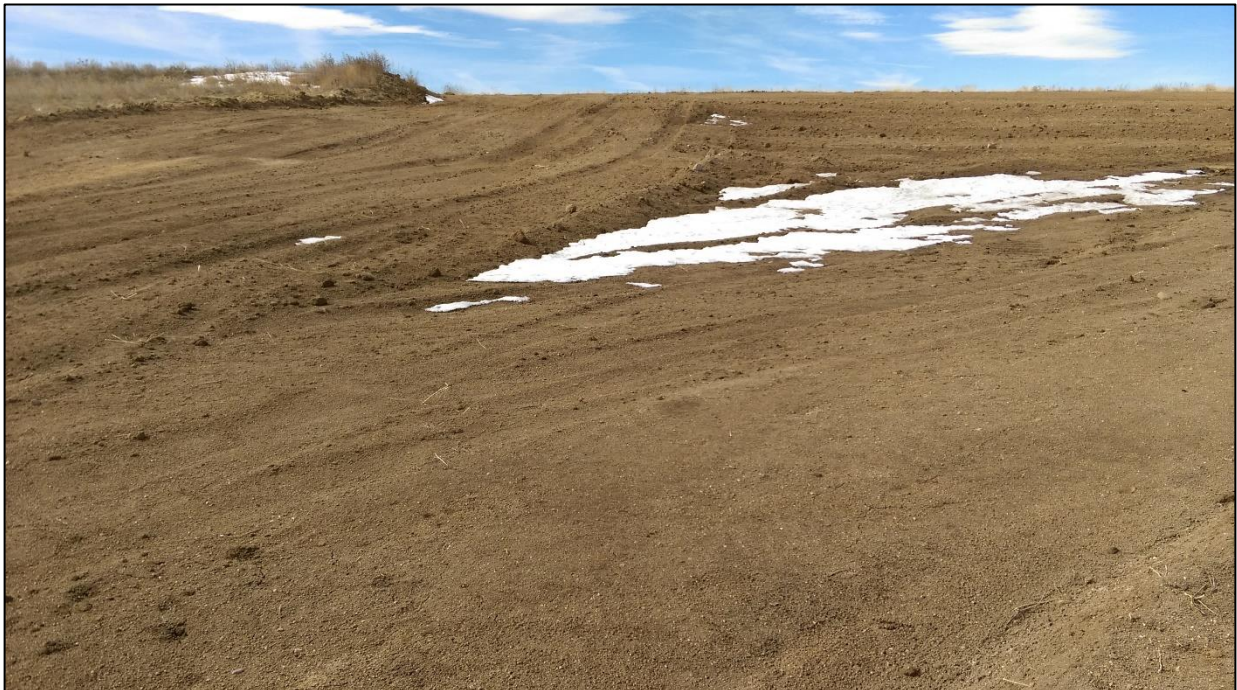
Photo 8. View looking southeast across area south of active pit that was stripped, but good quality gravel not found. Overburden was replaced, and topsoil will be replaced and area revegetated.

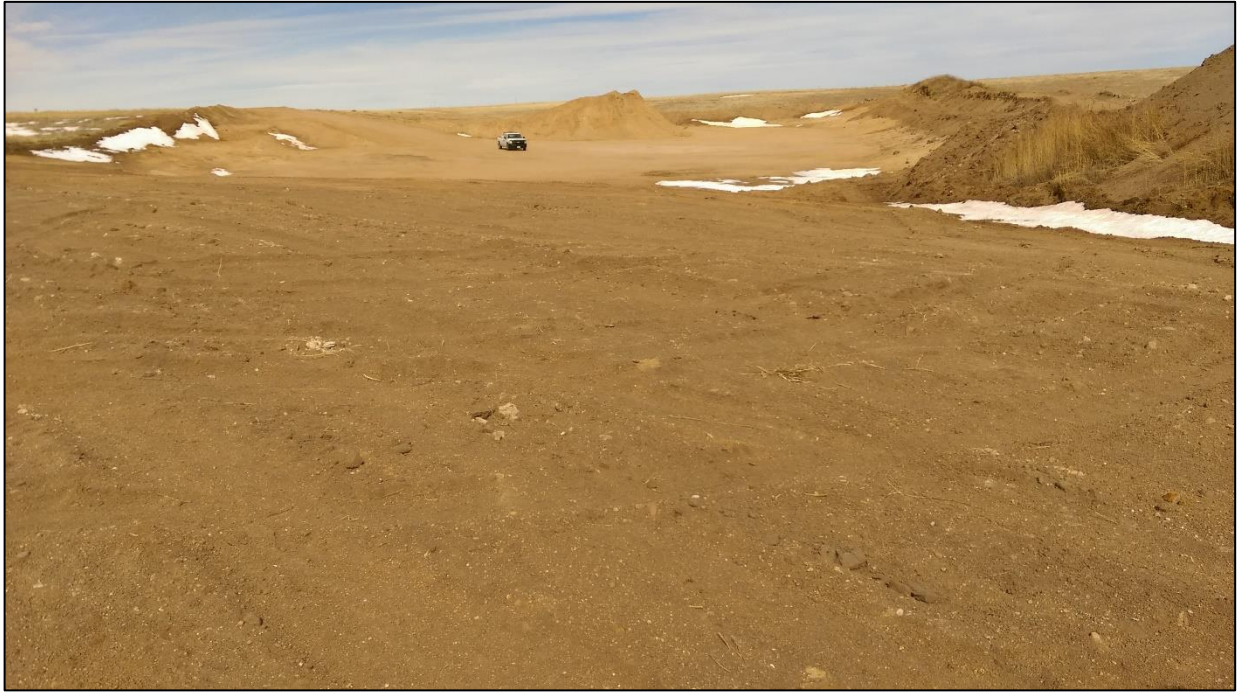
Photo 9. View looking north across area south of active pit that was stripped, but good quality gravel not found. Overburden was replaced, and topsoil will be replaced and area revegetated. Note active pit in background.

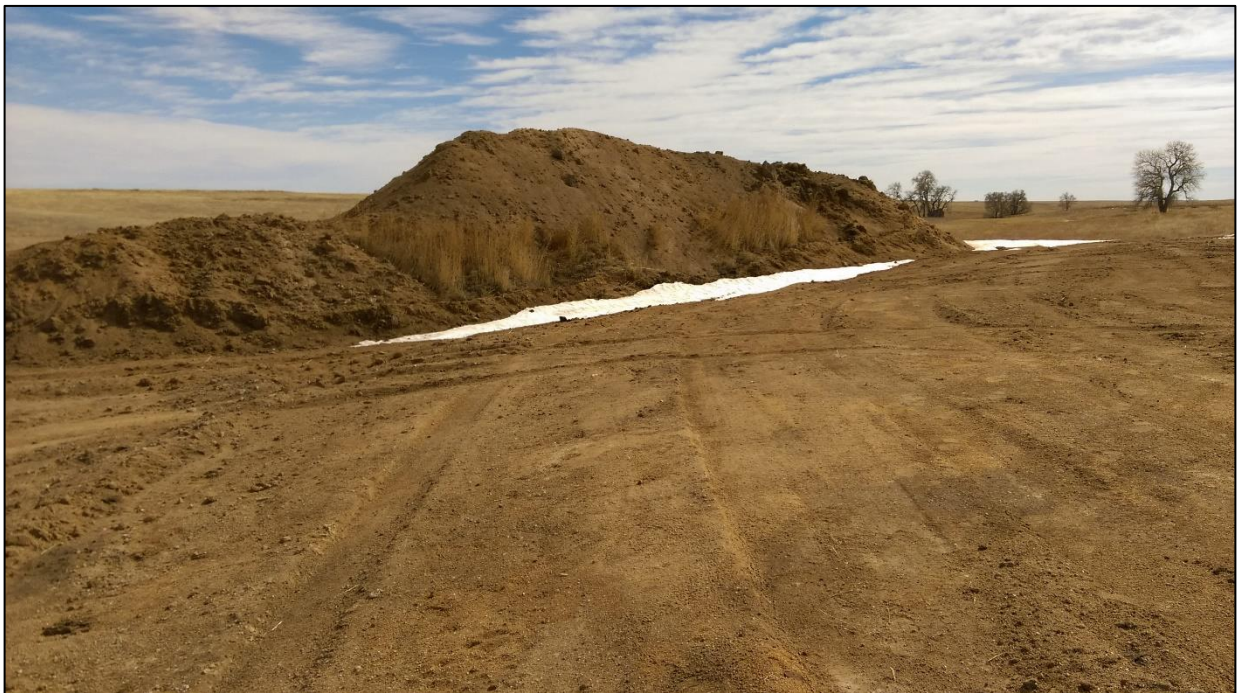
Photo 10. View looking east, showing topsoil stripped from area south of active pit, stockpiled along edge of stripped area. Topsoil appears stable, but will need to be replaced across disturbed area as soon as possible to protect area from erosion.
