MINERALS PROGRAM INSPECTION REPORT
PHONE: (303) 866-3567

MINE NAME: Revenue Mine	MINE/PROSPECTING ID#: M-2012-032	MINERAL: Lead, silver and gold	COUNTY: Ouray
INSPECTION TYPE: Monitoring	INSPECTOR(S): Travis H. Marshall	INSP. DATE: November 1, 2016	INSP. TIME: 11:00
OPERATOR: Ouray Silver Mines Inc.	OPERATOR REPRESENTATIVE: Brian Briggs	TYPE OF OPERATION: 112d-1 - Designated Mining Operation	
REASON FOR INSPECTION: Normal I&E Program	BOND CALCULATION TYPE: None	BOND AMOUNT: \$464,333.79	
DATE OF COMPLAINT: NA	POST INSP. CONTACTS: None	JOINT INSP. AGENCY: None	
WEATHER: Clear	INSPECTOR'S SIGNATURE:

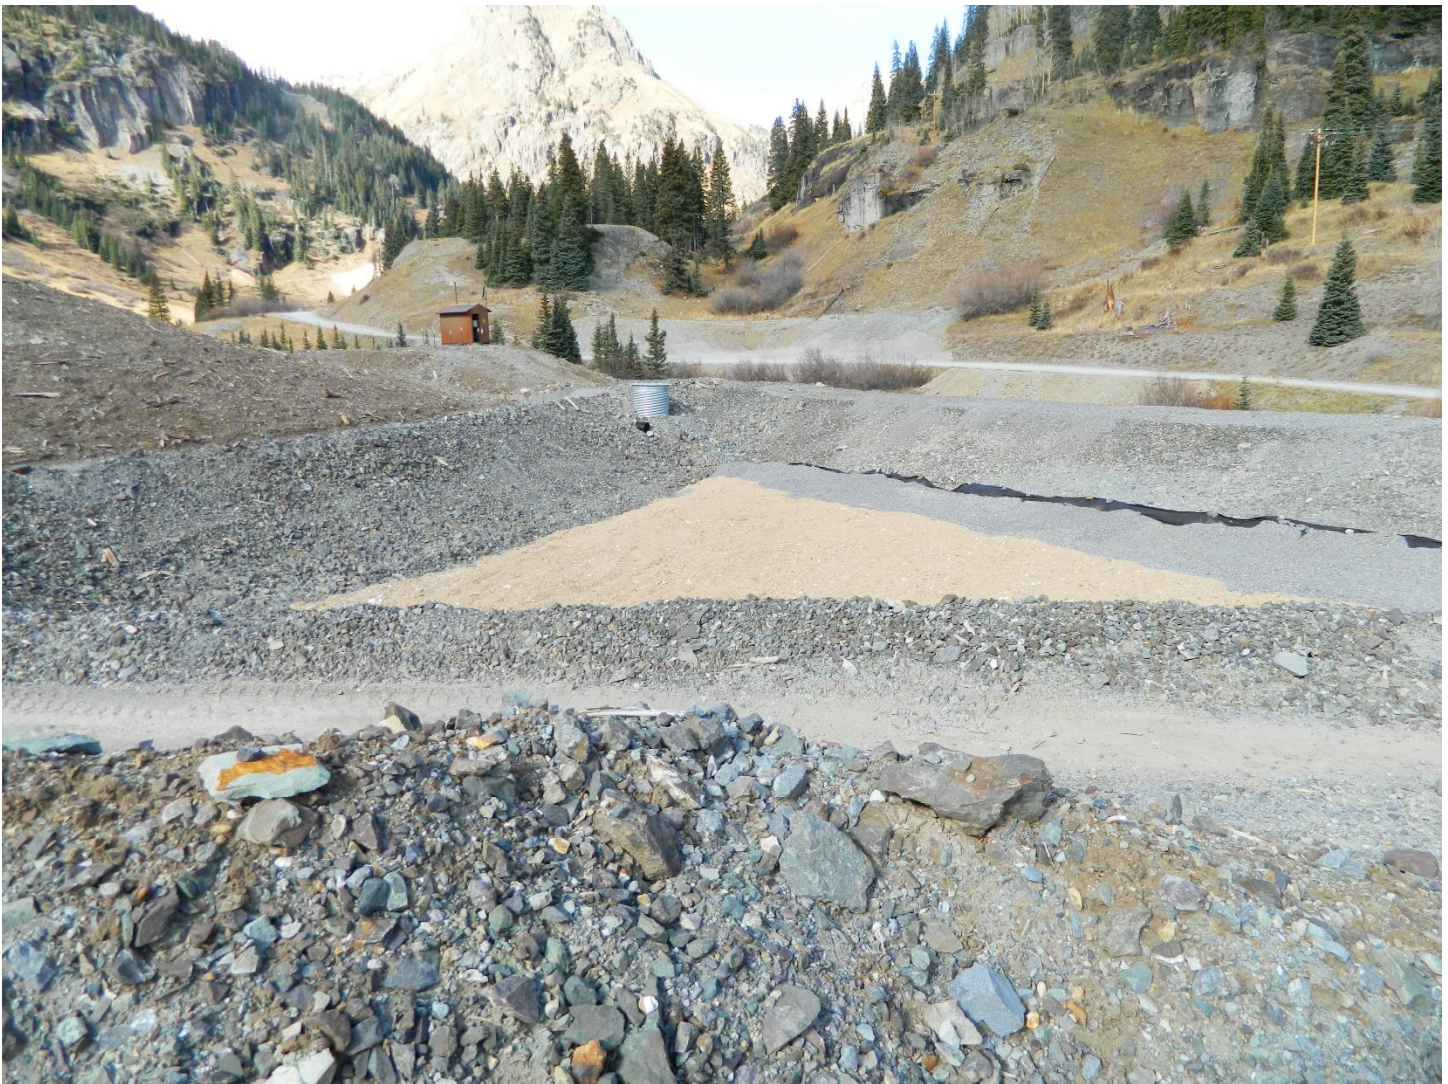
The main focus of the inspection was to observe the recently constructed bio-reactive bed and groundwater infiltration treatment system for the management of mine discharge water which was approved in Technical Revision No. 8 (TR-08). The treatment system was functioning during the inspection. Some minor changes were made to the final configuration of the structure that are different than what was submitted in TR-08, the operator provided "as-built" drawings to the DRMS. Overall the treatment system appeared to be properly functioning during the inspection. The operator is testing surface and groundwater down gradient of the infiltration zone to monitor for any changes in water quality.

Overview of the recently installed passive treatment structure.

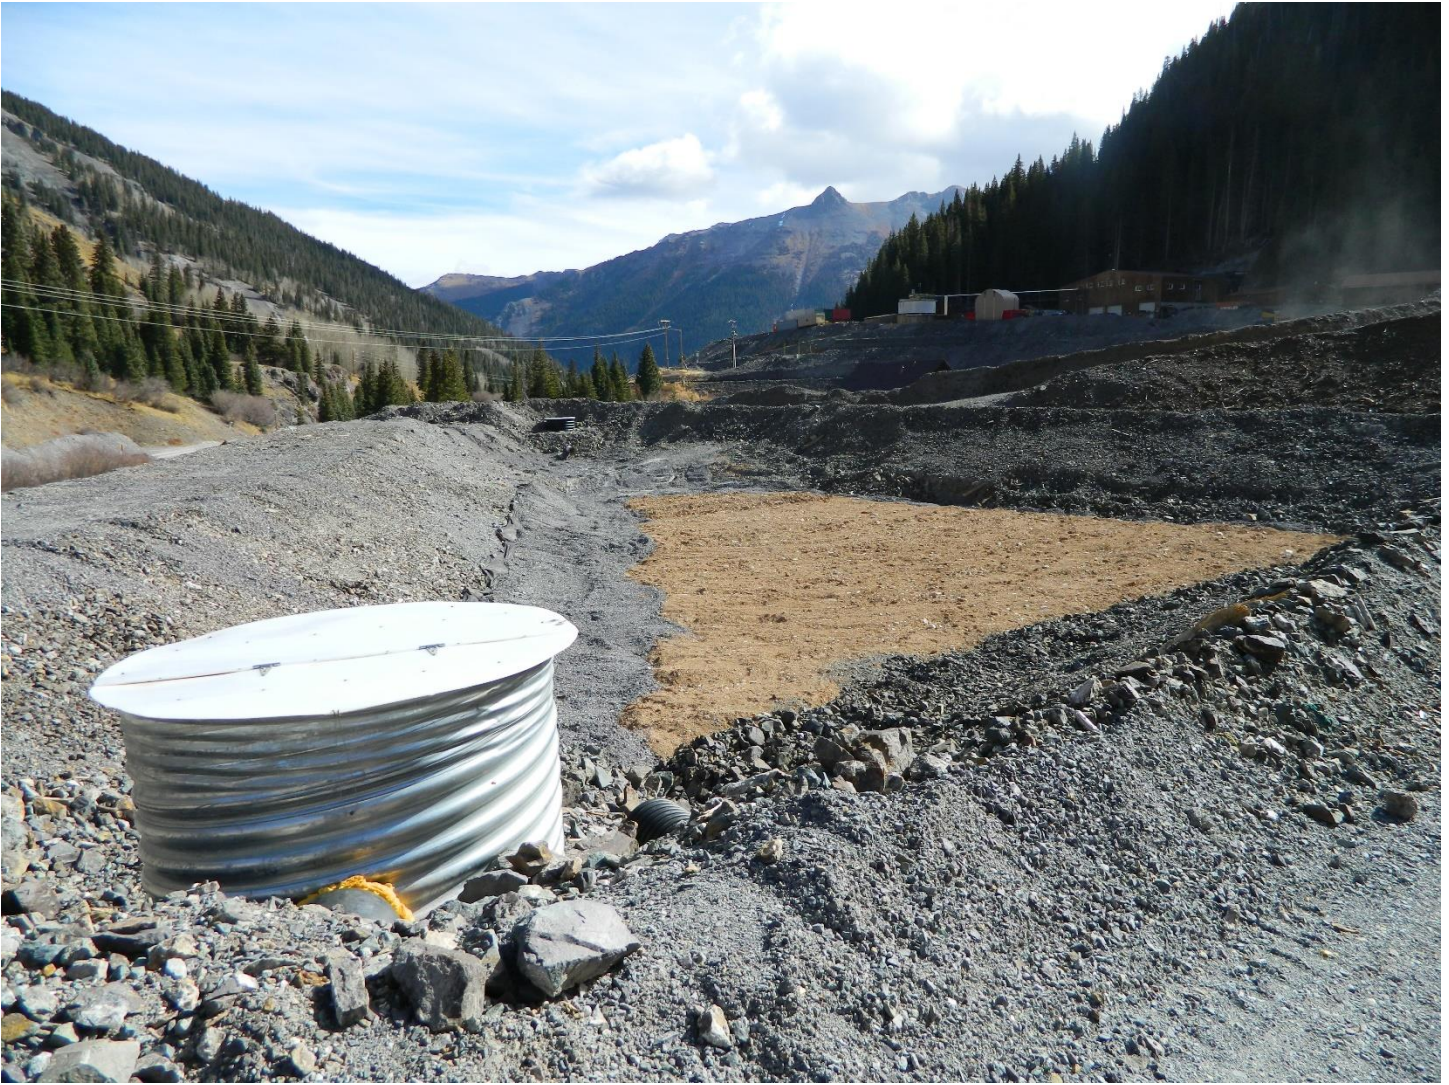
Facing northeast over passive treatment structure.

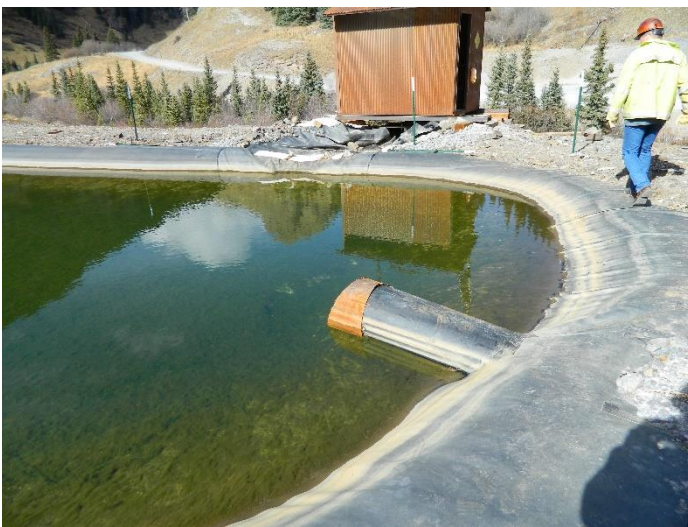
Inlet to treatment from existing discharge collection pond.

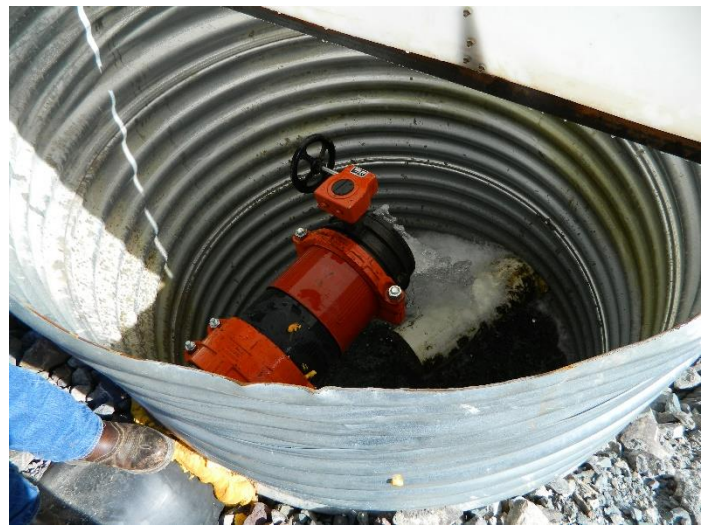
Inlet vault located on west side of treatment structure.

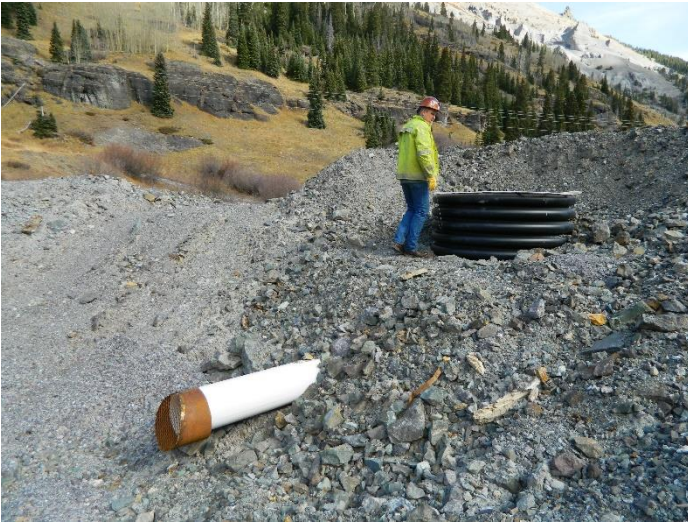
Overflow outlet structure.

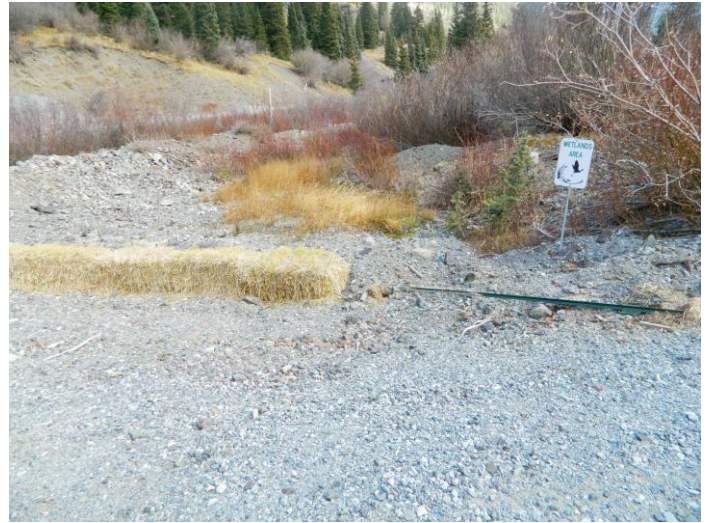
Straw bales adjacent to wetland

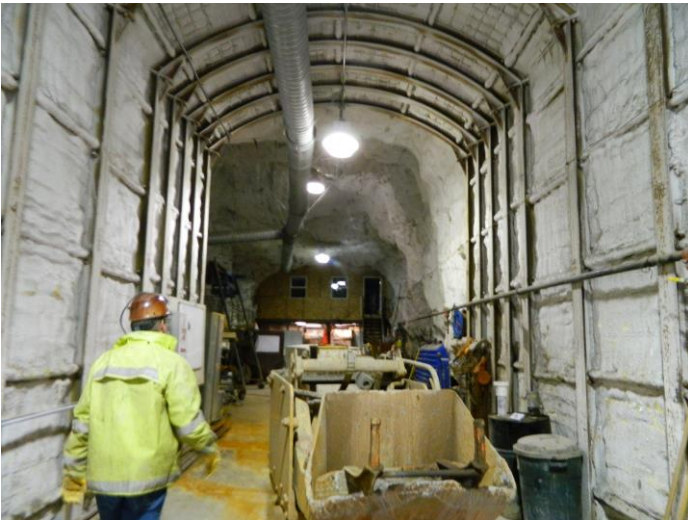
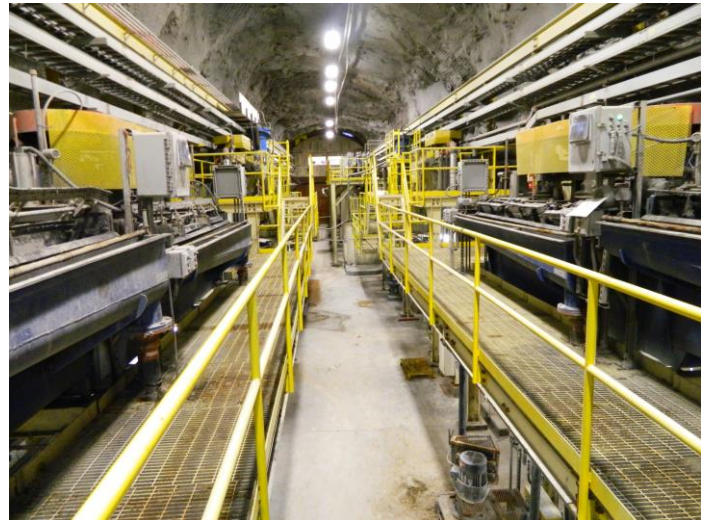
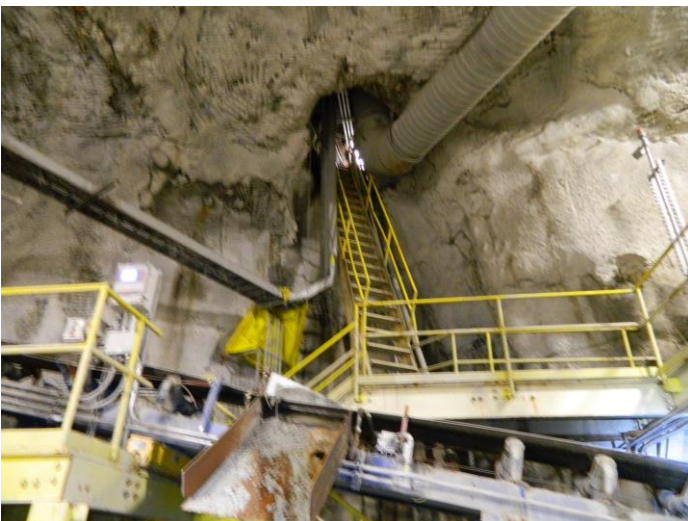
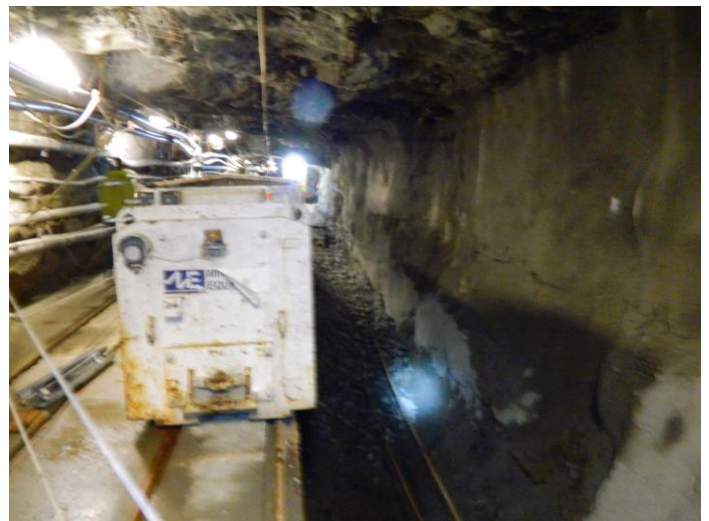
The underground mill was inspected. Mr. Briggs stated that some equipment changes were planned to refine the milling process. If any major changes to the milling process are to occur a technical revision must be submitted and approved.

Underground mill.
