MINERALS PROGRAM INSPECTION REPORT
PHONE: (303) 866-3567

MINE NAME: Cresson Project	MINE/PROSPECTING ID#: M-1980-244	MINERAL: Gold	COUNTY: Teller
INSPECTION TYPE: Monitoring	INSPECTOR(S): Elliott R. Russell	INSP. DATE: August 18, 2016	INSP. TIME: 08:30
OPERATOR: Cripple Creek & Victor Gold Mining Company	OPERATOR REPRESENTATIVE: Erik Munroe	TYPE OF OPERATION: 112d-3 - Designated Mining Operation

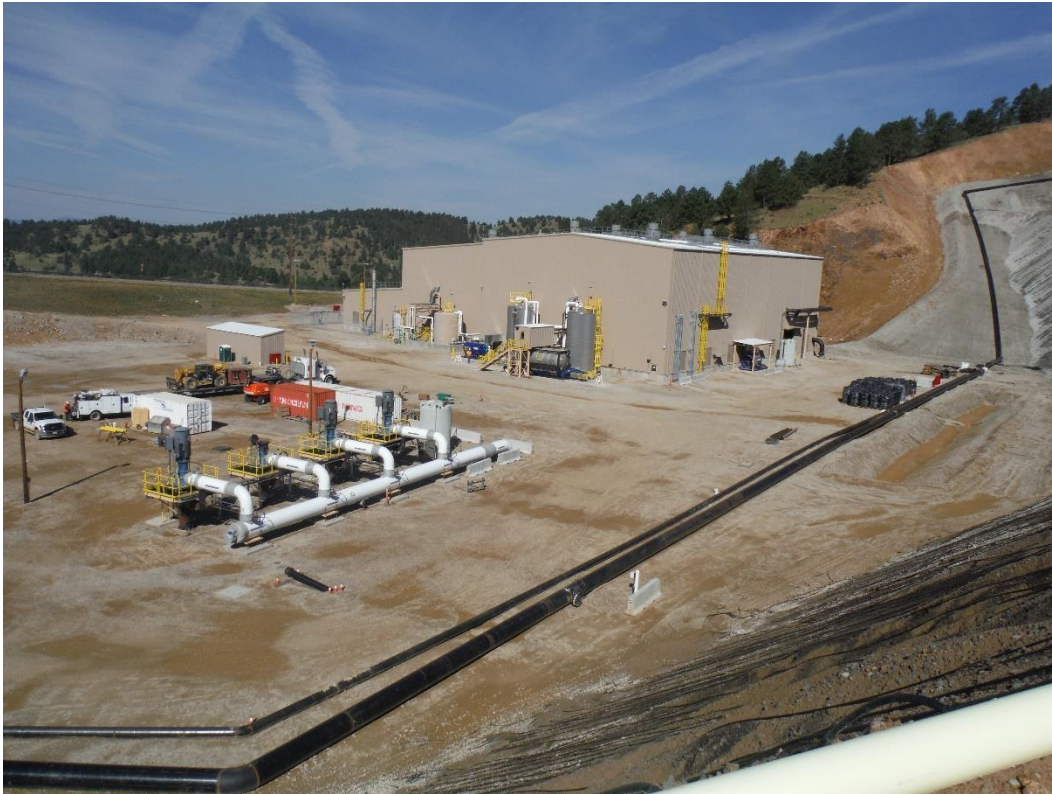
The Division and Mr. Munroe were accompanied by Mr. Zach Cook for the Squaw Gulch Adsorption, Desorption, and Recovery facility inspection/tour (**Photo 1**). The SGVLF and SGADR were approved under AM-10 and these facilities function the same as the AGVLF and AGADR. The ADRs receive pregnant solution from the VLFs, remove the gold in solution by absorption onto activated carbon, strip/desorption the gold from the activated carbon to create a concentrated gold solution, and recover the gold in an electrowinning circuit. The SGADR includes four carbon-in-column trains; Carbon Trains F and G were in operation while I and H, which are designed to handle the increase in ore and solution in the SGVLF as the leach pad develops, were inactive. The SGADR and chemical storage has been constructed within the Pregnant Solution Storage Area (PSSA) lined area of the SGVLF, which serves as secondary and tertiary containment.

Photo 1. SGADR; looking northwest.

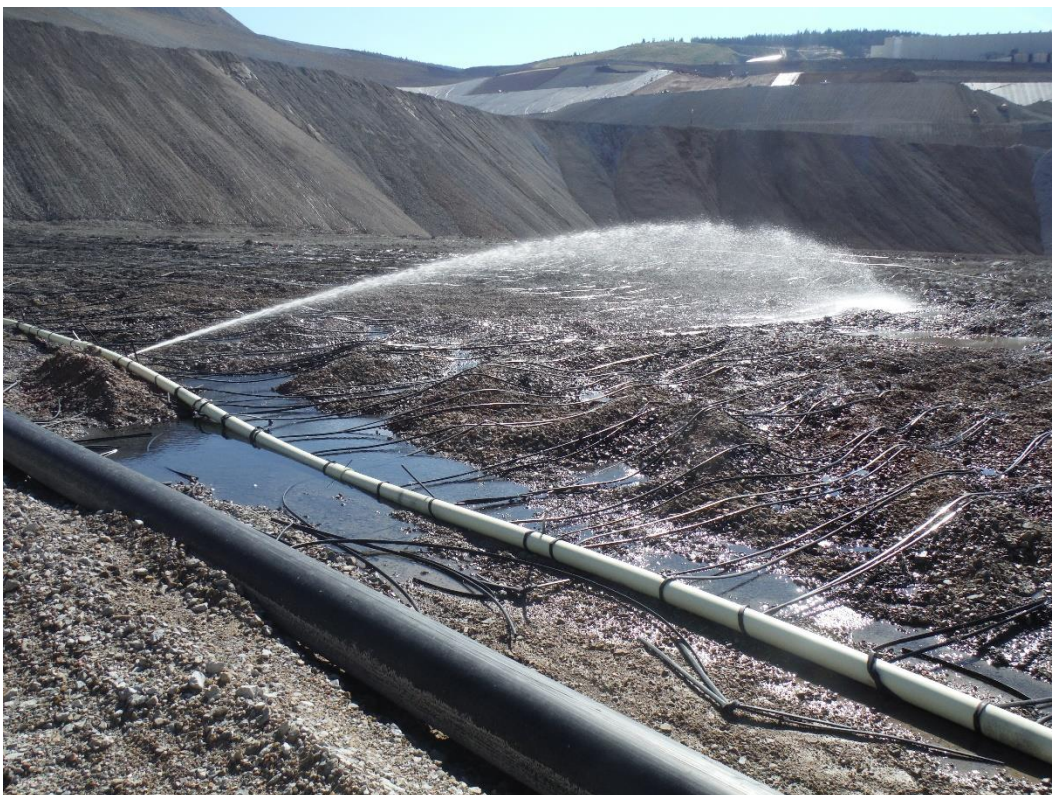
PROBLEM 1: A significant volume of process solution was ponded in the Squaw Gulch Valley Leach Facility. This is a potential attractant to wildlife. The surface area of the exposed fluid exceeded the permit condition (not to exceed 3 feet x 3 feet area).

On top of the first ore lift, the Division observed a significant amount of standing solution caused from a broken drip line port on one of the smaller distribution lines (**Photo 2**). Mr. Cook radioed process personnel to inspect the drip line and make repairs. Later, during the inspection, the Division observed that the drip line was repaired but the standing solution, which was greater than 9 square feet in size, had yet to infiltrate into the pad. This is cited as compliance problem 1 of this report; however, this problem was resolved during the Division's October 27, 2016 inspection as there was no longer standing solution in this area.

Photo 2. Damaged drip line causing standing solution; looking east.

CORRECTIVE ACTIONS: Provide the Division with photographic evidence that measures were taken to allow the solution within this area to infiltrate into the pad or other wildlife mitigation measures have been employed.

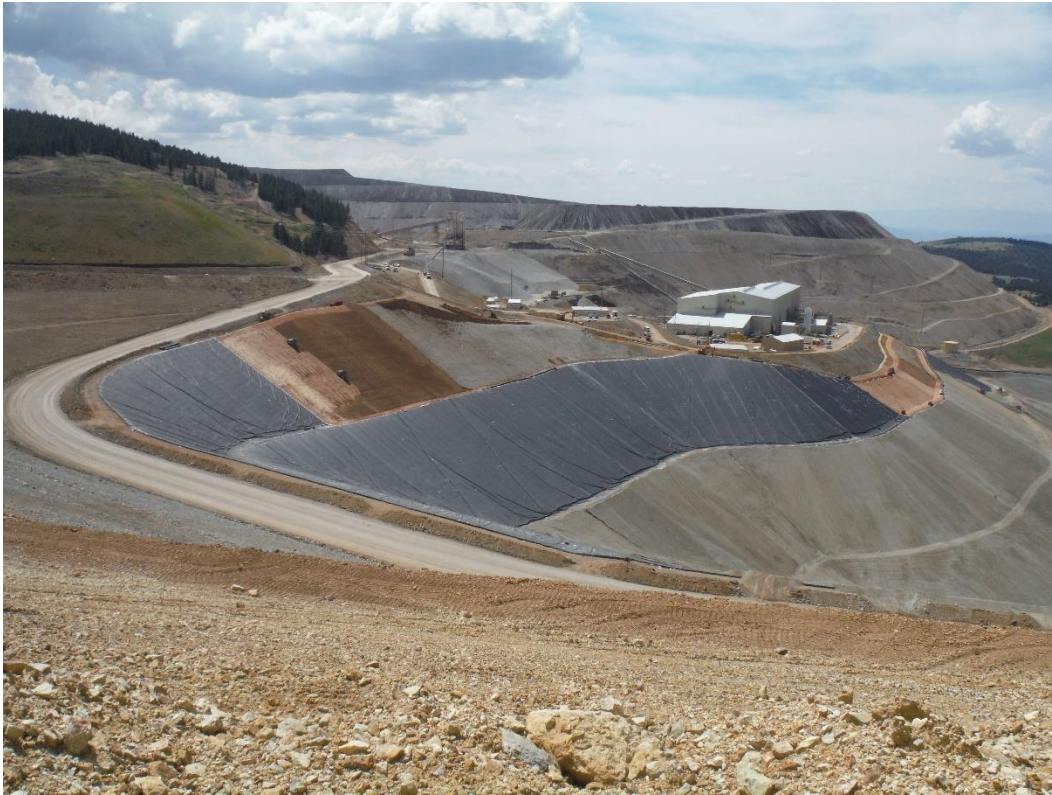
In the higher portion of the SGVLF, the Division observed active construction of the Soil Liner Fill (SLF) and the geomembrane liner. Crews were working just below the SGVLF haul road and the HGM (**Photo 3**). Once this section of liner is completed, Phase I will be finished. Phase II is located above the SGVLF Haul Road and with TR82, construction is deferred until Q2 of 2019 and is expected to be completed in Q3 of 2020.

Photo 3. SLF placement and liner deployment occurring below the SGVLF haul road; looking south.

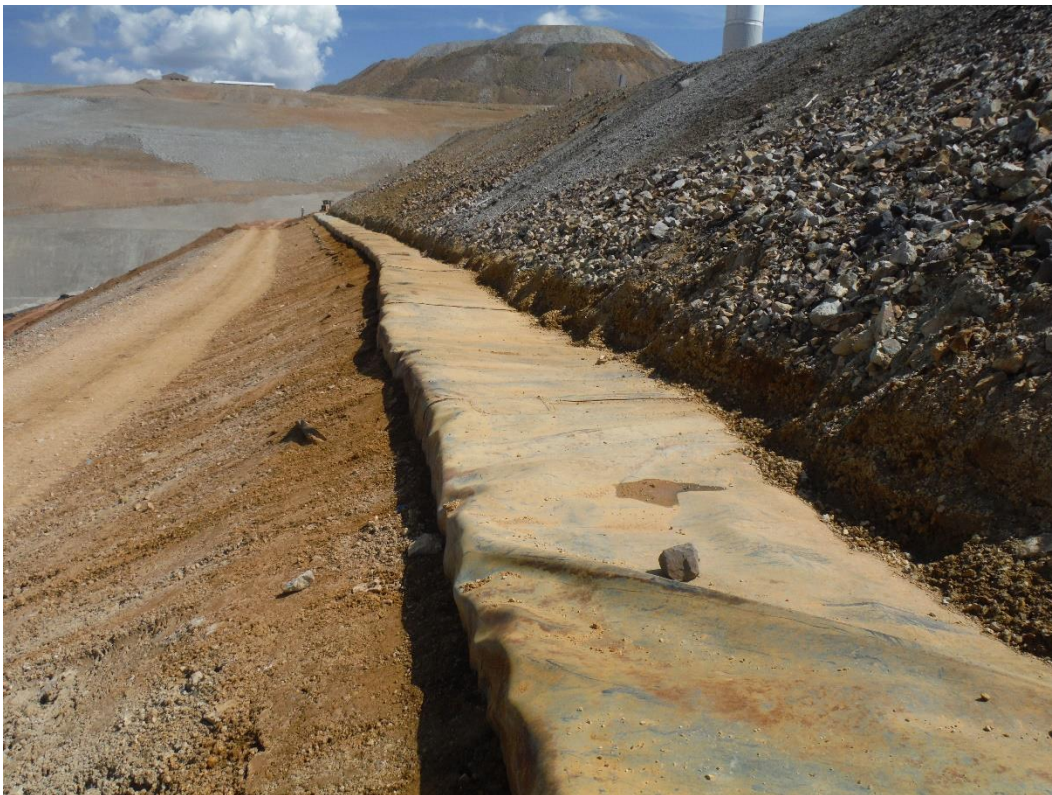
The Division and Mr. Munroe were accompanied by Mr. Ron DiDonato around the HGM. Liner crews were preparing the SGVLF liner to tie into the HGM liner. The HGM liner was exposed and SLF was being placed so the geomembrane from SGVLF could be deployed and tied into the HGM liner with an extrusion weld (**Photos 4 - 8**).

Photos 4. Exposed HGM liner; looking north.

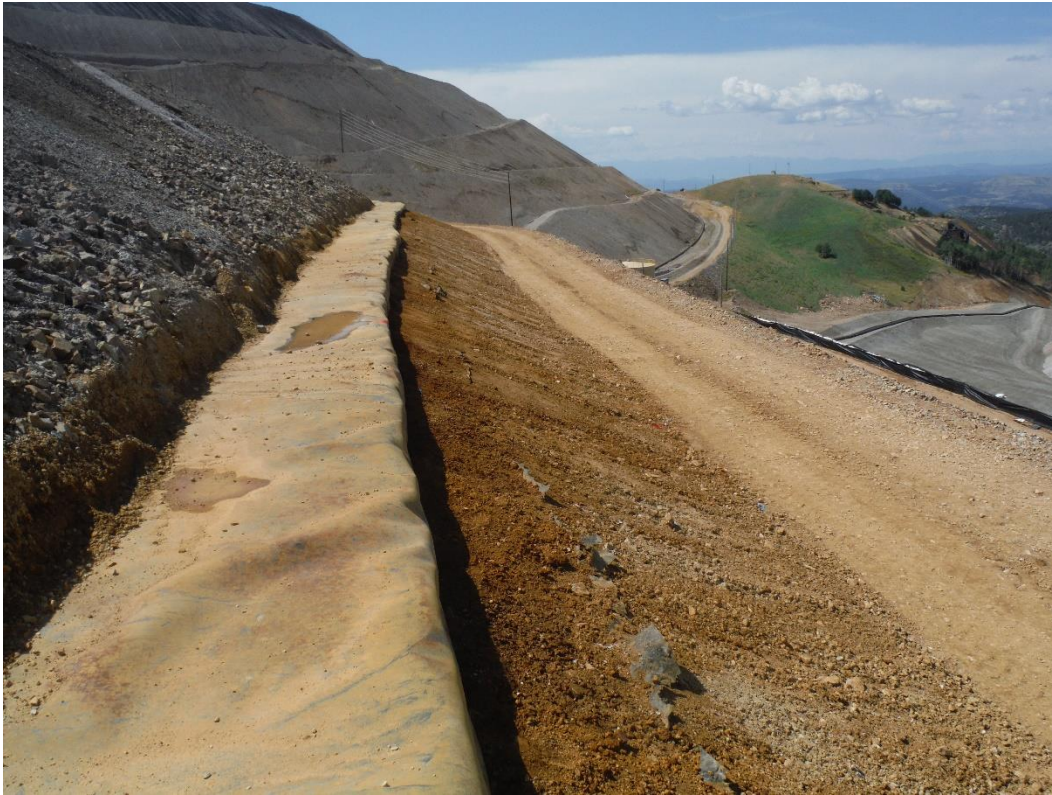
Photo 5. Exposed HGM liner; looking south.

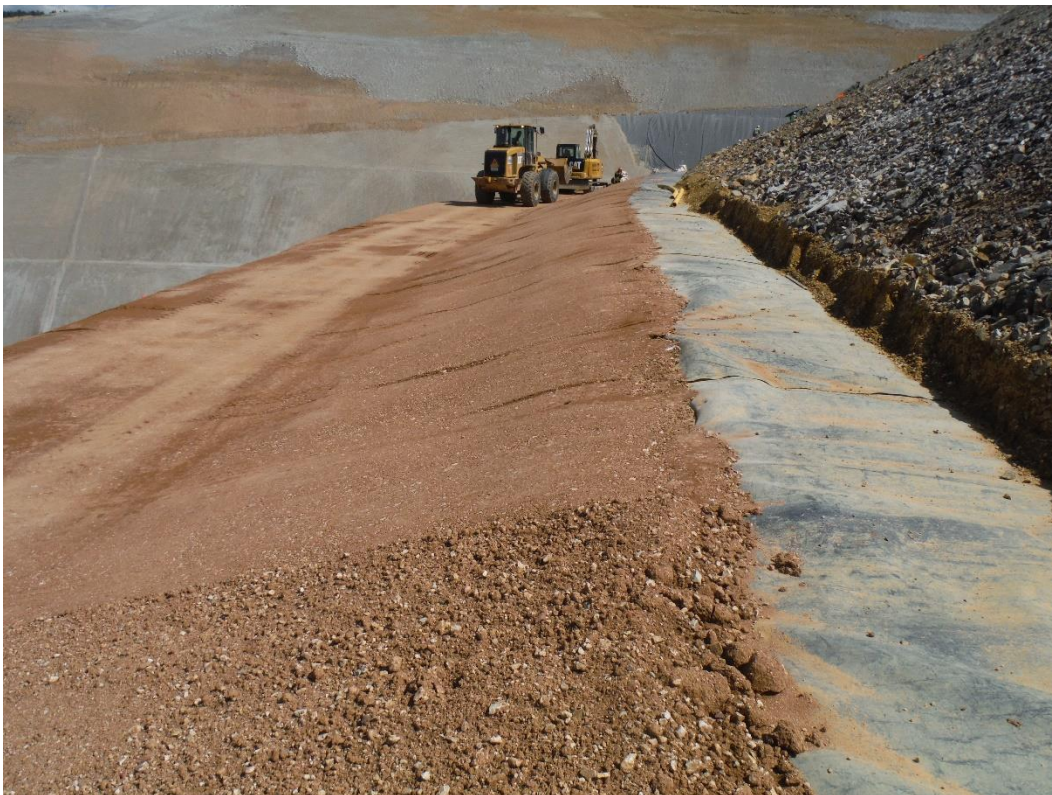
Photos 6. SLF between the SGVLF and HGM liners; looking northeast.

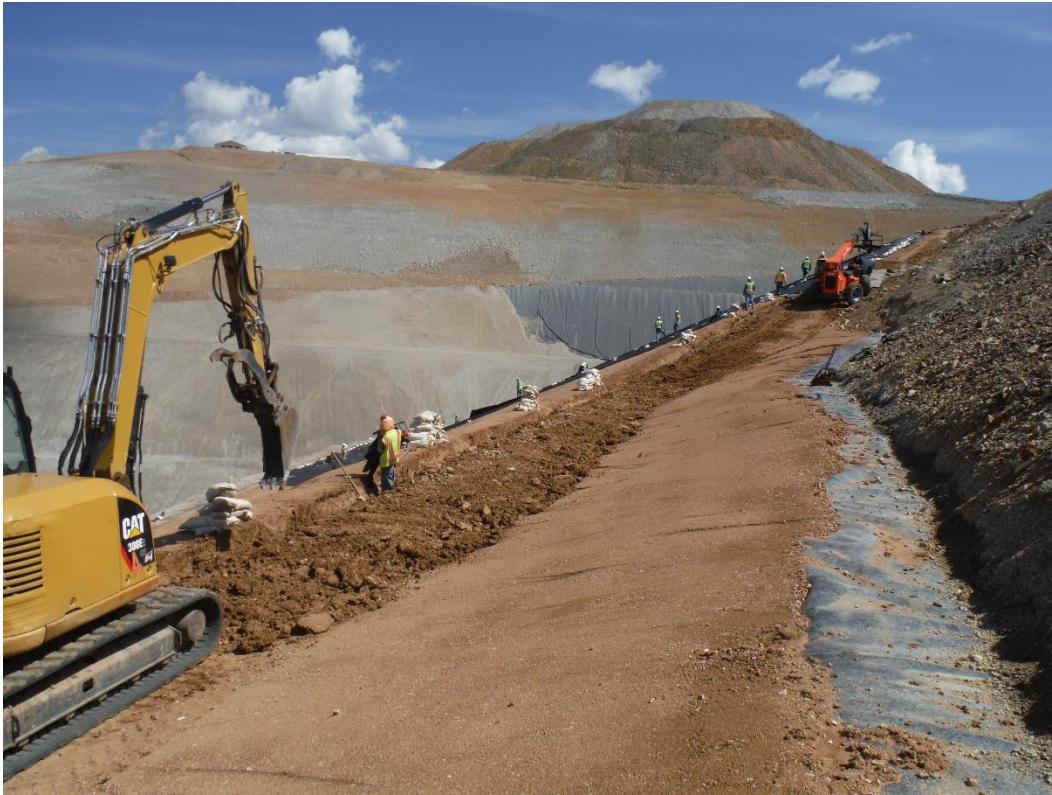
Photo 7. Installation of an anchor trench between the SGVLF and HGM liners; looking northeast.

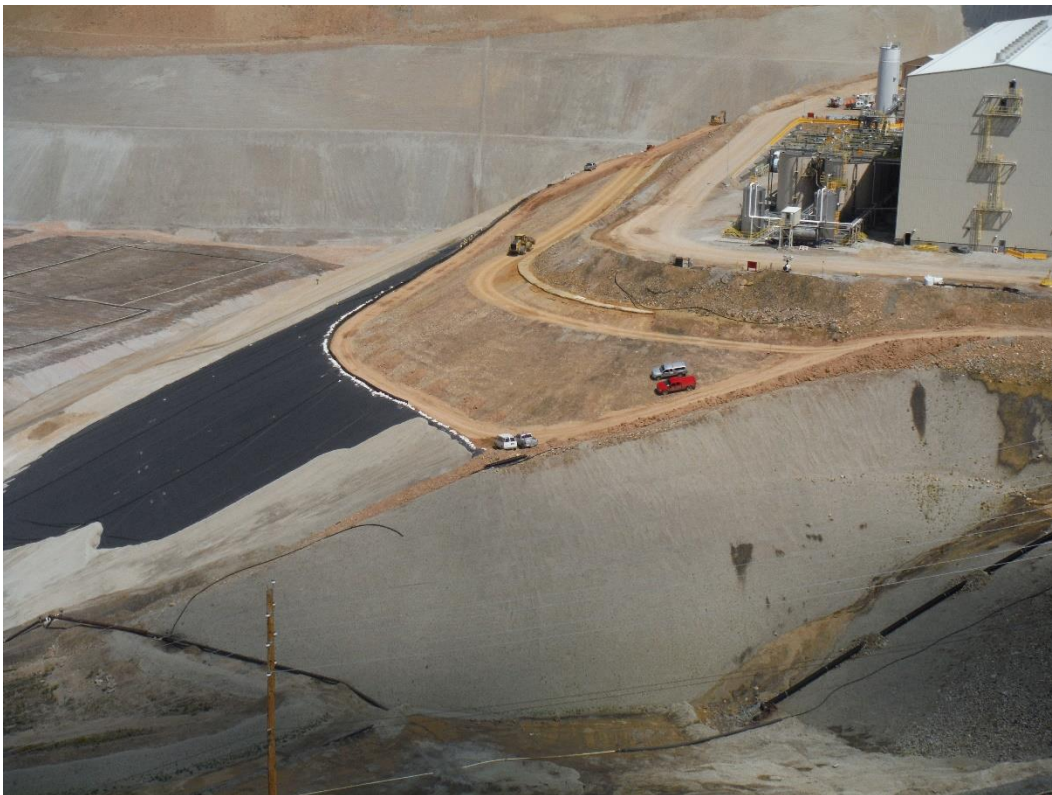
Photo 8. Overview of the HGM area showing where the liners will be tied in to each other; looking north.

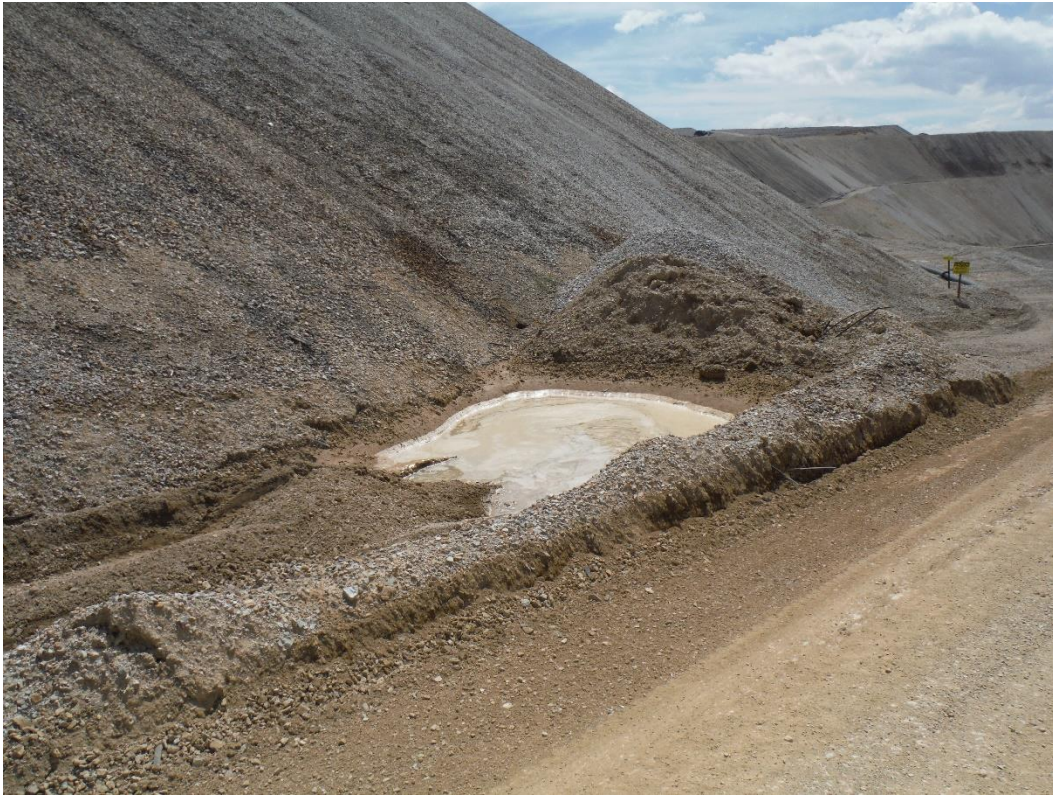
PROBLEM 1: A significant amount of potentially impacted water was observed in several stormwater sumps on the Arequa Gulch Valley Leach Facility. This is a potential attractant to wildlife. The surface area of the exposed fluid exceeded the permit condition (not to exceed 3 feet x 3 feet area).

The Division and Mr. Munroe inspected the AGVLF. The Division observed several storm water sumps along road between the Lout Out Bin and the AGADR, which contained standing water (**Photo 9**). It appears these sumps had collected sediment which was causing them to retain water instead of allowing water to infiltrate into the pad. Located on the AGVLF, the standing water within these sumps is considered impacted and thus not in compliance with the Wildlife Protection Plan. This is cited as Compliance Problem 2 of this report; however, this problem was resolved on September 6, 2016 when the operator emailed photographs showing that the AGVLF sumps on the ADR road were clean out.

Photo 9. AGVLF stormwater sump along the ADR road with standing water; looking south.

CORRECTIVE ACTIONS: Provide the Division with photographic evidence that measures were taken to allow the water within the sumps to infiltrate into the pad or other wildlife mitigation measures have been employed.

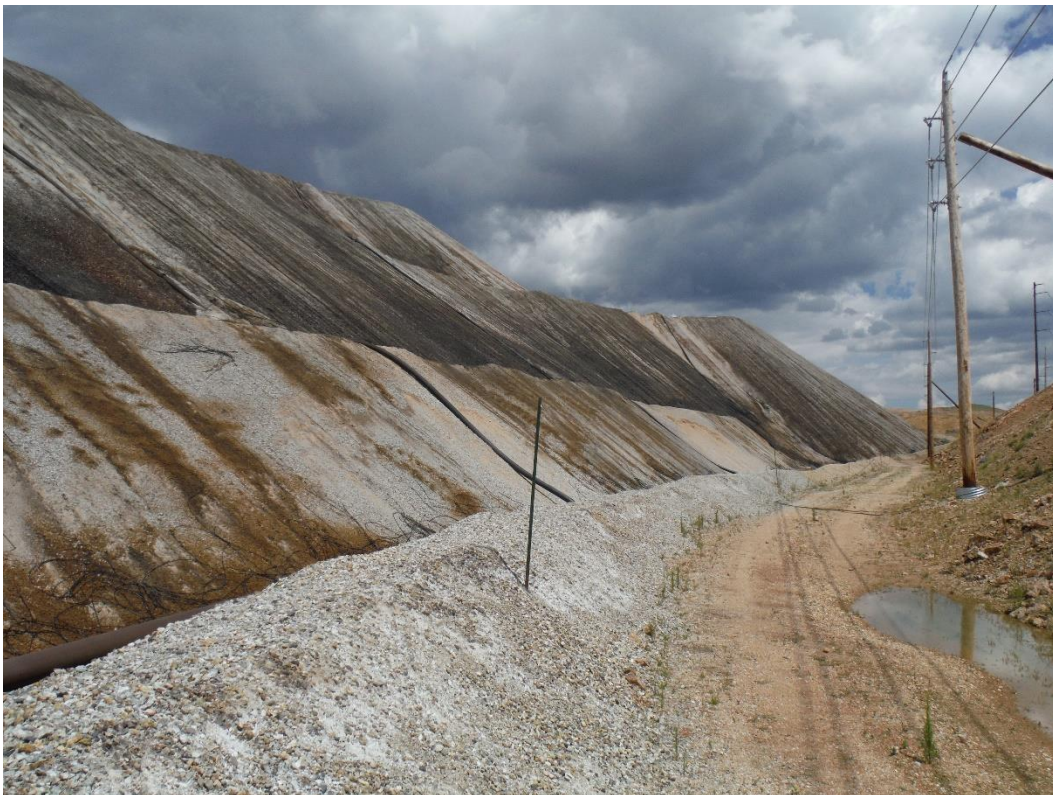
PROBLEM 3: Signs delineating the edge of the Arequa Gulch Valley Leach Facility liner are missing and/or damaged.

The eastern portion of the AGVLF, near the South Cresson Mine, was inspected. The Division observed approximately 3,800 feet of the edge of the AGVLF, between the Phase V Pumps and the Crusher, which no longer had signs delineating the edge of liner (**Photos 10 & 11**). It appears the wind caused the metal signs, which were secured to the metal posts with one bolt, to be blown off over time. These signs help ensure that off-liner equipment does not damage the containment berm nor the liner. These signs also help delineate the edge of liner if any incidents occur causing an off-liner impact. This is cited as Compliance Problem 3 of this report, requiring the signs to be replaced. The Division recommends that two bolts are used to secure the signs as this will likely help the signs being damaged by the wind again.

Photo 10. Missing edge of liner signage along the perimeter of the AGVLF east of the Phase V Pumps; looking northeast.

CORRECTIVE ACTIONS: Provide the Division with photographic evidence that the Edge of Liner Signs have been replaced before the corrective action due date.

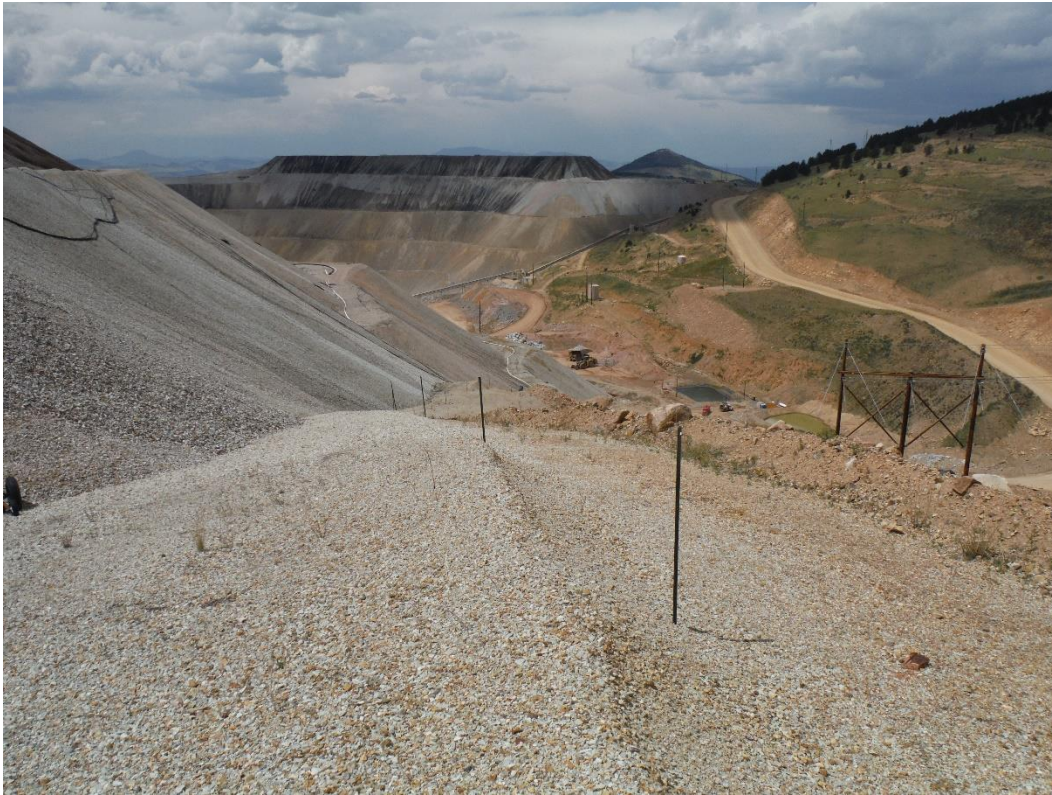
Photo 11. Missing edge of liner signage along the perimeter of the AGVLF east of the Crusher; looking northwest.
