MINERALS PROGRAM INSPECTION REPORT
PHONE: (303) 866-3567

MINE NAME: H & H Quarry #2	MINE/PROSPECTING ID#: M-1998-080	MINERAL: Sandstone (silica, st quartzite)	COUNTY: Dolores
INSPECTION TYPE: Multi Person Inspection	INSPECTOR(S): Lucas J. West	INSP. DATE: October 18, 2016	INSP. TIME: 13:19
OPERATOR: H & H Stone	OPERATOR REPRESENTATIVE: Marty and Andrea Holley	TYPE OF OPERATION: 110c - Construction Limited Impact	
REASON FOR INSPECTION: Normal I&E Program	BOND CALCULATION TYPE: None	BOND AMOUNT: \$6,347.00	
DATE OF COMPLAINT: NA	POST INSP. CONTACTS: None	JOINT INSP. AGENCY: None	
WEATHER: Clear	INSPECTOR'S SIGNATURE:

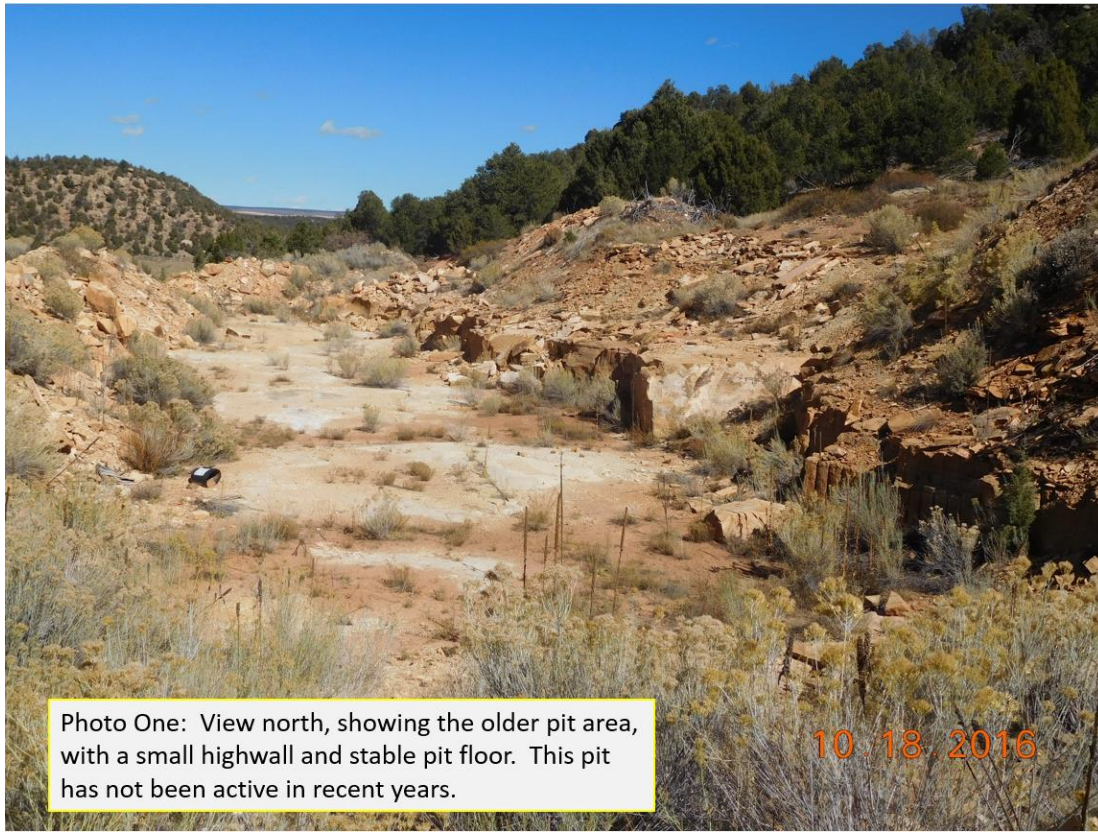
The site consists of two pit areas, one that has not been mined recently and the other, where the mining activity has been concentrated. The older pit, as seen in Photo One, consist of a small highwall that is approximately 4 feet tall. The mining area of the older pit appears to be stable and in good condition. The side slopes and pit floor have all been revegetated with volunteer species and show no signs of significant erosion. The main active pit, consists of a highwall ranging from 20 to 30 feet tall. The highwall appears to be stable and in good condition and can be seen in Photos Two and Three. Dimensional sandstone is periodically cut from the exposed highwall, and split into smaller pieces for removal from the site and sale. Stockpiles of the stone can also be seen in Photos Two and Three. Approximately 15 feet behind the exposed highwall has been stripped future extraction activities. The floor of the main pit area is also in good condition and appears to be stable.

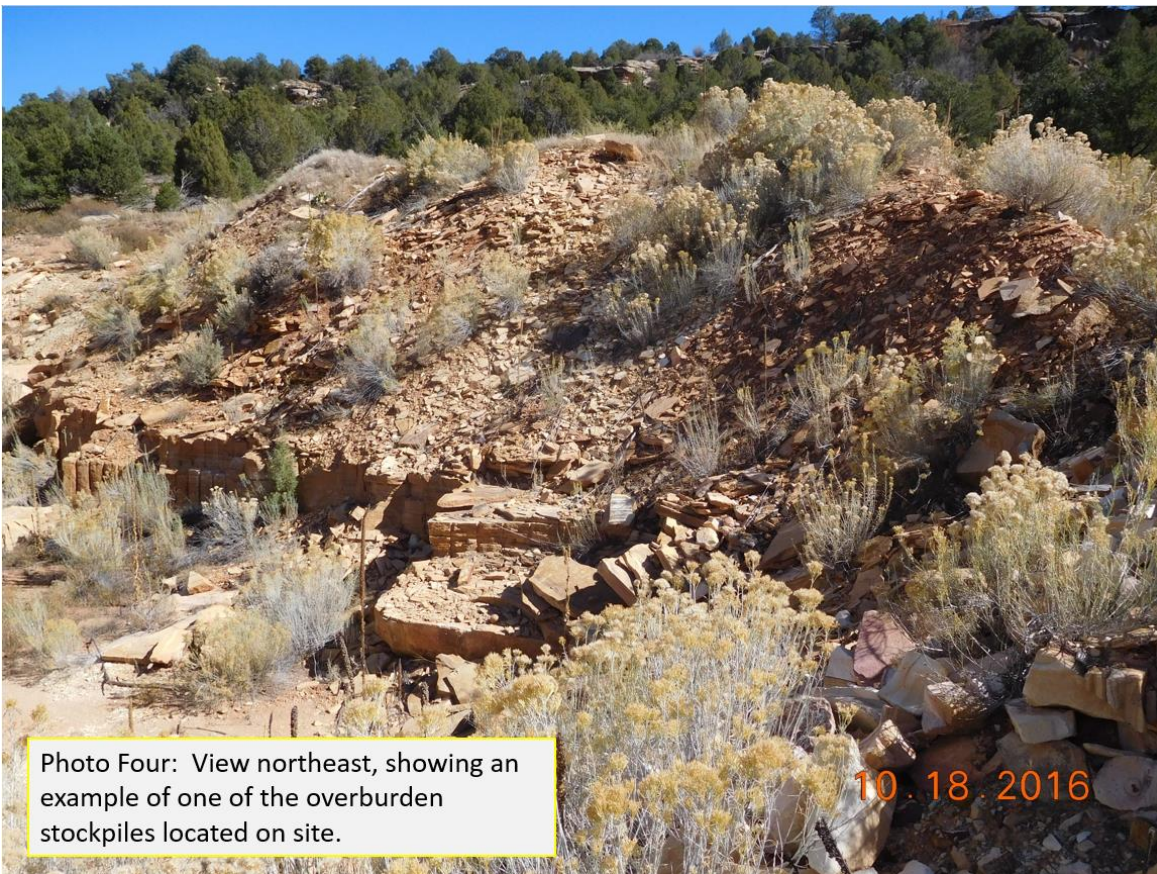
Several stockpiles of overburden material was observed around the main pit area. An example of the stockpiles can be seen in Photo Four. All of the overburden stockpiles appear to be stable and are well vegetated. The topsoil stockpile was also overserved and can be seen in Photo Five. Similar to the other stockpiles located on site, the topsoil pile is well vegetated with volunteer species and appears to be stable. Located just up gradient from the main pit area were several pallets of cut dimensional material. This material is being stored on site prior to removal and are in good condition.
