**COLORADO**Division of Reclamation,
Mining and Safety

MINERALS PROGRAM INSPECTION REPORT**PHONE: (303) 866-3567**

MINE NAME: Hartman Pit	MINE/PROSPECTING ID#: M-1997-087	MINERAL: Gravel	COUNTY: Pueblo
INSPECTION TYPE: Surety Release Inspection	INSPECTOR(S): Elliott R. Russell	INSP. DATE: September 22, 2016	INSP. TIME: 09:00
OPERATOR: Arnolds Custom Seeding, LLC	OPERATOR REPRESENTATIVE: James Simpson	TYPE OF OPERATION: 112c - Construction Regular Operation	
REASON FOR INSPECTION: Surety Release Requested	BOND CALCULATION TYPE: None	BOND AMOUNT: \$139,285.00	
DATE OF COMPLAINT: NA	POST INSP. CONTACTS: None	JOINT INSP. AGENCY: None	
WEATHER: Clear	INSPECTOR'S SIGNATURE:

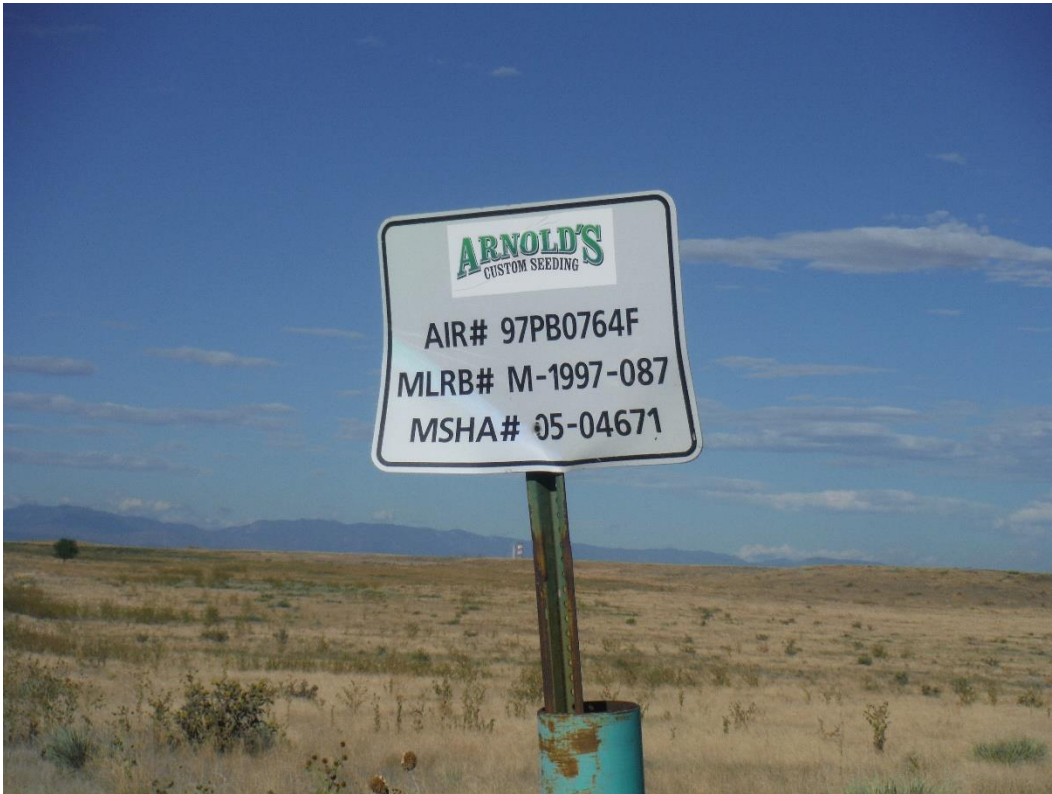
Mine identification sign posted at the entrance to the site; looking west.

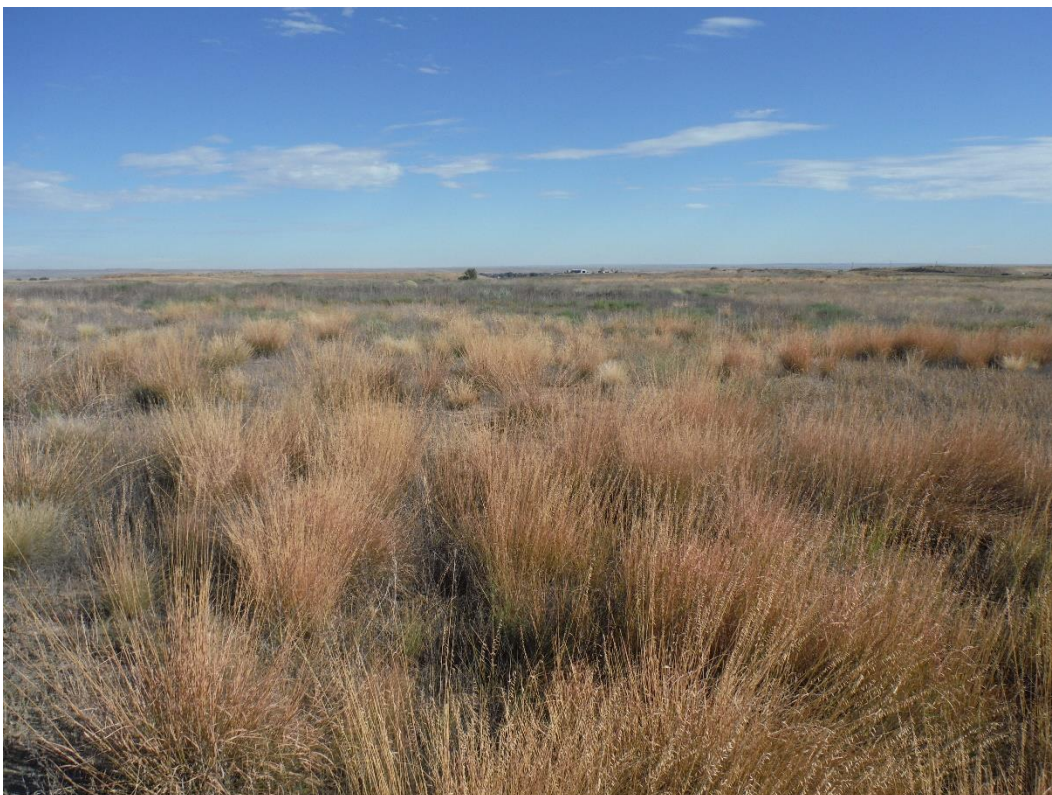
Sample photo of a portion of the permit with successful reclamation; looking north.

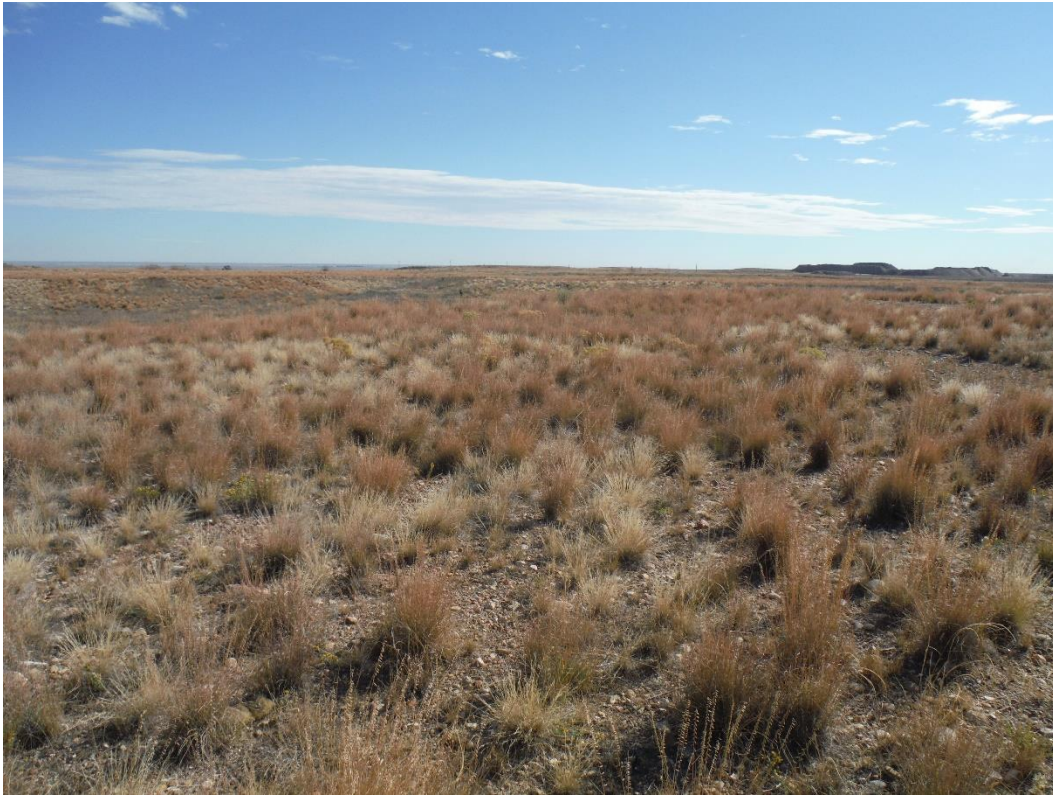
Sample photo of a portion of the permit with successful reclamation; looking west.

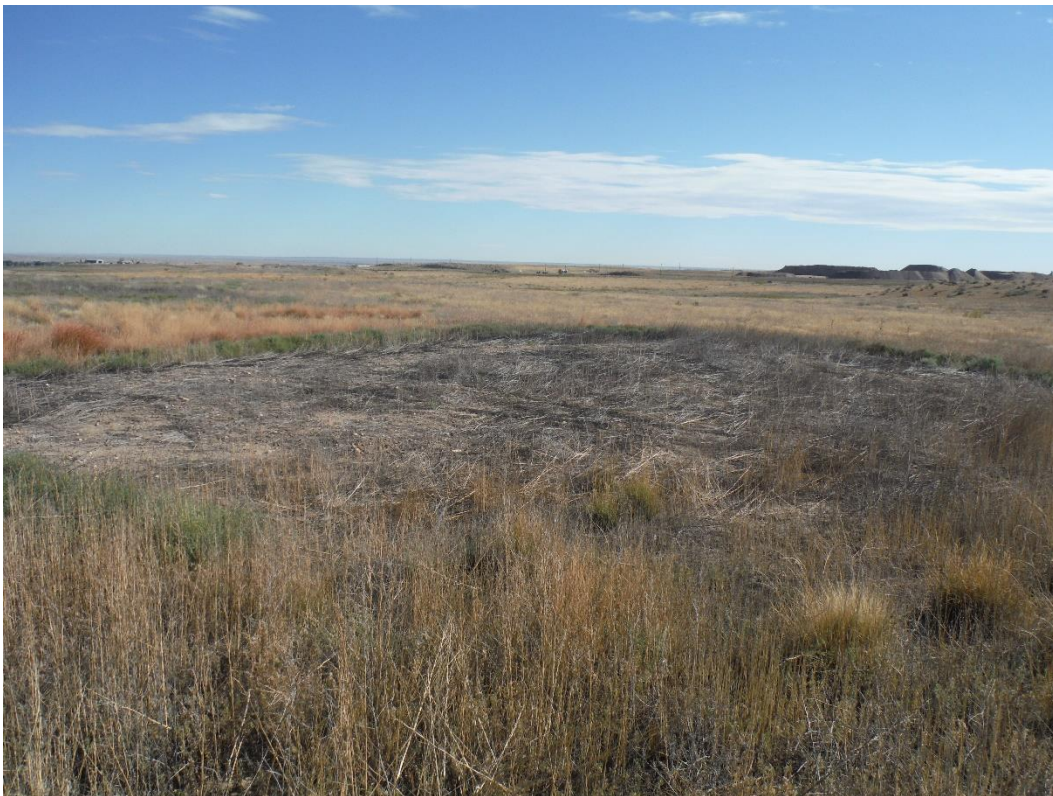
The Division observed a healthy landscape of blue grama, sideoats grama, switchgrass, and buffalo grasses on the majority of the reclaimed lands. Unfortunately, several areas of the disturbance (within the areas outside of the 14.3 acres to remain) were void of vegetation or were dominated by kochia. Mr. Simpson stated that they would reseed in the fall of 2016 to achieve better results. Additionally, the tamarisk that were treated with a foliar herbicide in the spring of 2016, were not entirely eradicated as several stems still had green/living foliage on them. In the spring/summer of 2017, the Division recommends the Operator monitor the tamarisk at the site to determine the effectiveness of the previous year's treatment and re-treat, as necessary.

Location of one area lacking vegetation, appears to be a graded-out stockpile; looking northeast.

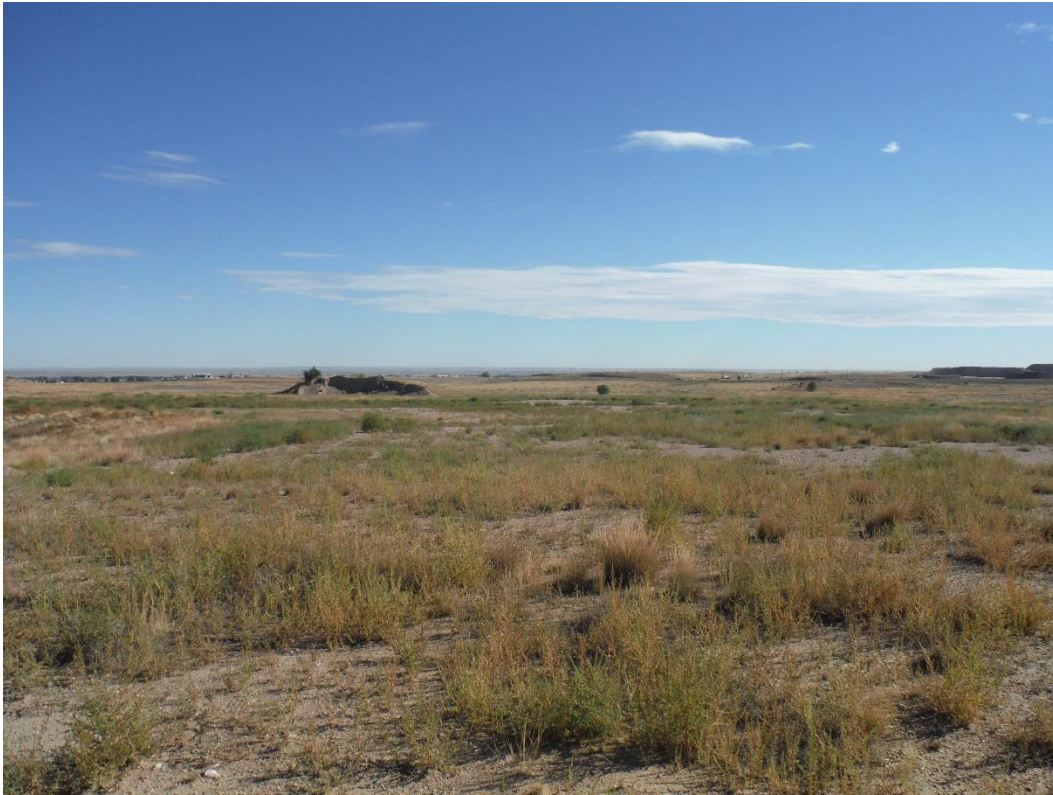
Sample photo of an area dominated by kochia; looking northeast.

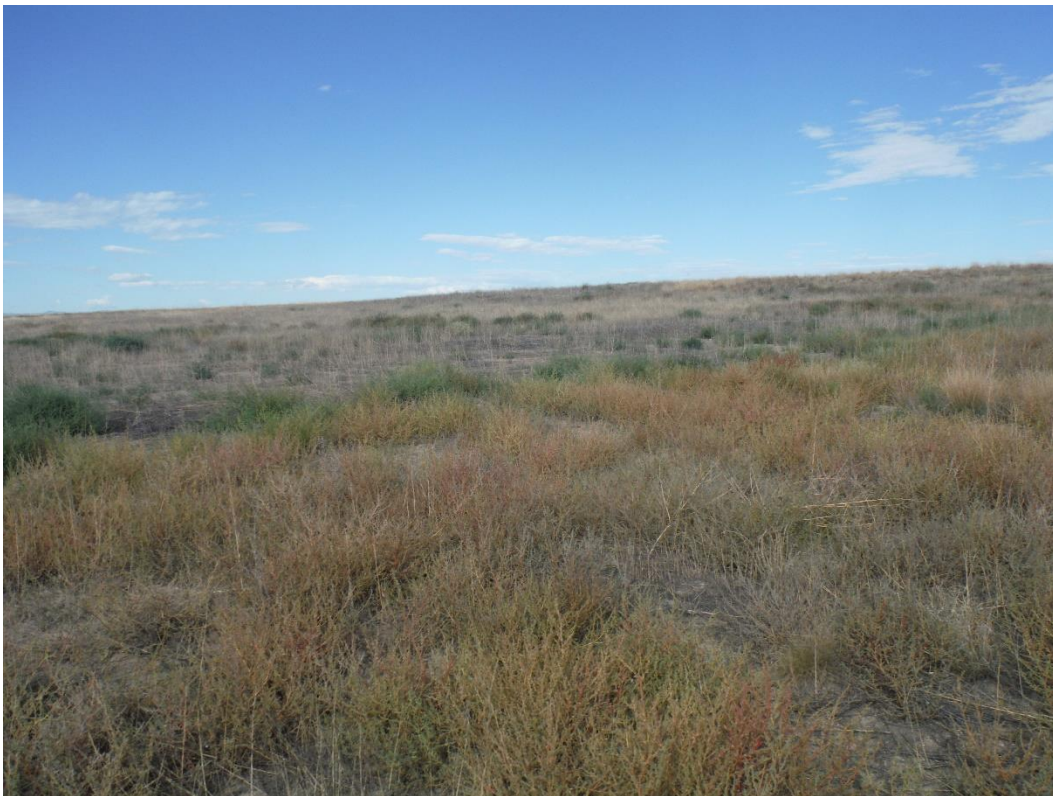
Sample photo of an area dominated by kochia; looking west.

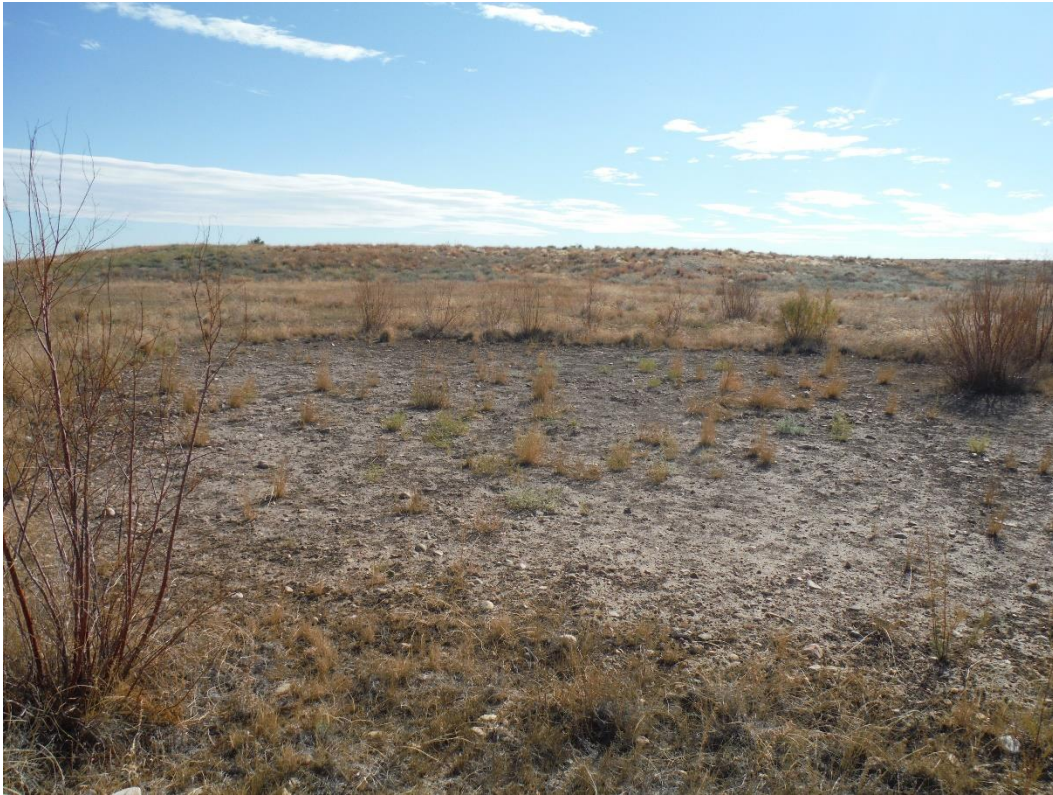
Small area lacking vegetation, evidence that tamarisk are still alive; looking east.

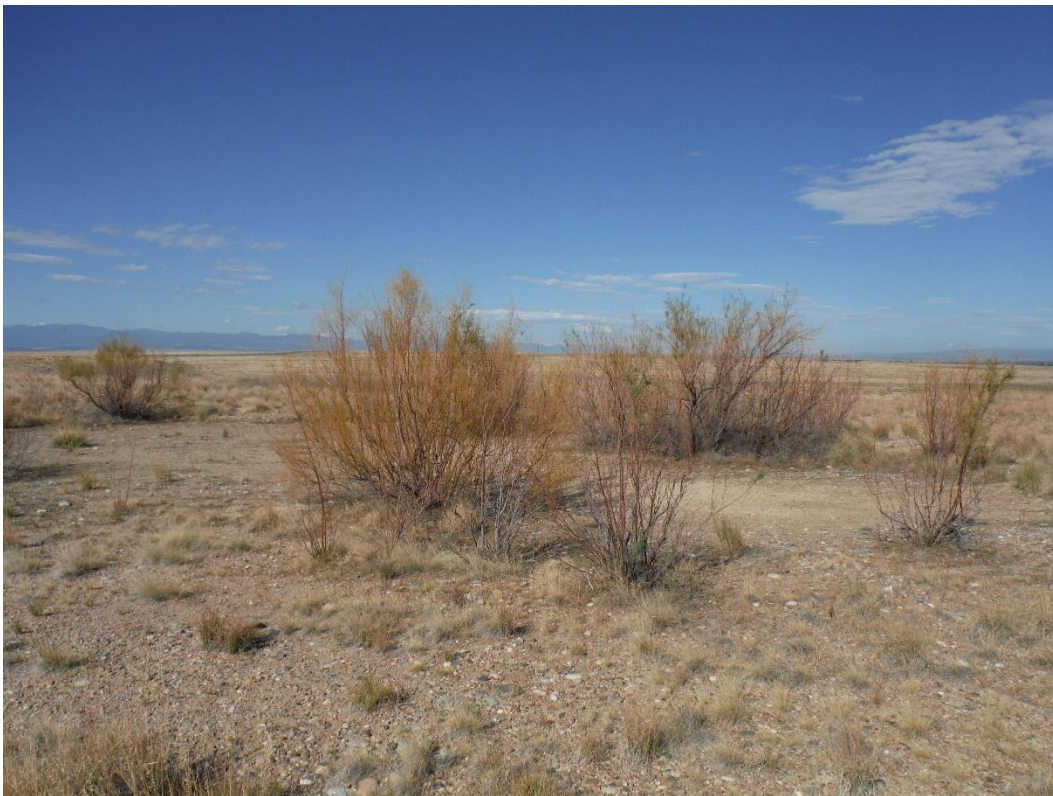
Additional area where tamarisk may need to be retreated; looking west.

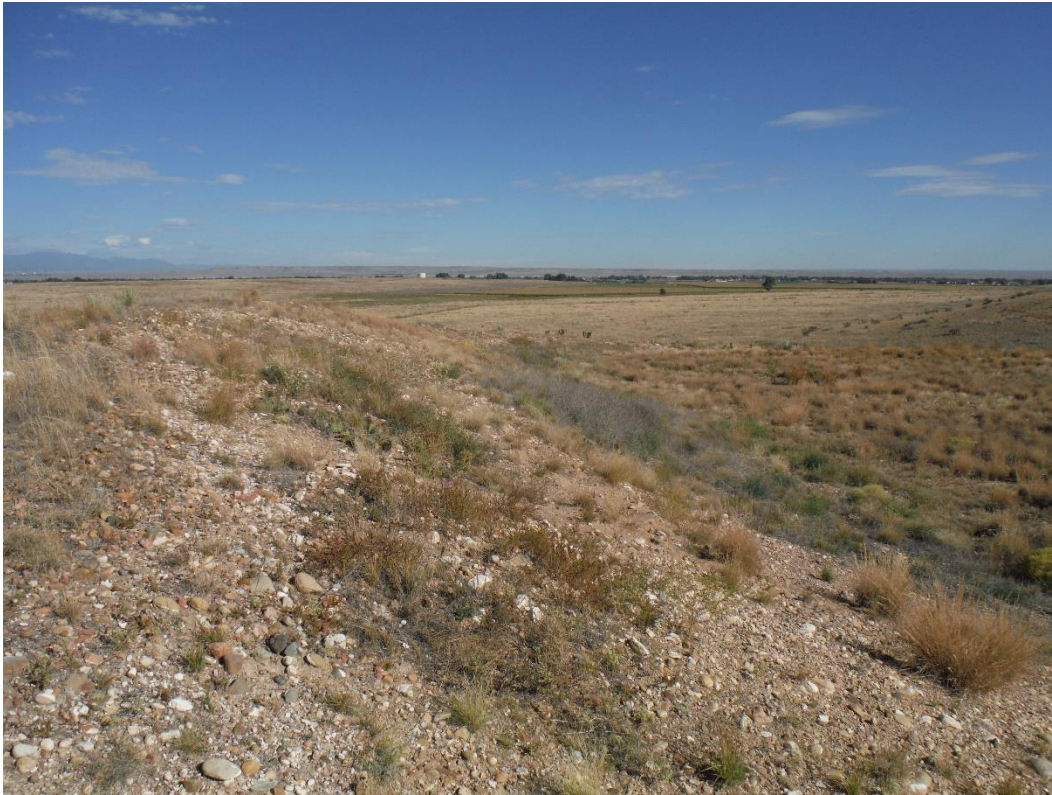
The Division observed three graded areas of the disturbance that did not meet the approved Reclamation Plan. These three areas observed are located at the edges of three mined-out "gravelly fingers" and consist of approximately 2H:1V slopes starting at the pit floor up to undisturbed topography. The Division has attached a Google Earth Print out showing the location of these three locations. The approved Reclamation Plan states that the mining operation will not create backslopes as the operation consists solely of removing the tops of the gravel knolls, creating a level pit floor. The approved Reclamation Plan Maps also reflects this with post-mining contours showing that the margins of the operation would day-light to existing topography. It appears the mining operation did not fully mine out the knolls, leaving these slopes. Since the approved Reclamation Plan and Map are different than the current conditions, the Operator will need to either grade these areas flat OR submit a Technical Revision to the permit revising the Reclamation Plan and Reclamation Plan Map. Attached is the Division's Technical Revision cover sheet, which can also be found on the Division website.

Western area with 2H:1V slope remaining; looking north.

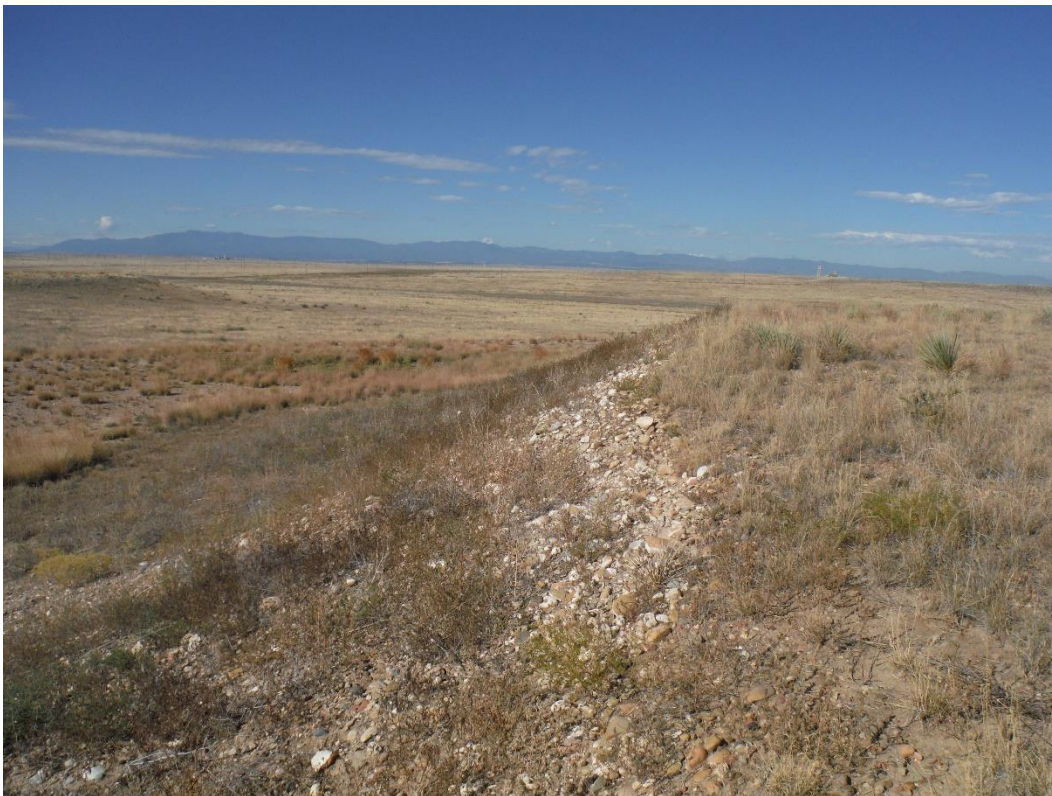
Northern area with 2H:1V slope remaining; looking west.

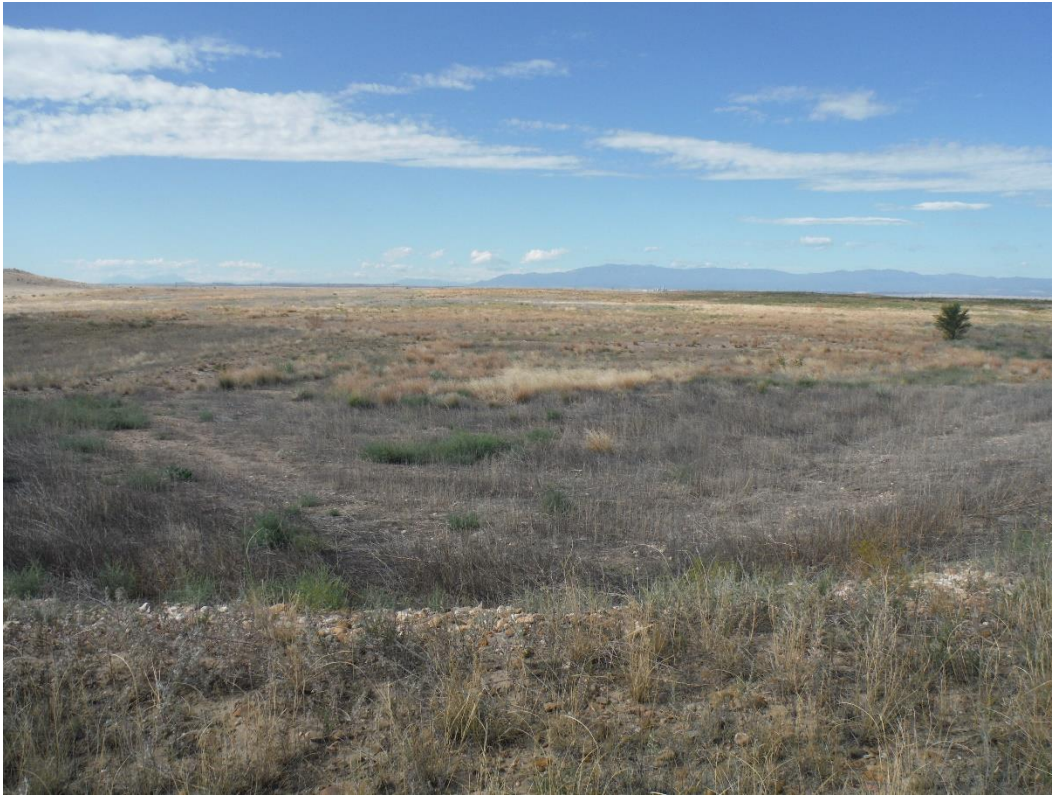
Eastern area with 2H:1V slope remaining, area lacking adequate vegetation as well; looking southwest.

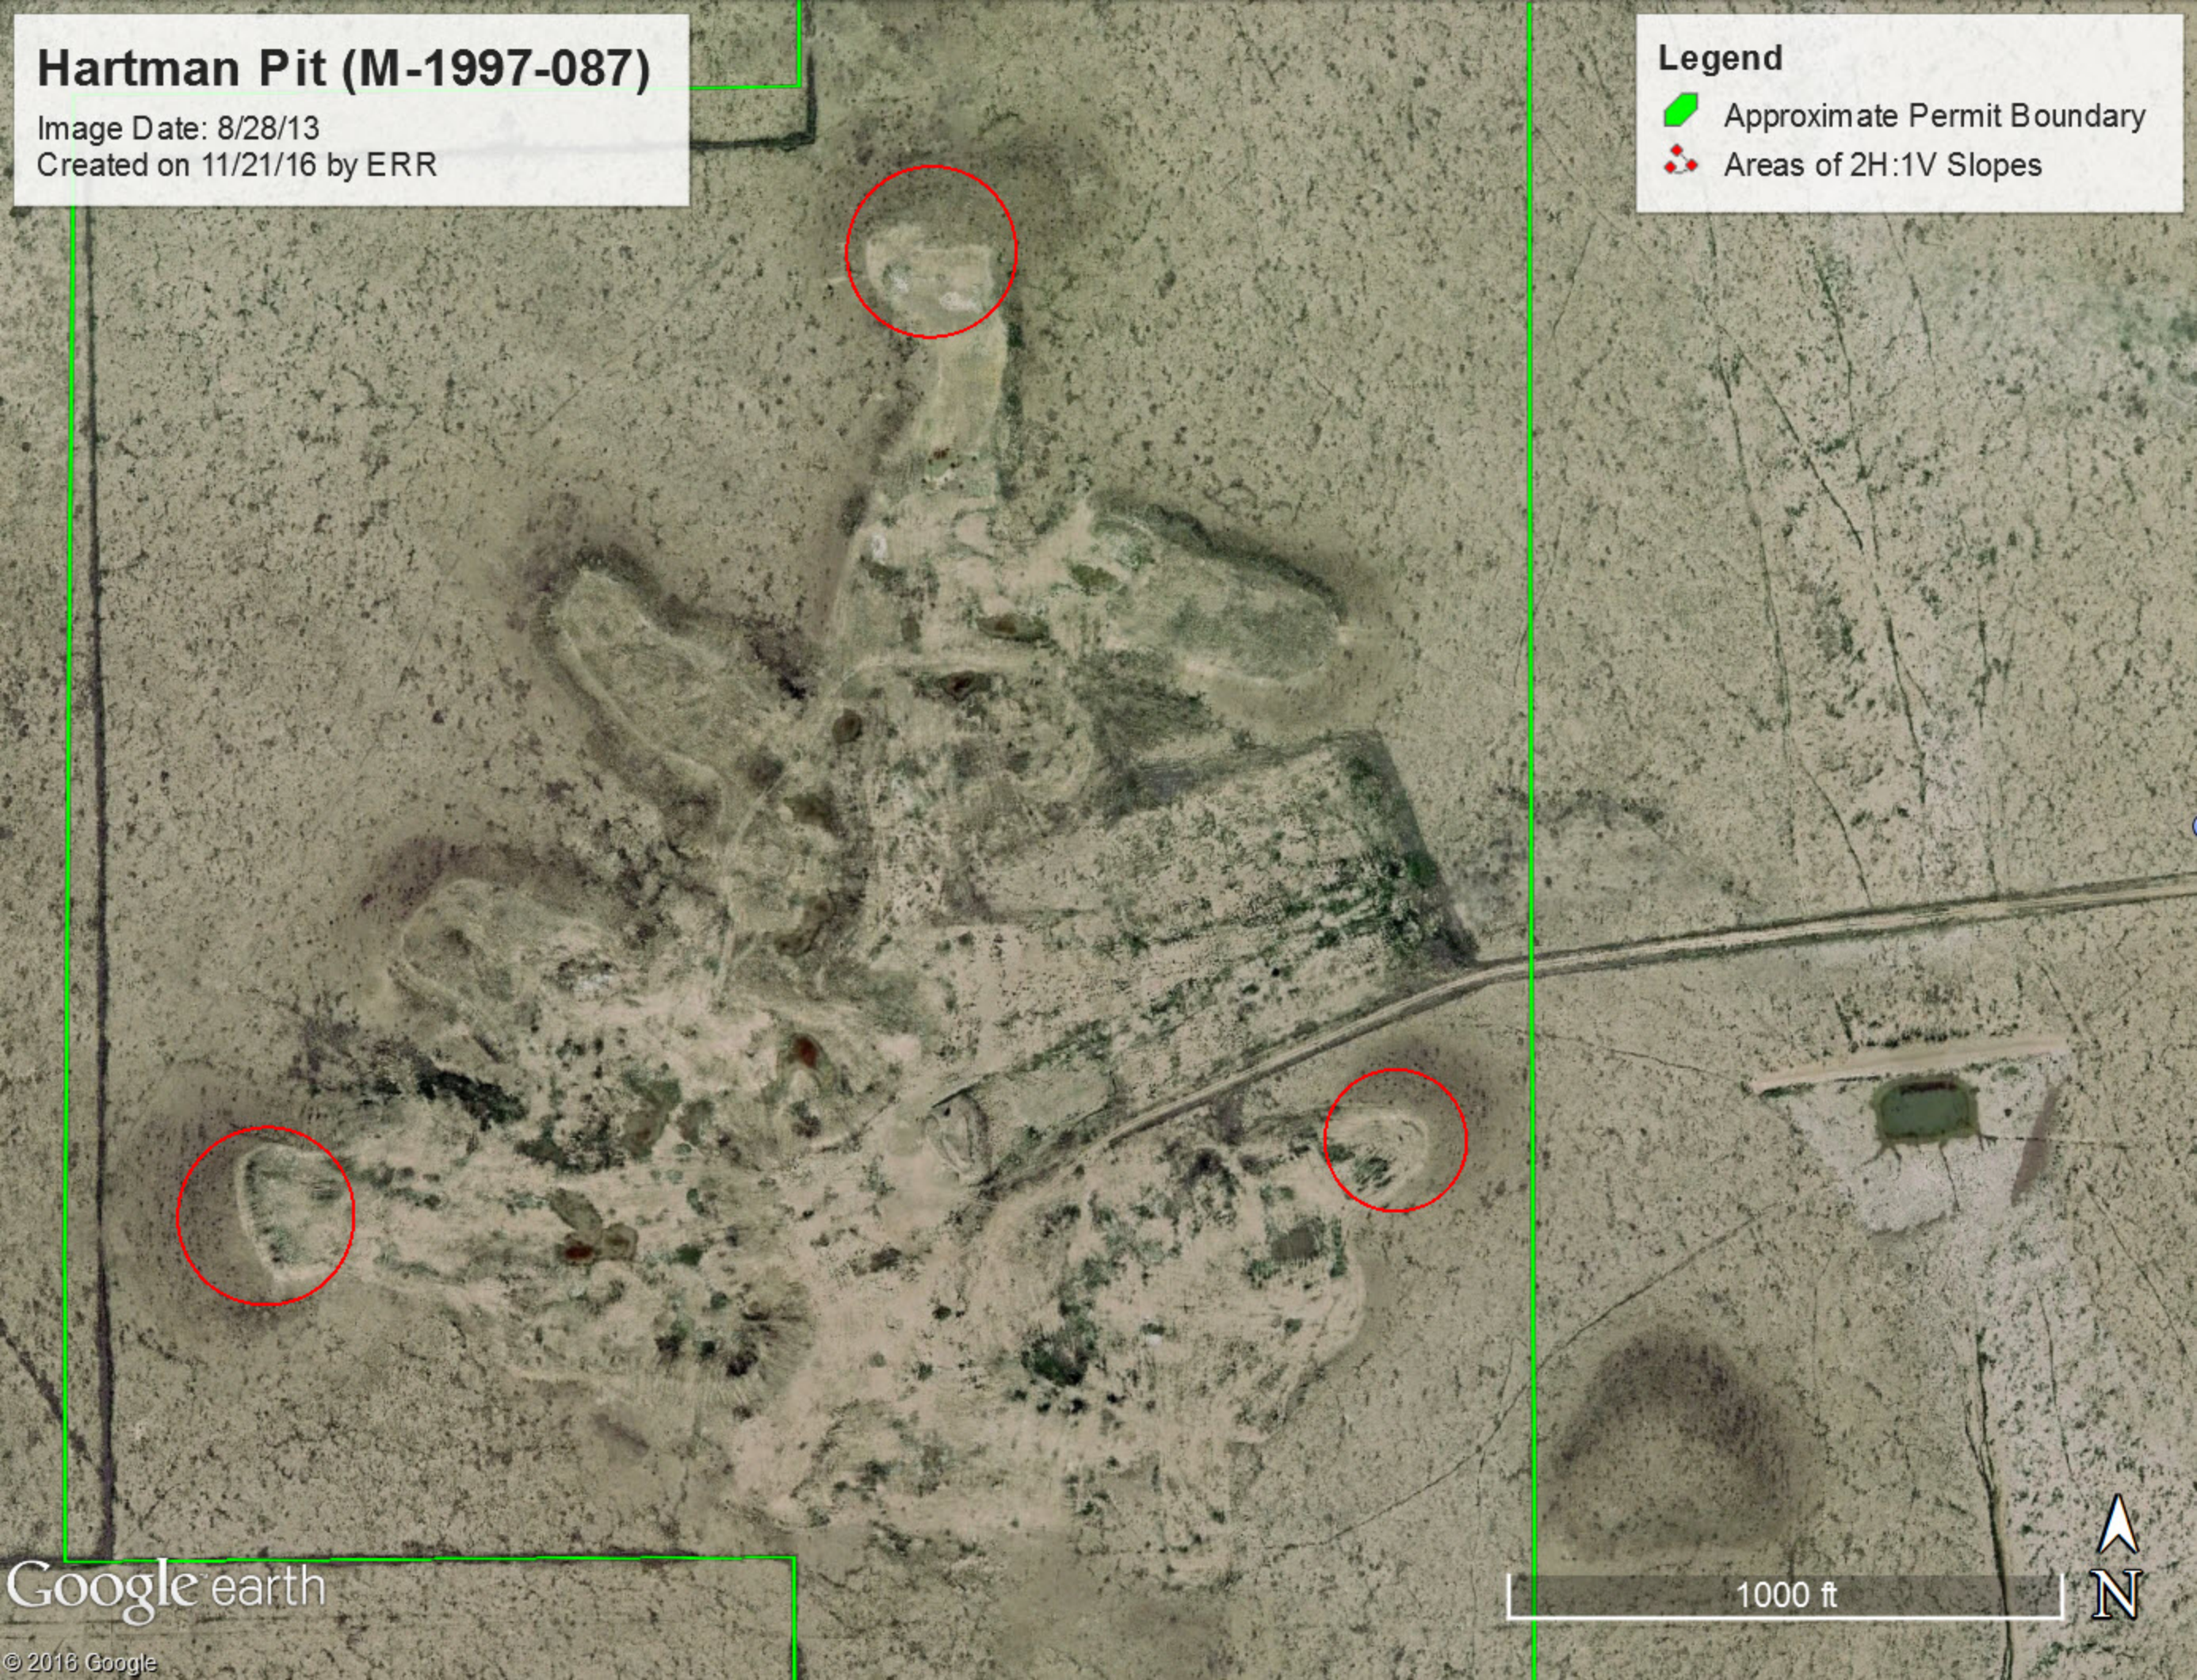
Hartman Pit (M-1997-087)

Areas of 2H:1V Slopes
