RE: North Bank Resources, Permit No. M-2006-018, Unresolved Problem(s) Noted in a Past Inspection Report

MINERALS PROGRAM INSPECTION REPORT**PHONE: (303) 866-3567**

MINE NAME: North Bank Resources	MINE/PROSPECTING ID#: M-2006-018	MINERAL: Sand and gravel	COUNTY: Garfield
INSPECTION TYPE: Preoperation Inspection	INSPECTOR(S): Amy C. Yeldell	INSP. DATE: September 1, 2016	INSP. TIME: 08:00
OPERATOR: Oldcastle SW Group, Inc. dba United Compai County	OPERATOR REPRESENTATIVE: Jason Burkey	TYPE OF OPERATION: 112c - Construction Regular Operation

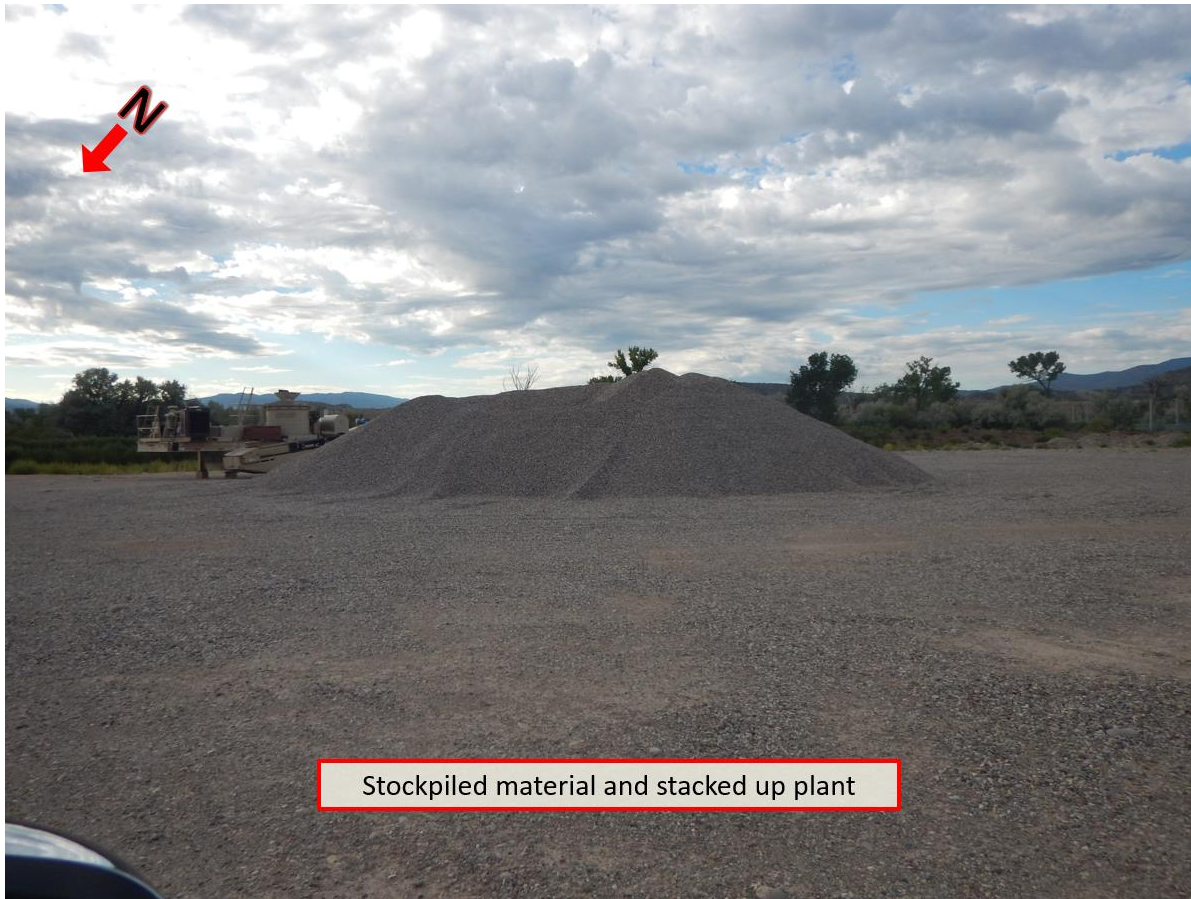
Stockpiled material and stacked up plant

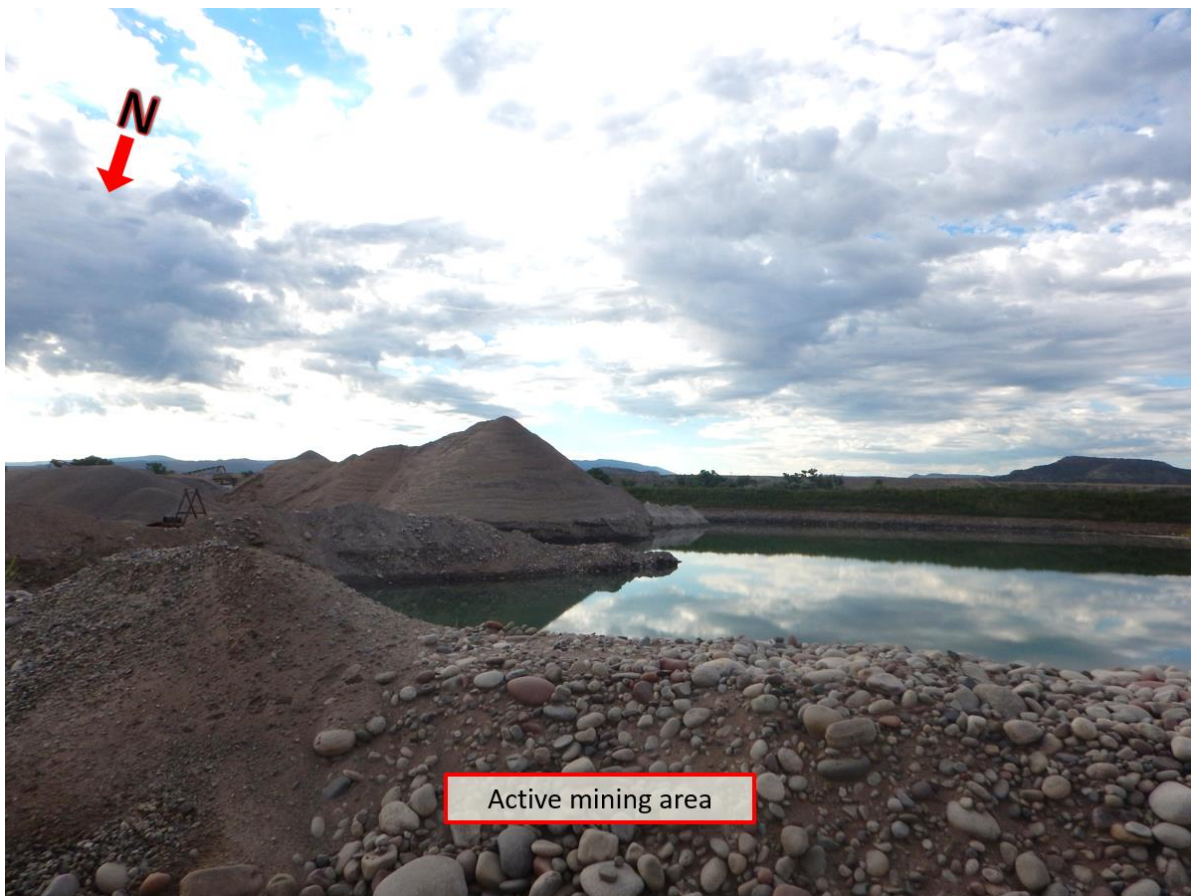
Active mining area
