## MINERALS PROGRAM INSPECTION REPORT

| <b>MINE NAME:</b><br>Henderson Mine | <b>MINE/PROSPECTING ID#:</b><br>M-1977-342 | <b>MINERAL:</b><br>Molybdenum | <b>COUNTY:</b><br>Clear Creek, Grand |
| <b>INSPECTION TYPE:</b><br>Monitoring | <b>INSPECTOR(S):</b><br>Michael A. Cunningham | <b>INSP. DATE:</b><br>November 8, 2016 | <b>INSP. TIME:</b><br>09:30 |

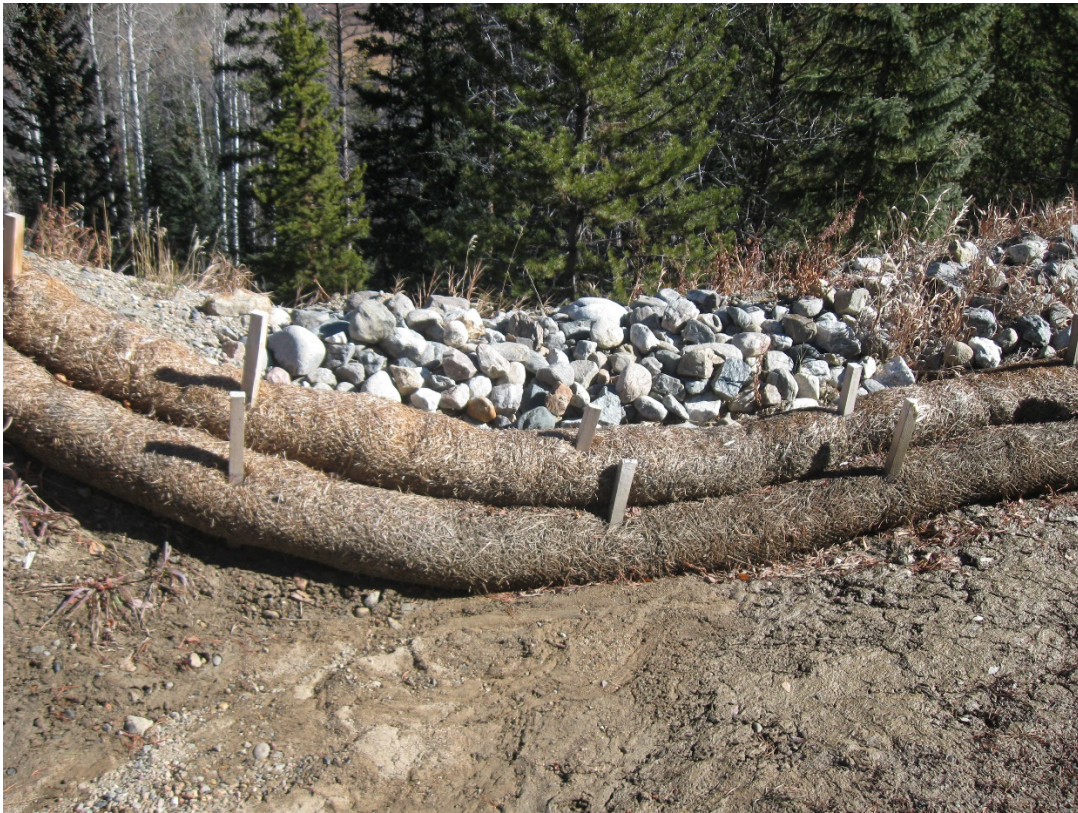
The inspection commenced with the ore haulage system, which extends for approximately five miles from the Henderson Mine Portal to the Henderson Mill. The outfalls along the conveyor route report to the Williams Fork River. The potential sources of pollution along the conveyor route include sediment from erosion, ore from the ore haulage system, and oil and grease from equipment. The storm water outfalls along the conveyor route utilize BMP's including rock check dams and straw wattles. In addition to inspecting the individual outfalls along the conveyor route, the Division inspected the PC2/PC3 Transfer Station Area and the Portal Lay-down Yard and found these areas to be clean and well maintained. The Division found the outfalls and storm water diversions along the conveyor route were free of obstructions and the BMPs were functioning as designed. The Division did not observe any pollutants leaving the site.

**1. Typical outfall BMP's.**

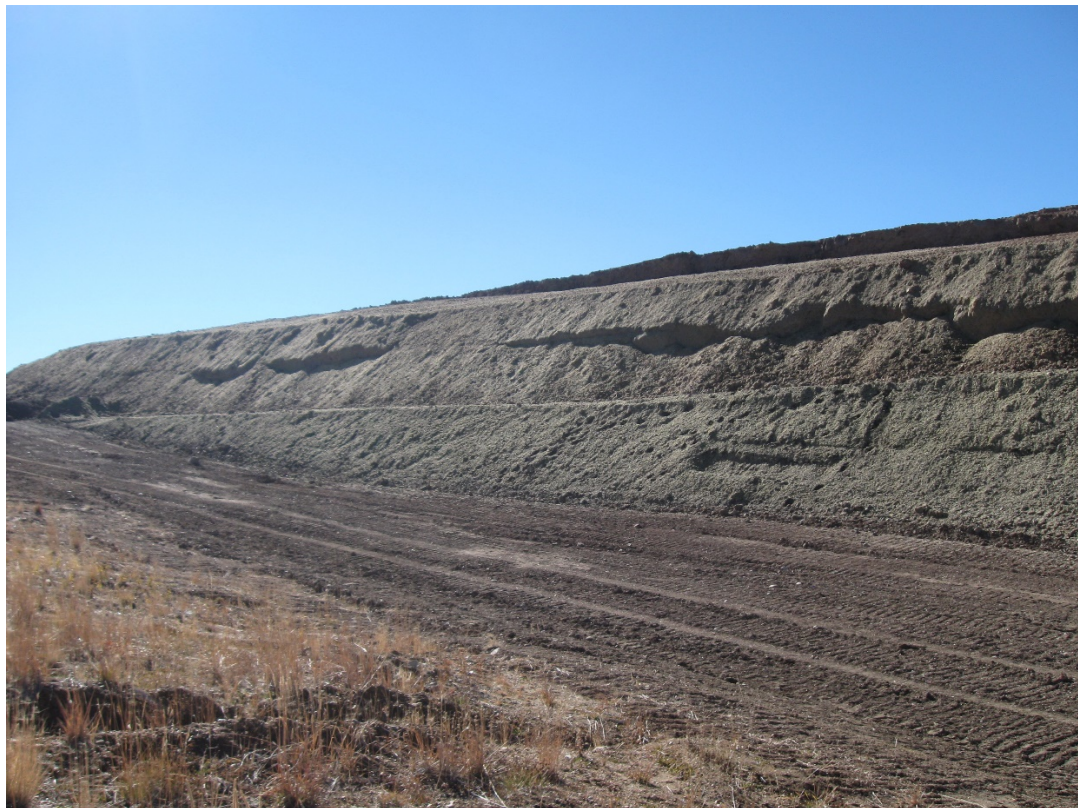
The topsoil stockpile located along west side of the Ultimate Canal was inspected. The Operator has recently stabilized the topsoil stockpile by benching and hydroseeding the lower portion of the stockpile. Henderson staff will bench and hydroseed the upper portion of the stockpile in 2017. No signs of erosion were observed on the topsoil stockpile.

**2. Topsoil stockpile stabilization.**

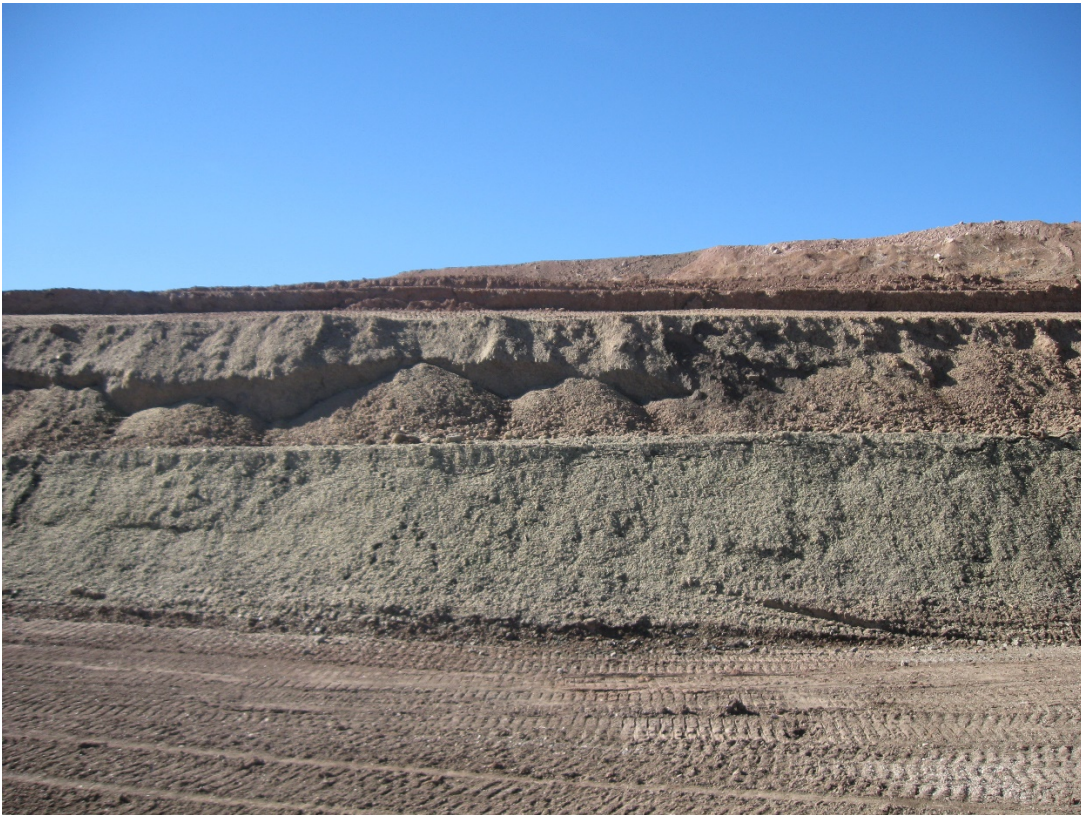
**3. Topsoil stockpile stabilization.**

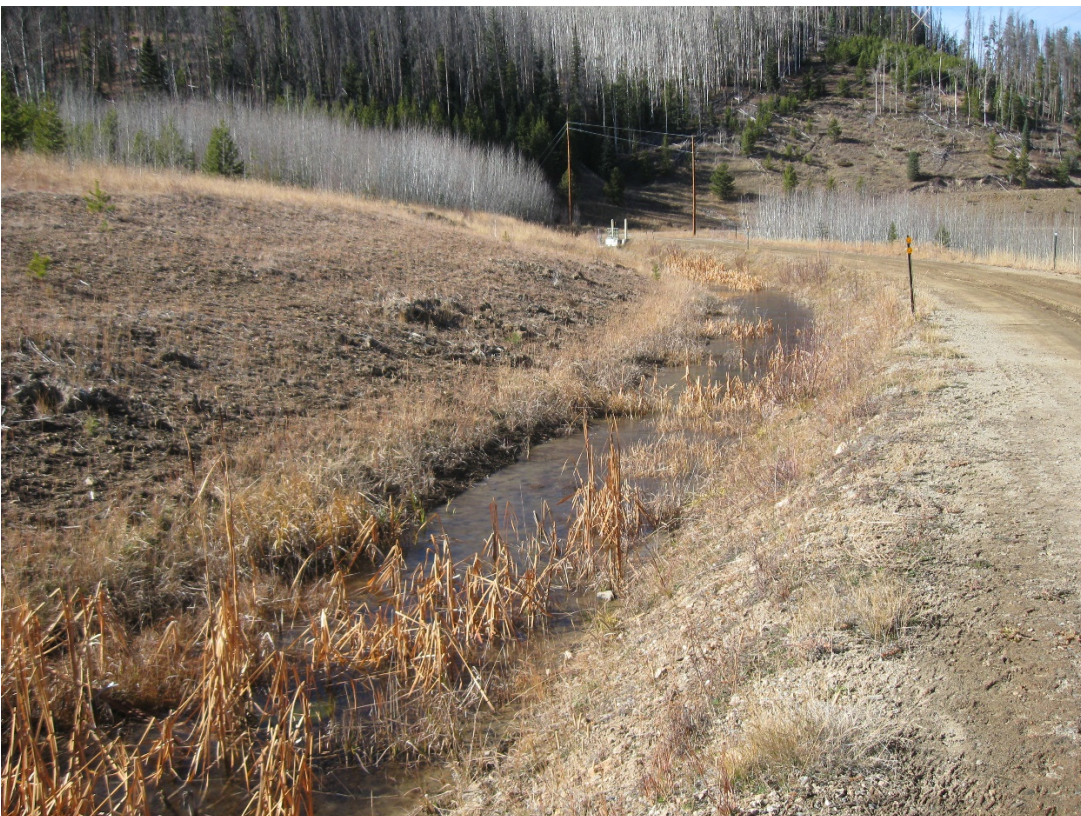
Following the inspection of the conveyor route, the Division and Henderson staff inspected the Ultimate Canal which intercepts storm water along the west and north sides of the tailings impoundment. Storm water collected in the Ultimate Canal reports to the Williams Fork River. The potential sources of pollution along the Ultimate Canal include sediment from the mountain drainages surrounding the tailings impoundment. In addition, several outfalls along the access road which follows the Ultimate Canal were inspected. The Ultimate Canal is unlined and discharges through a single outfall. There are several gates along the Ultimate Canal which can be manually opened to allow storm water to flow to wetland areas as well as into the tailings impoundment; the gates are operated on an as-needed basis. At the time of the inspection, there was water flowing through the diversion ditch. The banks of the diversion ditch are vegetated and the Division did not observe any signs of erosion. The Division observed cattails within several areas of the Ultimate Canal. The presence of cattails is not unexpected; however, if left uncontrolled they could significantly reduce the carrying capacity of the Ultimate Canal. According to Henderson staff, the cattails are manually removed each year. Removal of the cattails did not occur in 2016, but Henderson staff plans on conducting removal activities in 2017. The Division found the Ultimate Canal to be well maintained and functioning as designed.

**4. Cattails within Ultimate Canal.**

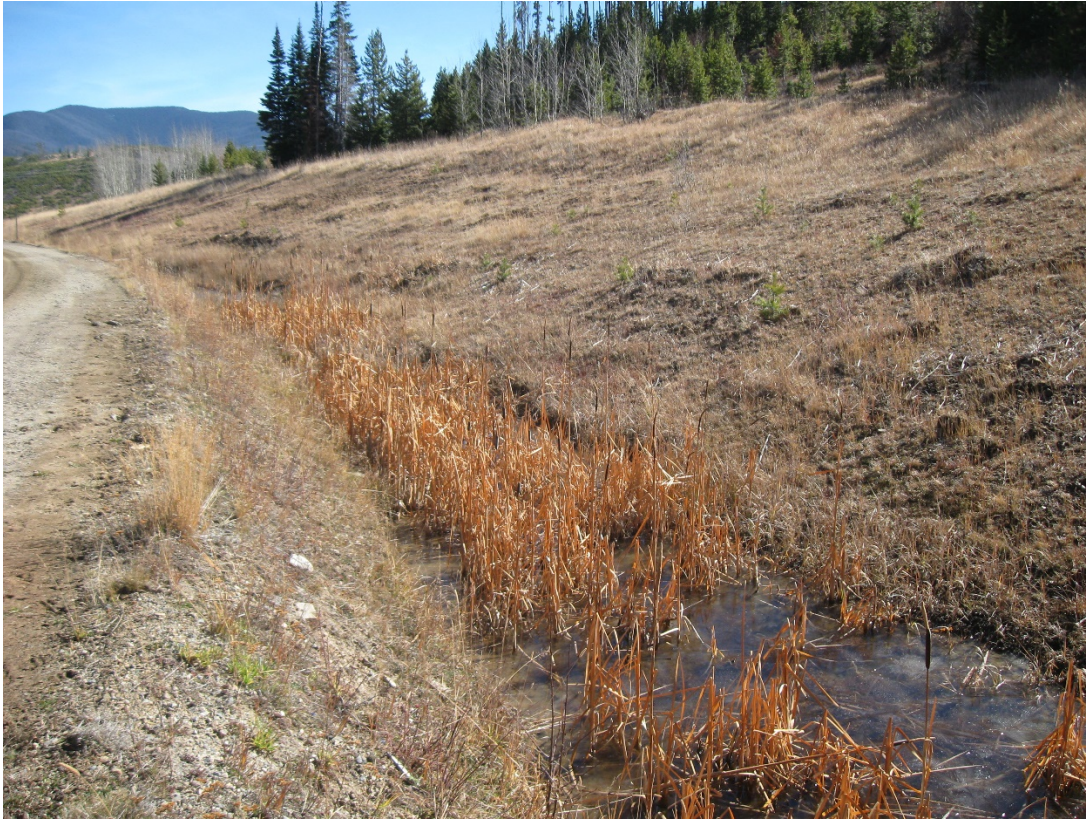
**5. Cattails within Ultimate Canal.**
