**COLORADO**Division of Reclamation,  
Mining and Safety

**MINERALS PROGRAM INSPECTION REPORT****PHONE: (303) 866-3567**

<b>MINE NAME:</b> Cedar Point Picture Rock Quarry	<b>MINE/PROSPECTING ID#:</b> M-2004-048	<b>MINERAL:</b> Stone	<b>COUNTY:</b> San Miguel
<b>INSPECTION TYPE:</b> Multi Person Inspection	<b>INSPECTOR(S):</b> Lucas J. West, Russ Means	<b>INSP. DATE:</b> November 16, 2016	<b>INSP. TIME:</b> 13:30
<b>OPERATOR:</b> Robert Daugherty	<b>OPERATOR REPRESENTATIVE:</b> None	<b>TYPE OF OPERATION:</b> 110c - Construction Limited Impact	
<b>REASON FOR INSPECTION:</b> Normal I&E Program	<b>BOND CALCULATION TYPE:</b> Complete	<b>BOND AMOUNT:</b> \$7,321.00	
<b>DATE OF COMPLAINT:</b> NA	<b>POST INSP. CONTACTS:</b> None	<b>JOINT INSP. AGENCY:</b> None	
<b>WEATHER:</b> Cloudy	<b>INSPECTOR'S SIGNATURE:</b>

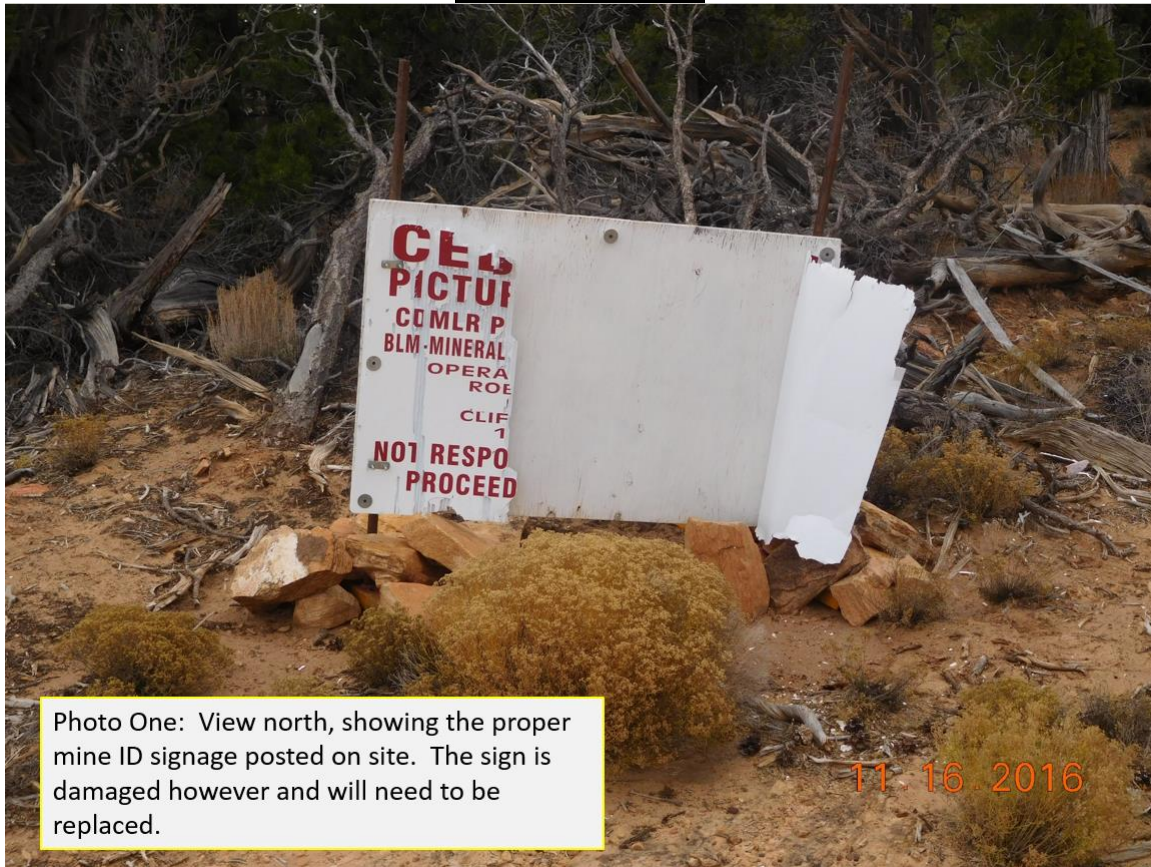
There was no operator representative present during the inspection. No equipment was on site, and the site was not active. As seen in Photo One, the proper mine identification signage was posted on site, however the sign is in disrepair and will need to be replaced soon. The quarry consist of 1.5 permitted acres that was clearly marked with T-posts. All disturbance is contained within the permitted area. The main mining activity is concentrated on a sandstone outcrop near the center of the site, where large pieces of dimensional stone are removed using expansive Plug and Feathers which can be seen in Photo Two. Photo Three shows the main mining area which is stable and in good condition.

Photo One: View north, showing the proper mine ID signage posted on site. The sign is damaged however and will need to be replaced.

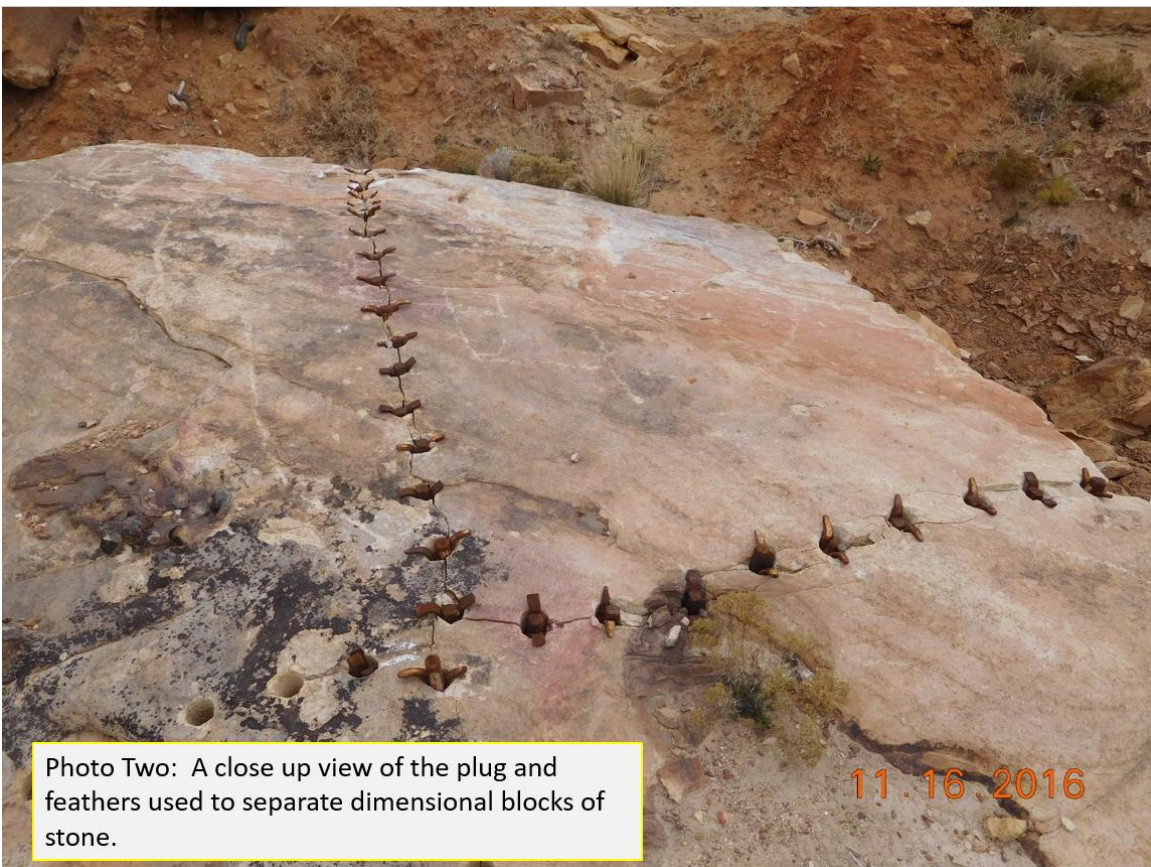
Photo Two: A close up view of the plug and feathers used to separate dimensional blocks of stone.

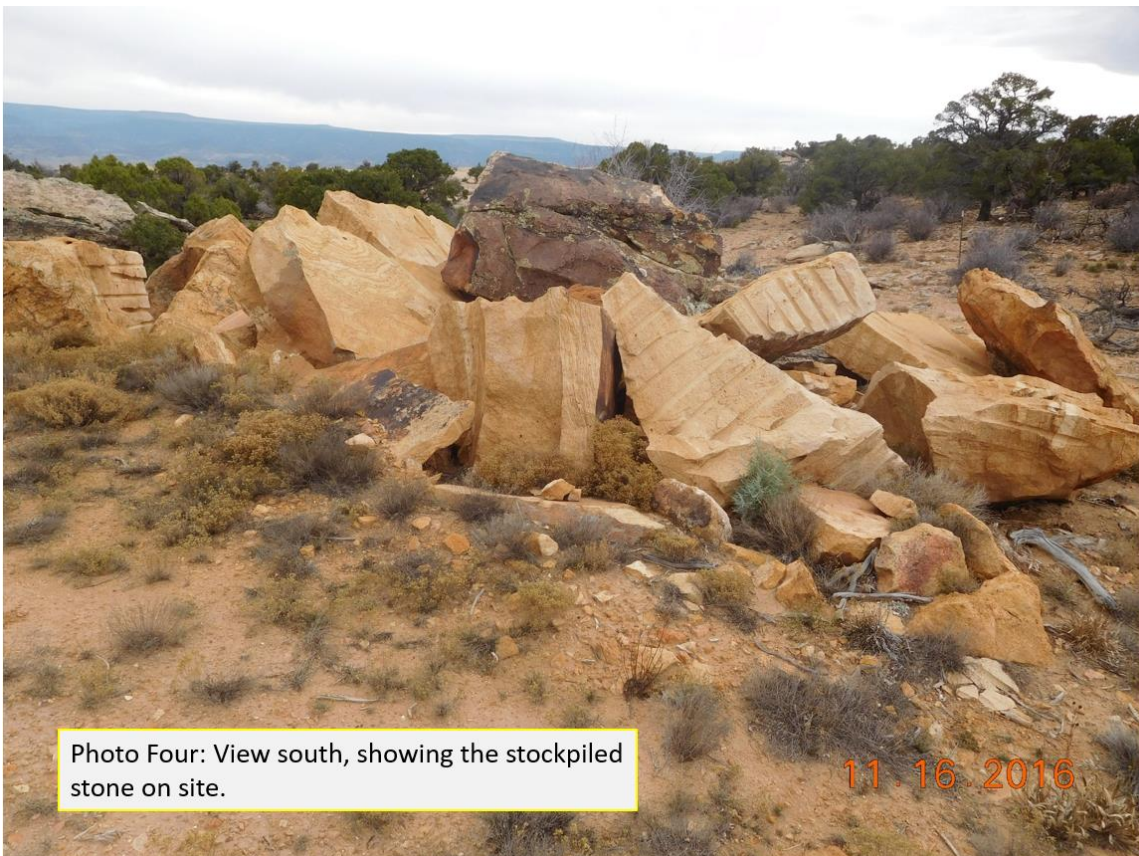
Several large blocks that have been previously removed from the outcrop are stockpiled on site. Examples of the stockpiled materials can be seen in Photo Four. The stockpile area is kept orderly and in good condition. A stockpile of overburden and other debris is located near the access road, shown in Photo Five. The stockpile is small, and apparently in good condition. The access road, which leads to the site from County Road 14Z and makes a loop within the permitted area is also in good condition. The road is rough in some spots but still provides good access to the site. No signs of significant erosion, or noxious weeds were noted on site. The overall footprint of the site was in good condition and free from trash and debris. No problems or possible violations were observed during this inspection.
