MINERALS PROGRAM INSPECTION REPORT
PHONE: (303) 866-3567

MINE NAME: Crystal Pit	MINE/PROSPECTING ID#: M-1989-116	MINERAL: Gravel	COUNTY: Teller
INSPECTION TYPE: Surety Release Inspection	INSPECTOR(S): Timothy A. Cazier	INSP. DATE: November 10, 2016	INSP. TIME: 09:55
OPERATOR: City of Colorado Springs	OPERATOR REPRESENTATIVE: Dave Jordan & Sarah Hunke	TYPE OF OPERATION: 110c - Construction Limited Impact	
REASON FOR INSPECTION: Surety Release Requested	BOND CALCULATION TYPE: IT.Bondcalculationtype.CD.Desc	BOND AMOUNT: \$0.00	
DATE OF COMPLAINT: NA	POST INSP. CONTACTS: U.S.Forest Service	JOINT INSP. AGENCY: U.S.Forest Service	
WEATHER: Clear	INSPECTOR'S SIGNATURE:

Subject: Technical Revision Request
Permit M-89-116, Crystal Gravel Mine

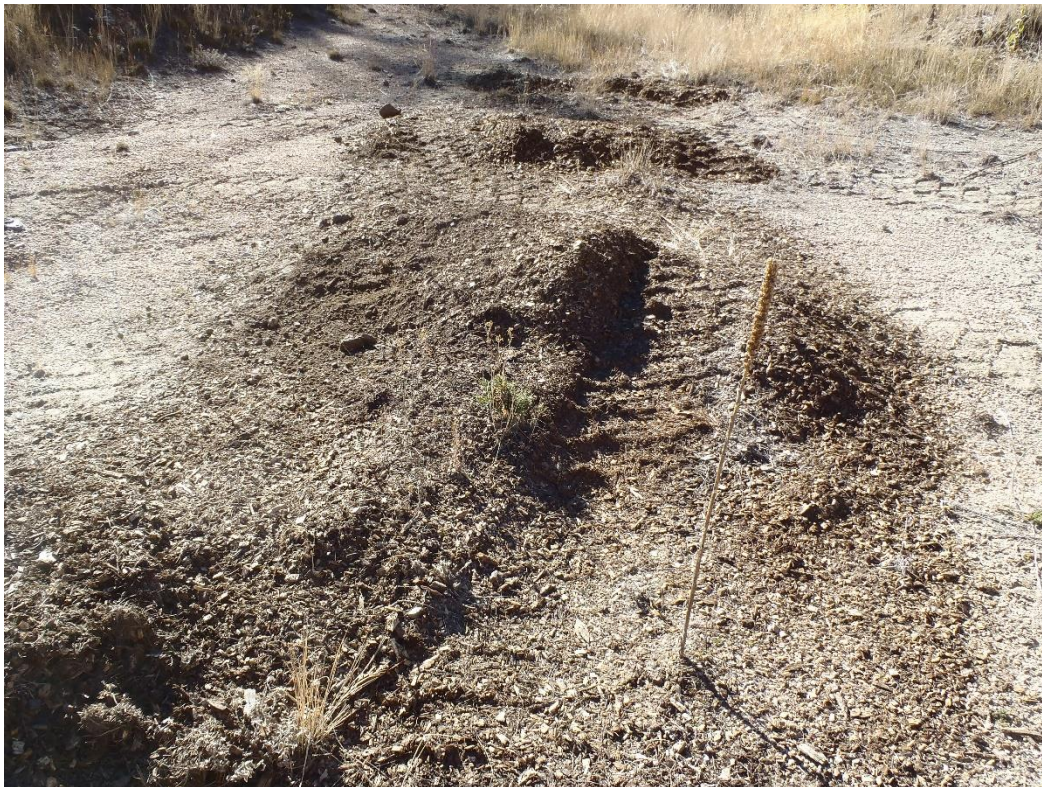
Reclamation: Mr. Jordan stated the City of Colorado Springs brought in mulch to place in the bottom drainage ways of the two pits the day before the inspection (East Pit, see **Photo 1**; West Pit, see **Photo 2**). Reclamation performed to date appears to conform to the approved reclamation plan with slopes no steeper than 2H:1V and small rises and catchments created in the valley bottoms.

Photo 1. Typical mulch/wood chip placement in East Pit.

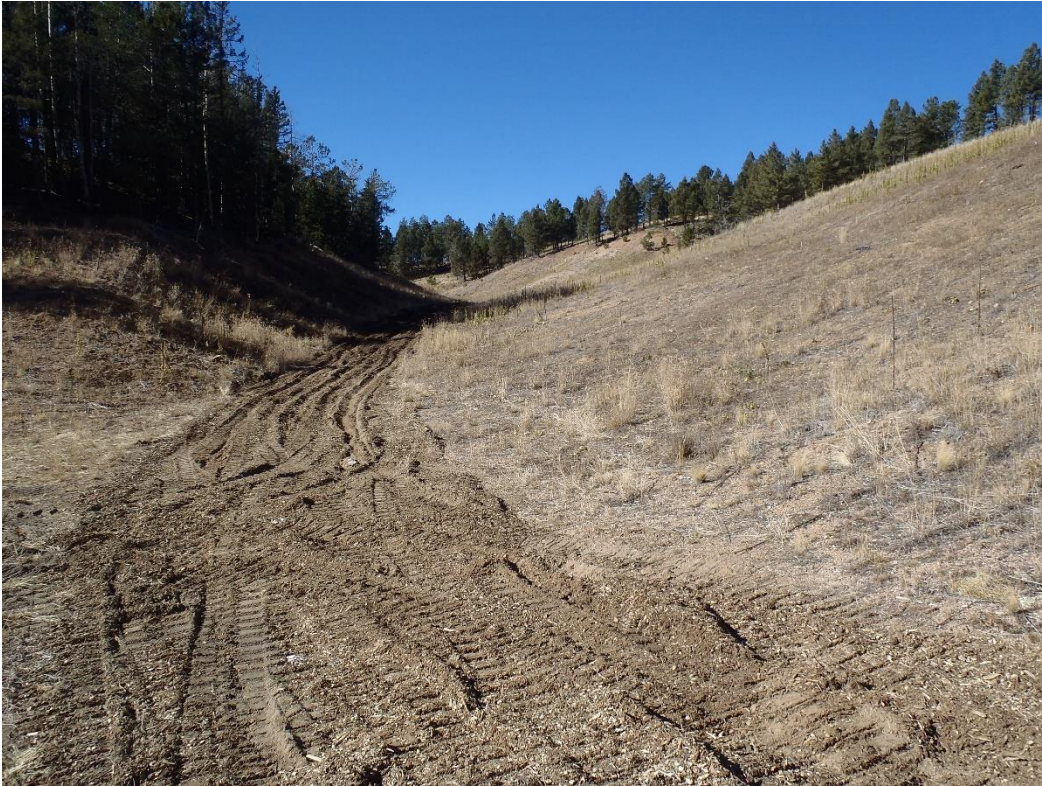
Photo 2. Typical mulch/wood chip placement in West Pit (looking west).

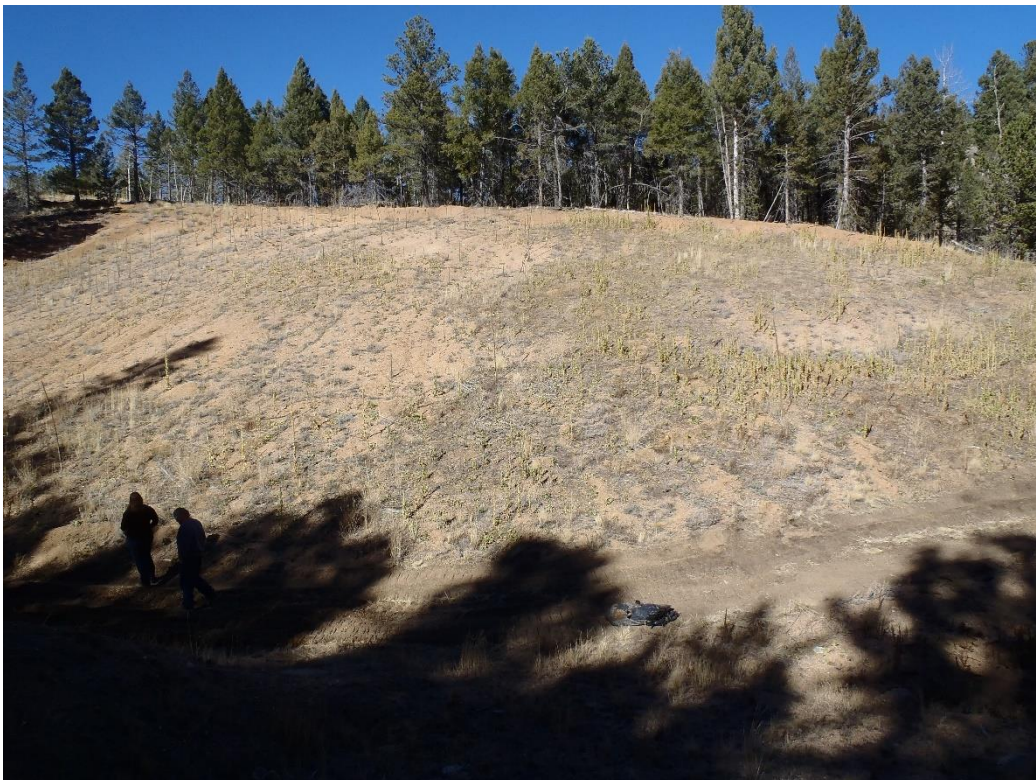
Vegetation appears to be establishing well on the flatter upper slopes and north facing steeper slopes, but not as well on the steeper south facing slopes. The few small patches of Canada Thistle observed during the previous inspection were gone. However, Common Mullein (a Colorado List C noxious weed) were observed in large numbers on the south facing slopes of the West Pit (see **Photo 3**) and to a lesser extent on the south facing slopes of the east/lower end of the east Pit (see **Photo 4**). Mr. Hovermale suggested planting a sterile crop to help control the mullein. The Division's vegetation specialist concurs, suggesting a triticale hybrid be used. As a sterile crop is a single season application and does not contribute to the available seed bank, a revision to the permit is not required for its implementation.

Photo 3. Common Mullein observed on the south facing slopes of West Pit (looking south).

1. The Common Mullein needs to be controlled before becoming a problem. The Division and USFS recommends adding a sterile crop to help control it. Implementing a noxious weed control program, developed with input from the local or county extension office is also recommended.
2. The City should add the vegetative media discussed above and committed to in 1998 (TR-01) on the south facing slopes to aid vegetation establishment.
3. Best management practices (BMPs) should be implemented on the south facing slopes until the vegetation becomes established.
4. The Division will deny the request for release from reclamation liability.

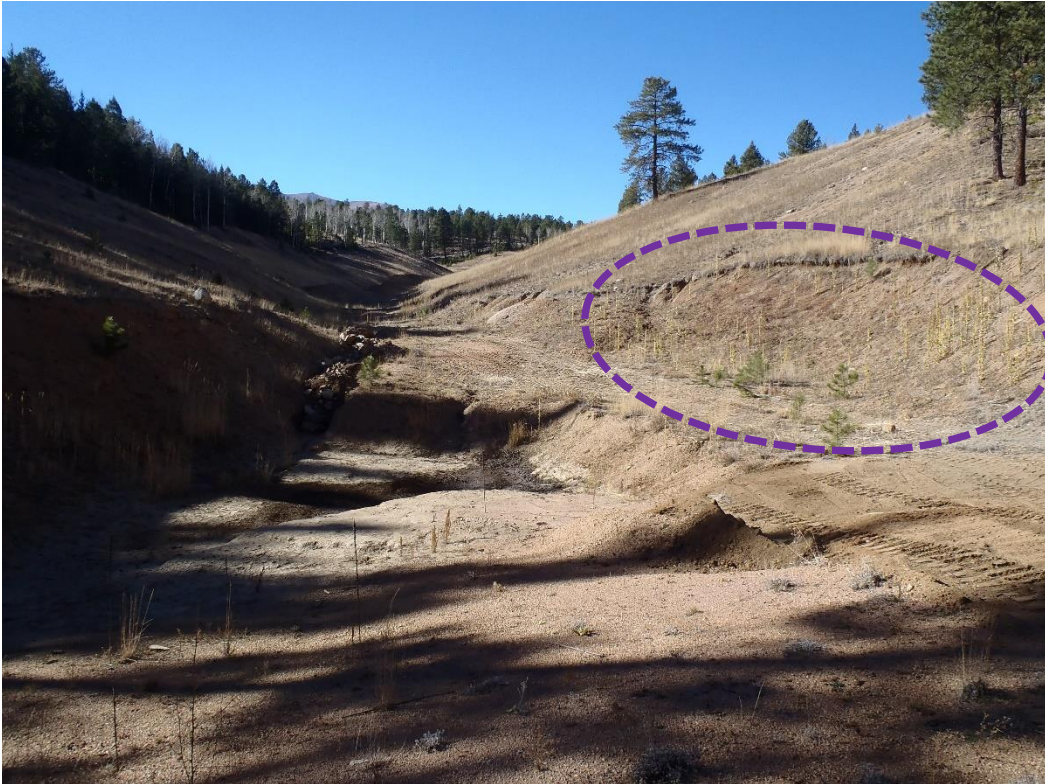
Photo 4. Common Mullein observed on the south facing slopes of East Pit (looking west).

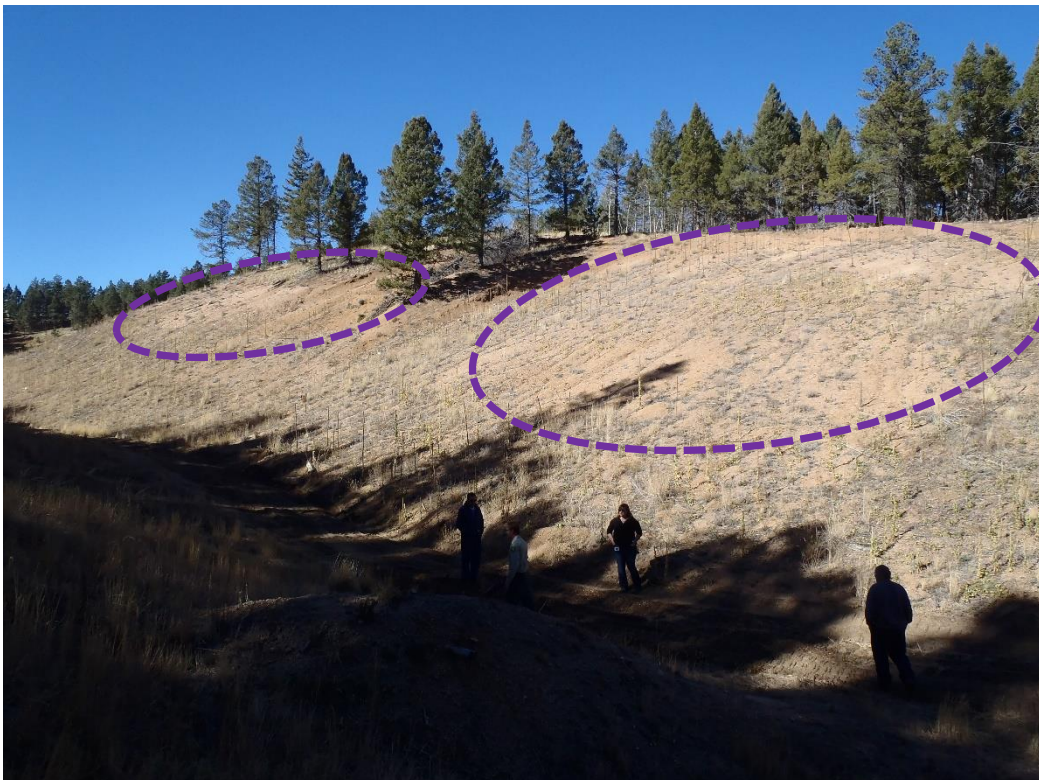
The City representatives indicated the site has been seeded four or five times. As discussed above, the south facing slopes have been unsuccessful in establishing vegetation (see **Photo 5**). While in the field, both this inspector and Mr. Hovermale made it clear that implementing some best management practices (BMPs) such as contour furrowing, straw wattles, and/or placing logs on contour would be helpful in retaining moisture on these slopes and encourage seed germination. **Attachment A** presents some guidelines from the Montana NRCS for "contour log felling". Upon further permit review, TR-01 approved by the Division in 1998, committed to placing a 4 to 6 inch layer of vegetative media comprised of a mixture of stormwater sediment, seasoned horse manure, and tree compost on the slopes for reclamation (see "Records" discussion below). We recommend this approach be implemented as was committed to in 1998. The City may also consider revisiting the seed mix. If it is desired to modify the seed mix again, a new technical revision to the permit is required.

Photo 5. Typical poorly vegetated south facing slopes (West Pit – looking west).
