**MINERALS PROGRAM INSPECTION REPORT****PHONE: (303) 866-3567**

<b>MINE NAME:</b> Cottonwood Pit	<b>MINE/PROSPECTING ID#:</b> M-1988-042	<b>MINERAL:</b> Sand and gravel	<b>COUNTY:</b> Weld
<b>INSPECTION TYPE:</b> Monitoring	<b>INSPECTOR(S):</b> Peter S. Hays	<b>INSP. DATE:</b> August 29, 2016	<b>INSP. TIME:</b> 10:00
<b>OPERATOR:</b> Martin Marietta Materials, Inc.	<b>OPERATOR REPRESENTATIVE:</b>	<b>TYPE OF OPERATION:</b> 112c - Construction Regular Operation

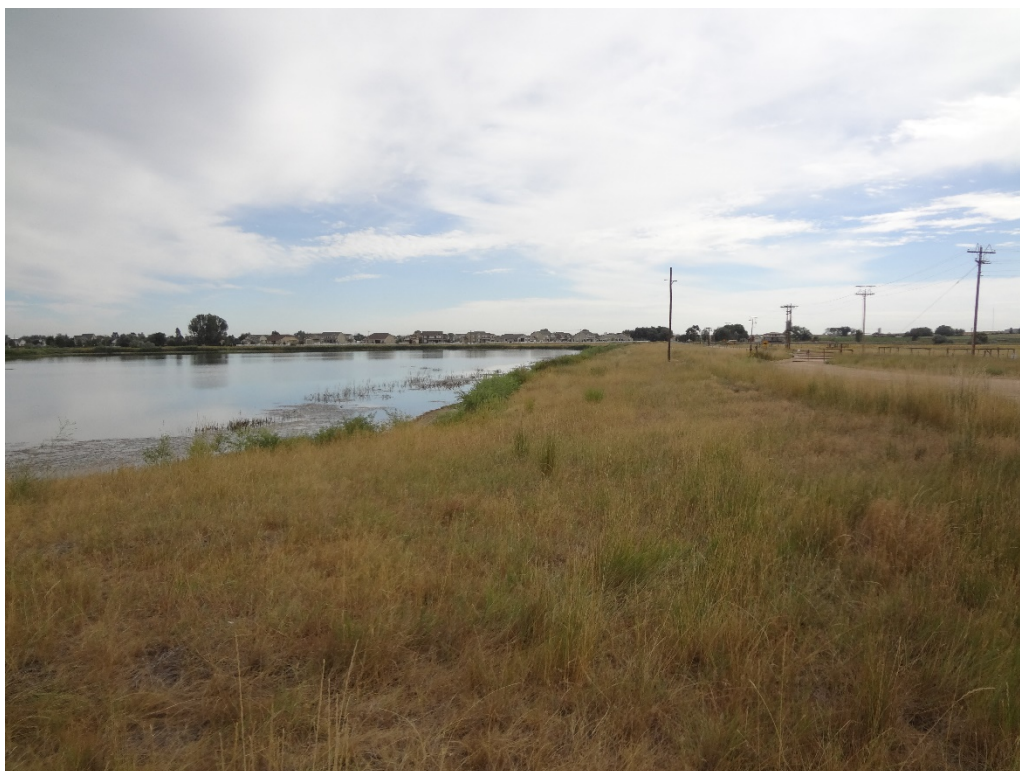
The vegetation in mining area CW3 consisted of reclamation grasses with interspersed cheat grass, willows along the shoreline and patches of kochia along the north side of the lake. Noxious weeds including Russian olive and common teasel were observed along Idaho Creek. The observed noxious weeds are List B species on the Colorado Noxious Weed List. The Operator must implement the approved weed control management plan to stop the continued spread of these species. The vegetation in mine areas CW1 and CW2 consisted of reclamation vegetation with some annual weeds.

View of CW3 south shoreline from SW corner looking east

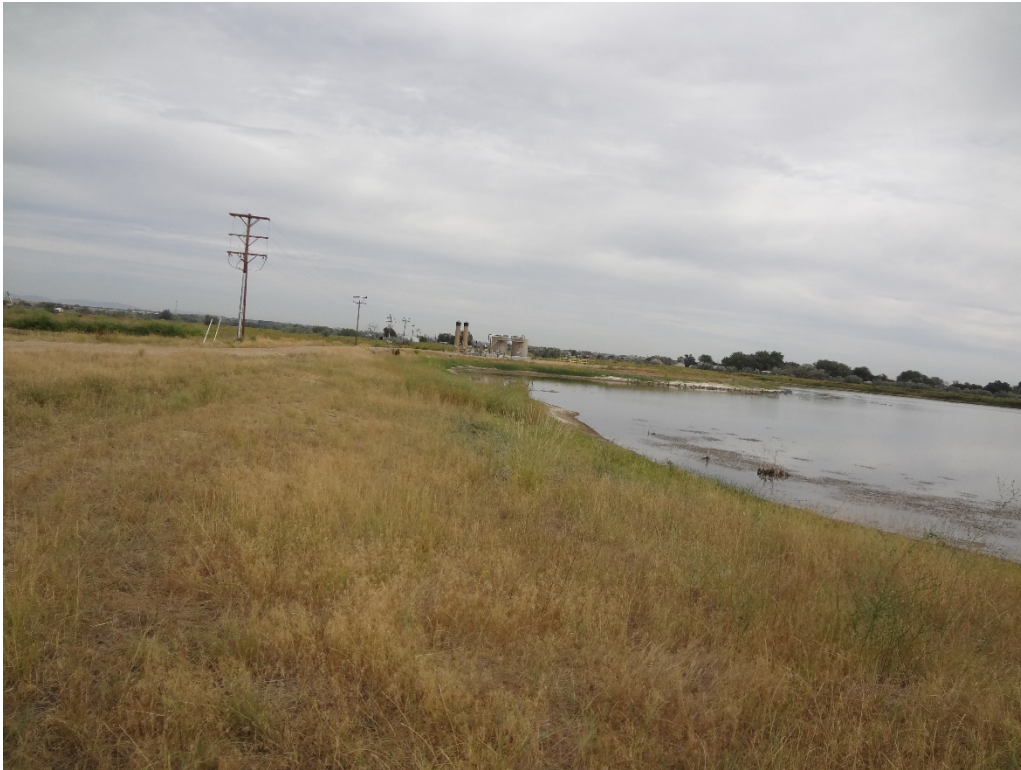
View of CW3 west shoreline from SW corner looking north

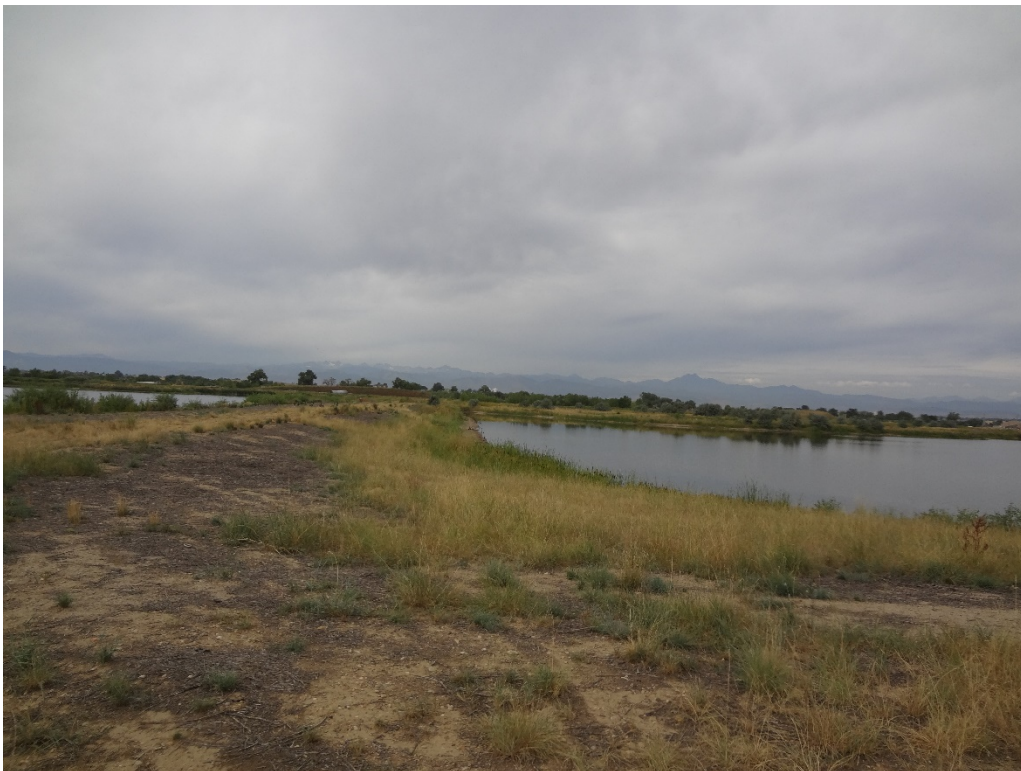
View of CW2 south shoreline from SE corner looking west

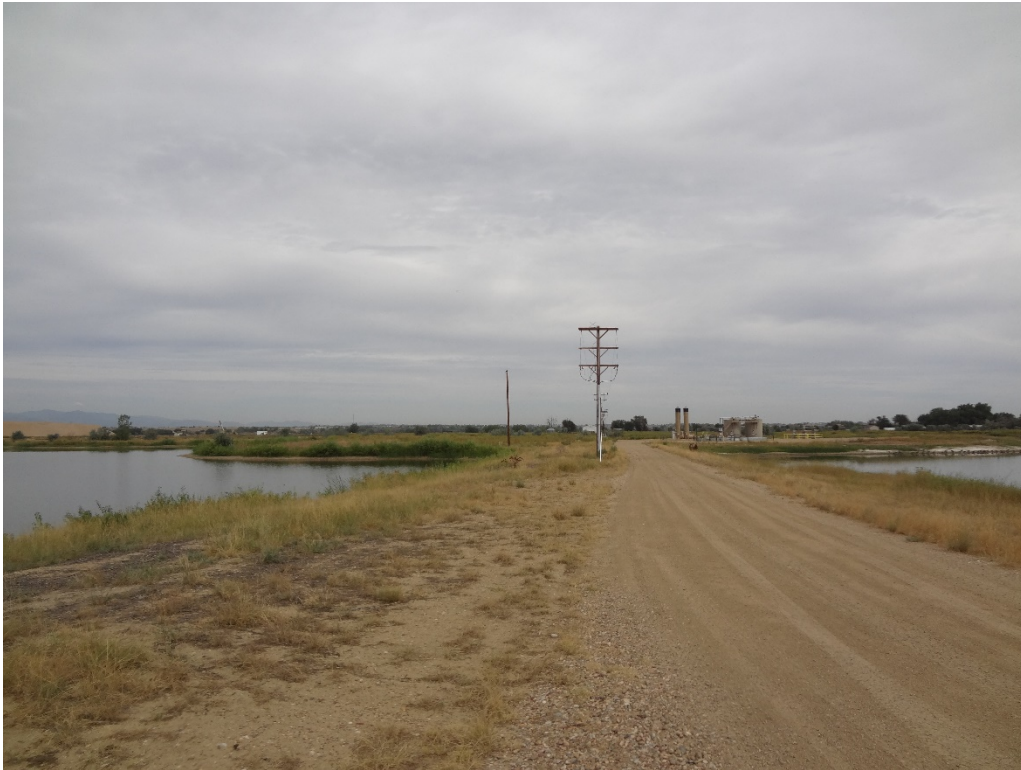
View of CW2 west shoreline from SE corner looking north

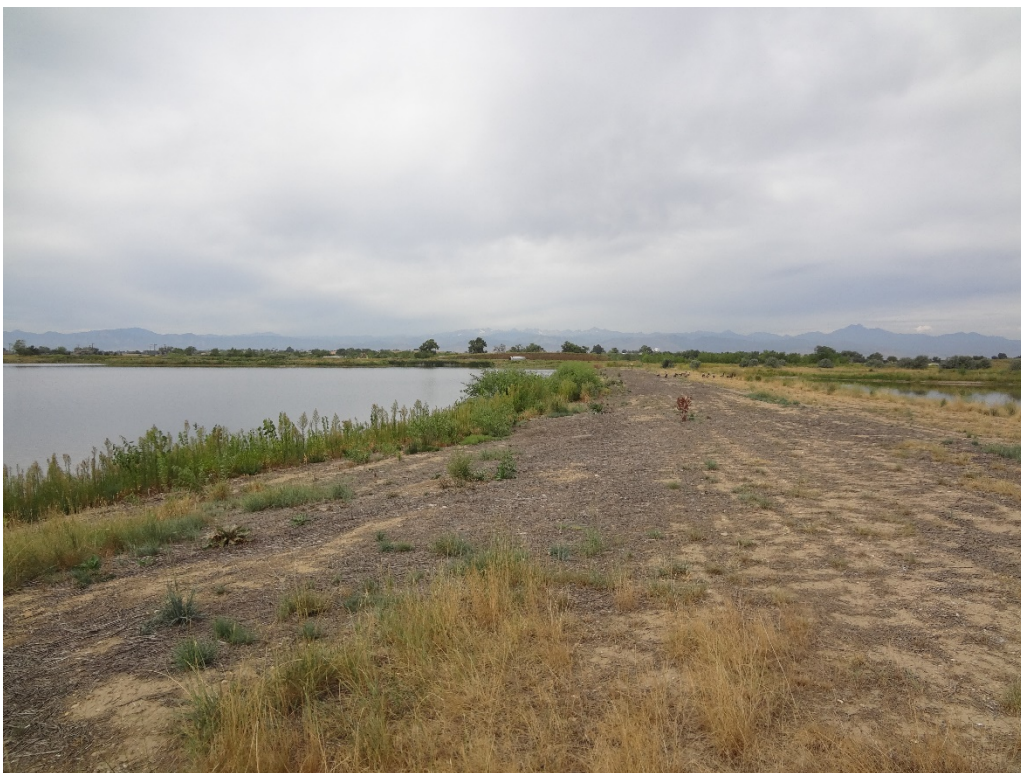
View of CW1 north shoreline from NE corner looking west

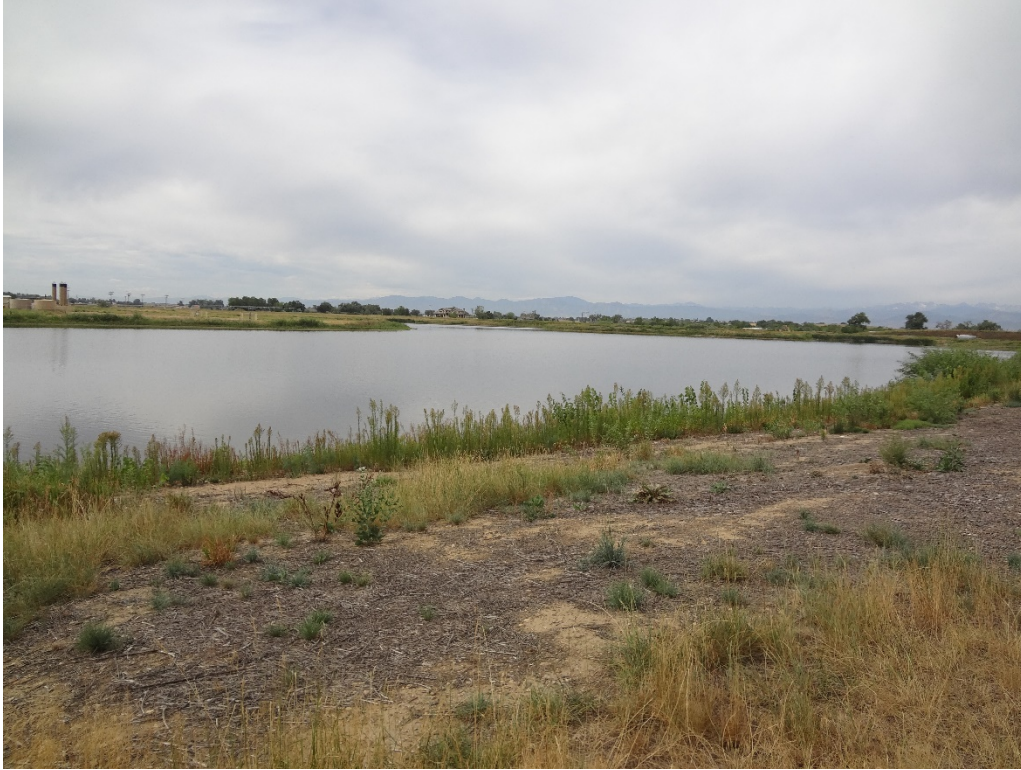
View of CW1 from NE corner looking SW

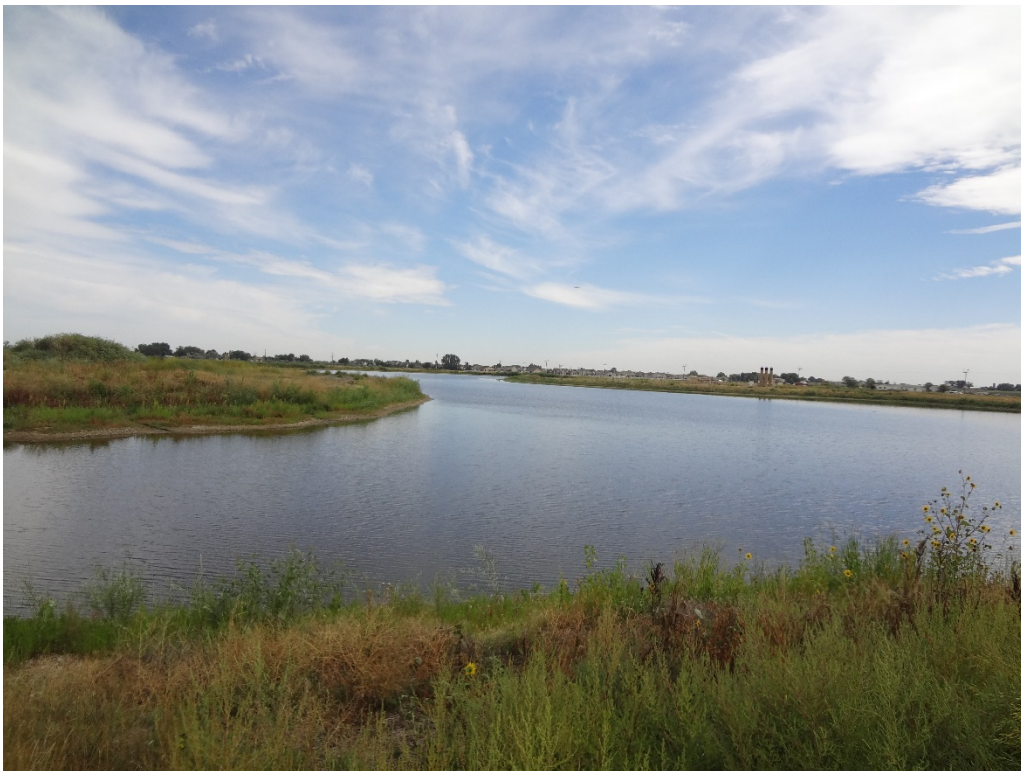
View of CW1 from south shoreline looking north

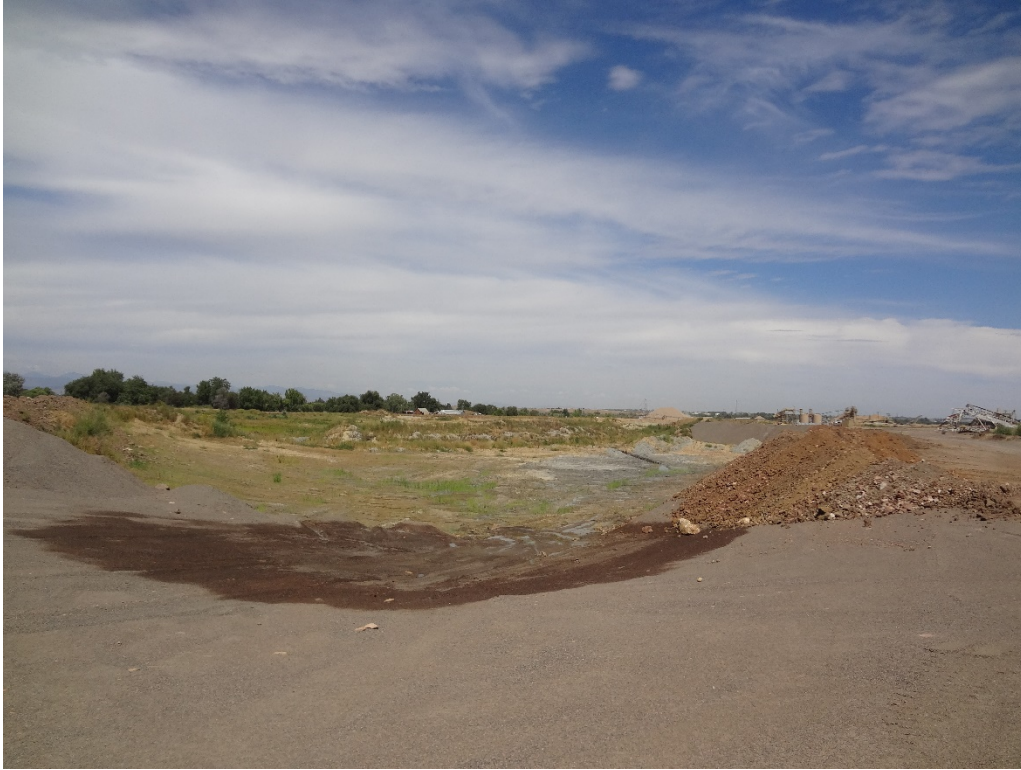
**INSPECTION TOPIC:** Backfilling & Grading**PROBLEM/POSSIBLE VIOLATION:** Problem: The site is utilizing off-site fill without prior approval by the Division per 3.1.5(9) of the Rule.**CORRECTIVE ACTIONS:** The Operator shall provide a notarized affidavit, stating the fill is inert and addressing all requirements pursuant to Rule 3.1.5(9), which describes the intended use of inert/off-site fill by the corrective action date.**CORRECTIVE ACTION DUE DATE:** 2/06/17**OBSERVATIONS**

Mining extraction is progressing to the north in CW5. The Operator stated portions of mining areas CW4 and CW5 would be backfilled with imported fill material to construct the pit slopes, reduce the size of an open water lake and allow the processing plant to be moved to the northeast corner of CW5. The relocation of the plan will allow the resource under the plant can be mined. The source of the imported fill is from the Spec Aggregate site and a site in Boulder owned by the Operator. The imported material will consist mostly of processing waste and will be clean and inert. As cited as a problem, the Operator must comply with the requirements of Rule 3.1.5(9) for the fill material generated outside of the approved permit area for the material placed in mining areas CW4 and CW5 and for all future imported material at the site.

View of SE corner of CW5 looking at slope backfill with imported material

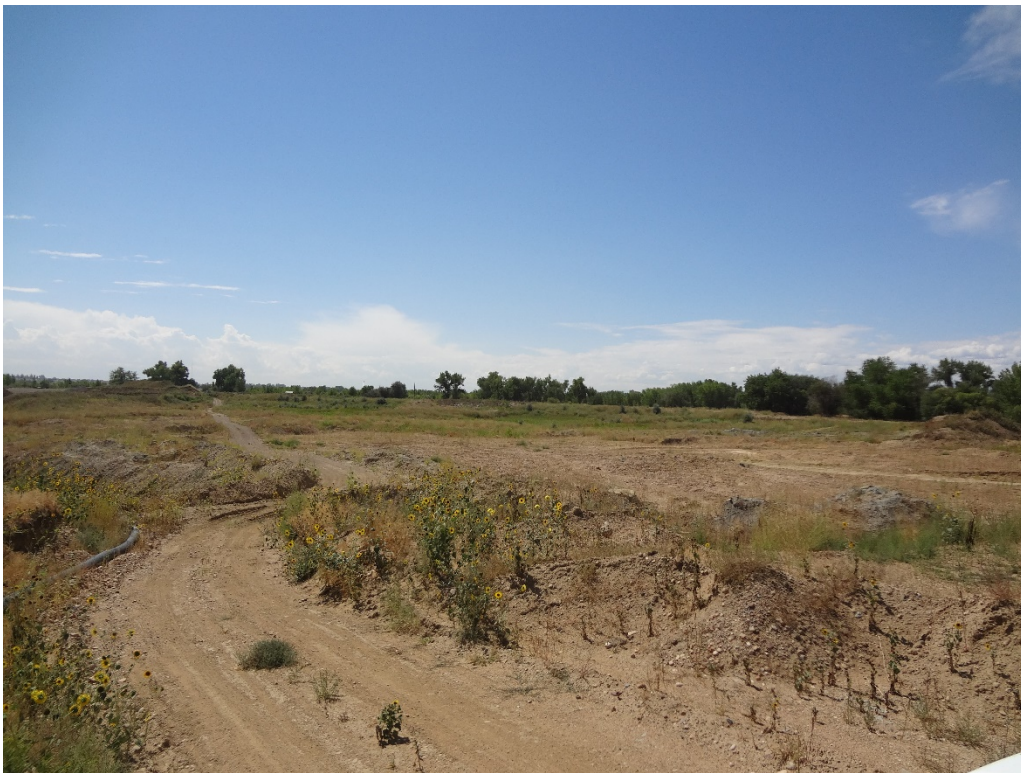
View from NW corner of CW1 looking south

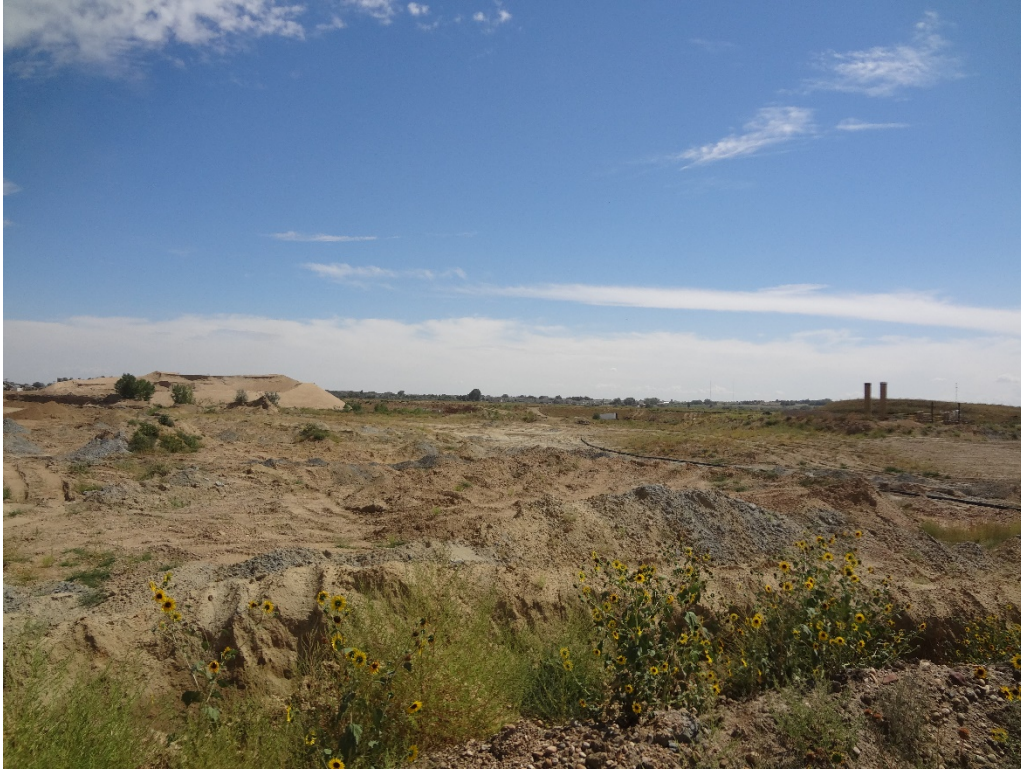
View from NW corner of CW1 looking east

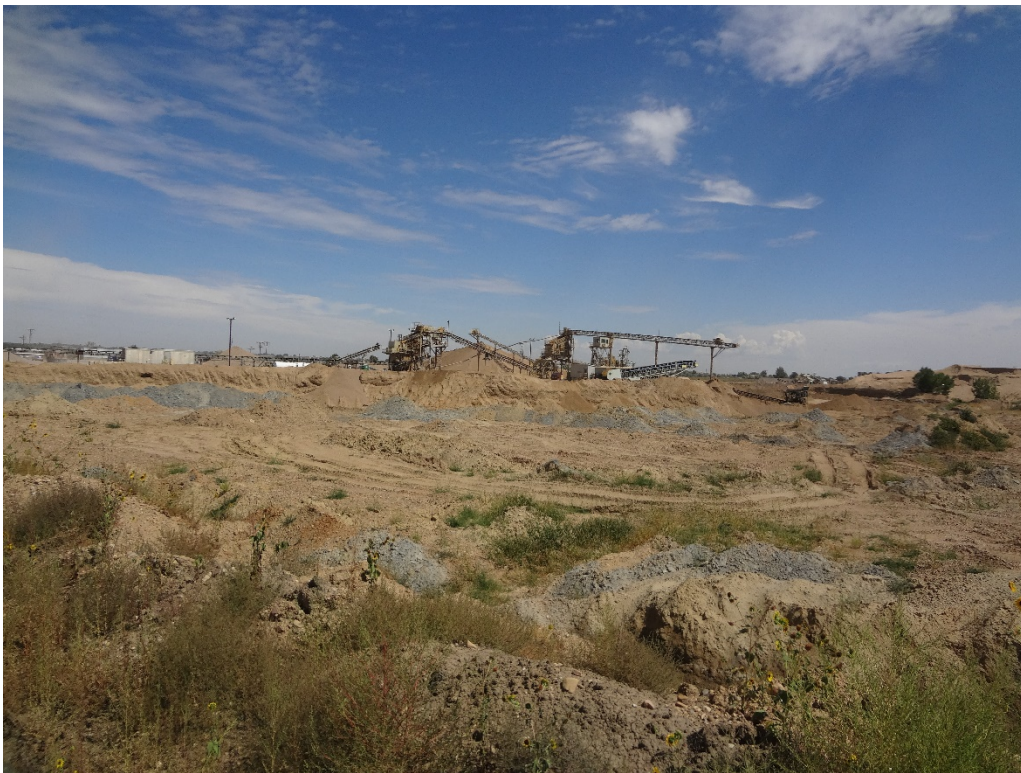
View from NW corner of CW1 looking NE
