**MINERALS PROGRAM INSPECTION REPORT****PHONE: (303) 866-3567**

<b>MINE NAME:</b> Bluestone Pit	<b>MINE/PROSPECTING ID#:</b> M-1991-035	<b>MINERAL:</b> Sand and gravel	<b>COUNTY:</b> Jefferson
<b>INSPECTION TYPE:</b> Surety Release Inspection	<b>INSPECTOR(S):</b> Michael A. Cunningham	<b>INSP. DATE:</b> November 22, 2016	<b>INSP. TIME:</b> 10:00
<b>OPERATOR:</b> Lafarge West, Inc.	<b>OPERATOR REPRESENTATIVE:</b> Christine Felz	<b>TYPE OF OPERATION:</b> 112c - Construction Regular Operation

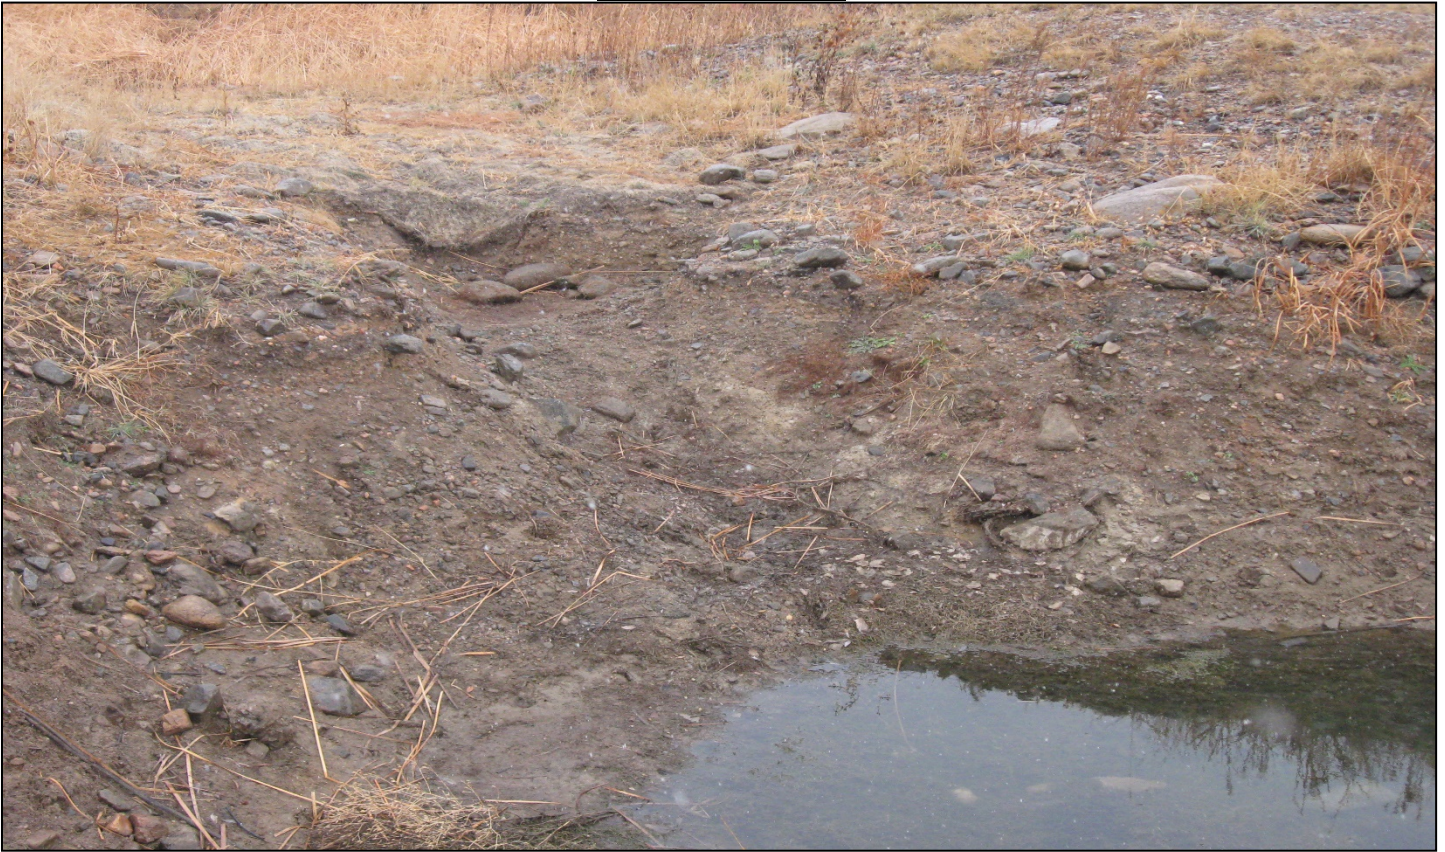
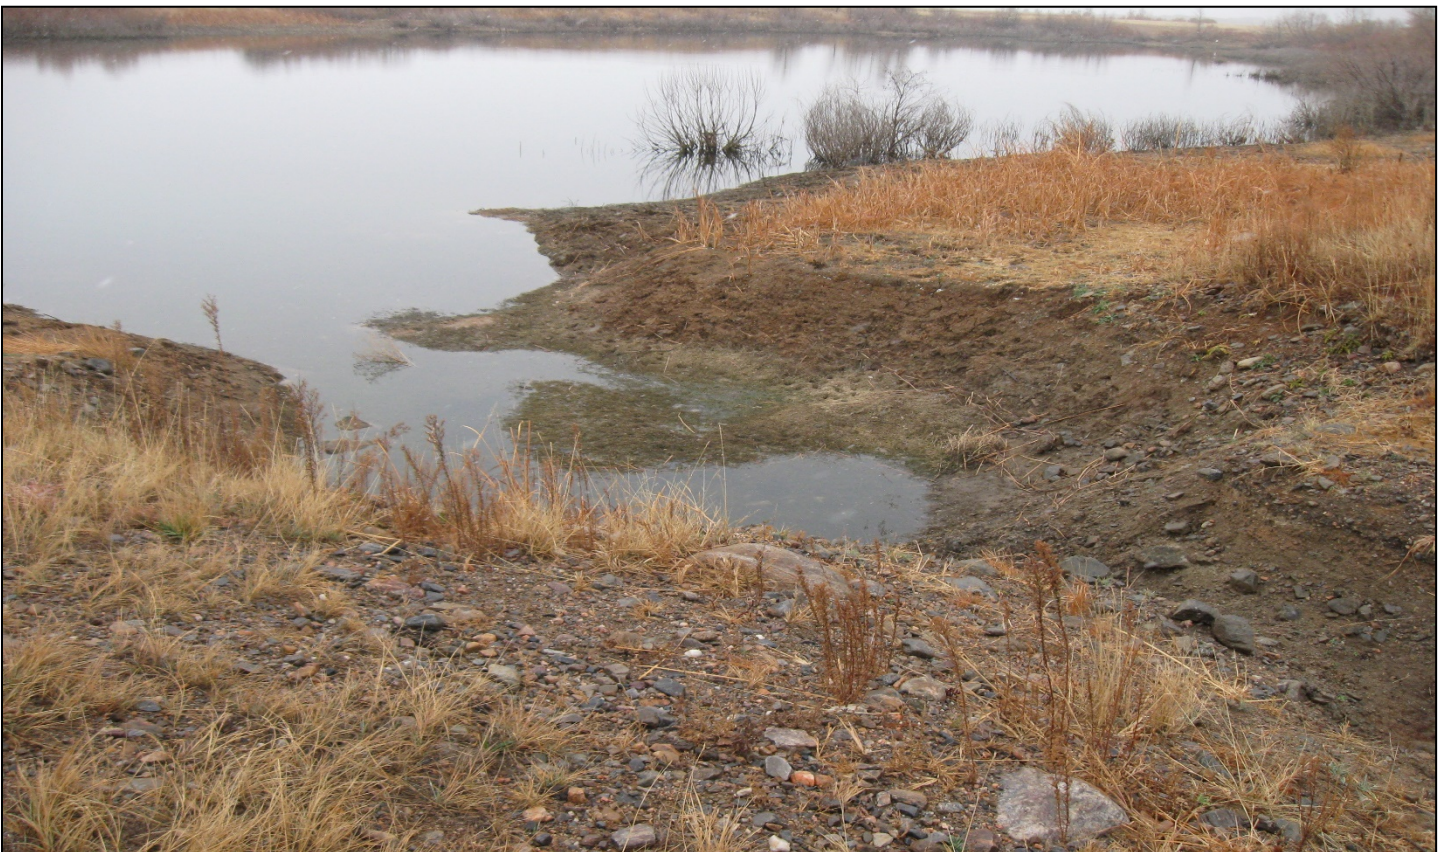
The inspection commenced at the Groundwater Pond located in the northwest corner of the permit area. The Groundwater Pond was present before the permit was issued and the groundwater was exposed prior to January 1, 1981. Therefore, the evaporative depletions do not need to be replaced through an augmentation plan or temporary substitute water supply plan. The comments received from the DOE were in regard to a breach of the Groundwater Pond which occurred during the September 2013 flood. The breach released water and debris onto the adjacent property where the National Wind Technology Center is located. The Operator submitted Technical Revision No. 4 on August 12, 2014 to address the off-site breach. The Operator constructed a spillway on the southeast corner of the Groundwater Pond to allow flood waters to pass through the pond and enter the natural drainage system. Vegetation within the spillway has not fully established. In addition, the Division observed erosion at the inlet of the Groundwater Pond which is located on the northwest corner. The headcutting observed in this area is currently being stopped by erosion matting and established vegetation. However, if the erosion to the inlet is not repaired, additional headcutting of the channel could move outside of the permit area.

The areas of erosion observed at the Groundwater Pond, the Kettle Pond and Breach No. 2 have been cited as a problem and will require corrective action by the Operator. Please see the first page of this report for additional information.

1. Erosion at inlet of Groundwater Pond.

2. Erosion at inlet of Groundwater Pond.

**INSPECTION TOPIC:** Hydrologic Balance**PROBLEM/POSSIBLE VIOLATION:** Problem: Erosion gullies and ruts were observed on-site. This is a problem at this time for failure to protect the affected land from erosion pursuant to C.R.S. 34-32.5-116 (4) (j).**CORRECTIVE ACTIONS:** The operator shall provide photo documentation to the Division verifying erosion gullies and ruts have been repaired, and that the site has have been reconstructed and stabilized to prevent erosion damage by the corrective action date.**CORRECTIVE ACTION DUE DATE:** 2/06/17**INSPECTION TOPIC:** Reclamation Success**PROBLEM/POSSIBLE VIOLATION:** Problem: Trash and refuse was noticed on the site. This is a problem at this time for failure to dispose of refuse in a manner that controls unsightliness or deleterious effects of such refuse pursuant to C.R.S. 34-32.5-116(4)(e).**CORRECTIVE ACTIONS:** The operator shall submit a written notice to the Division with photo documentation, that the trash has been removed from the site by the corrective action date.**CORRECTIVE ACTION DUE DATE:** 2/06/17

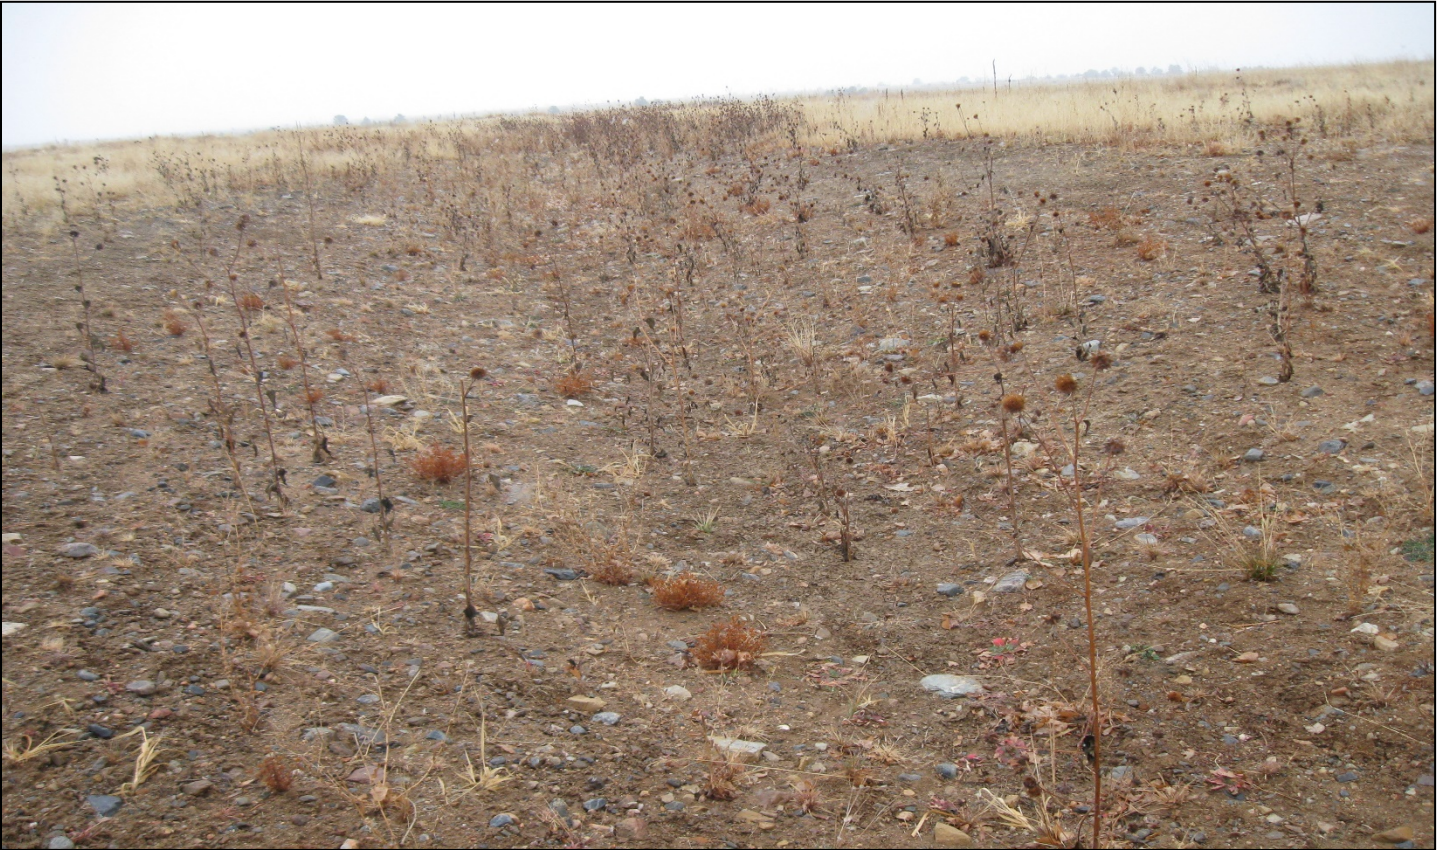
3. Groundwater Pond spillway, photo taken facing east.

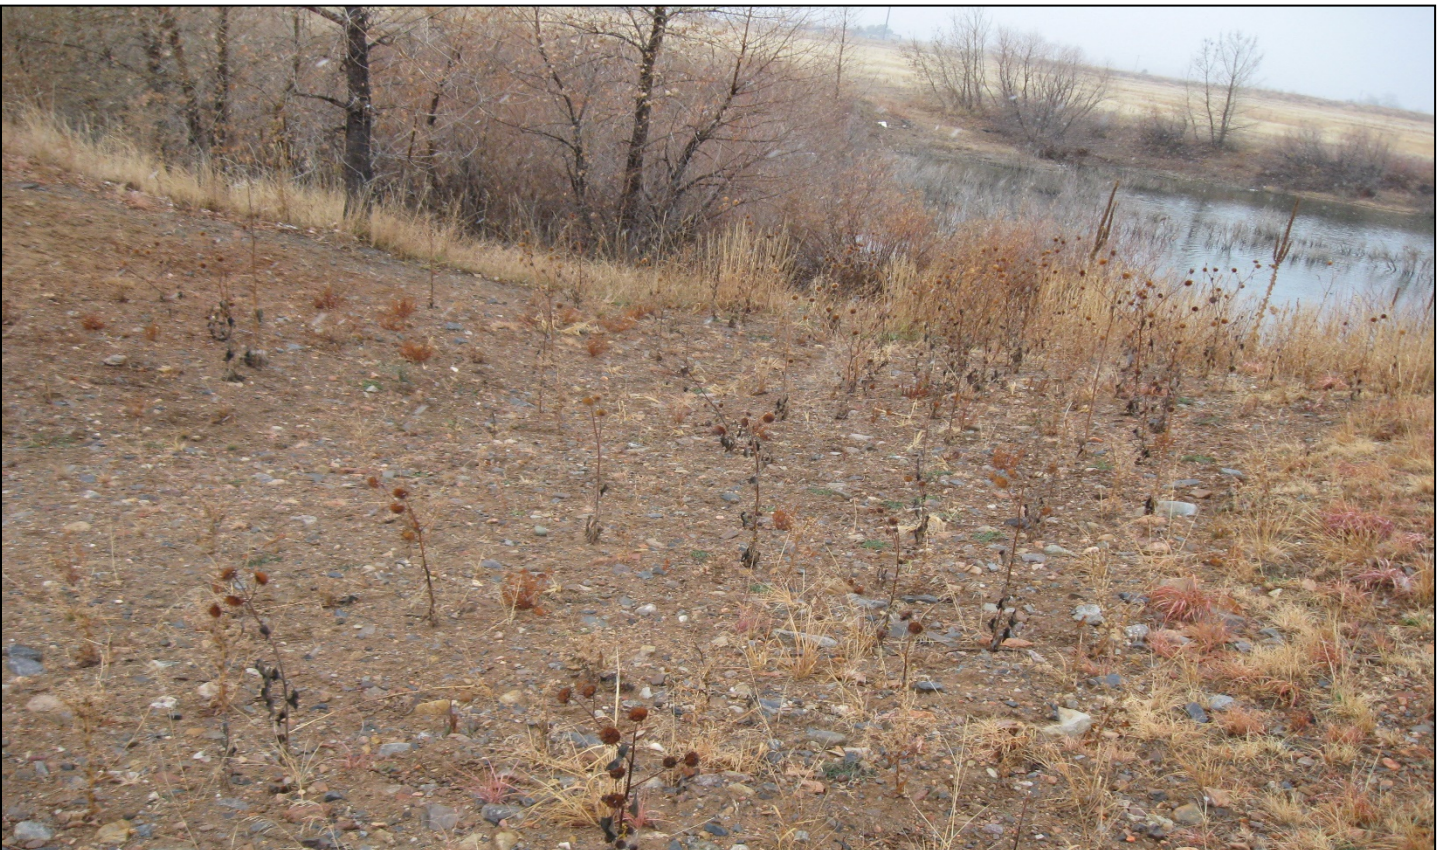
4. Groundwater Pond spillway, photo taken facing west.

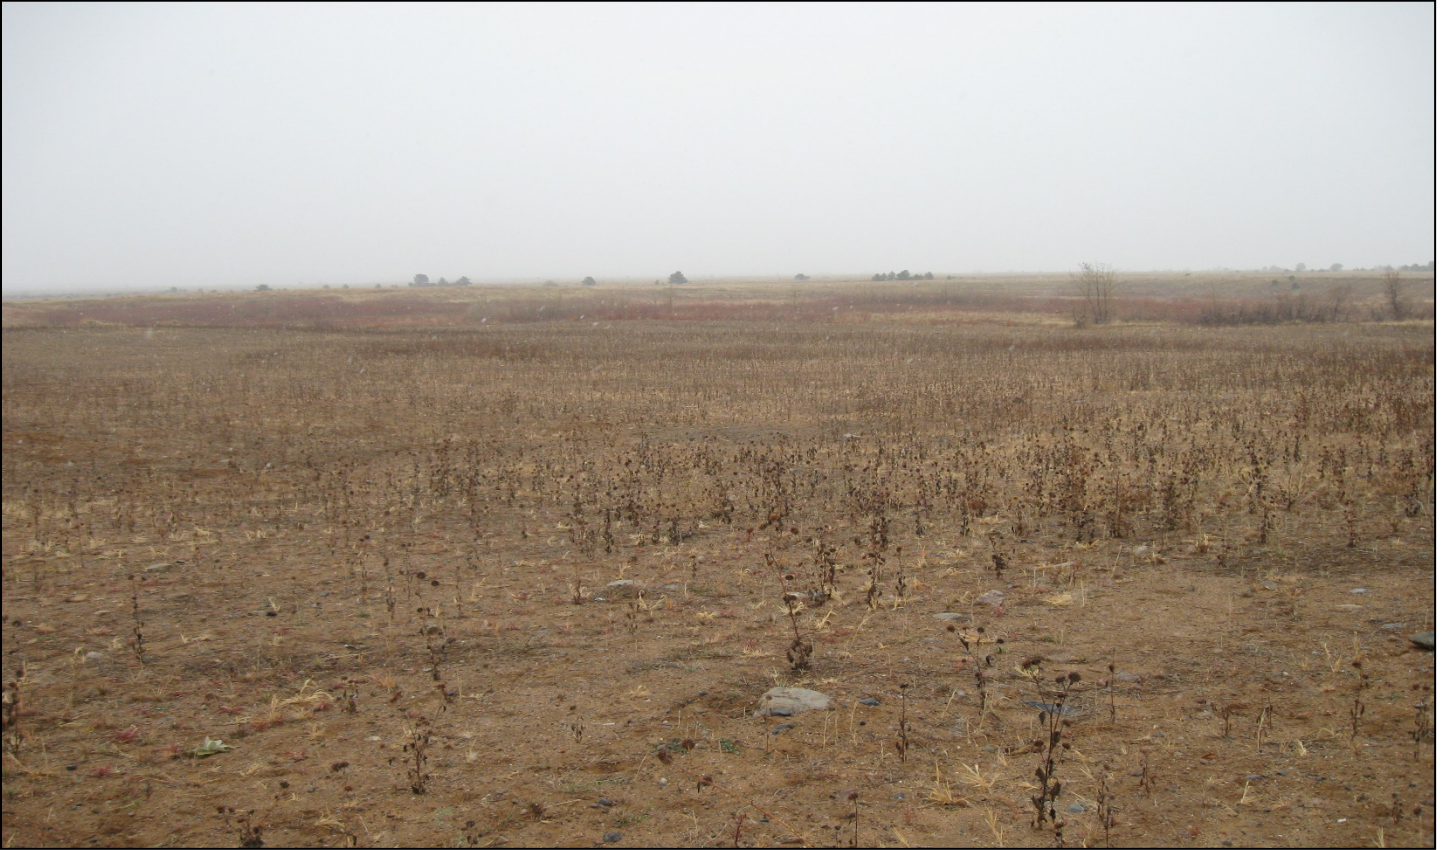
During the site visit the vegetation was inspected to ensure the reclaimed areas met the reclamation performance standards outlined in Rule 3.1.10(1). The Division found vegetation was well established throughout the majority of the site. However, several areas did not have an adequate cover of vegetation capable of self-regeneration. In addition to the areas described under the Hydrologic Balance section of this report, the Division found the main site access road adjacent to the Groundwater Pond was not adequately vegetated. Also, a former access road which runs parallel to the western permit boundary lacked adequate vegetation. These areas will require additional time for vegetation to establish or they may need to be reseeded.

5. Recently graded area with inadequate vegetative cover.

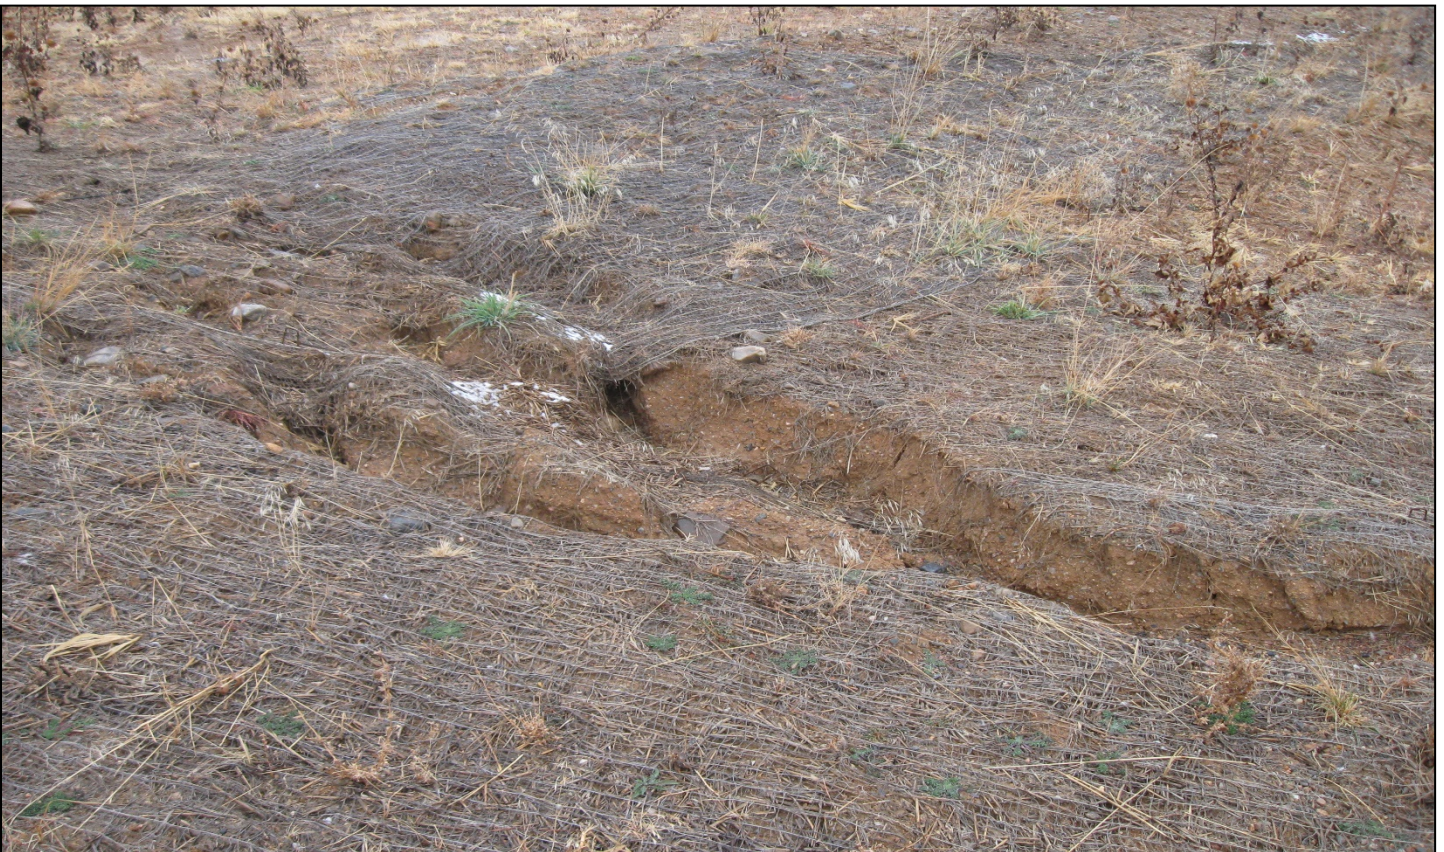
The Division inspected the Kettle Pond located approximately 1,000 ft. southeast of the groundwater pond. During previous inspections, the Division has observed standing water in the Kettle Pond. Following the last inspection conducted on October 26, 2015, the Operator performed grading in this area to eliminate exposed groundwater. The Division did not observe any water in this area during the inspection. However, the vegetation has not established in the re-graded areas and minor rilling was observed.

6. Rilling near the Kettle Pond.

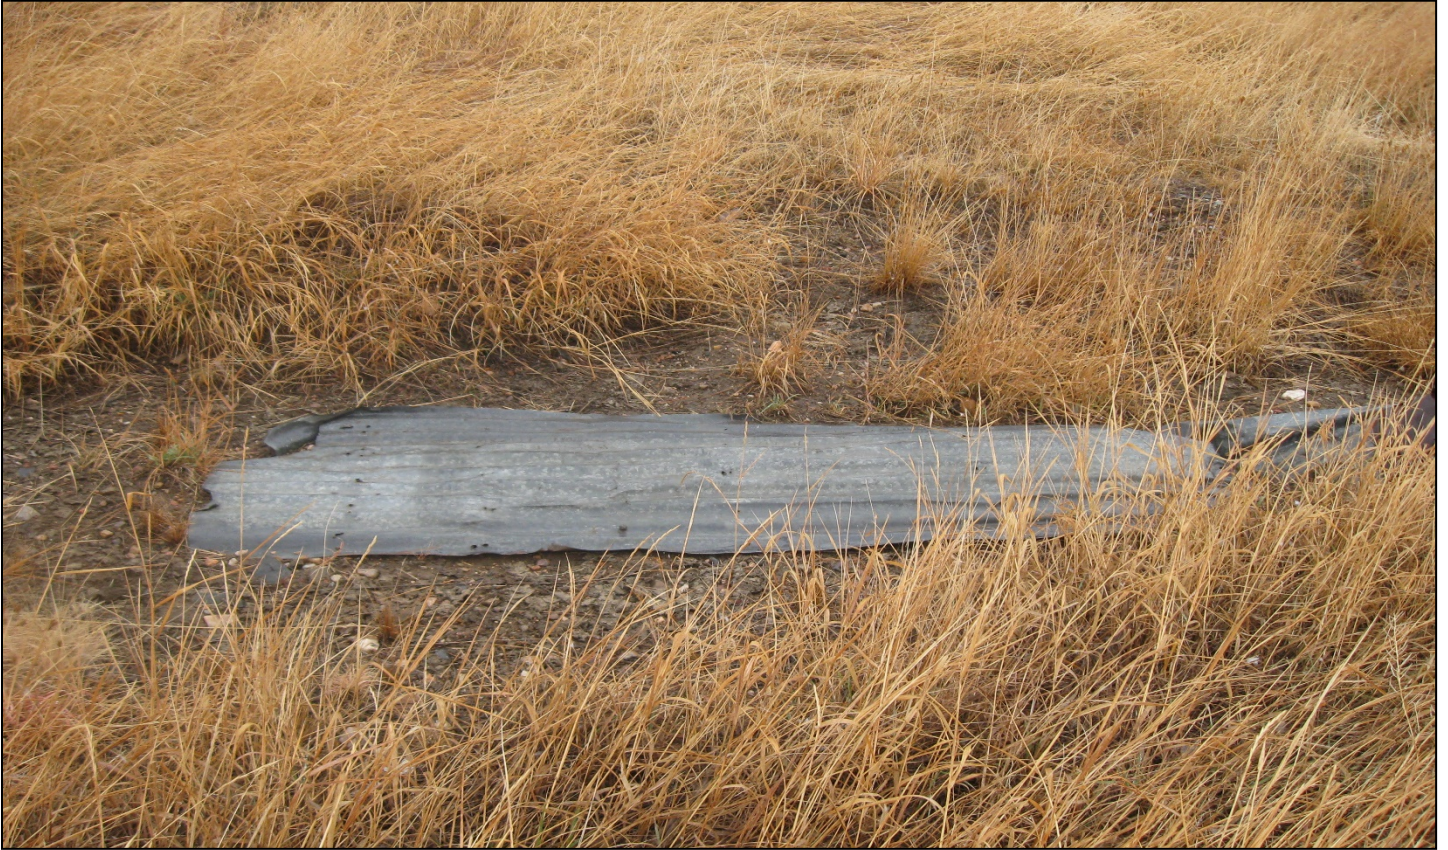
The Division observed numerous pieces of sheet metal near the western permit boundary. The presence of refuse within the site has been cited as a problem. Please see the first page of this report for additional information.

7. Sheet metal near western permit boundary.

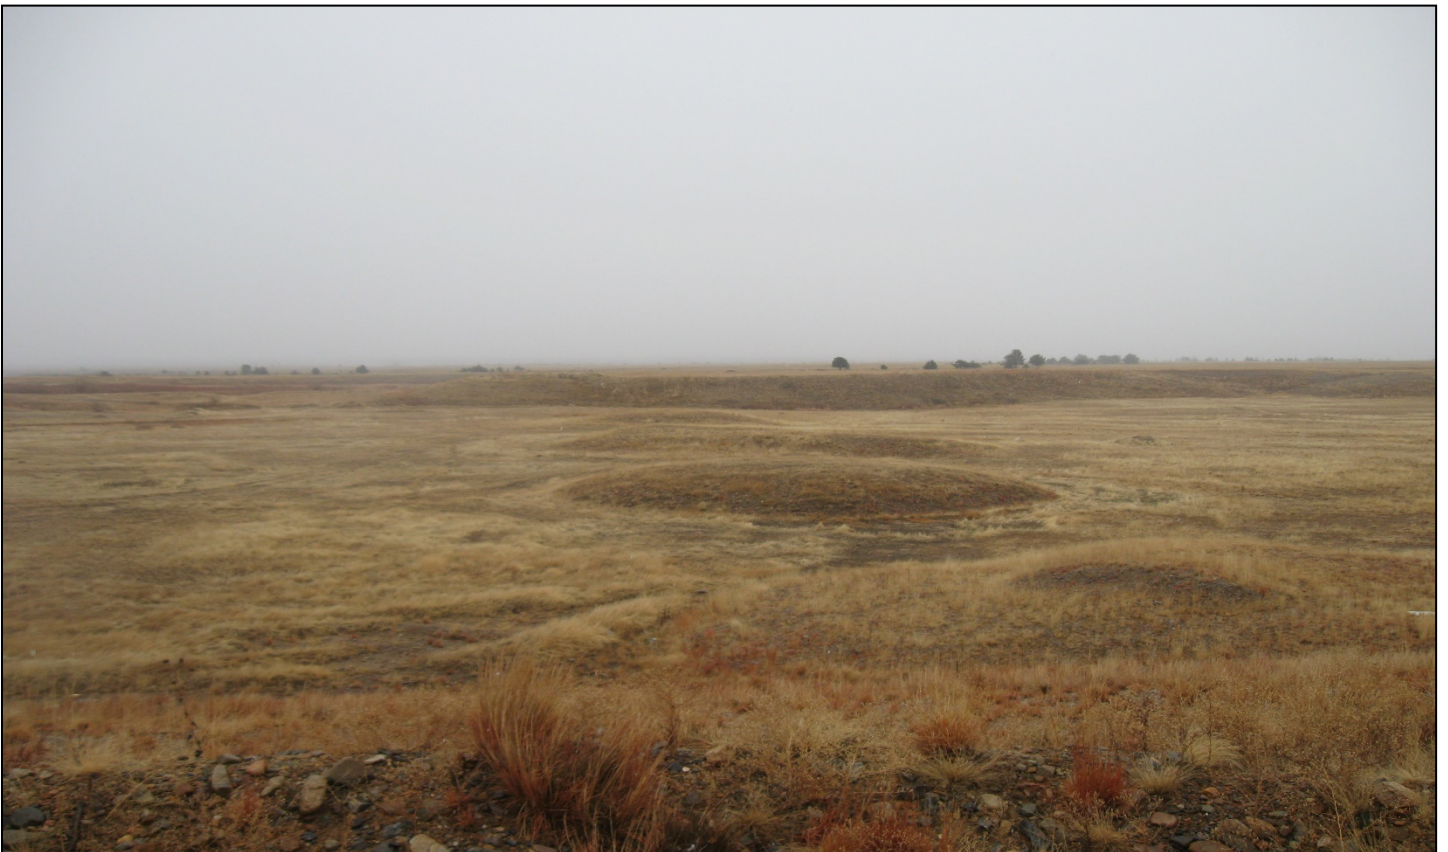
8. Overview of reclaimed site.

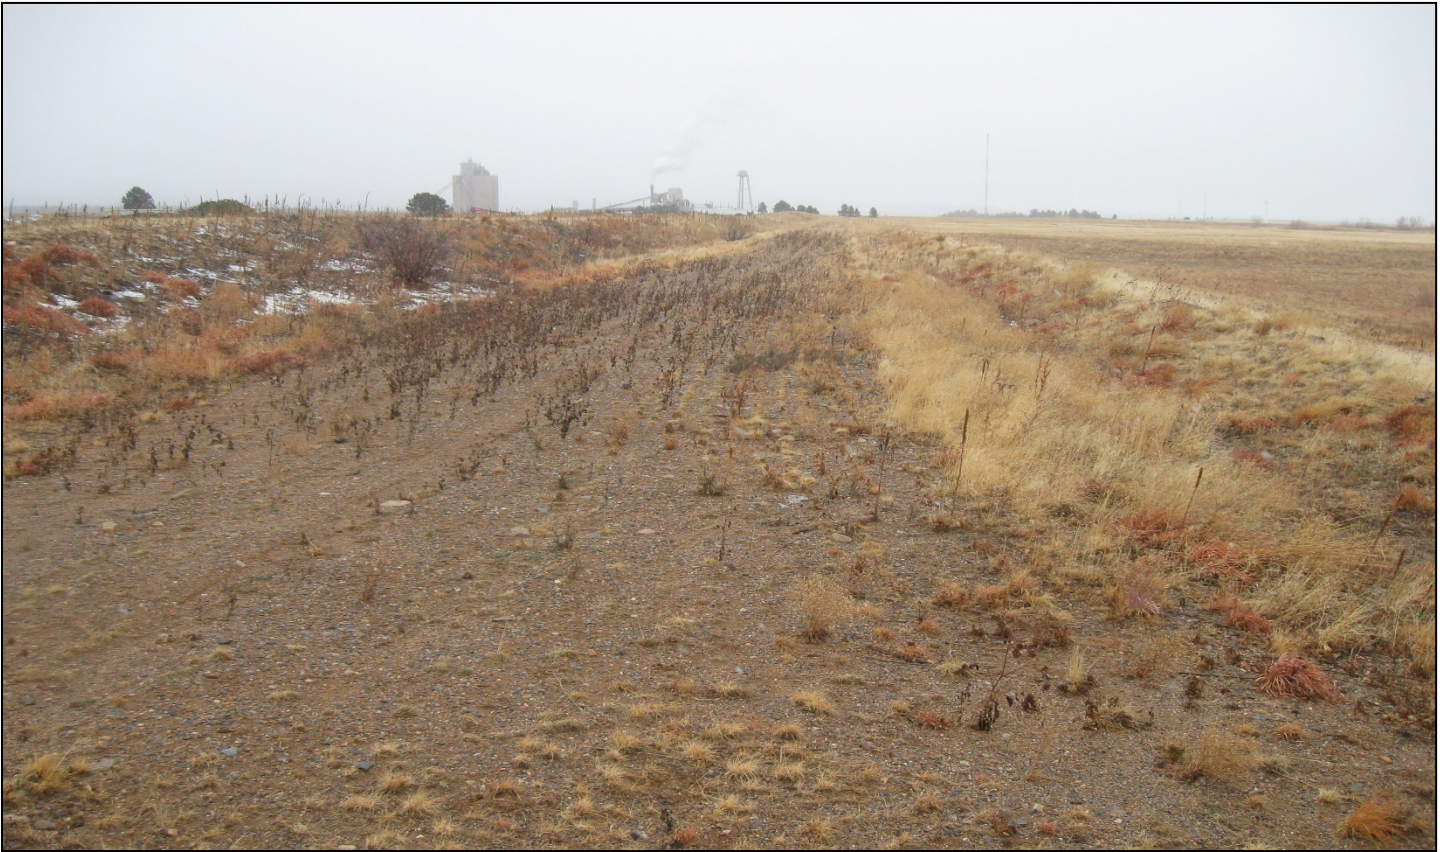
9. Access road along the western permit boundary.

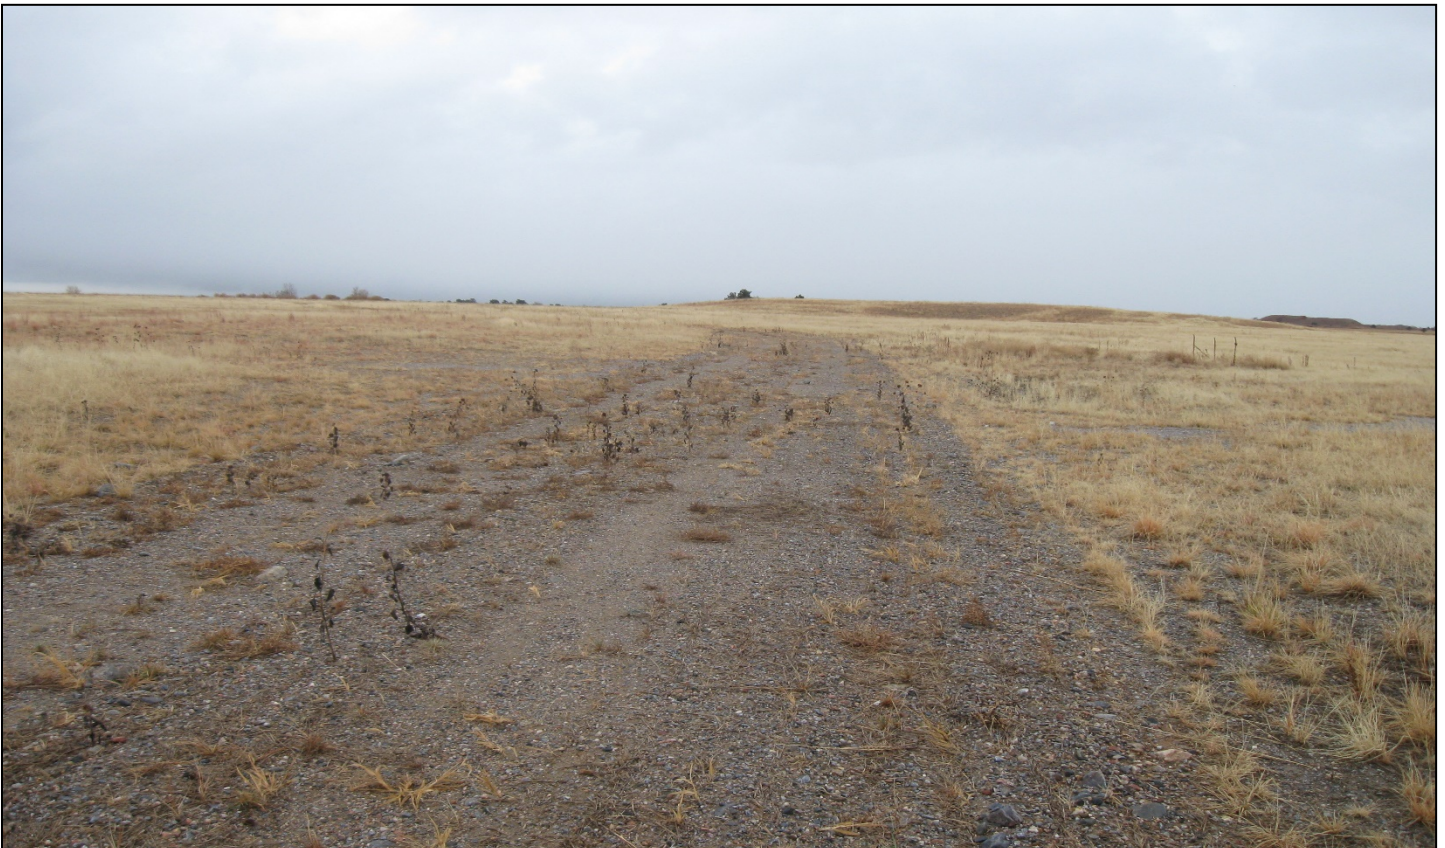
10. Main access road.
