**COLORADO**Division of Reclamation,
Mining and Safety

MINERALS PROGRAM INSPECTION REPORT**PHONE: (303) 866-3567**

MINE NAME: Loloff Mine	MINE/PROSPECTING ID#: M-1985-112	MINERAL: Sand and gravel	COUNTY: Weld
INSPECTION TYPE: Monitoring	INSPECTOR(S): Peter S. Hays	INSP. DATE: December 6, 2016	INSP. TIME: 11:15
OPERATOR: Loloff Construction, Inc.	OPERATOR REPRESENTATIVE: Kelly Hodge	TYPE OF OPERATION: 112c - Construction Regular Operation

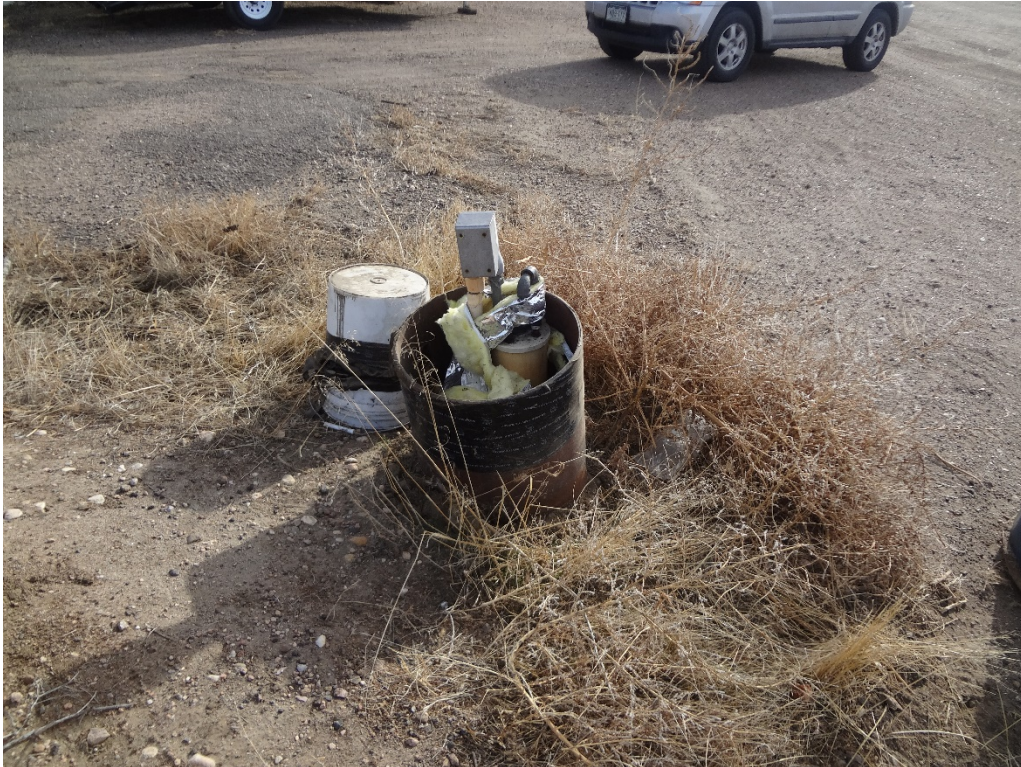
The Division met with Mr. Tyrrell on his property prior to inspecting the Loloff Mine site. The complaint letter states very little water has been in the well for the last three (3) weeks. The Tyrrell well is registered with the Office of the State Engineer under permit # 134824-A. The well was constructed in 1983 to a total depth of thirty five (35) feet below grade. Shale bedrock was encountered at twenty nine and a half (29.5) feet below grade. The well is approved for domestic use at a rate of 15 GPM.

The upper well casing, wellhead and underground vault containing a surge tank were observed during the inspection. The groundwater and pump elevations could not be determined during the inspection, due to the lack of an access port in the well. Mr. Tyrrell stated the well had been performing better though the summer, but lost water again three (3) weeks ago.

Based on the GPS data and calculations from Google Earth Pro, the Division estimates the Tyrrell well is located 900 feet (275 meters) south of the southern Loloff Mine boundary. The pit radius of Loloff Mine was estimated at 270 feet (82 meters). Using the USGS Analytical and Numerical Simulation of Steady-State Hydrologic Effects of Mining Aggregate in Hypothetical Sand-and-Gravel and Fractured Crystalline-Rock Aquifers, Report 02-4267, the Division calculated a drawdown of 7.5 feet (2.3 meters) for the Tyrrell well due to the dewatering of the Loloff Mine.

The Division believes sufficient evidence exists to support the Tyrrell complaint that the current dewatering activity at the Loloff Mine is affecting the groundwater well located at 417 East 8th Street, Greeley, CO 80631. This is a problem related to Rule 3.1.6 of the Mineral Rules and Regulations of the Colorado Mined Land Reclamation Board for the Extraction of Construction Materials and CRS 34-32.5-116(4)(h) of the Colorado Land Reclamation Act for the Extraction of Construction Materials.

Tyrrell well

As cited as a problem, Loloff Construction, Inc. must implement the approved mitigation plan for the site and work with Mr. Tyrrell to investigate and rehabilitate the well on this property within 10 days of the mailing date of this inspection report. Failure to comply with the corrective action may result in the problem escalating to possible violation and an enforcement hearing being scheduled in front of the Mined Land Reclamation Board.

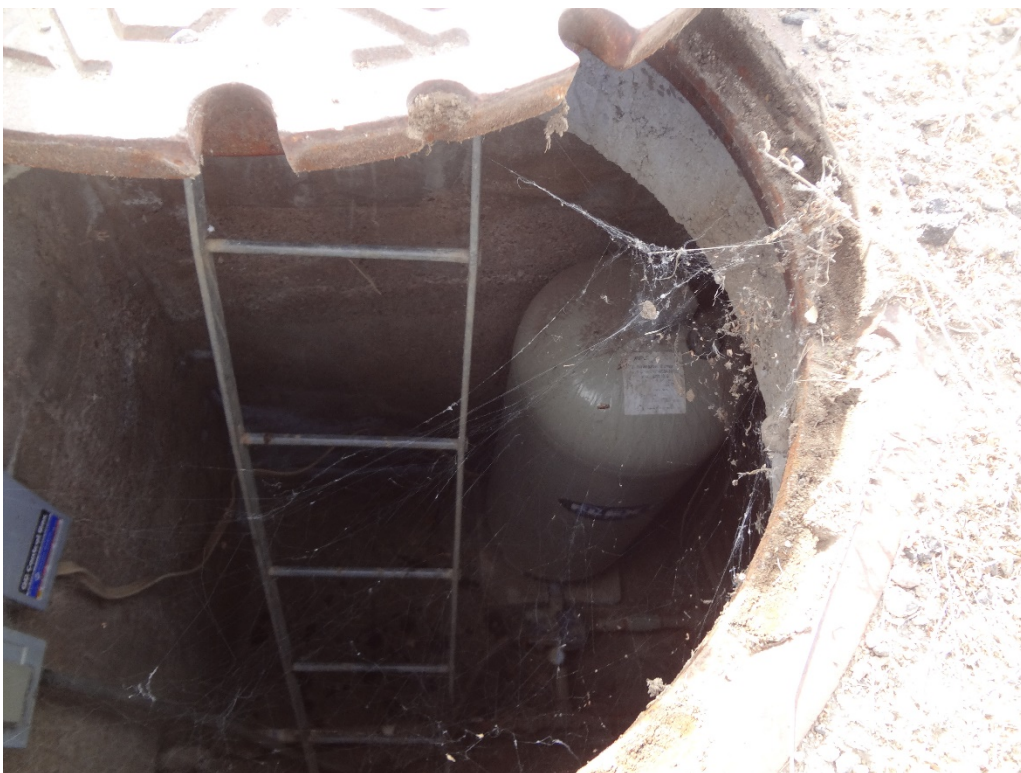
Tyrrell well vault and surge tank

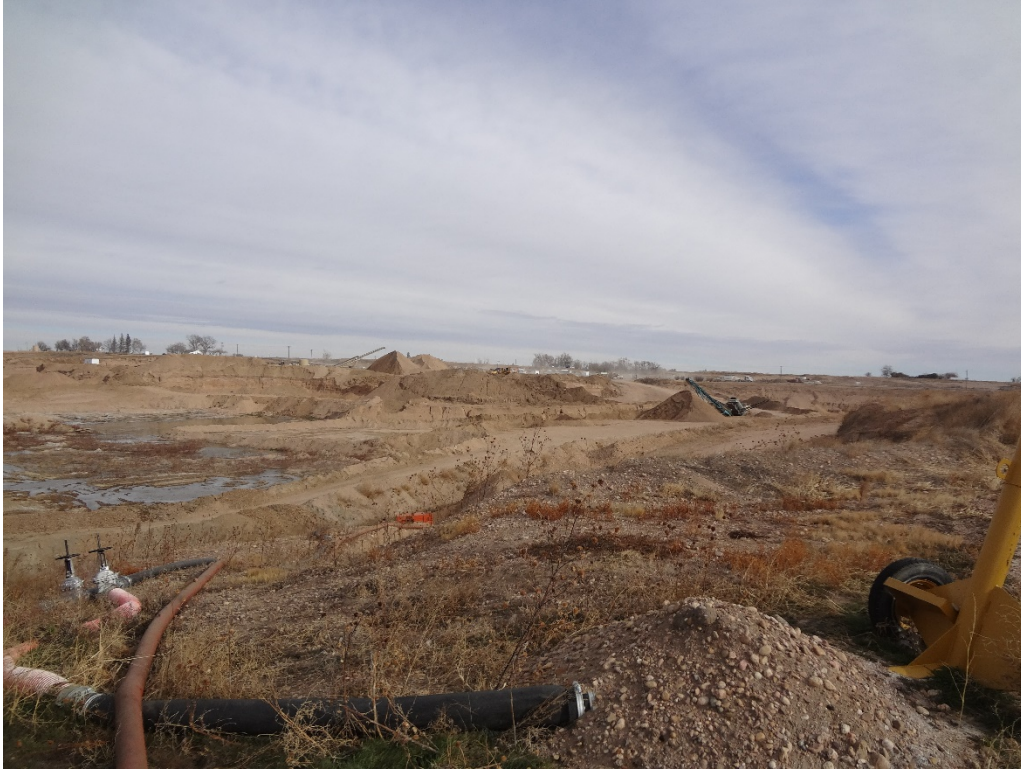
The mine site was actively mining and dewatering during the inspection. The depth from the top of slope to the top of the dewatering trench in the southwest corner of the site was determined to be 30 feet based on a previous GPS survey and Google Earth Pro data. Dewatering pumps with 8" diameter discharge pipes were observed in the southwest corner of the mine site. The water is discharged into a ditch which runs southeast from the site, crosses under Balsam Ave and East 8th St. and into the Ogilvy Ditch. The discharge activity is permitted under NPDES permit # COG500375.

View of dewatered Loloff Mine from SW corner looking NE

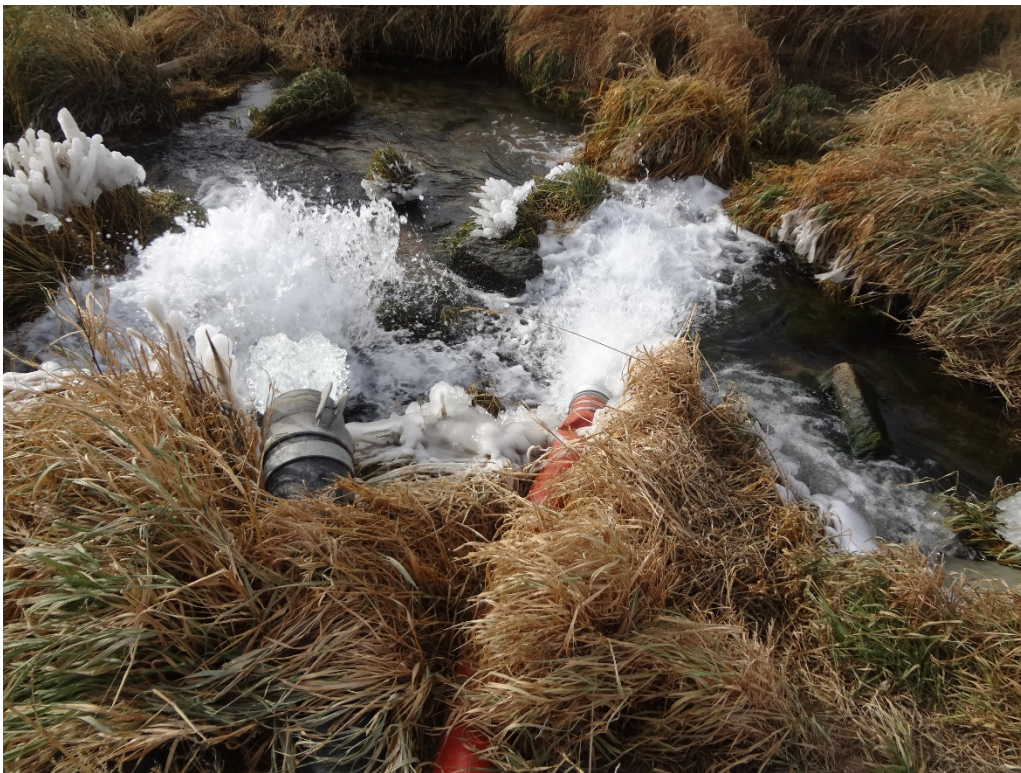
The Operator is currently mitigating impacts to other wells surrounding the mine site by recharging groundwater from the mine site into the irrigation ditch along the western boundary. The recharging effect does not appear to have increased the groundwater elevations in Mr. Tyrrell's well.

Loloff Mine dewatering discharge point
