**MINERALS PROGRAM INSPECTION REPORT****PHONE: (303) 866-3567**

<b>MINE NAME:</b> Riverview Resources	<b>MINE/PROSPECTING ID#:</b> M-1999-098	<b>MINERAL:</b> Sand and gravel	<b>COUNTY:</b> Weld
<b>INSPECTION TYPE:</b> Monitoring	<b>INSPECTOR(S):</b> Peter S. Hays	<b>INSP. DATE:</b> July 12, 2016	<b>INSP. TIME:</b> 10:00
<b>OPERATOR:</b> Aggregate Industries - WCR, Inc.	<b>OPERATOR REPRESENTATIVE:</b> Connie Davis	<b>TYPE OF OPERATION:</b> 112c - Construction Regular Operation

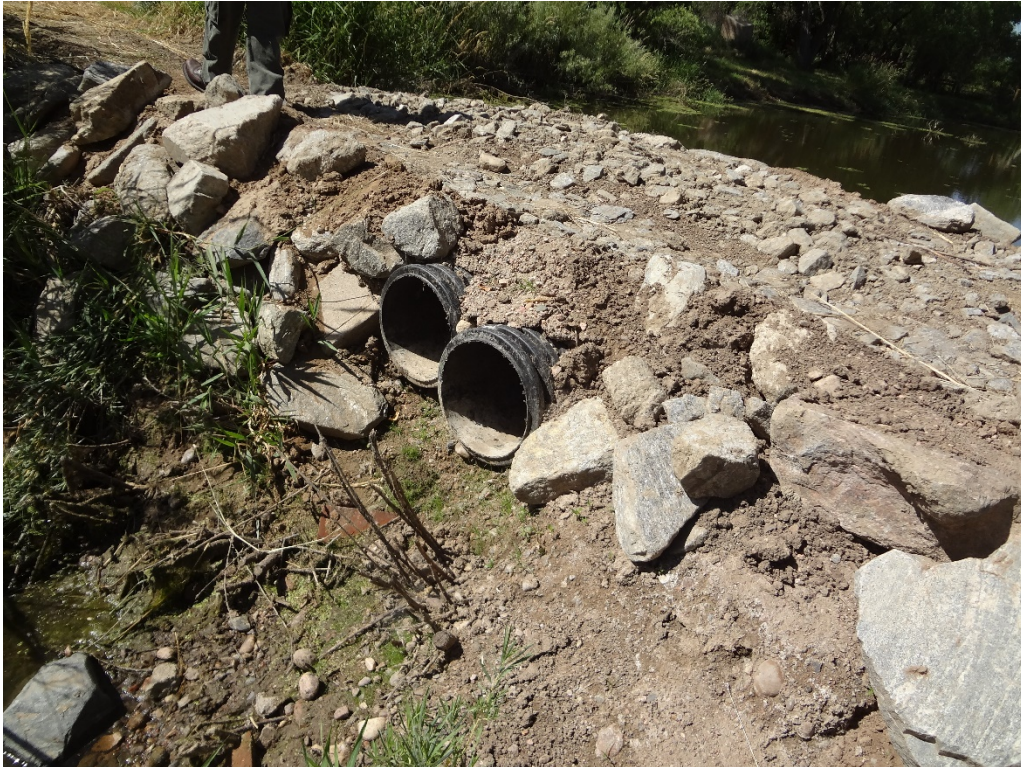
The VomBaur property was inspected by the Division and the Aggregate Industries representative. The flooding on the VomBaur property receded by the time of the inspection. The land bridge was repaired by the landowner. The field south of the VomBaur residence was dry and accessible. The main open area was mowed recently and preparations for summer camp were underway. The eastern extent of the property and the bank of the Poudre River were observed and no flooding was noted. The location of the 30 foot wide gap in the berm was observed. The berm gap appeared unchanged since the 2015 inspection. The culvert location was inspected and appeared unchanged since the 2015 inspection.

Repaired land bridge south of VomBaur residence

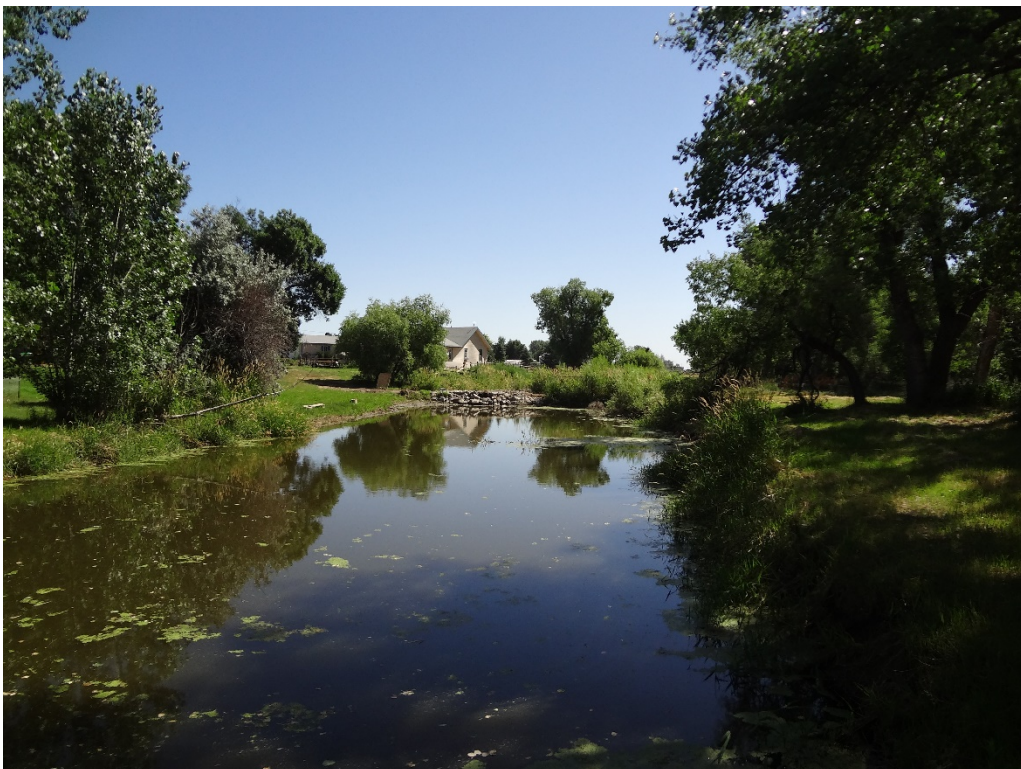
View of west pond looking west from land bridge

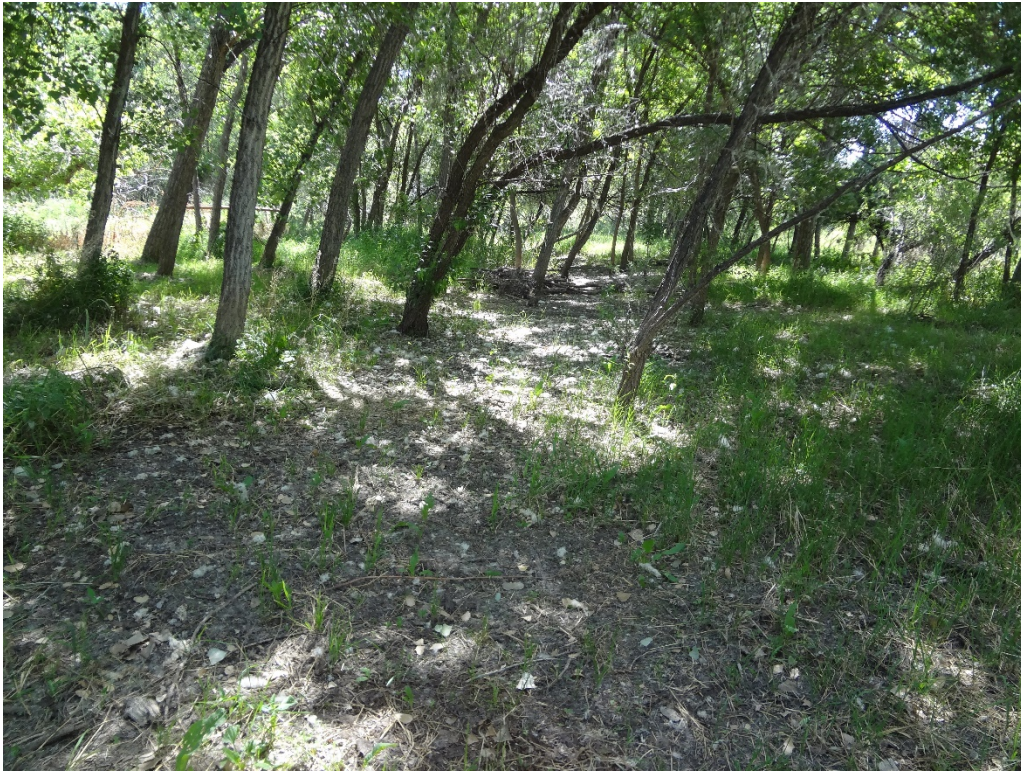
View of northern portion of 15 acre area south of VomBaur residence

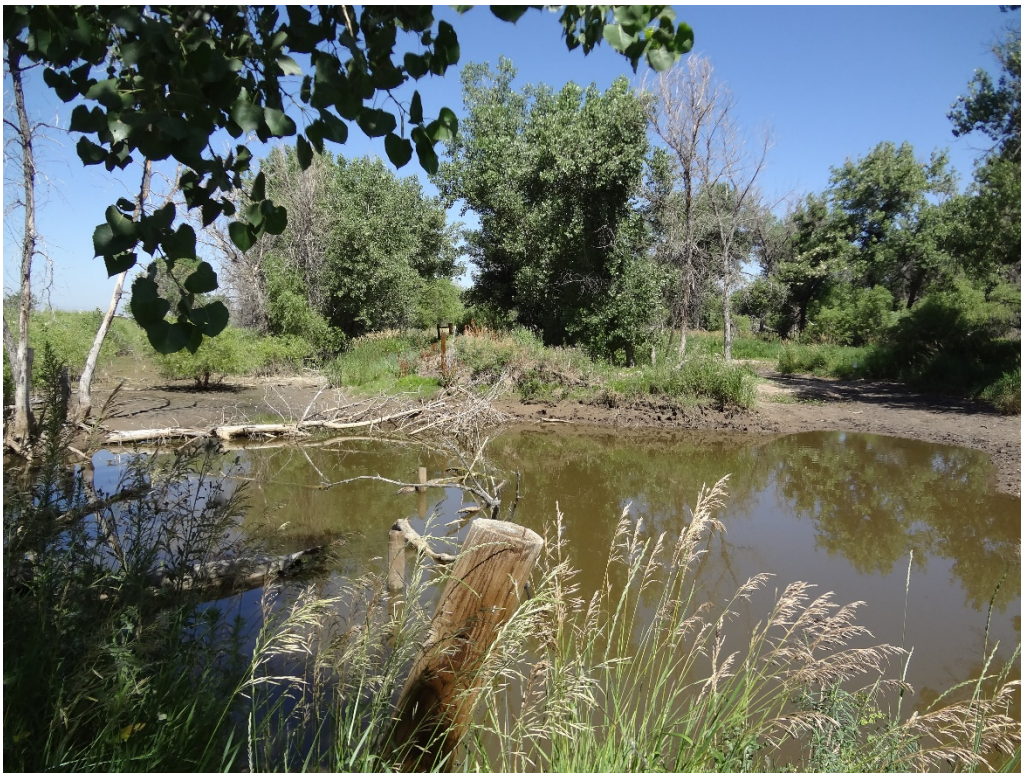
The 30 foot gap in the berm located in the southeastern portion of the VomBaur property appears to be the natural topography of the area prior to the start of mining at the Riverview Resource site based on Google Earth images. Mr. VomBaur may elect to fill in the berm gap to reduce the chances of flood waters entering his property. This must be completed in accordance with all applicable state laws. Mr. VomBaur may elect to remove or plug the culvert to reduce the chances of flood waters entering his property.

View of 30 foot berm gap looking east

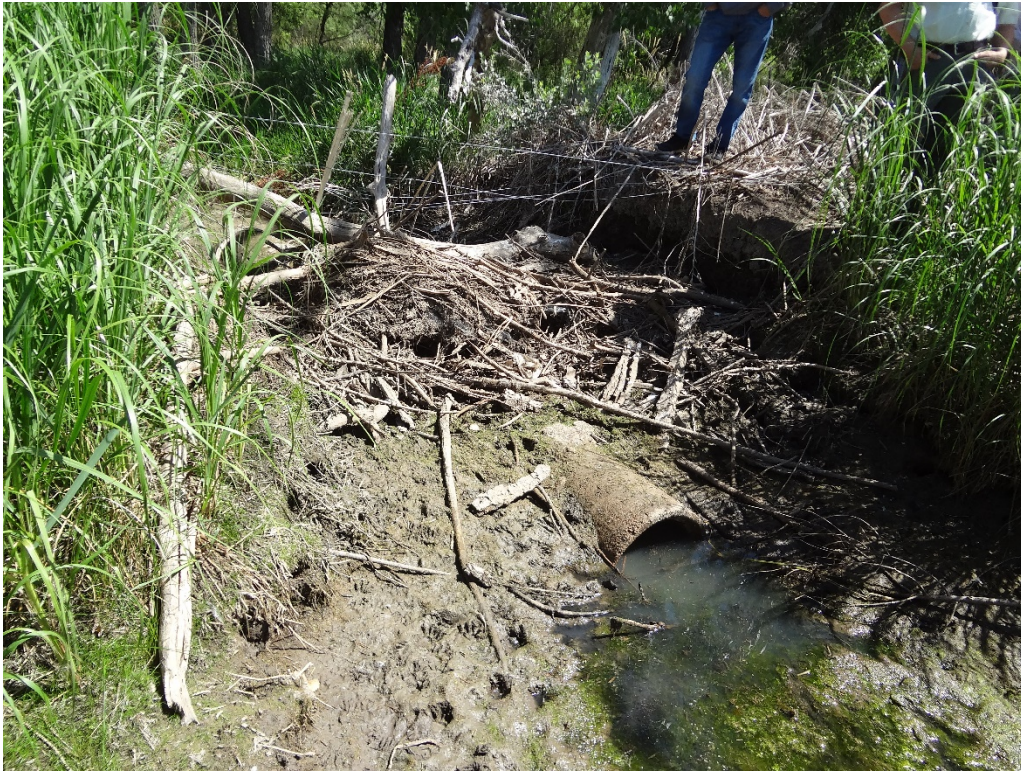
View of culvert on VomBaur property north of Cell 3

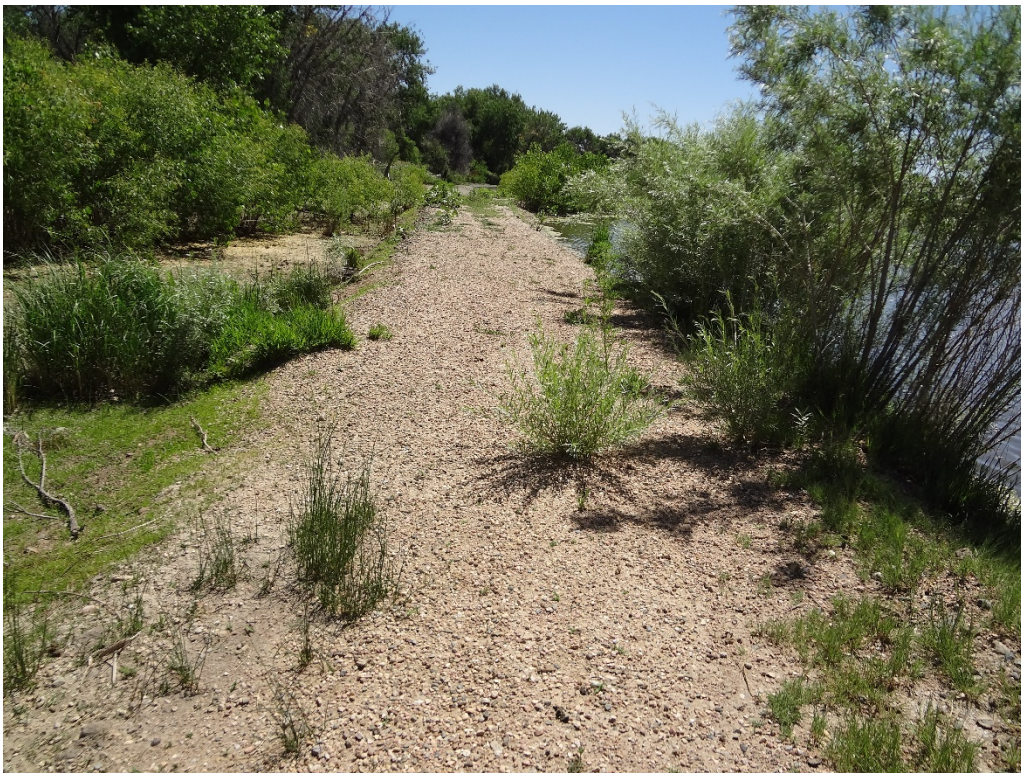
The north shore of Riverview Resource Cell 3 was inspected as part of the complaint investigation. As stated in the last inspection report, based on Google Earth Pro image review, it appears the northern bank of the southeast section of Cell 3 was breached during a flood event in 2011. The previous report indicated one (1) breach area. During this inspection, three (3) smaller breach locations were observed east of the 2015 observed breach location. The Operator failed to repair these breaches following the 2011 flood event and did not repair them as part of the 2015 beach repair work in Cell 3.

View of 2015 repaired section of the north bank of Cell 3 looking east

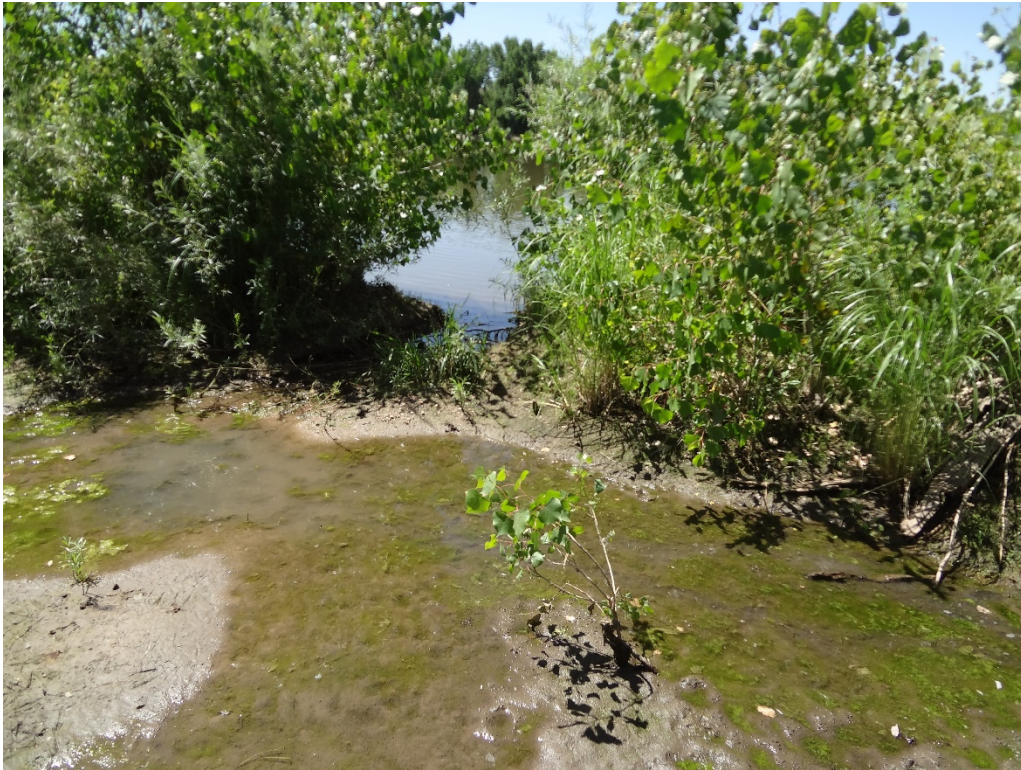
**PROBLEM/POSSIBLE VIOLATION:** Problem: The Operator failed to repair damaged sections of the northern bank of Cell 3 resulting in increased flood water flows into the VomBaur property. Therefore, the Division believes Aggregate Industries failed to maintain the prevailing hydrologic balance in the area as required by Rule 3.1.6 and Section 34-32.5-116(4)(h) of the Colorado Land Reclamation Act for the Extraction of Construction Materials.

As cited as a problem, the Operator failed to repair the damaged sections of the northern bank of Cell 3 resulting in increased flood water flows into the VomBaur property. Therefore, the Division believes Aggregate Industries failed to maintain the prevailing hydrologic balance in the area as required by Rule 3.1.6 and Section 34-32.5-116(4)(h) of the Colorado Land Reclamation Act for the Extraction of Construction Materials. The Operator must repair the breaches in the northern bank of Cell 3 within 60 days, resurvey the sections of Cell 3 to verify the topography is consistent with the approved Reclamation Plan, notify the Division of the breach repair completion and submit the new survey results to the Division.

View of one of the breach areas observed east of the repaired berm section

**CORRECTIVE ACTIONS:** The Operator must repair the breaches in the northern bank of Cell 3 within 60 days, resurvey the sections of Cell 3 to verify the topography is consistent with the approved Reclamation Plan, notify

the Division of the breach repair completion and submit the new survey results to the Division.

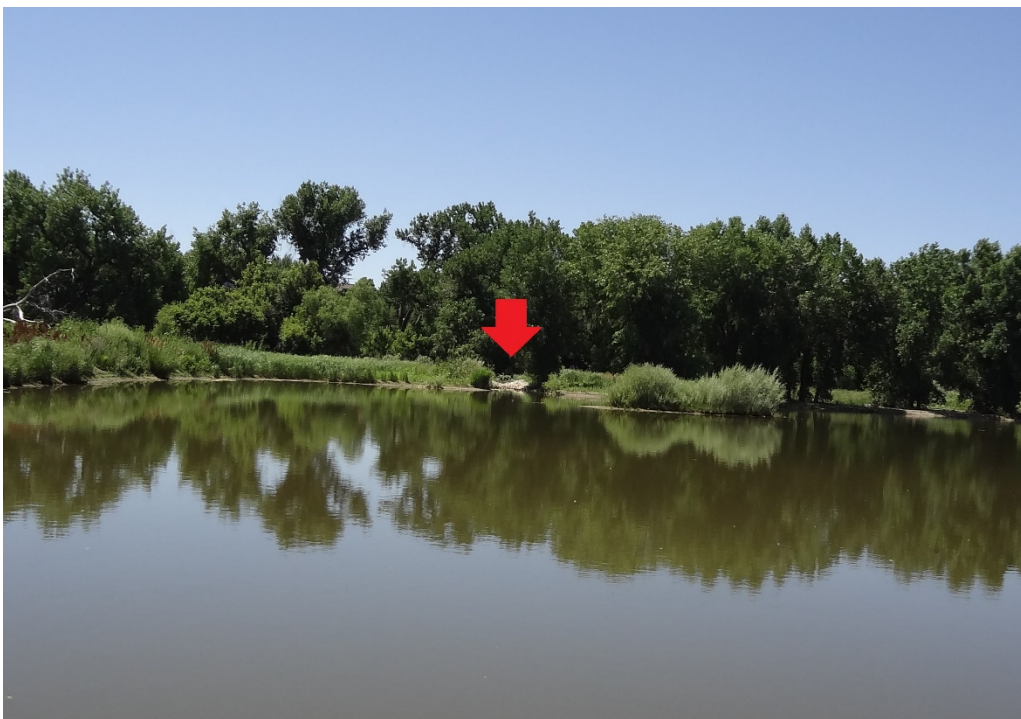
**PROBLEM/POSSIBLE VIOLATION:** Problem: A spillway was observed in the southeast corner of Cell 3 during the inspection. The spillway is not part of the approved reclamation plan for the site and is not approved by the Division. The current reclamation plan needs to be updated and clarified pursuant to C.R.S. 34-32.5-116 (1).

A small spillway was observed in the southeast corner of Cell 3 during the inspection. The spillway is not part of the approved reclamation plan for the site and is not approved by the Division. The spillway did not appear to be properly sized to allow the 100 year storm event to exit the site. As cited as a problem, the Operator must submit the construction plans for the spillway as a technical revision to the reclamation plan. The revision must demonstrate the spillway is designed to allow a 100 year storm event to pass through the spillway and must include as-built drawings and an engineering certification.

View of spillway in the SE corner of Cell 3 looking south

**CORRECTIVE ACTIONS:** The Operator shall submit a Technical Revision, with the required \$216 revision fee, to update and clarify the approved reclamation plan to describe the spillway design by the corrective action date. The revision must demonstrate the spillway is designed to allow a 100 year storm event to pass through the spillway and must include as-built drawings and an engineering certification.
