## MINERALS PROGRAM INSPECTION REPORT

<b>MINE NAME:</b> Daniels Sand Pit 2	<b>MINE/PROSPECTING ID#:</b> M-1973-007-SG	<b>MINERAL:</b> Sand and gravel	<b>COUNTY:</b> El Paso
<b>INSPECTION TYPE:</b> Preoperation Inspection	<b>INSPECTOR(S):</b> Timothy A. Cazier	<b>INSP. DATE:</b> December 7, 2016	<b>INSP. TIME:</b> 13:00
<b>OPERATOR:</b> Continental Materials Corporation	<b>OPERATOR REPRESENTATIVE:</b> B. Heser, A. Laroche & G. Smith	<b>TYPE OF OPERATION:</b> 112c - Construction Regular Operation

<b>REASON FOR INSPECTION:</b> Preoperation Inspection	<b>BOND CALCULATION TYPE:</b> Partial Bond	<b>BOND AMOUNT:</b> \$1,038,500.00
<b>DATE OF COMPLAINT:</b> NA	<b>POST INSP. CONTACTS:</b> None	<b>JOINT INSP. AGENCY:</b> None
<b>WEATHER:</b> Snowing	<b>INSPECTOR'S SIGNATURE:</b>

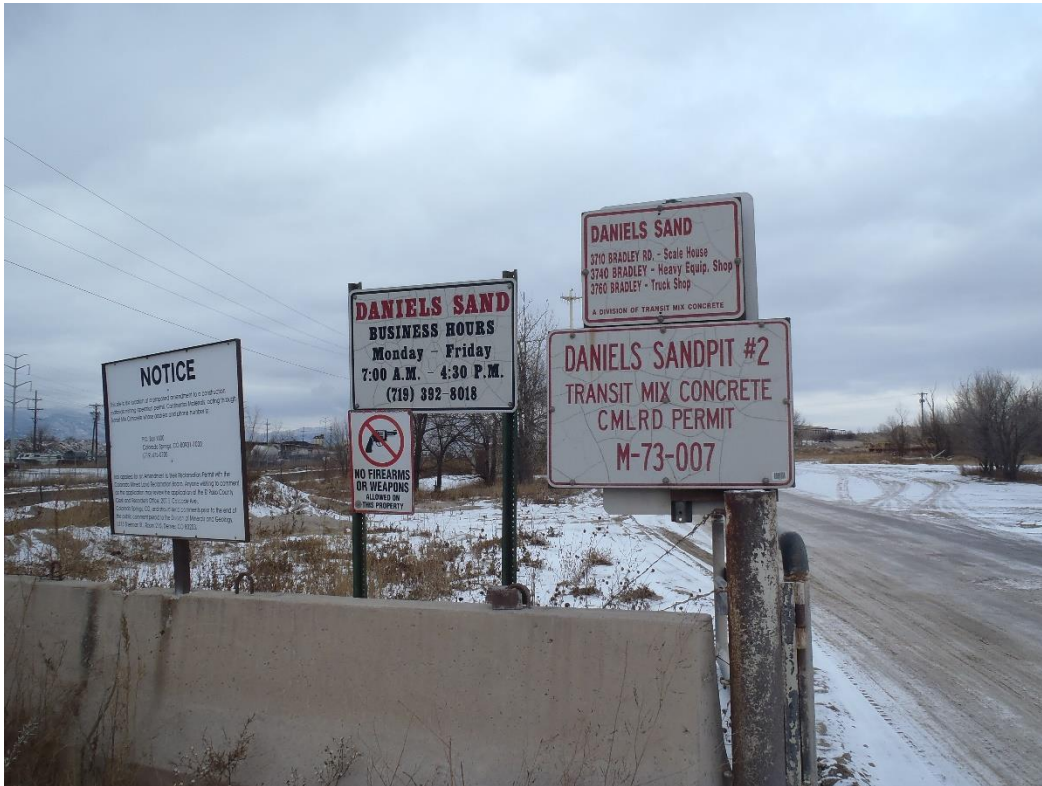
**Markers & Boundary** – A permit sign was displayed at the site entrance (see **Photo 1**). The Division drove the roads along the perimeter prior to the inspection and noted the affected area boundary was marked by visual berms on the west and berms and/or fences on the north, east and south.

Photo 1. Permit sign at entrance.

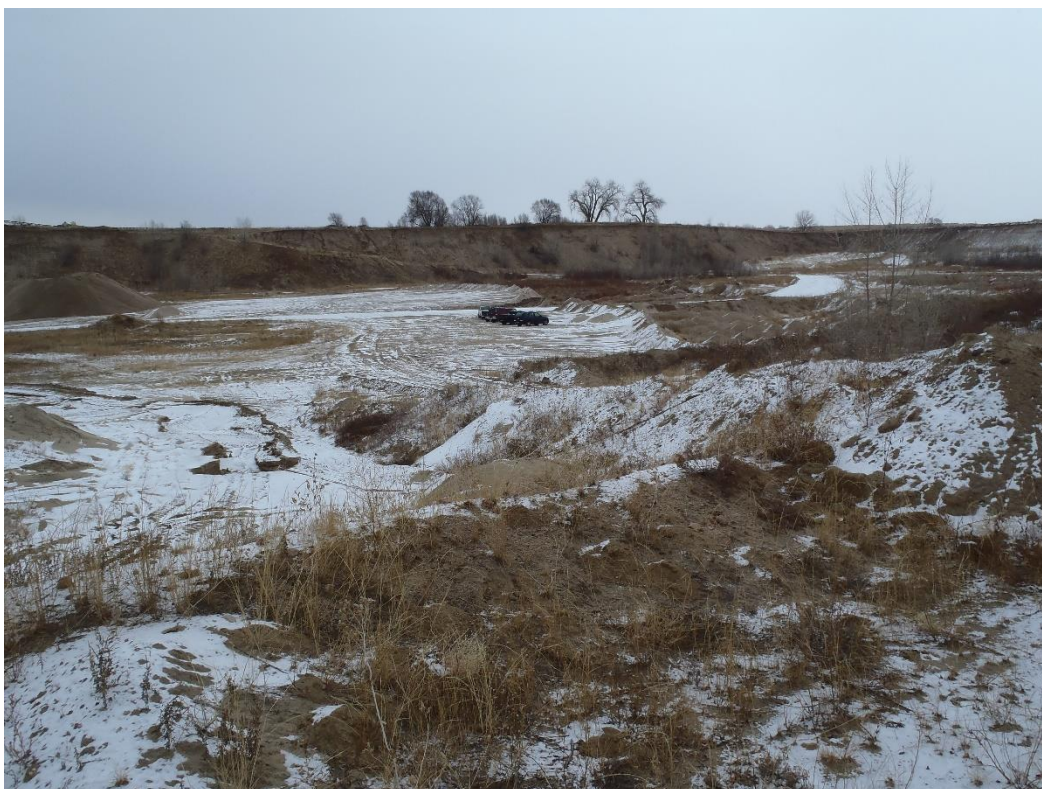
**Wash Pond Areas** – All personnel involved in the inspection visited the site of the proposed wash pond embankment (TR-05). The alignment and north abutment is shown in **Photo 2**. Wash fines would be placed east of the proposed embankment in the previously mined out area. The south abutment is shown in **Photos 3** and **4**. The Division expressed concern about the potential failure of both the existing and proposed wash pond embankment failures resulting from a worst case seismic event which might cause liquefaction of the embankments and stored wash fines and whether or not the loosened material might impact S. Academy Blvd on the west end of the South Pit. Messrs. Humphries and Hesser proposed increasing the storage volume downstream of the wash pond embankments and within the south pit by either over excavating the existing pit floor or building a secondary shorter embankment some distance from the toe of the proposed embankment. The Division agreed the additional storage has potential to mitigate potential impacts to S. Academy Blvd. Stability analyses would be necessary to assess the effectiveness of a secondary embankment. It was agreed that appropriate geotechnical stability analyses of the proposed 30-foot embankment (as well as the possible secondary embankment) would be completed incorporating an applicable seismic load and submitted to the Division for review. The Division also posed placing piezometers in the new embankment (if approved) to monitor the phreatic surface for the purpose of monitoring water saturation that could lead to slope failure. An agreement was reached to install an appropriate number of piezometers in the proposed embankment unless an engineering evaluation could demonstrate they would not be necessary. Although the new embankment would be approximately 30 feet in height, Mr. Smith indicated there would likely be no more than 6 to 8 feet of water stored behind it at any given time. The rest of the storage volume would be taken up with fines storage. It was acknowledged that the variation in particle size would likely result in lenses of tighter material that locally would not facilitate infiltration, resulting in some water being trapped in the impoundment. Mr. Humphries suggested vegetative cover could help with removing water from these lenses through evapotranspiration. The Division agreed, except for the deeper lenses, where deep rooted trees as proposed for the reclamation of the current wash pond would be more effective. The Division raised concerns about the management of the water and wash fines placement with respect to how water might be kept away from the embankment. Mr. Smith stated he manages the water in the current wash pond by alternating the location from which he pumps water out of the pond. The Division also posed moving the spigot/slurry discharge location using either a manifold

Photo 2. Proposed wash pond embankment alignment and north abutment (looking NE).

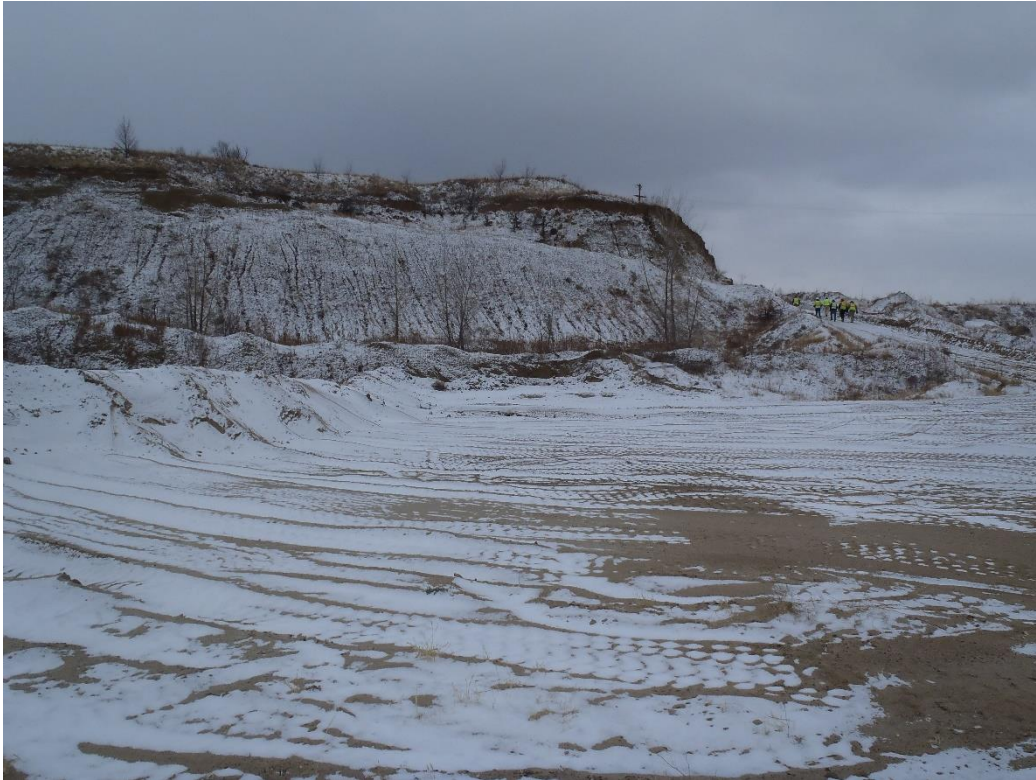
Photo 3. Proposed wash pond embankment alignment and south abutment (looking south).

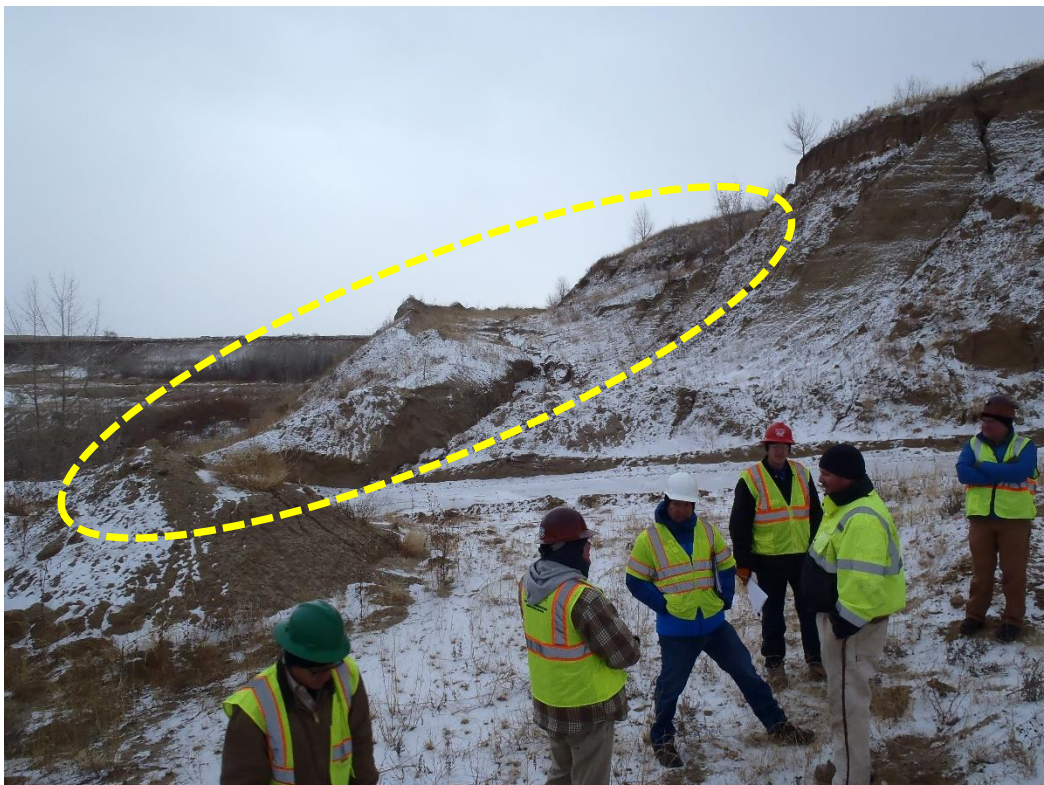
Photo 4. Proposed wash pond south abutment (looking east).

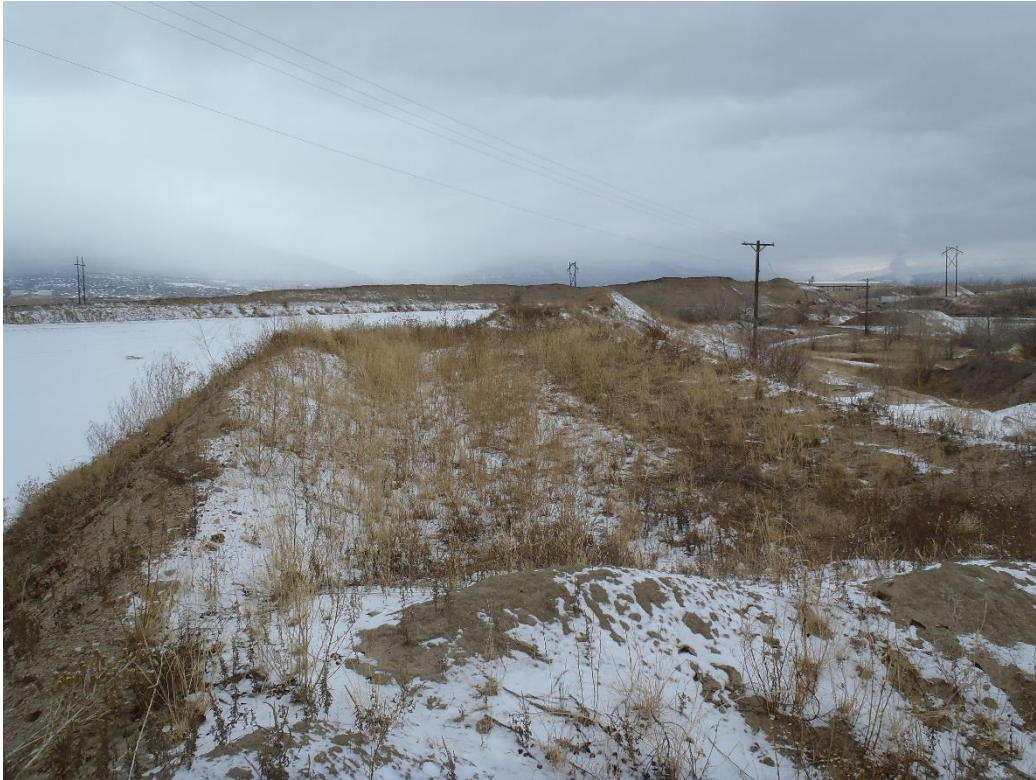
All parties walked the perimeter of the current wash pond while Mr. Smith explained how he manages it and how the southwest embankment was constructed. **Photo 5** shows the north embankment of the current wash pond. **Photo 6** shows the curved crest of the southwest embankment of the current wash pond. This southwest embankment appears to approximately 15 feet above native ground at its tallest point. Mr. Smith stated it was constructed using imported fill, which he described as having good cohesive and compactible properties while being placed in 6 to 8-inch lifts with scrapers and shaping with dozers. The Division inspected the outer face of the southwest embankment, observing sparse vegetation, erosion rilling and portions that appeared over steepened. The over steepened slope may have resulted from material being borrowed from the toe for the area shown in **Photo 7** that appeared to be newly graded and mulched. **The poor condition of the outer face of the southwest embankment is cited as a Problem on page 1 of this report.** An agreement was reached to place additional material on the outside face of the southwest embankment to achieve a slope no steeper than 3H:1V, work to establish a vegetative cover to reduce erosion potential and conduct a geotechnical investigation for the purpose of assessing the slope stability of this embankment.

Photo 5. North embankment of the current wash pond (looking west).

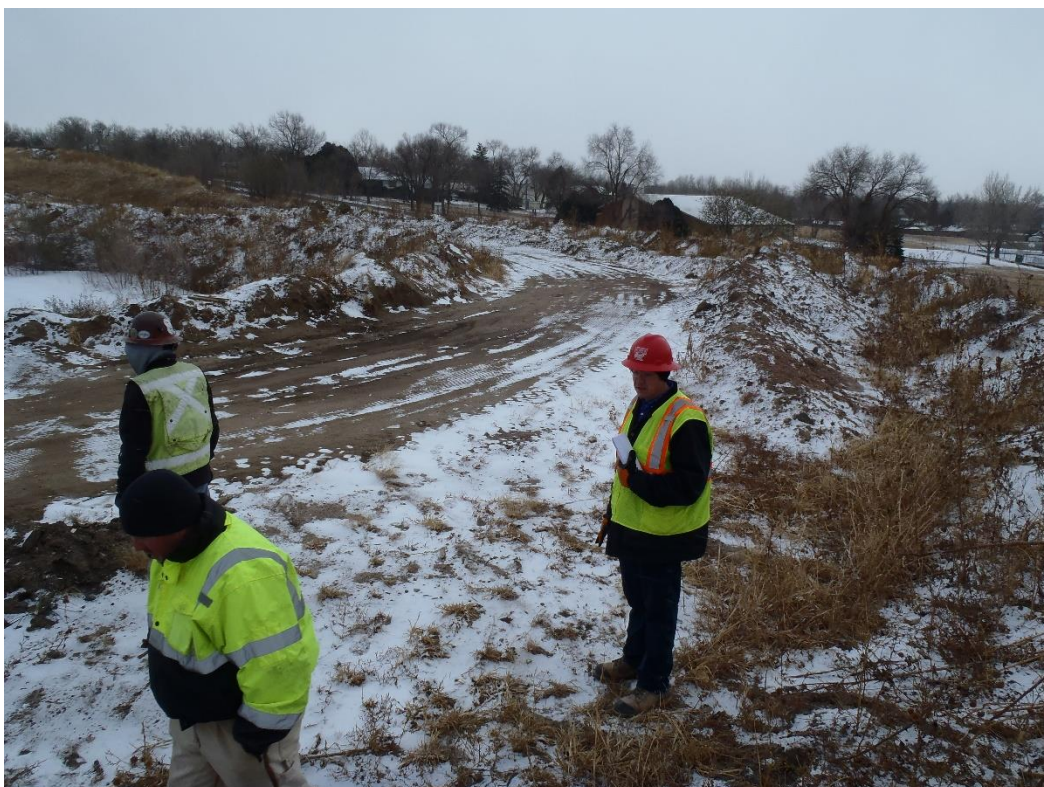
**PROBLEM/POSSIBLE VIOLATION:** Problem: Observed sparse vegetation, erosion rilling and portions of over steepened slope on the southwest embankment outer face of the current wash pond reducing the erosional stability and potentially the geotechnical stability of the embankment.

Photo 6. Curved crest of the southwest embankment of current wash pond (looking SE).

**CORRECTIVE ACTIONS:** Prior to the Corrective Action due date, the Operator must: (a). Place additional material on the outside face of the southwest embankment to achieve a slope no steeper than 3H:1V; (b) Work to establish a vegetative cover to reduce erosion potential; and (c) Conduct a geotechnical investigation for the purpose of assessing the slope stability of this embankment.

1. A problem was cited for the poor condition of the southwest embankment of the existing wash pond. Prior to the Corrective Action due date, the Operator must:

- a. Place additional material on the outside face of the southwest embankment to achieve a slope no steeper than 3H:1V,
  - b. Work to establish a vegetative cover to reduce erosion potential, and

- c. Conduct a geotechnical investigation for the purpose of assessing the slope stability of this embankment.
2. Continue monitoring for noxious weeds as outlined in the noxious weed control plan approved as TR-04 in 2005.

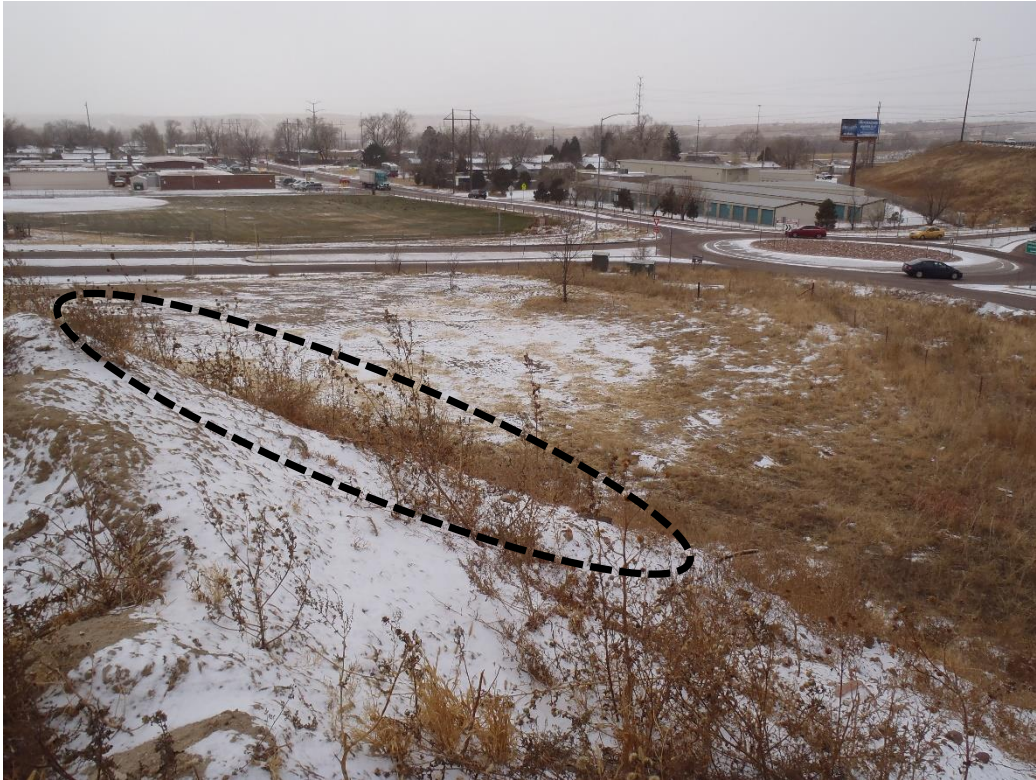
Photo 7. Over steepened southwest embankment slope & newly graded area (looking south from crest).
