## Fwd: First bentonite notes ready to be sent to DRMS

William was back out onsite after we had the operator cut the swale a little deeper. Attached are the notes.

**Reclamation Notes on 11292016 Site Visit.pdf**

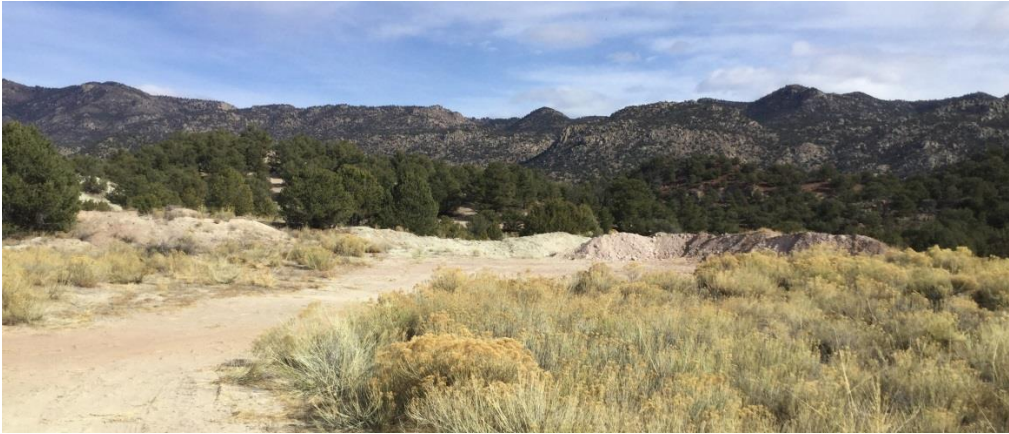
- Stockpiles of product still remain at the lower stockpile area.
  - The operator has indicated that they are trying to sell the rest of this material.

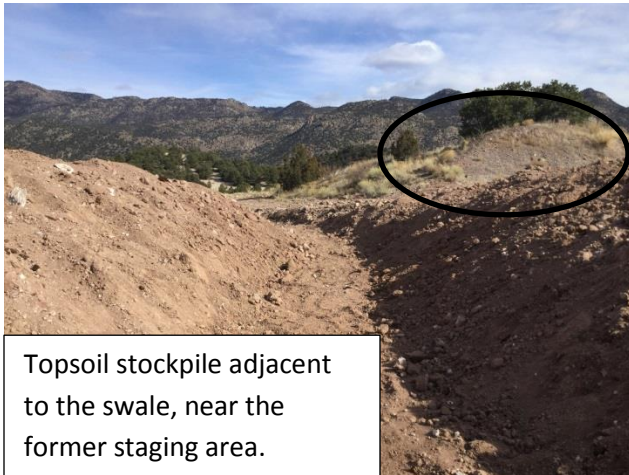
- Two stockpiles of soil were observed along the former route to the highwall from the staging area. The stockpiled material should be used in the ongoing reclamation efforts (this material could be used for the area where the product piles are currently being stored), so that there are no stockpiles remaining on the site.

Topsoil stockpile adjacent to the swale, near the former staging area.

- The operator should add a sign stating "Reclamation in Progress, Keep Off"
- After the remaining product piles have been removed, the operator will need to rip the rest of the access road (to Kerr Gulch road intersection) and spread the remaining topsoil (currently stockpiled) over the current product pile storage area. Afterwards, the road and product pile storage area will need to be seeded.
- BLM will monitor the slopes in the Spring of 2017 to see if the winter/spring settling helps to soften the highwall slope to a 3:1.

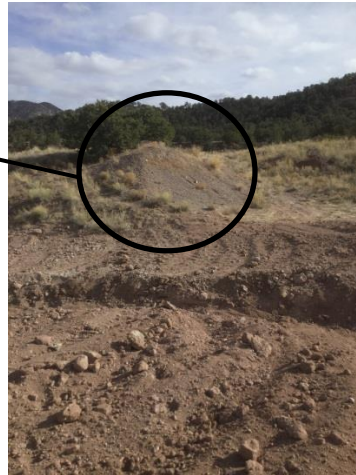
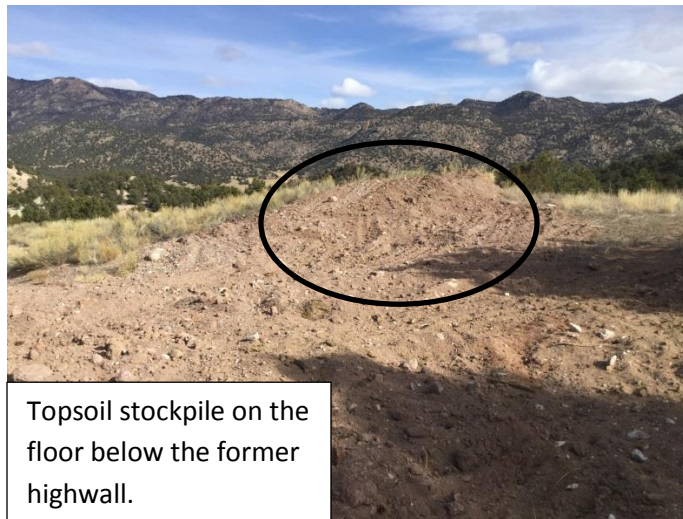
Topsoil stockpile on the floor below the former highwall.

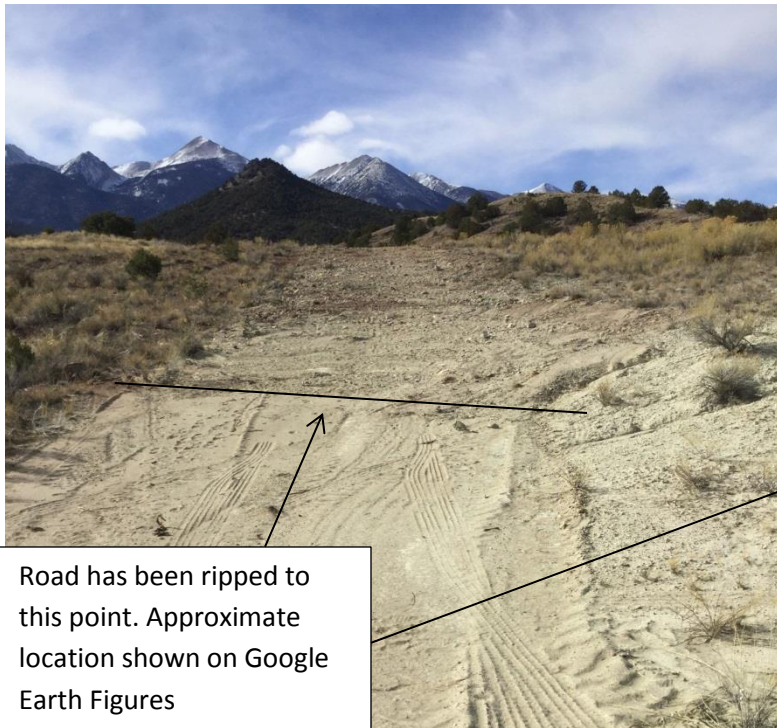
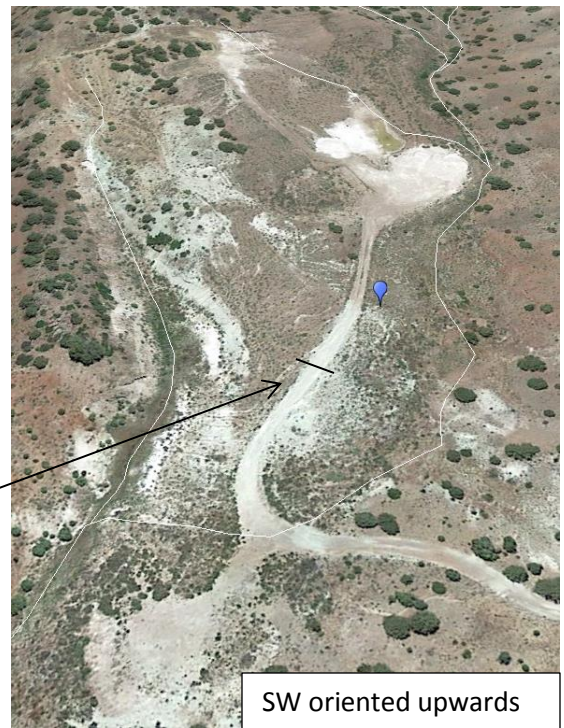
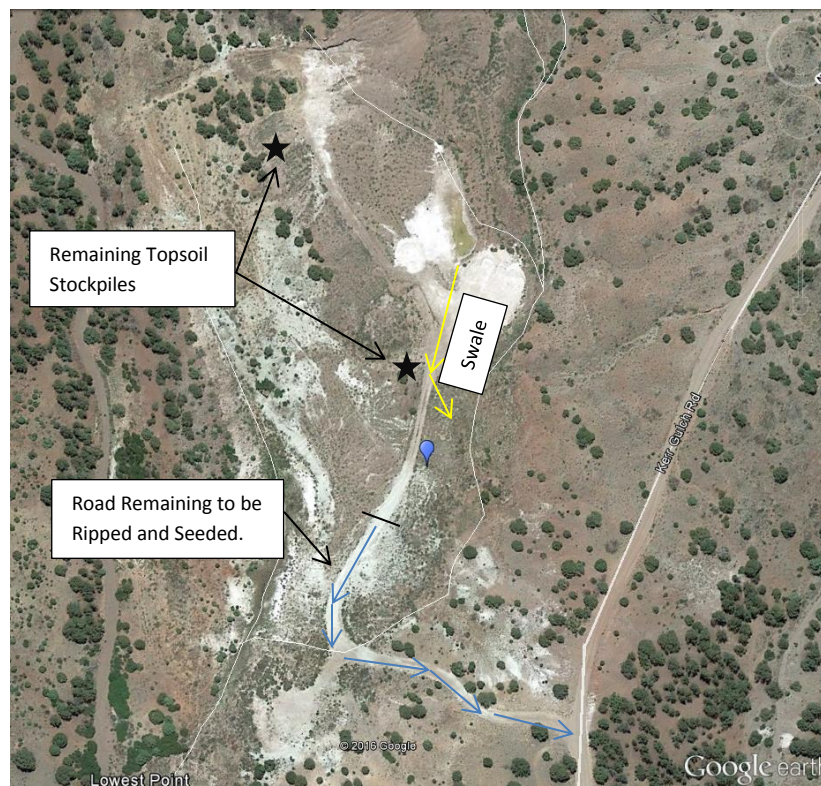
- Part of the Access Road has been graded, extending from the former staging area and stopping before the lower stockpile area.
  - The remainder of the access road will need to be ripped and seeded for final reclamation.

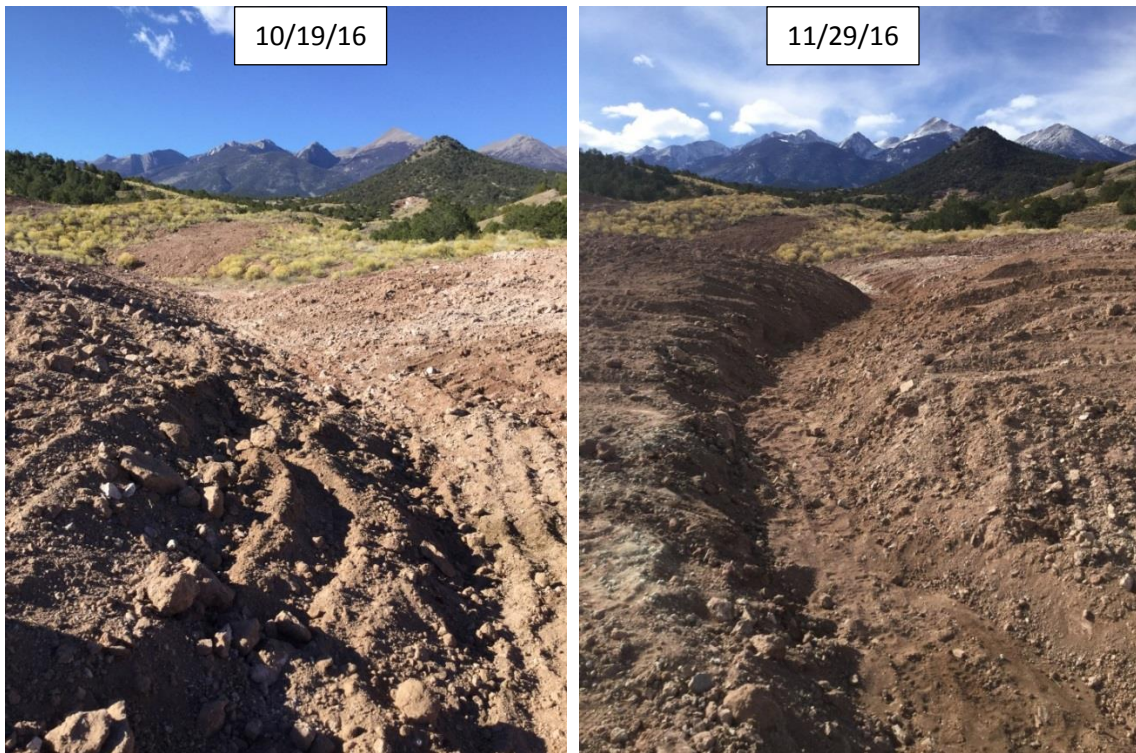
- The existing swale has been cut deeper to facilitate the site's drainage.

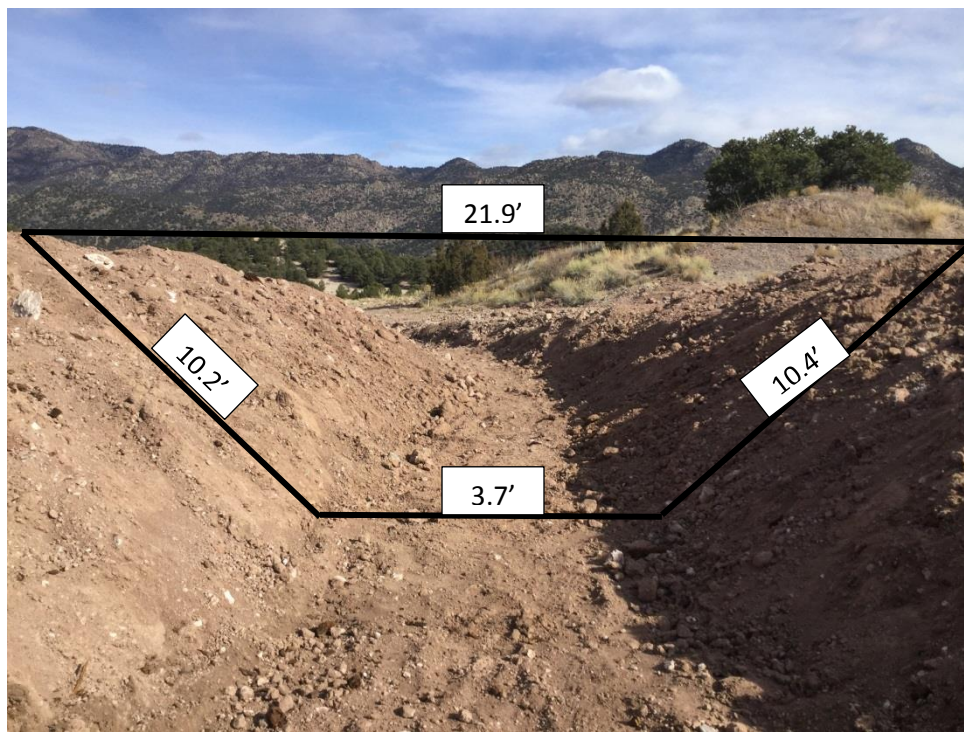
- Inverted trapezoidal cross-section notes (refer to figure):
  - 3.7' (base) x 10.2' (left diagonal) x 10.4' (right diagonal) x 21.9' (top)

- Approximate Area of Trapezoid =  $61.76 \text{ ft}^2$
- Approximate volume of material removed for swale =  $61.76 \text{ ft}^2 \times 160 \text{ ft (ground length)} = 9,881.6 \text{ ft}^3$  of material. The real number will be less than this because this assumes a constant depth (swale-bank top).

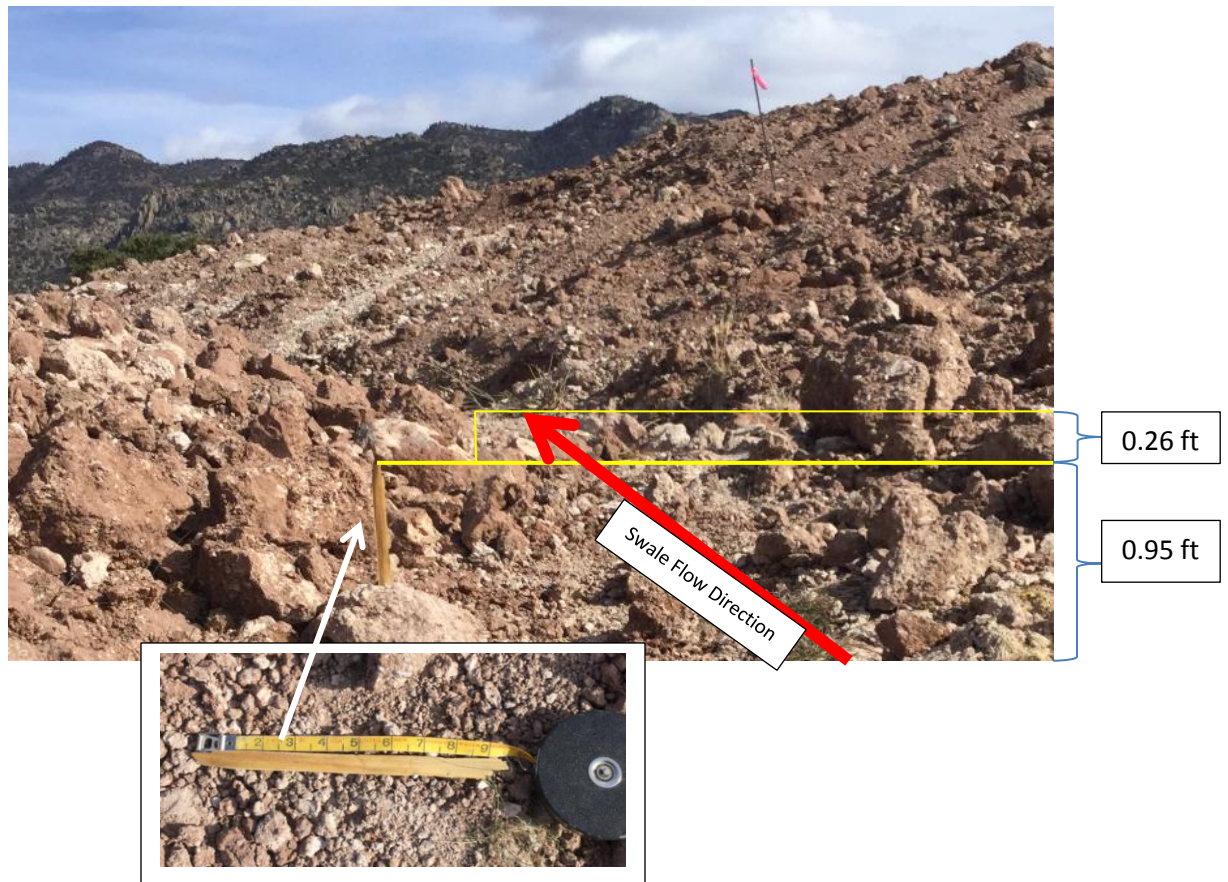
- In order for the water to drain through the swale's length, it appears that it will need to overtop 1.21 feet of vertical increase in the swale channel. It should be noted that this vertical increase is located at the beginning of the swale.

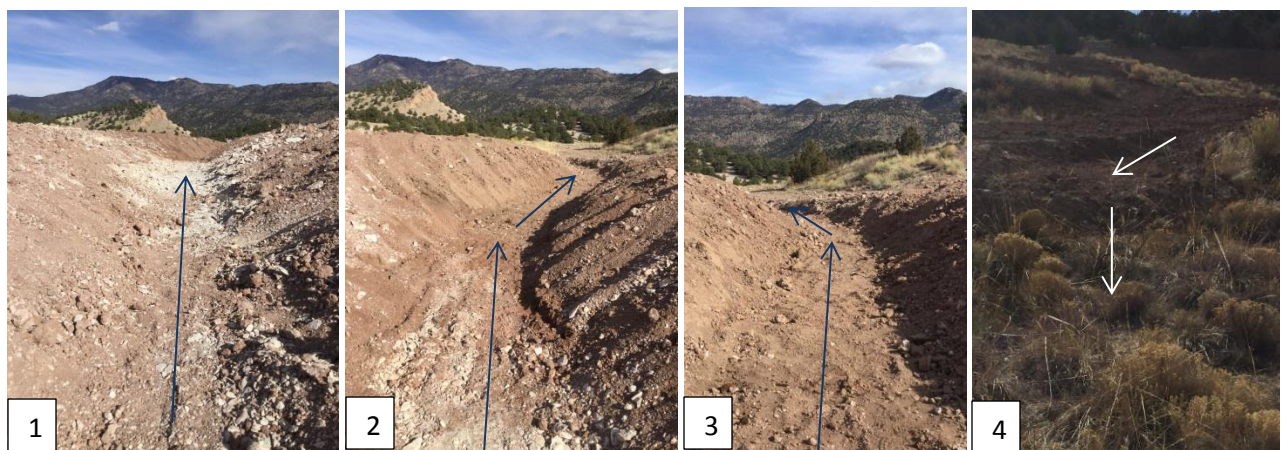
- The above photos show the sequence that water would take through the swale after overtopping the vertical increase of 1.21 feet at the beginning of the swale's channel. Photo 4 shows where the swale terminates into the pre-existing drainage basin.

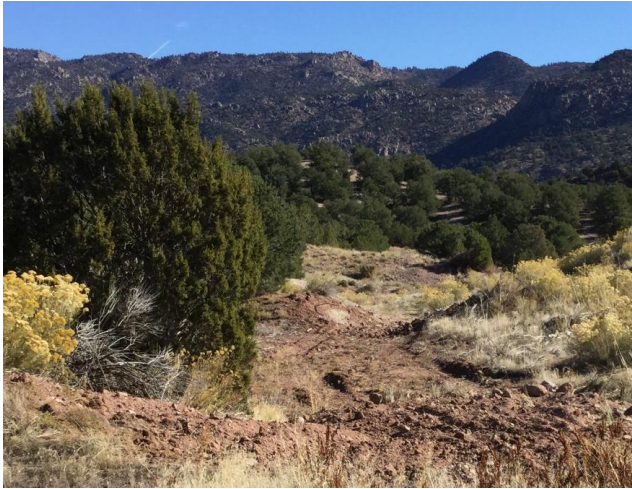
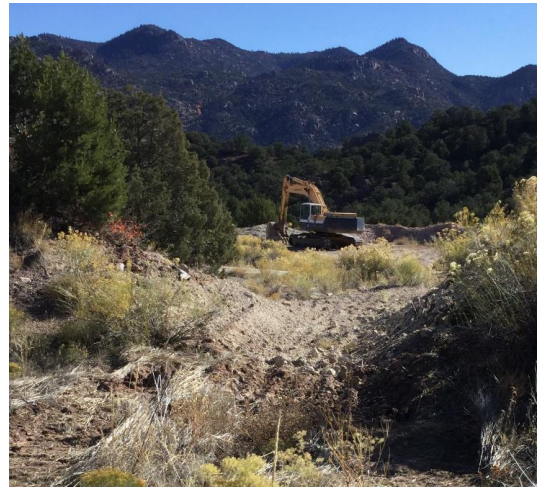
- The above photos show where drainage channels have been cut through the check dams below the swale. They are shown in sequential order as you travel down the drainage path.

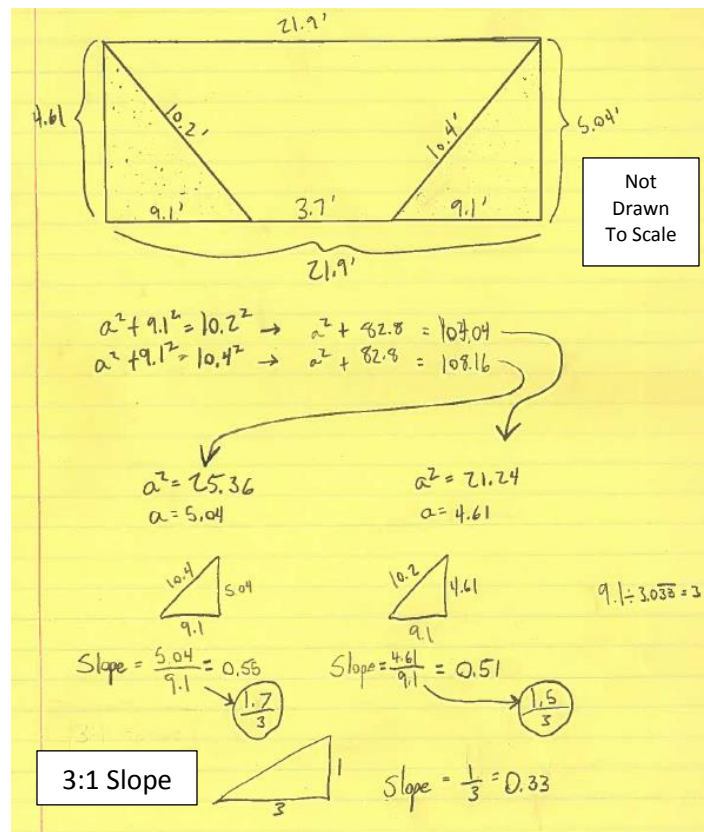
- Some reclaimed slopes exceed CDRMS' maximum slope of 3:1; however, the material is loose in these areas and will likely fill in towards the respective toe of each slope, making the slopes more gradual.
  - As we will have to wait for the growing season on the site's revegetation, it might be sufficient to monitor these slopes over the coming months.
- Swale side slopes are adequate (3 : 1.6).

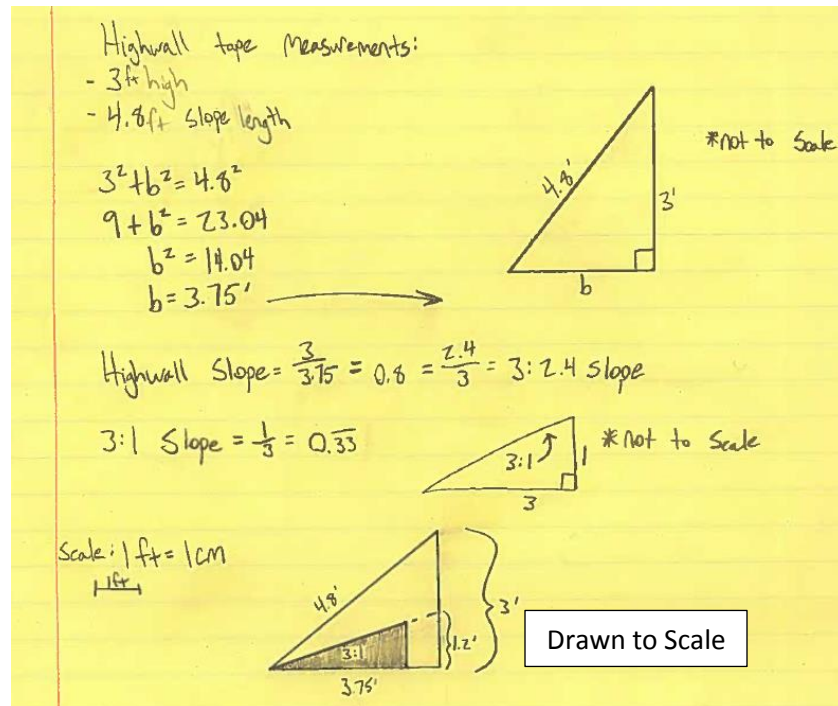
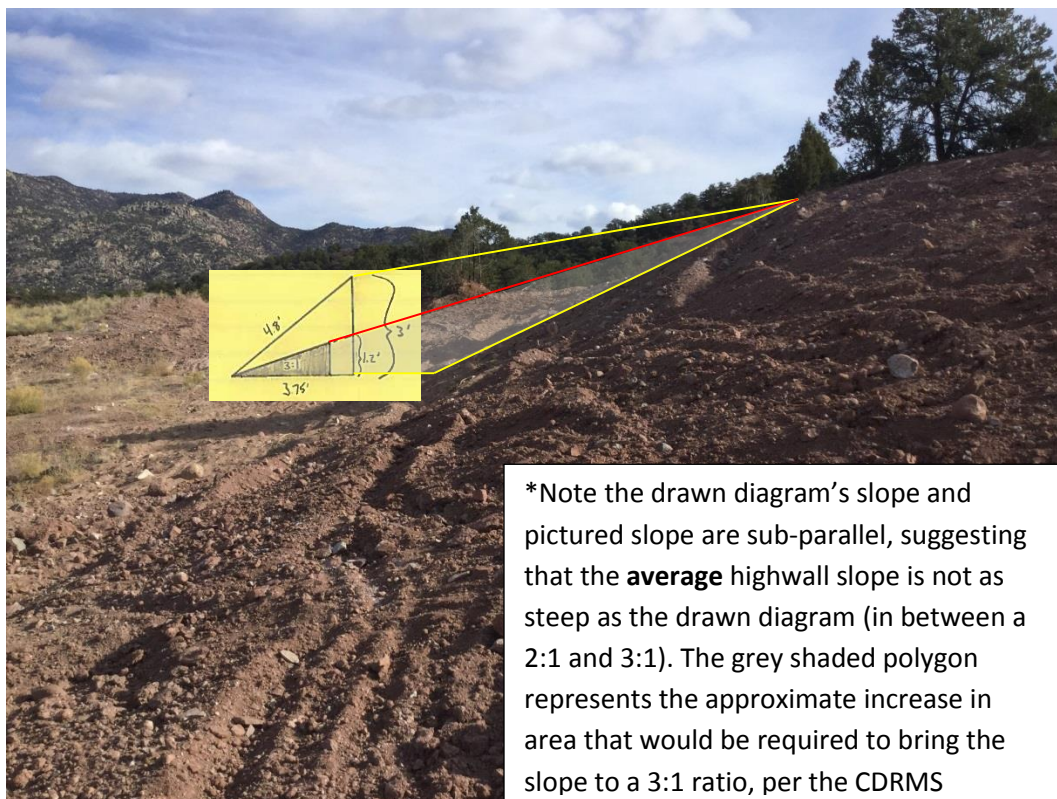
- The Highwall Slope at its steepest angle is  $\leq 2 \times$  greater the CDRMS 3:1 slope standard. Refer to the scaled triangle at the base of the figure, which compares a 3:1 slope (shaded) and the current slope of the highwall.

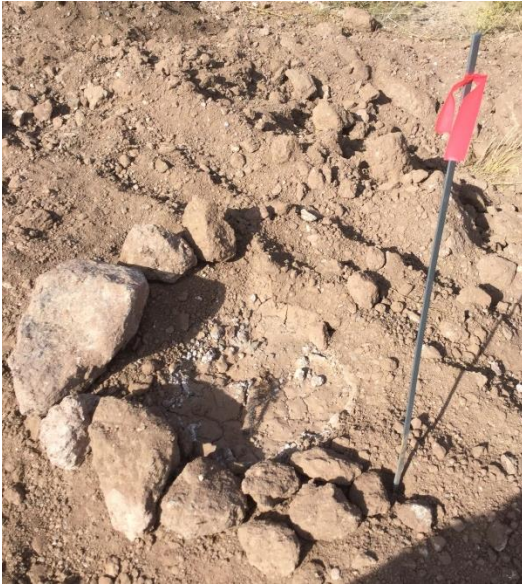
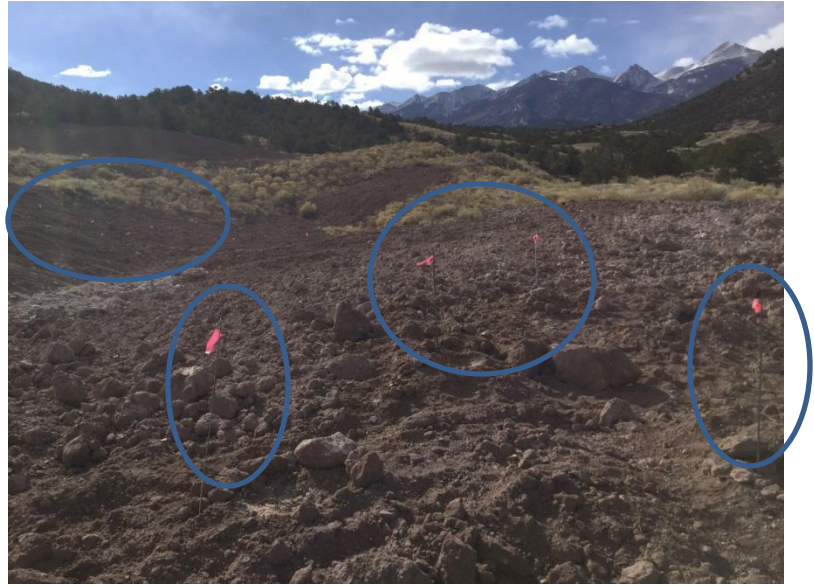
- The operator has spread some seed, but intends to spread more.
- Several saplings (flagged and circled in blue) have been planted since the previous site visit, and they are marked by the rock rings which surround them.

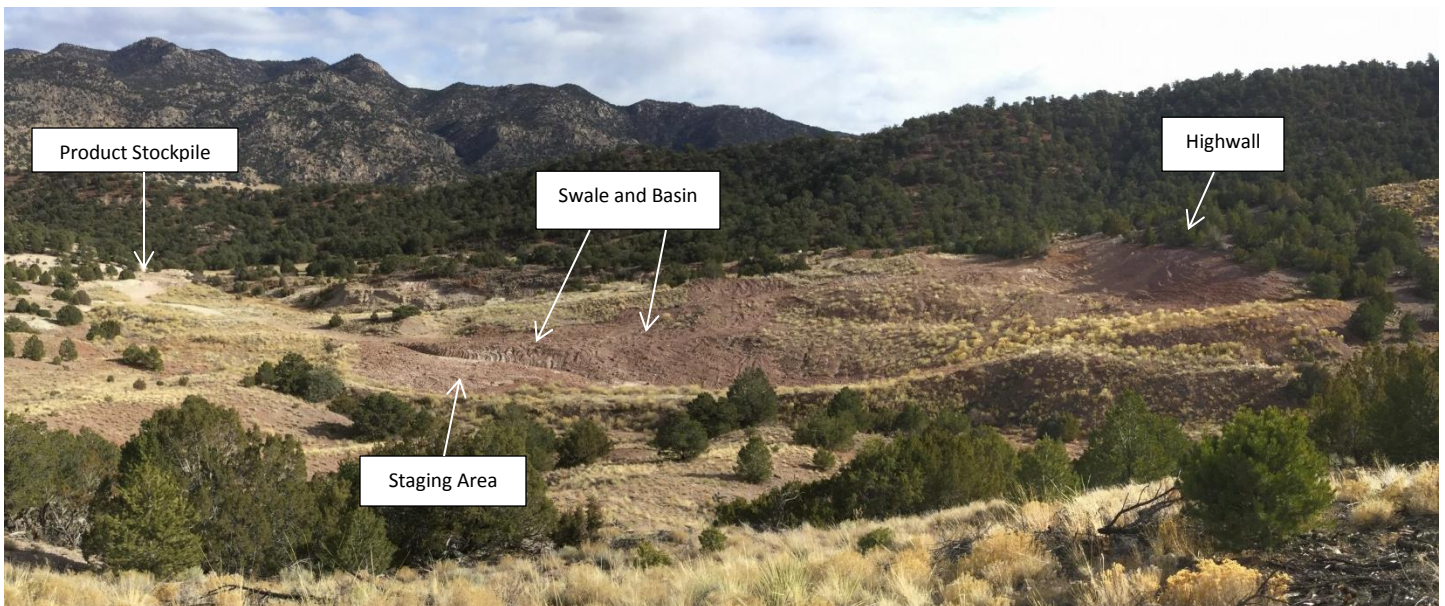
- From a visual standpoint, the grading and re-contouring efforts appear to have been successful. From Kerr Gulch Rd., the previous disturbances appear to be well blended with the surrounding topography (see photo below).
