**COLORADO**Division of Reclamation,
Mining and Safety

MINERALS PROGRAM INSPECTION REPORT**PHONE: (303) 866-3567**

MINE NAME: 83rd Joint Venture	MINE/PROSPECTING ID#: M-1992-069	MINERAL: Sand and gravel	COUNTY: Weld
INSPECTION TYPE: Monitoring	INSPECTOR(S): Peter S. Hays	INSP. DATE: July 12, 2016	INSP. TIME: 12:00
OPERATOR: Aggregate Industries - WCR, Inc.	OPERATOR REPRESENTATIVE: Connie Davis, Mike Refer	TYPE OF OPERATION: 112c - Construction Regular Operation

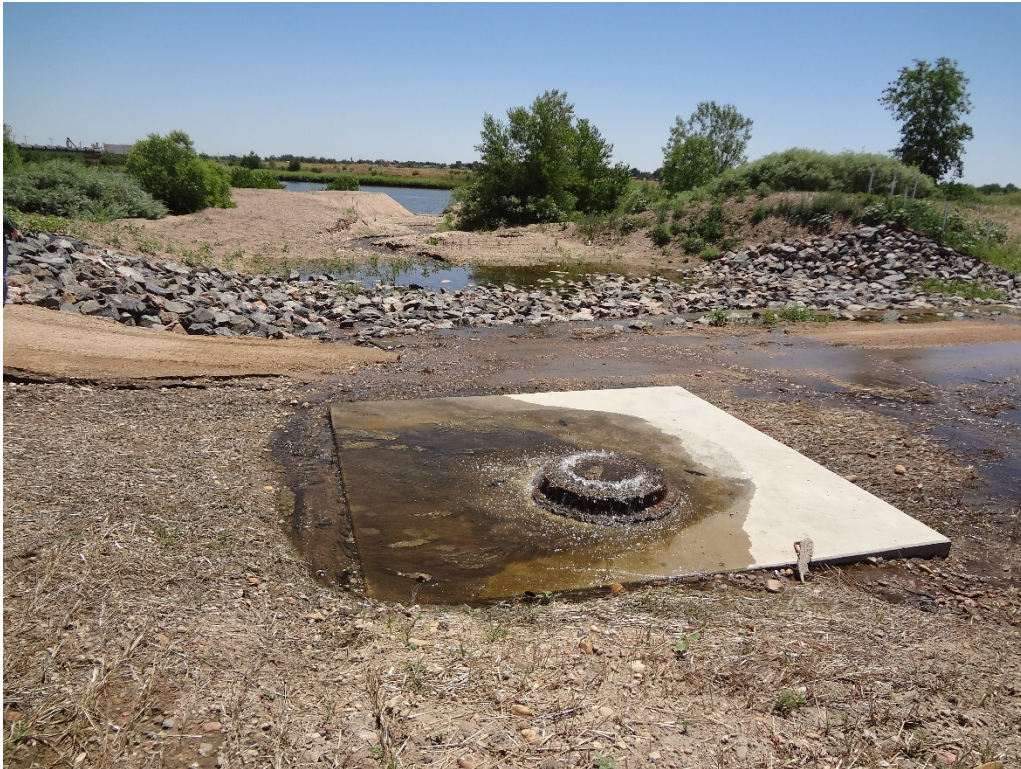
View of repaired Boyd Freeman Ditch looking east into 83rd Joint Venture site

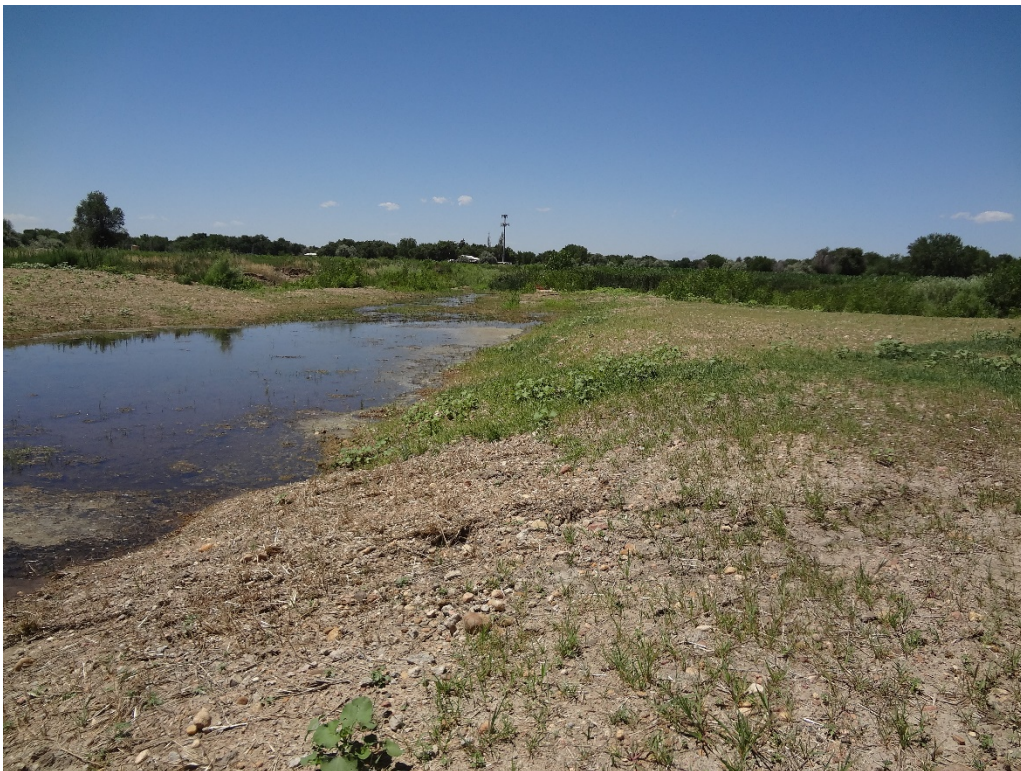
View of erosion gully through "F" Street Property looking west

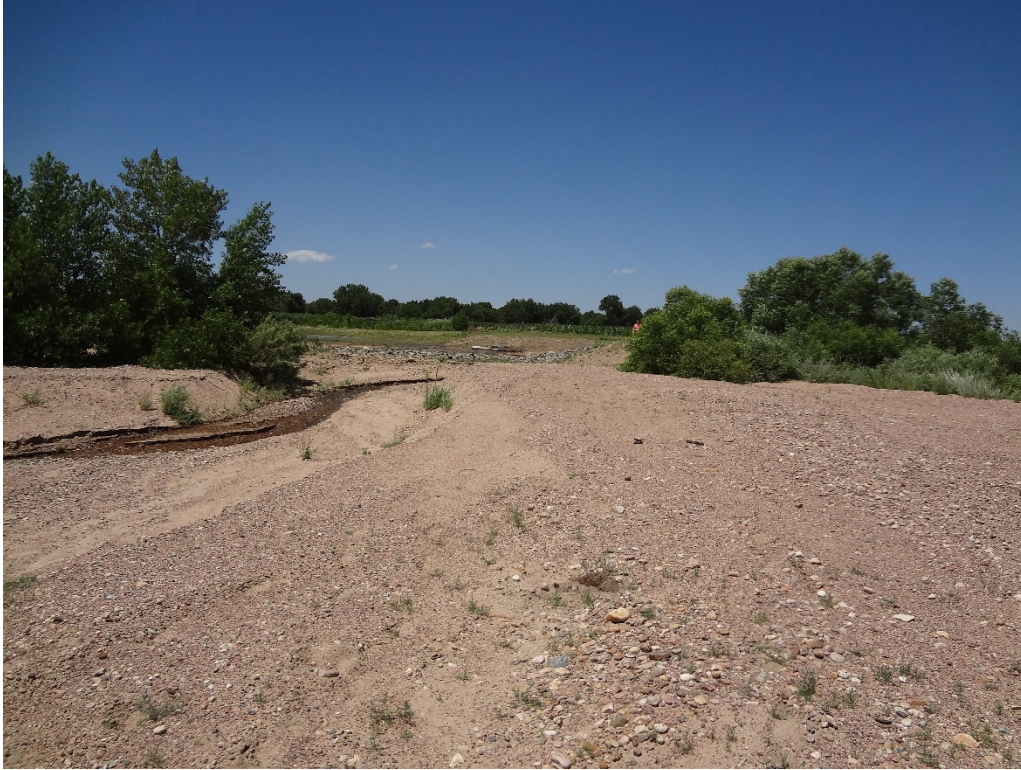
View of alluvial fan in 83rd Joint Venture site looking west

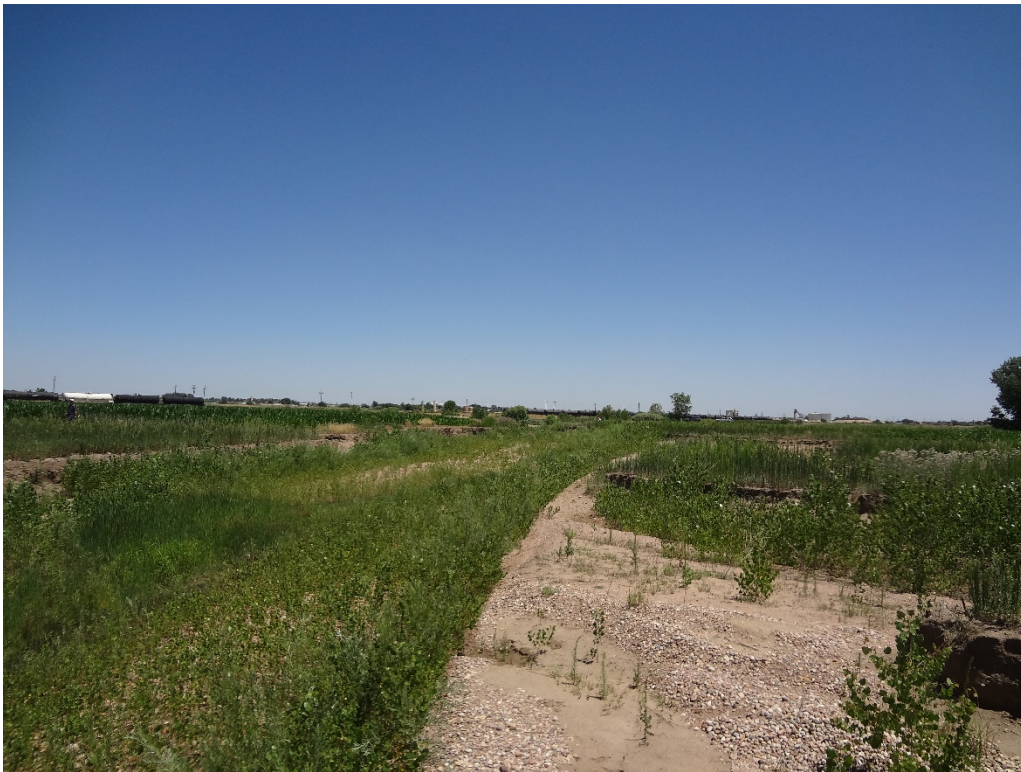
View of erosion feature in "F" Street Property looking east

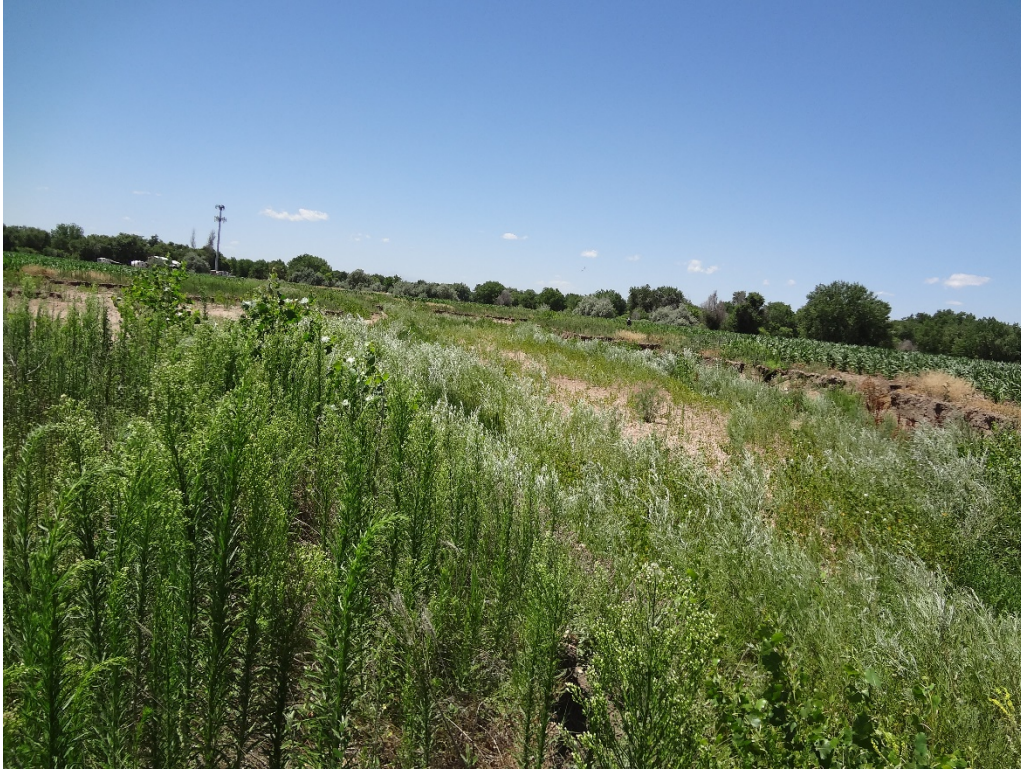
View of erosion feature in "F" Street Property looking west

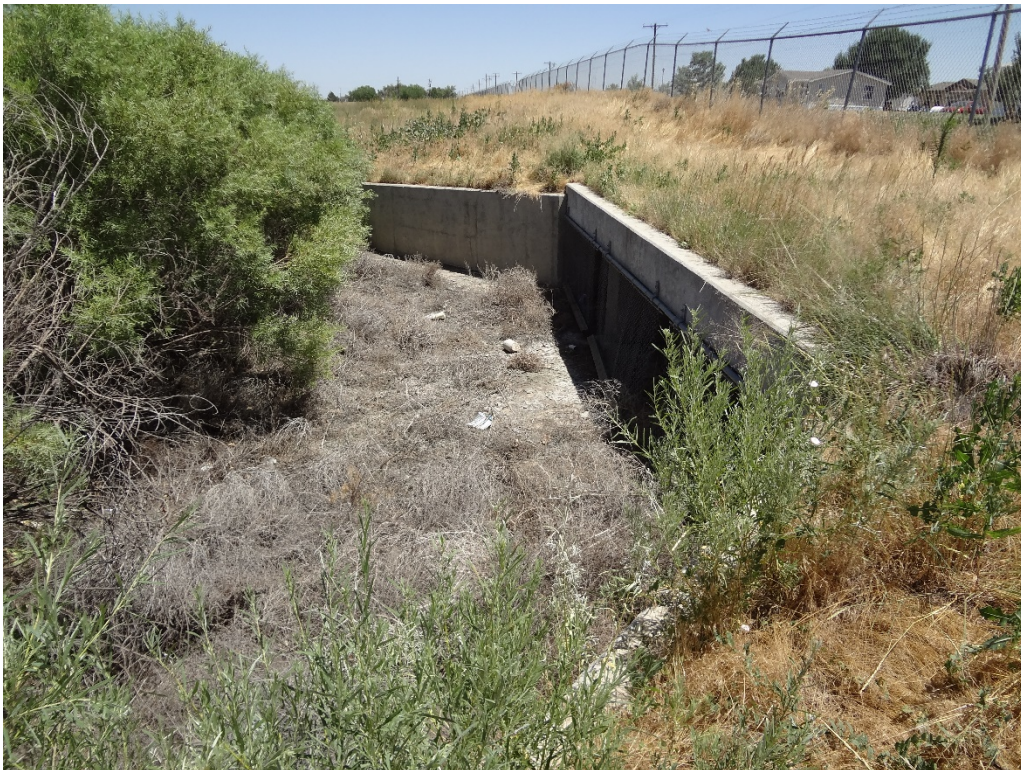
The stormwater outlet located in the southwest corner of the east pit of the 83rd Joint Venture site and the culverts under the railroad tracks, located in the northeast corner of the east pit, were observed. The stormwater outlet was dry, evidence of recent flows was not observed. The culverts under the railroad tracks were dry, evidence of recent flows was not observed.

Stormwater outlet structure in east lake of the 83rd Joint Venture site
