**COLORADO**Division of Reclamation,
Mining and Safety

MINERALS PROGRAM INSPECTION REPORT**PHONE: (303) 866-3567**

MINE NAME: Irwin/Thomas Mine	MINE/PROSPECTING ID#: M-2016-054	MINERAL: Sand and gravel	COUNTY: Boulder
INSPECTION TYPE: Preoperation Inspection	INSPECTOR(S): Michael A. Cunningham	INSP. DATE: December 13, 2016	INSP. TIME: 13:00
OPERATOR: Aggregate Industries - WCR, Inc.	OPERATOR REPRESENTATIVE: Connie Davis, Bill Schenderlein	TYPE OF OPERATION: 112c - Construction Regular Operation	
REASON FOR INSPECTION: Normal I&E Program	BOND CALCULATION TYPE: None	BOND AMOUNT: No Bond Held	
DATE OF COMPLAINT: NA	POST INSP. CONTACTS: None	JOINT INSP. AGENCY: None	
WEATHER: Windy	INSPECTOR'S SIGNATURE:

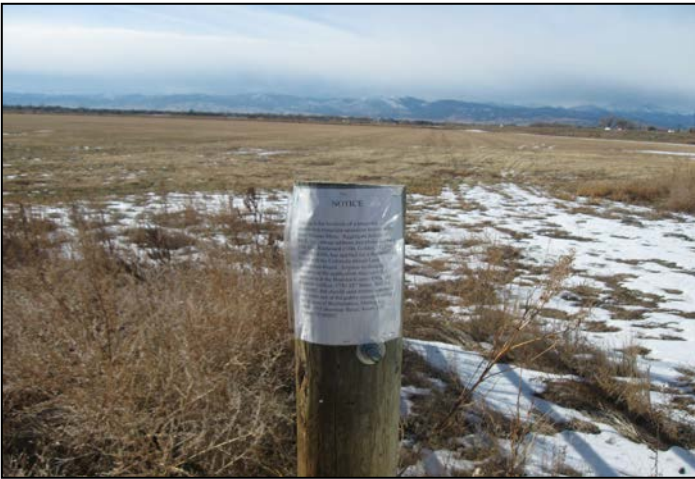
1. Public notice sign at site entrance.

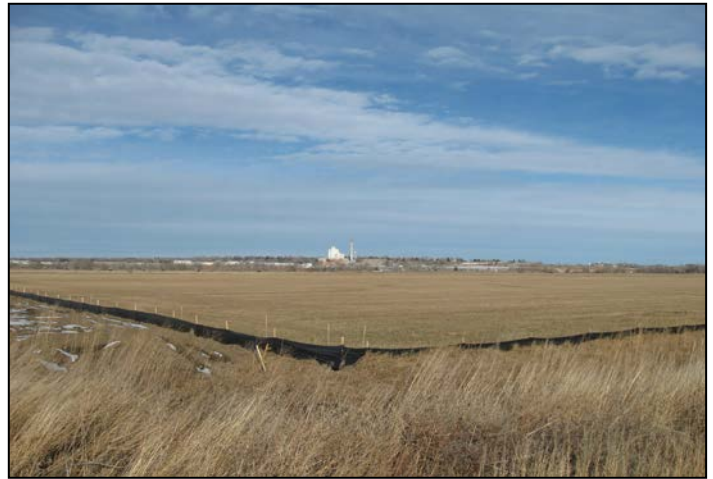
Mining Area 1 consists primarily of irrigated pasture and is located to the south of Highway 119. There is a residential structure located on the east side of Mining Area 1 which is owned by Golden Farm Ltd. This residential structure is located within Mining Cell 5 and the Applicant was unsure if the structure would be demolished. Prior to the removal of the residential structure, the Applicant will have to demonstrate to the Division that the landowner has approved the removal of the house. The other major structure within Mining Area 1 is the Bonus Ditch which runs west to east across the site. The Bonus Ditch will remain in place and will not be impacted by the mining operation.

2. Mining Area 1. (Photo taken at southwest corner facing northeast)

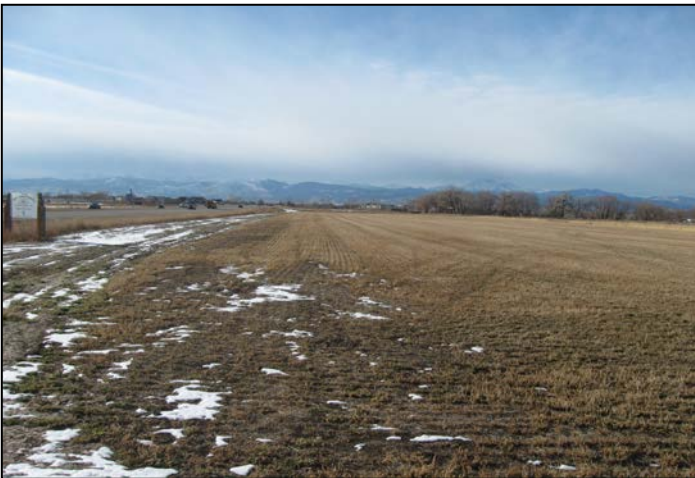
Mining Area 2 is located immediately north of Highway 119 and is bounded by St. Vrain Creek on the north side. Mining Area 2 consists of irrigated pasture and includes a barn and several out-buildings owned by the City of Longmont. The structures will not be impacted by the mining operation. Mining Area 2 contains 2 lined irrigation laterals which discharge through culverts located on the north side of the parcel. The existing culverts may be utilized as discharge points for the dewatering of Mining Area 2.

3. Mining Area 2. (Photo taken facing west)

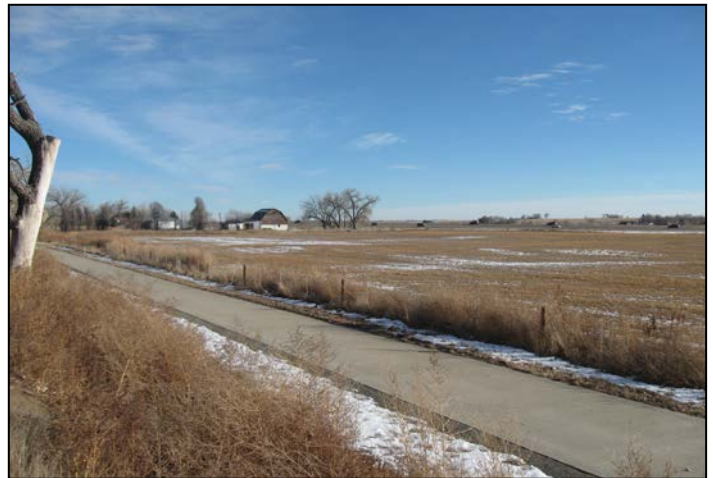
4. Mining Area 2. (Photo taken facing southeast)

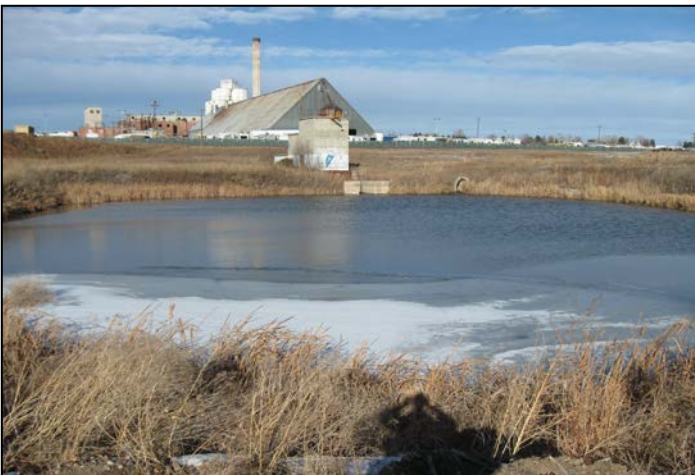
Mining Area 3 and Mining Area 4 are located north of the St. Vrain Creek and are separated by an active railroad line which runs east to west. Portions of Mining Area 3 are used to store railroad ties and other equipment for the railroad. In addition, the City of Longmont has several stockpiles of fill material on the west side of Mining Area 3. Mining Area 4 is comprised of a wetland area and the dominant vegetation is cattails. There is a small pond located on the east side of Mining Area 4. The Division observed a Great Blue Heron standing in the center of the pond, indicating the water is very shallow. The Applicant did not know the source of water for the pond. Based on the proximity to the St. Vrain Creek and the adjacent wetlands, the Division believes there is exposed groundwater in the pond.

5. Pond in Mining Area 4.

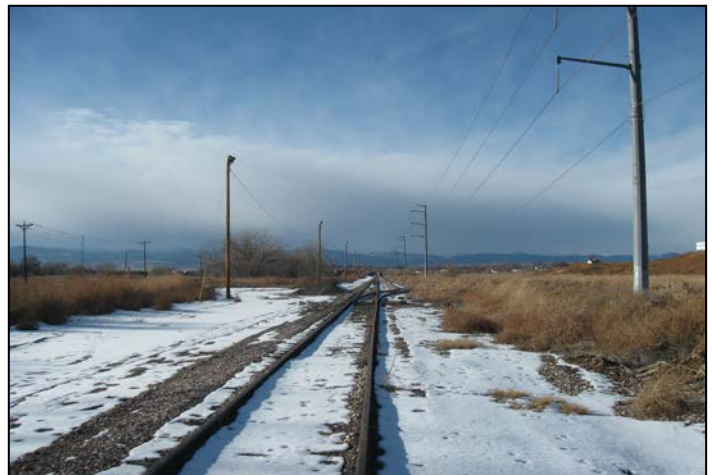
6. Railroad line between Mining Area 3 and Mining Area 4. (Photo taken facing west)

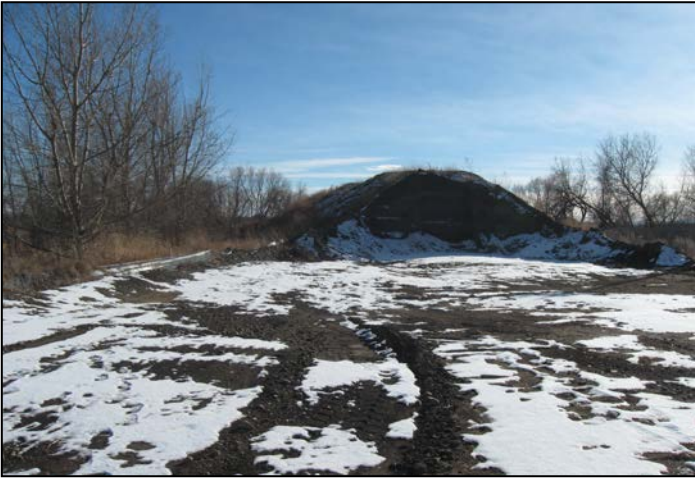
7. Material stockpile in Mining Area 3.

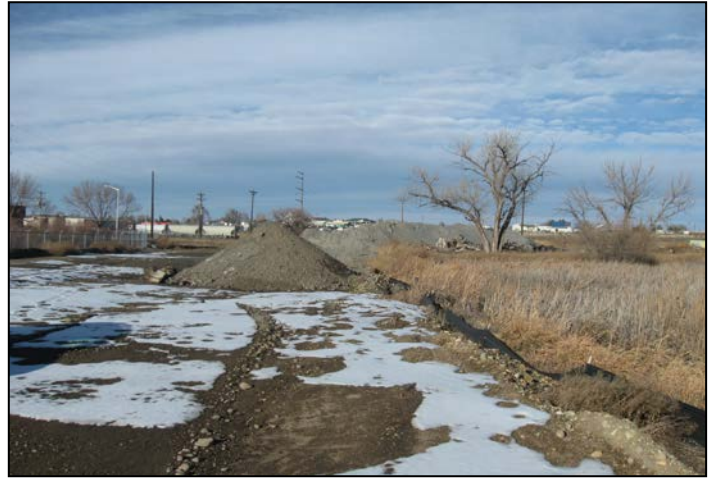
8. Material stockpile in Mining Area 3.

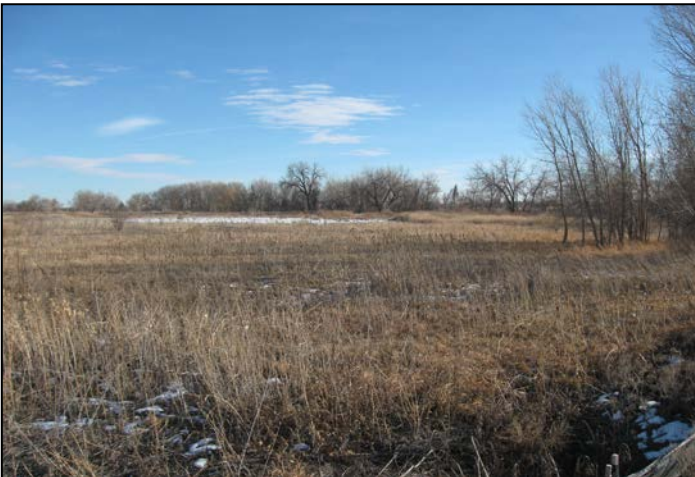
9. Mining Area 3. (Photo taken facing west)

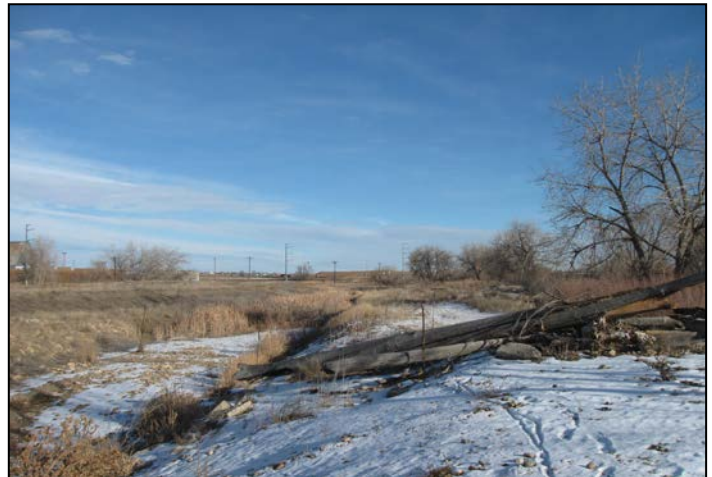
10. Mining Area 3. (Photo taken facing west)
