MINERALS PROGRAM INSPECTION REPORT

MINE NAME: Katuska Pit	MINE/PROSPECTING ID#: M-1991-037	MINERAL: Gravel and gold	COUNTY: Park
INSPECTION TYPE: Monitoring	INSPECTOR(S): Michael A. Cunningham	INSP. DATE: December 5, 2016	INSP. TIME: 11:00
OPERATOR: High Speed Mining, LLC	OPERATOR REPRESENTATIVE: None	TYPE OF OPERATION: 110c - Construction Limited Impact	
REASON FOR INSPECTION: Citizen Complaint	BOND CALCULATION TYPE: Complete Bond	BOND AMOUNT: \$21,110.00	
DATE OF COMPLAINT: NA	POST INSP. CONTACTS: None	JOINT INSP. AGENCY: None	
WEATHER: Clear	INSPECTOR'S SIGNATURE:

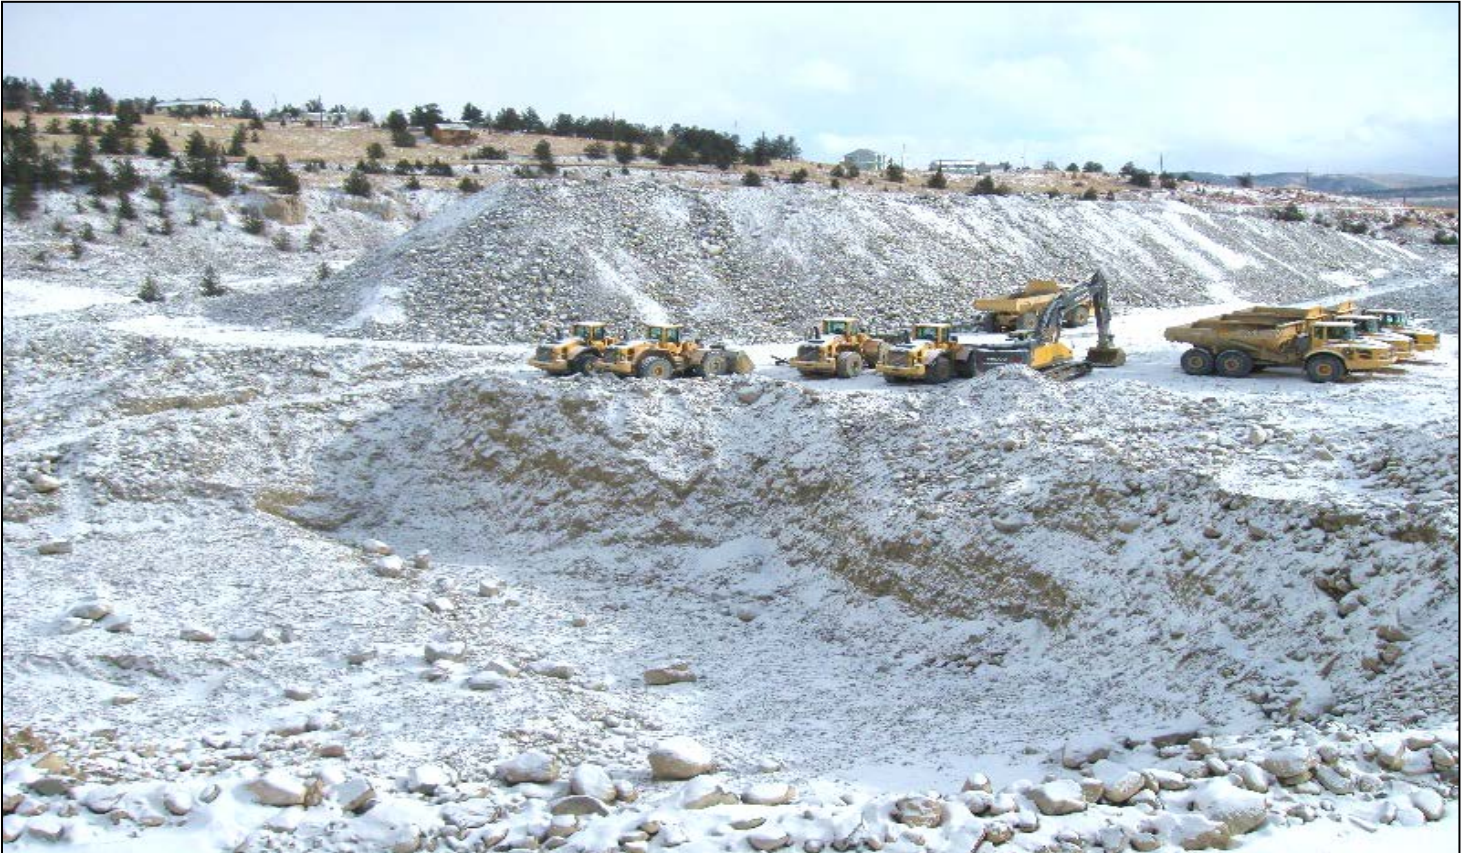
1. Overview of pit.

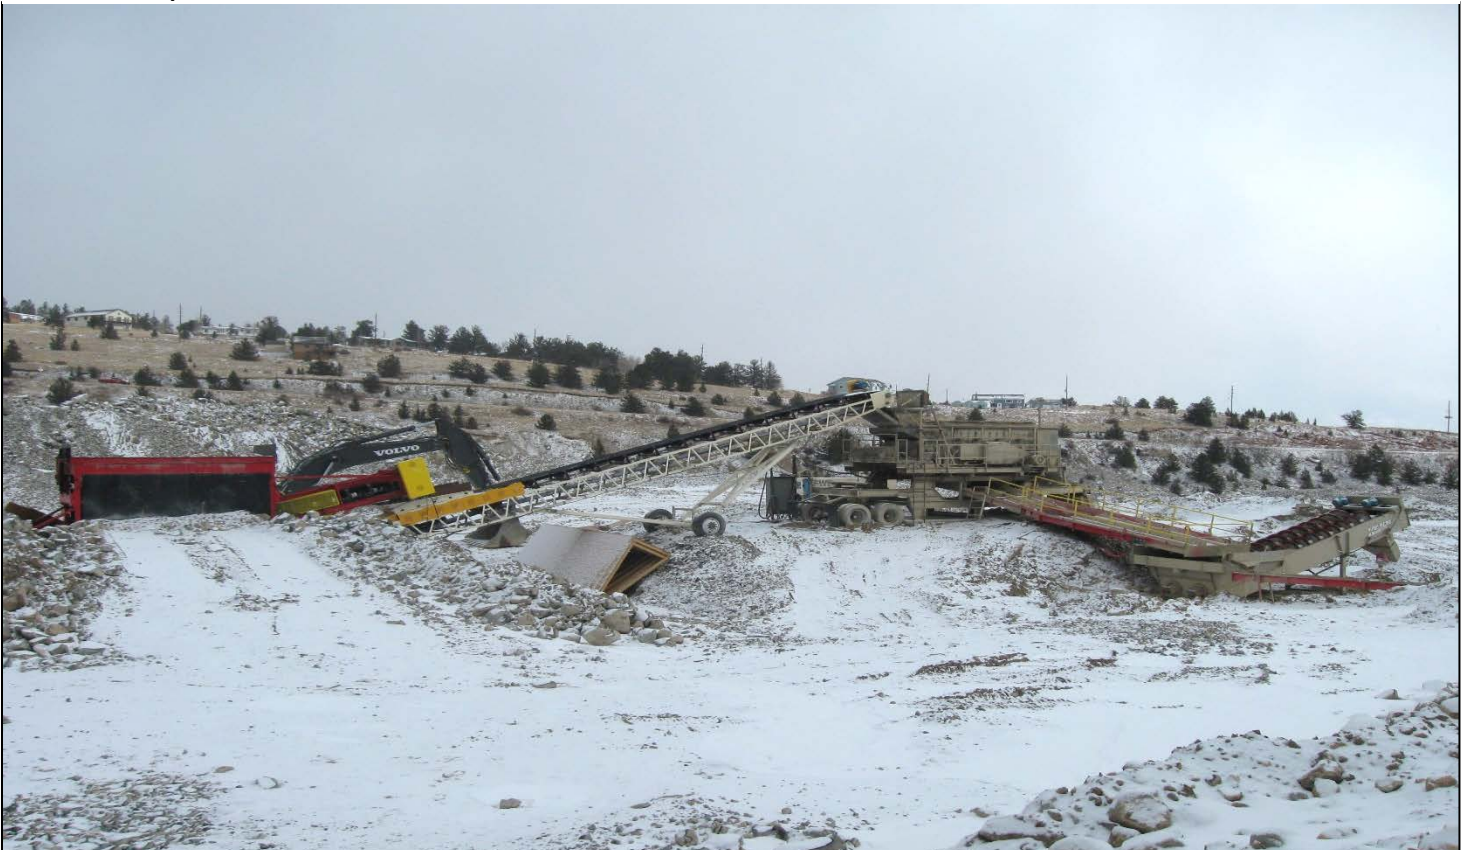
2. Processing equipment.

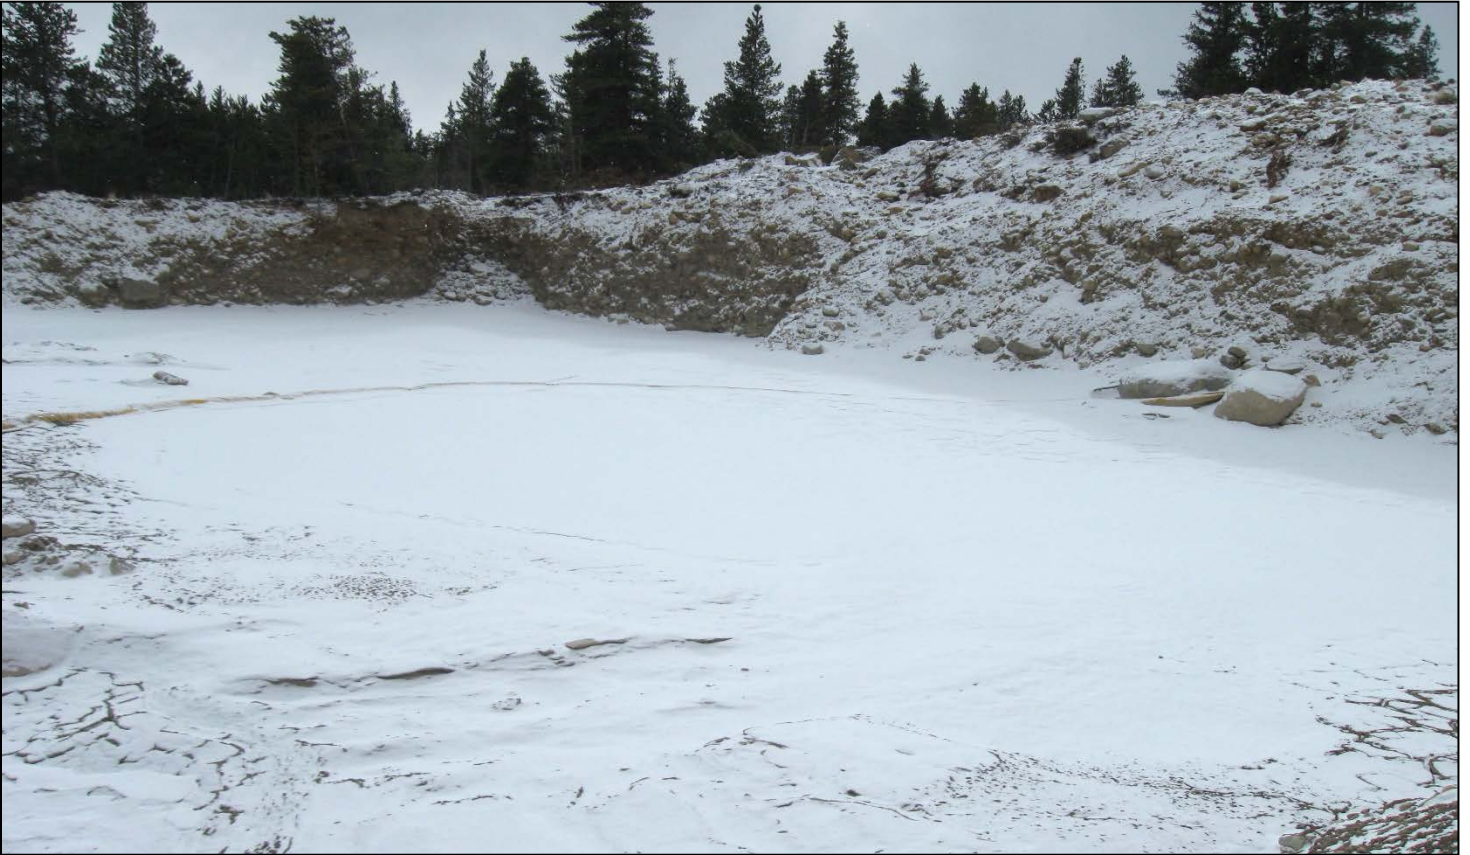
3. Settling pond.

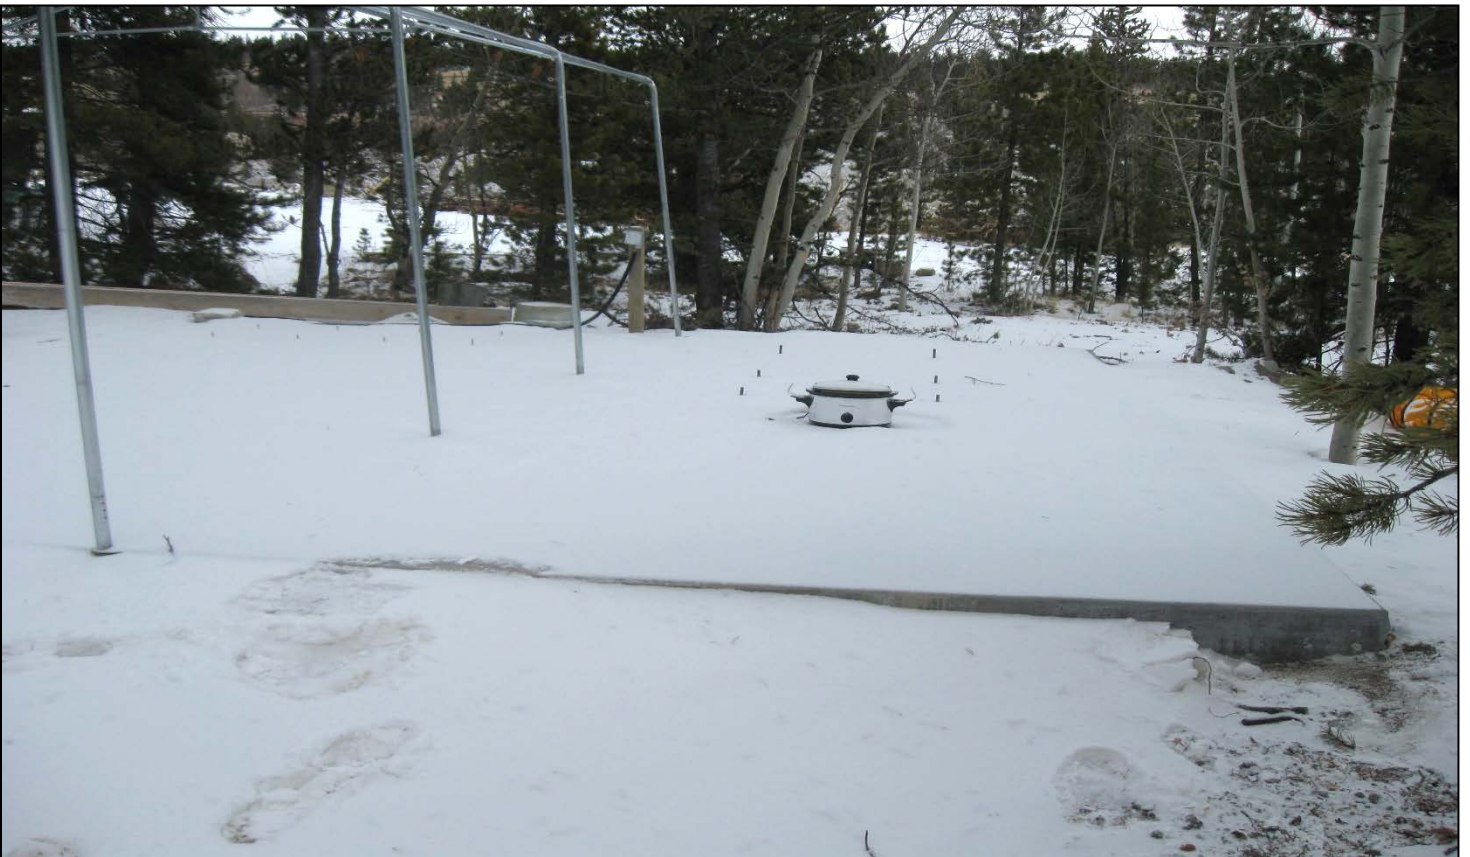
4. Concrete pad located outside of permit boundary.

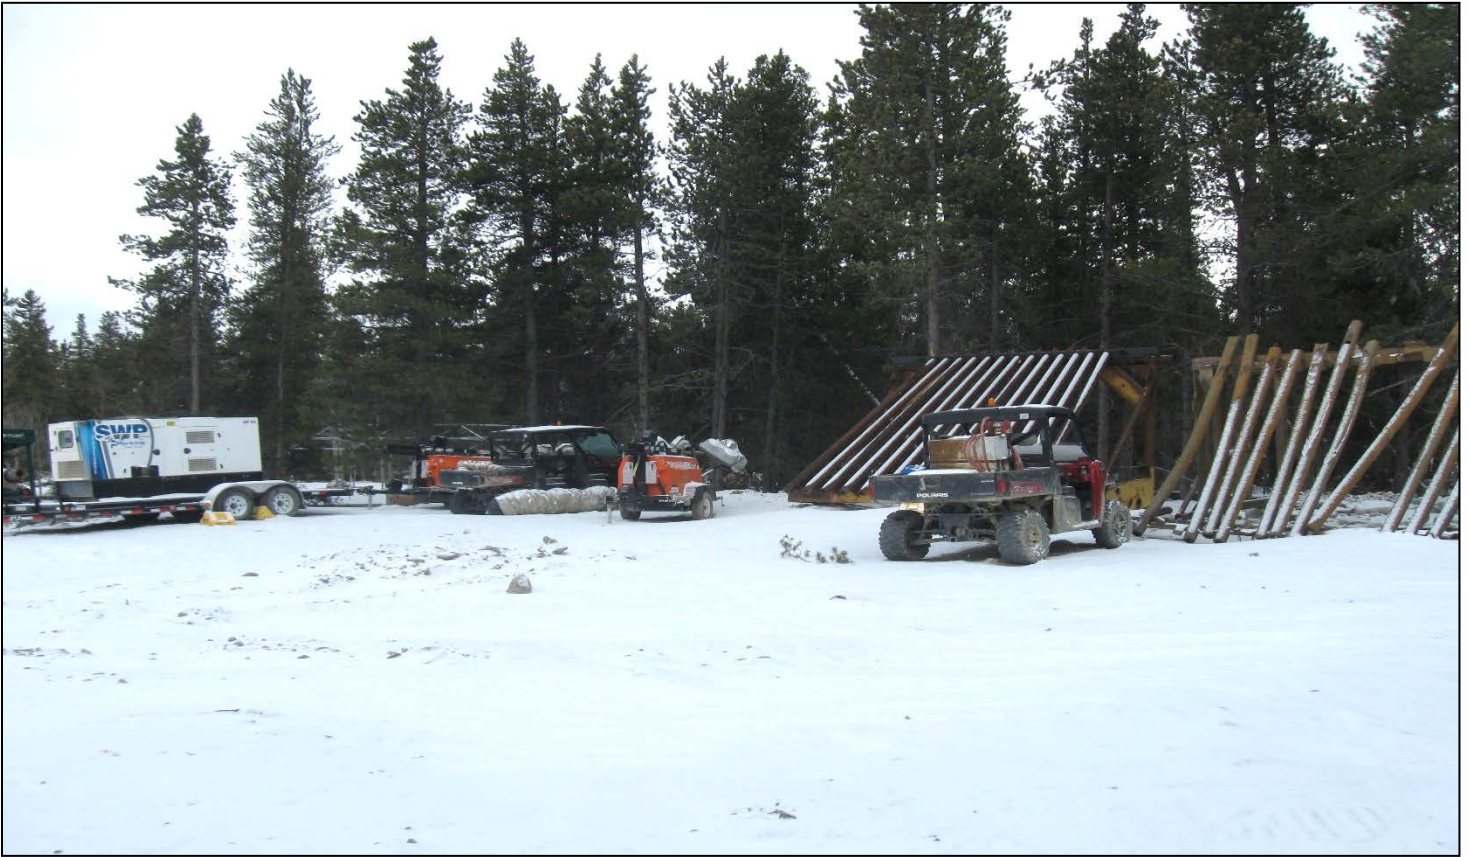
5. Equipment located outside of permit boundary.

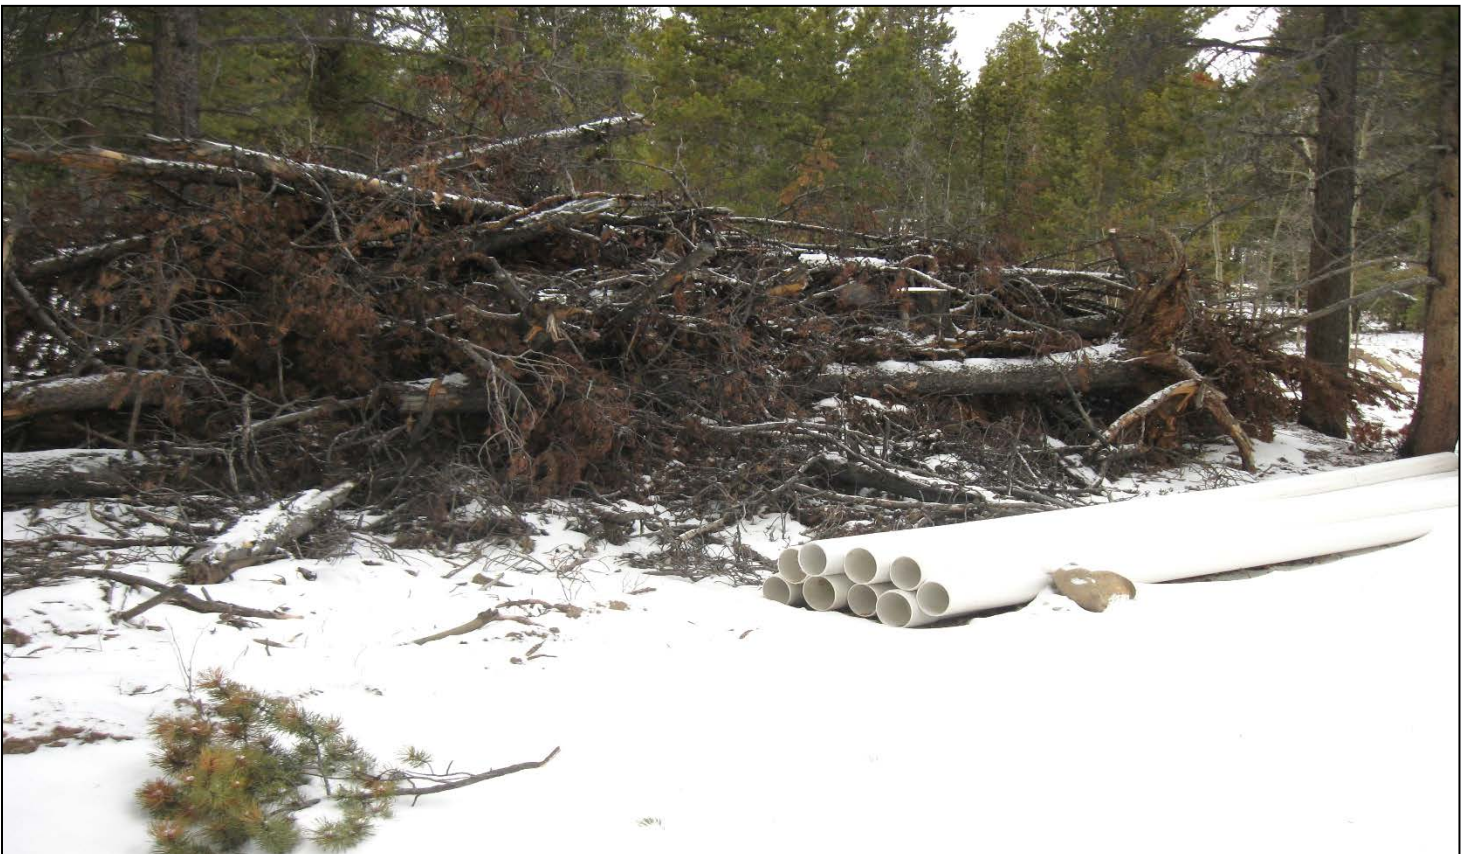
6. Trees removed outside of permit boundary.

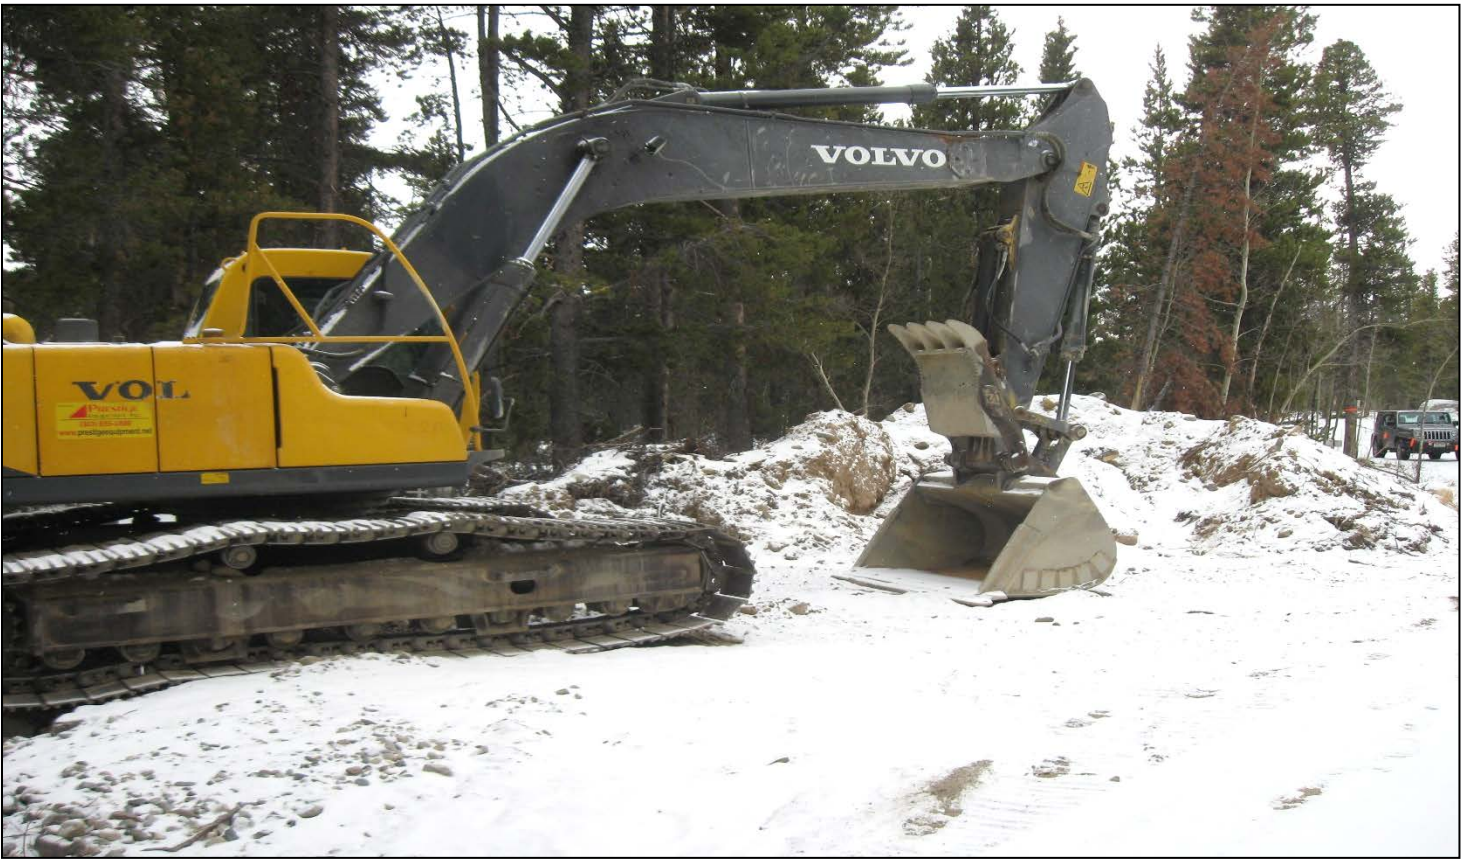
7. Equipment located outside of permit boundary.

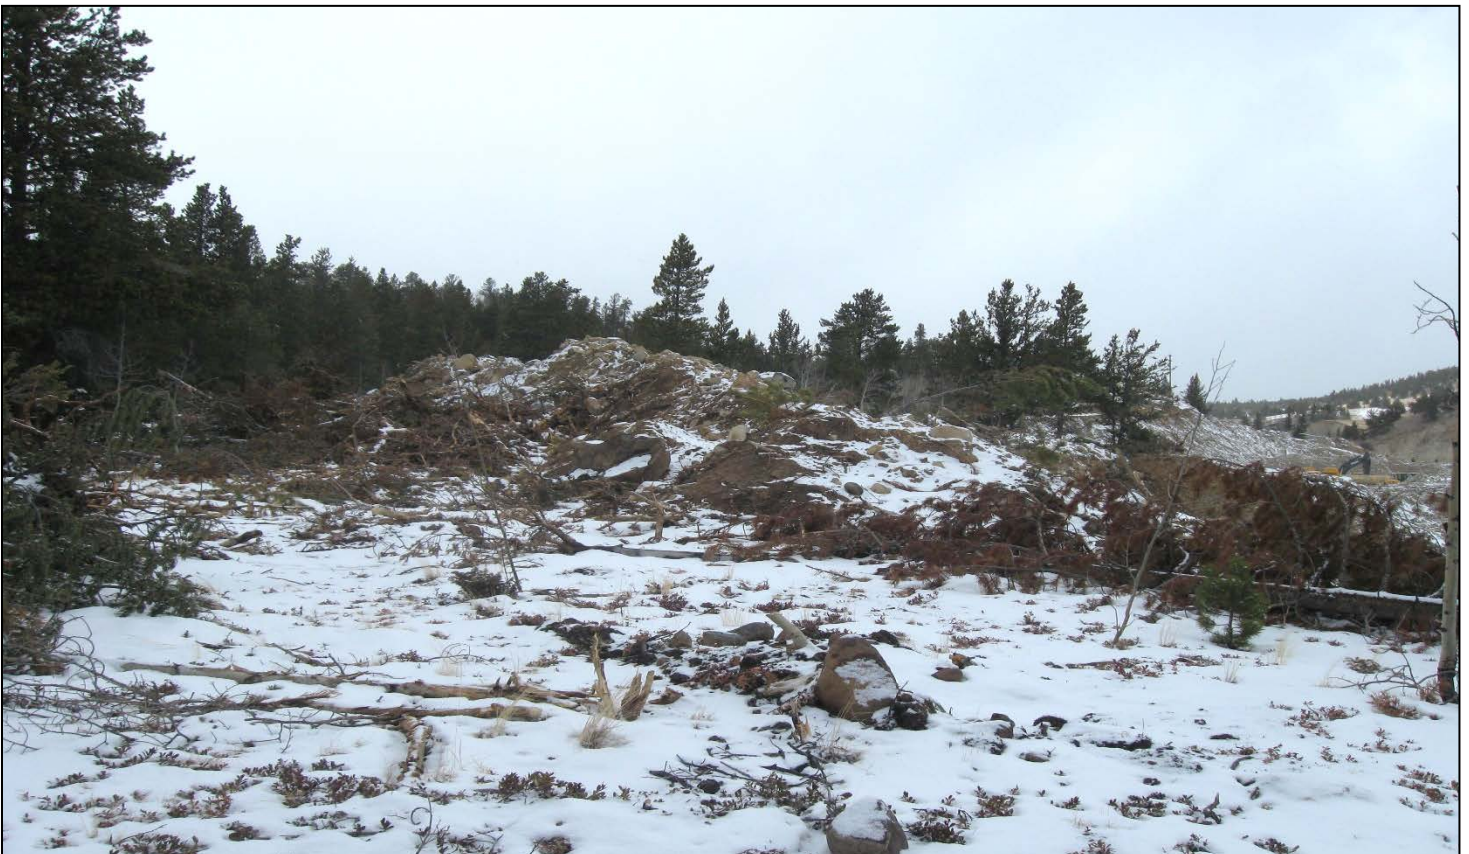
8. Topsoil cleared from areas affected outside of permit boundary.

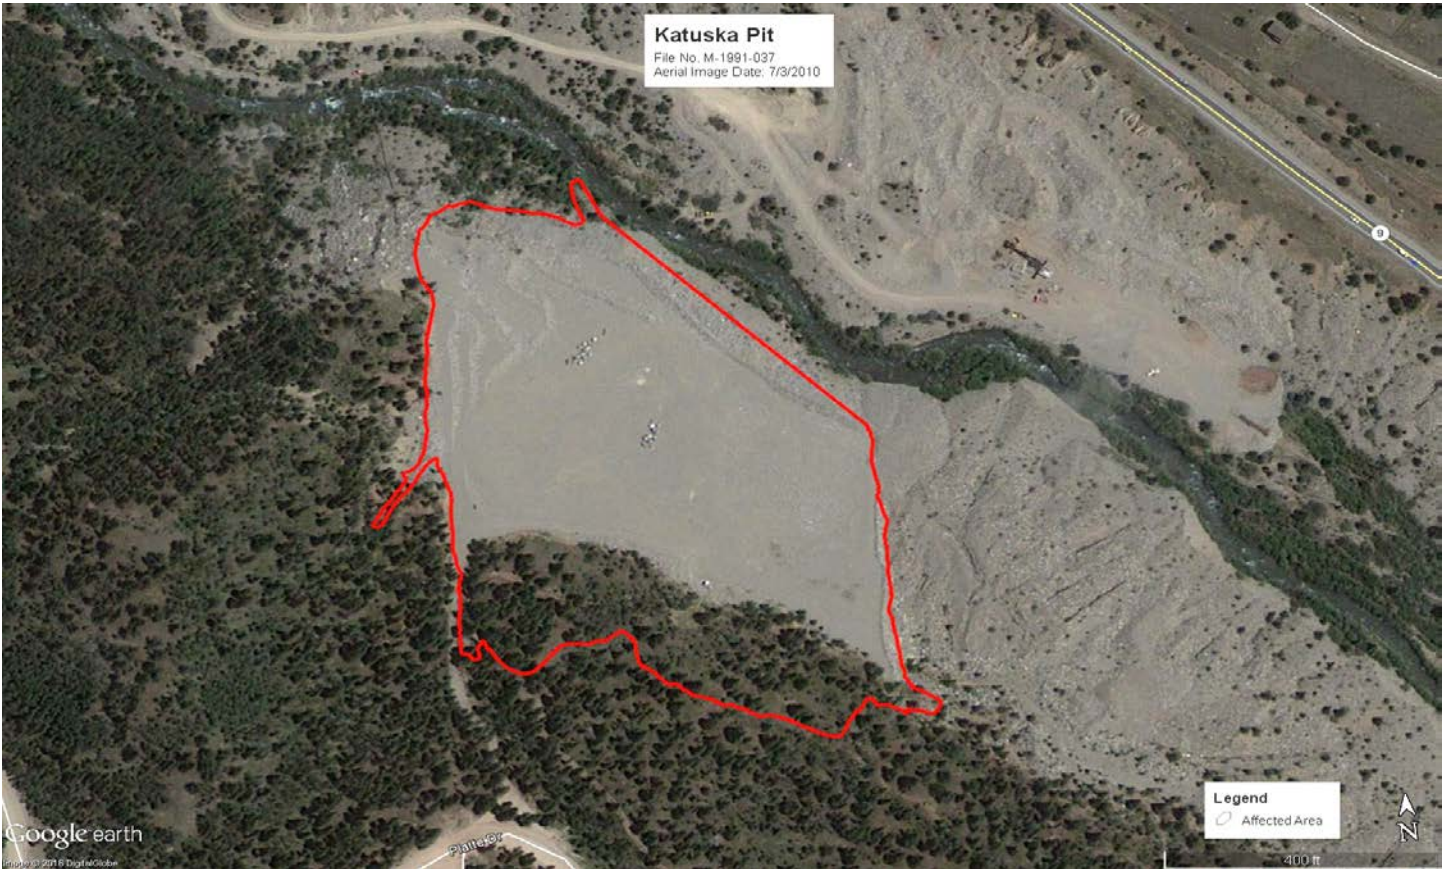
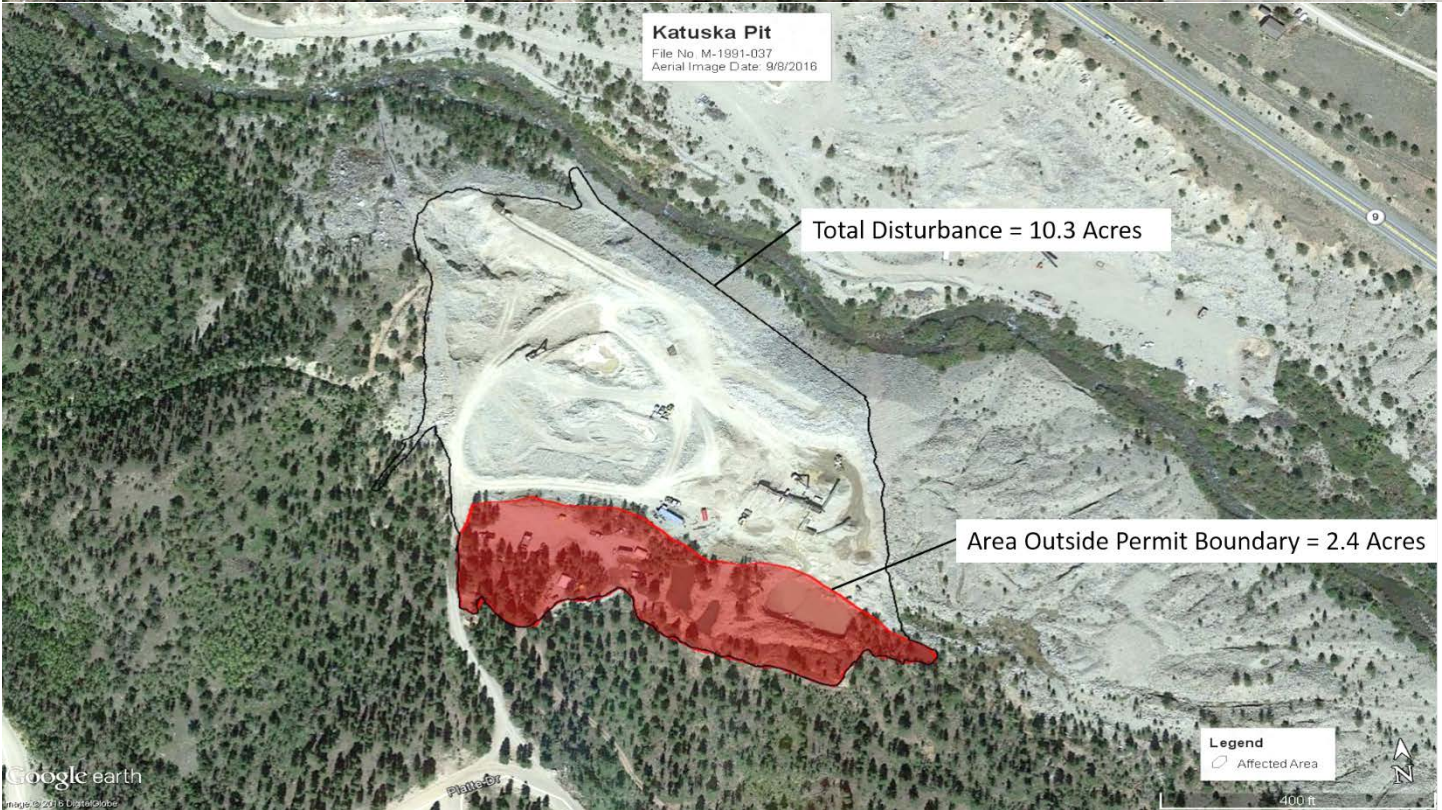
This photo shows new recent mining activity south of the boundary described in the permit map (area with no vegetation) extending into an area with vegetation/trees to the south.

This new area includes ponds and roads, and shows that many trees were removed.
