**MINERALS PROGRAM INSPECTION REPORT****PHONE: (303) 866-3567**

<b>MINE NAME:</b> Schumacher Pit #3	<b>MINE/PROSPECTING ID#:</b> M-2006-072	<b>MINERAL:</b> Gravel, clay (general)	<b>COUNTY:</b> Logan
<b>INSPECTION TYPE:</b> Monitoring	<b>INSPECTOR(S):</b> Jared L. Ebert	<b>INSP. DATE:</b> December 15, 2016	<b>INSP. TIME:</b> 10:30
<b>OPERATOR:</b> Jeffrey L. Schumacher	<b>OPERATOR REPRESENTATIVE:</b> None	<b>TYPE OF OPERATION:</b> 112c - Construction Regular Operation

Schumacher Pit #3, M-2006-072, December 15, 2016 Inspection

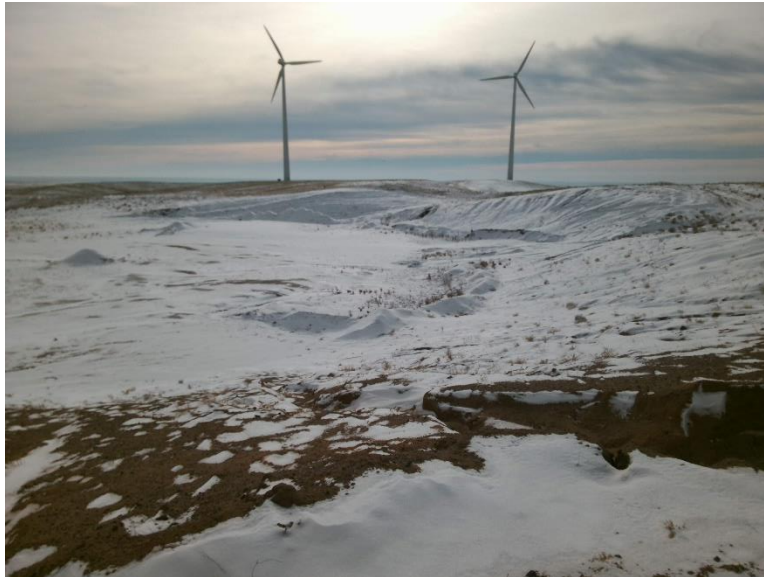
Figure 1. From the north end of western pit looking south.

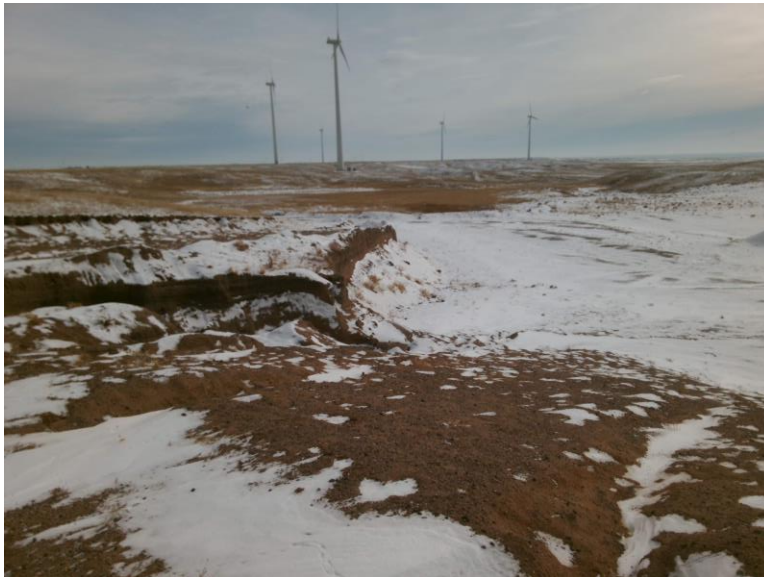
Figure 2. From the northern end of western pit excavation looking east.
