MINERALS PROGRAM INSPECTION REPORT**PHONE: (303) 866-3567**

MINE NAME: Schumacher Pit	MINE/PROSPECTING ID#: M-1995-063	MINERAL: Sand and gravel	COUNTY: Logan
INSPECTION TYPE: Monitoring	INSPECTOR(S): Jared L. Ebert	INSP. DATE: December 15, 2016	INSP. TIME: 11:05
OPERATOR: Logan County	OPERATOR REPRESENTATIVE: Rob Quint and Betty Green	TYPE OF OPERATION: 112c - Construction Regular Operation

Schumacher Pit, M-1995-063, December 15, 2016 Inspection

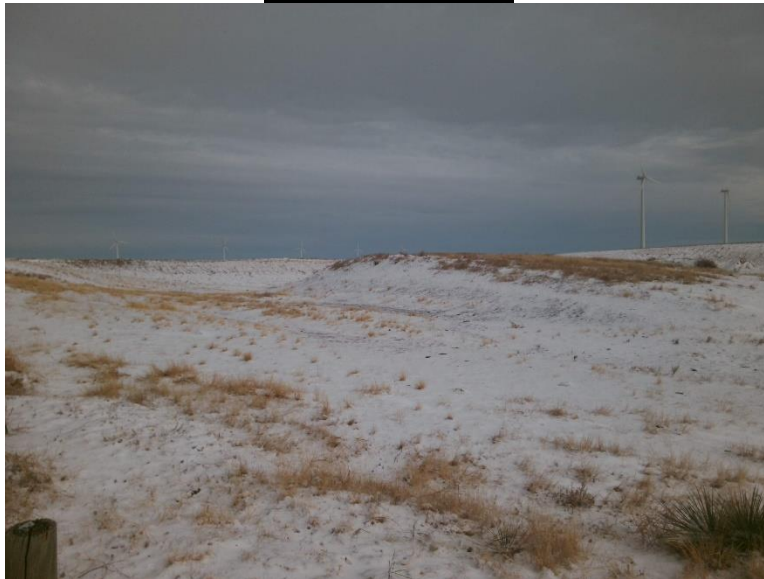
The mining and reclamation plan indicated that no topsoil was present at the site, and that none would be removed. However, a pile of overburden or topsoil was located on the western end of the site. The stockpile appeared stable and vegetated.

Figure 1. From the entrance to the mine site looking northeast. Topsoil/overburden stockpile visible.

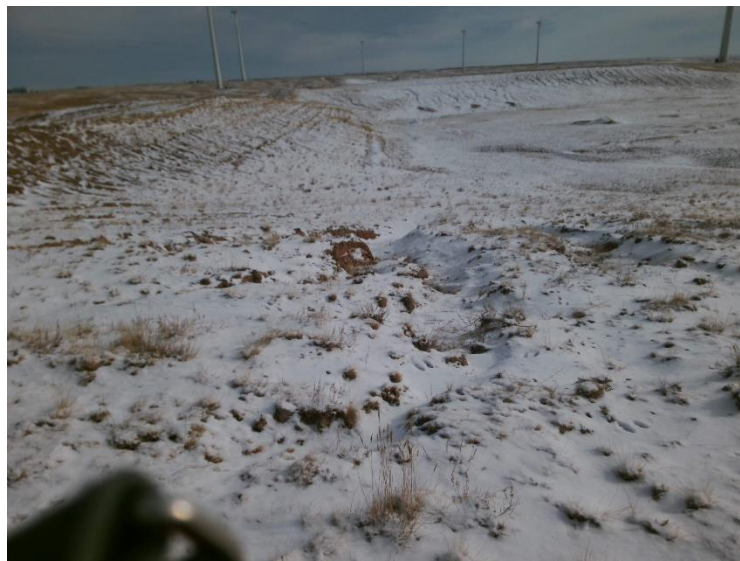
Figure 2. From the northwest corner looking east.

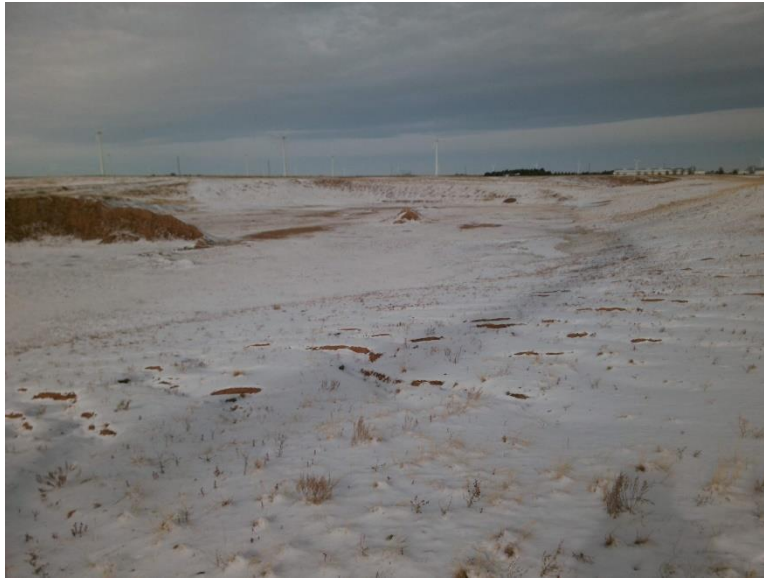
Figure 3. From the southwest corner of the pit looking north.

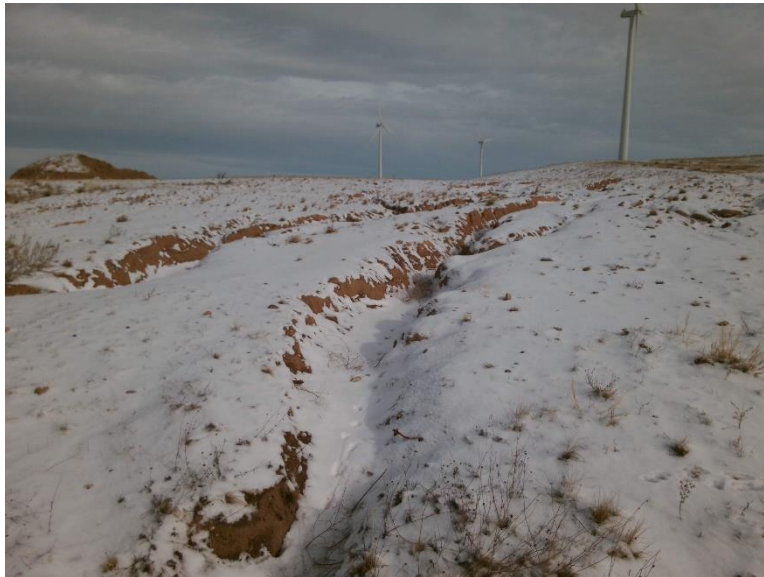
The Division observed several gullies that have formed at the southern end of the site. The drainage from the affected area drains to this area. These gullies will need to be repaired and erosion control and siltation protection measures should be implemented in order to ensure off-site sedimentation is not occurring. This issues was discussed with Mr. Quint and Mrs. Green, and it was agreed that erosion control waddles, silt fence or straw bales could be installed in this area and or a small sump could be used to contain the sediment. The Division will require Logan County to repair these gullies and stabilize the area and install erosion control features.

Figure 4. Erosion control gullies at the south end.

INSPECTION TOPIC: Hydrologic Balance**PROBLEM/POSSIBLE VIOLATION:** Problem: Erosion gullies and ruts were observed on-site. This is a problem at this time for failure to protect the affected land from erosion pursuant to C.R.S. 34-32.5-116 (4) (j).**CORRECTIVE ACTIONS:** The operator shall provide photo documentation to the Division verifying erosion gullies and ruts have been repaired, and that the site has have been reconstructed and stabilized to prevent erosion damage by the corrective action date.**CORRECTIVE ACTION DUE DATE:** 3/31/17

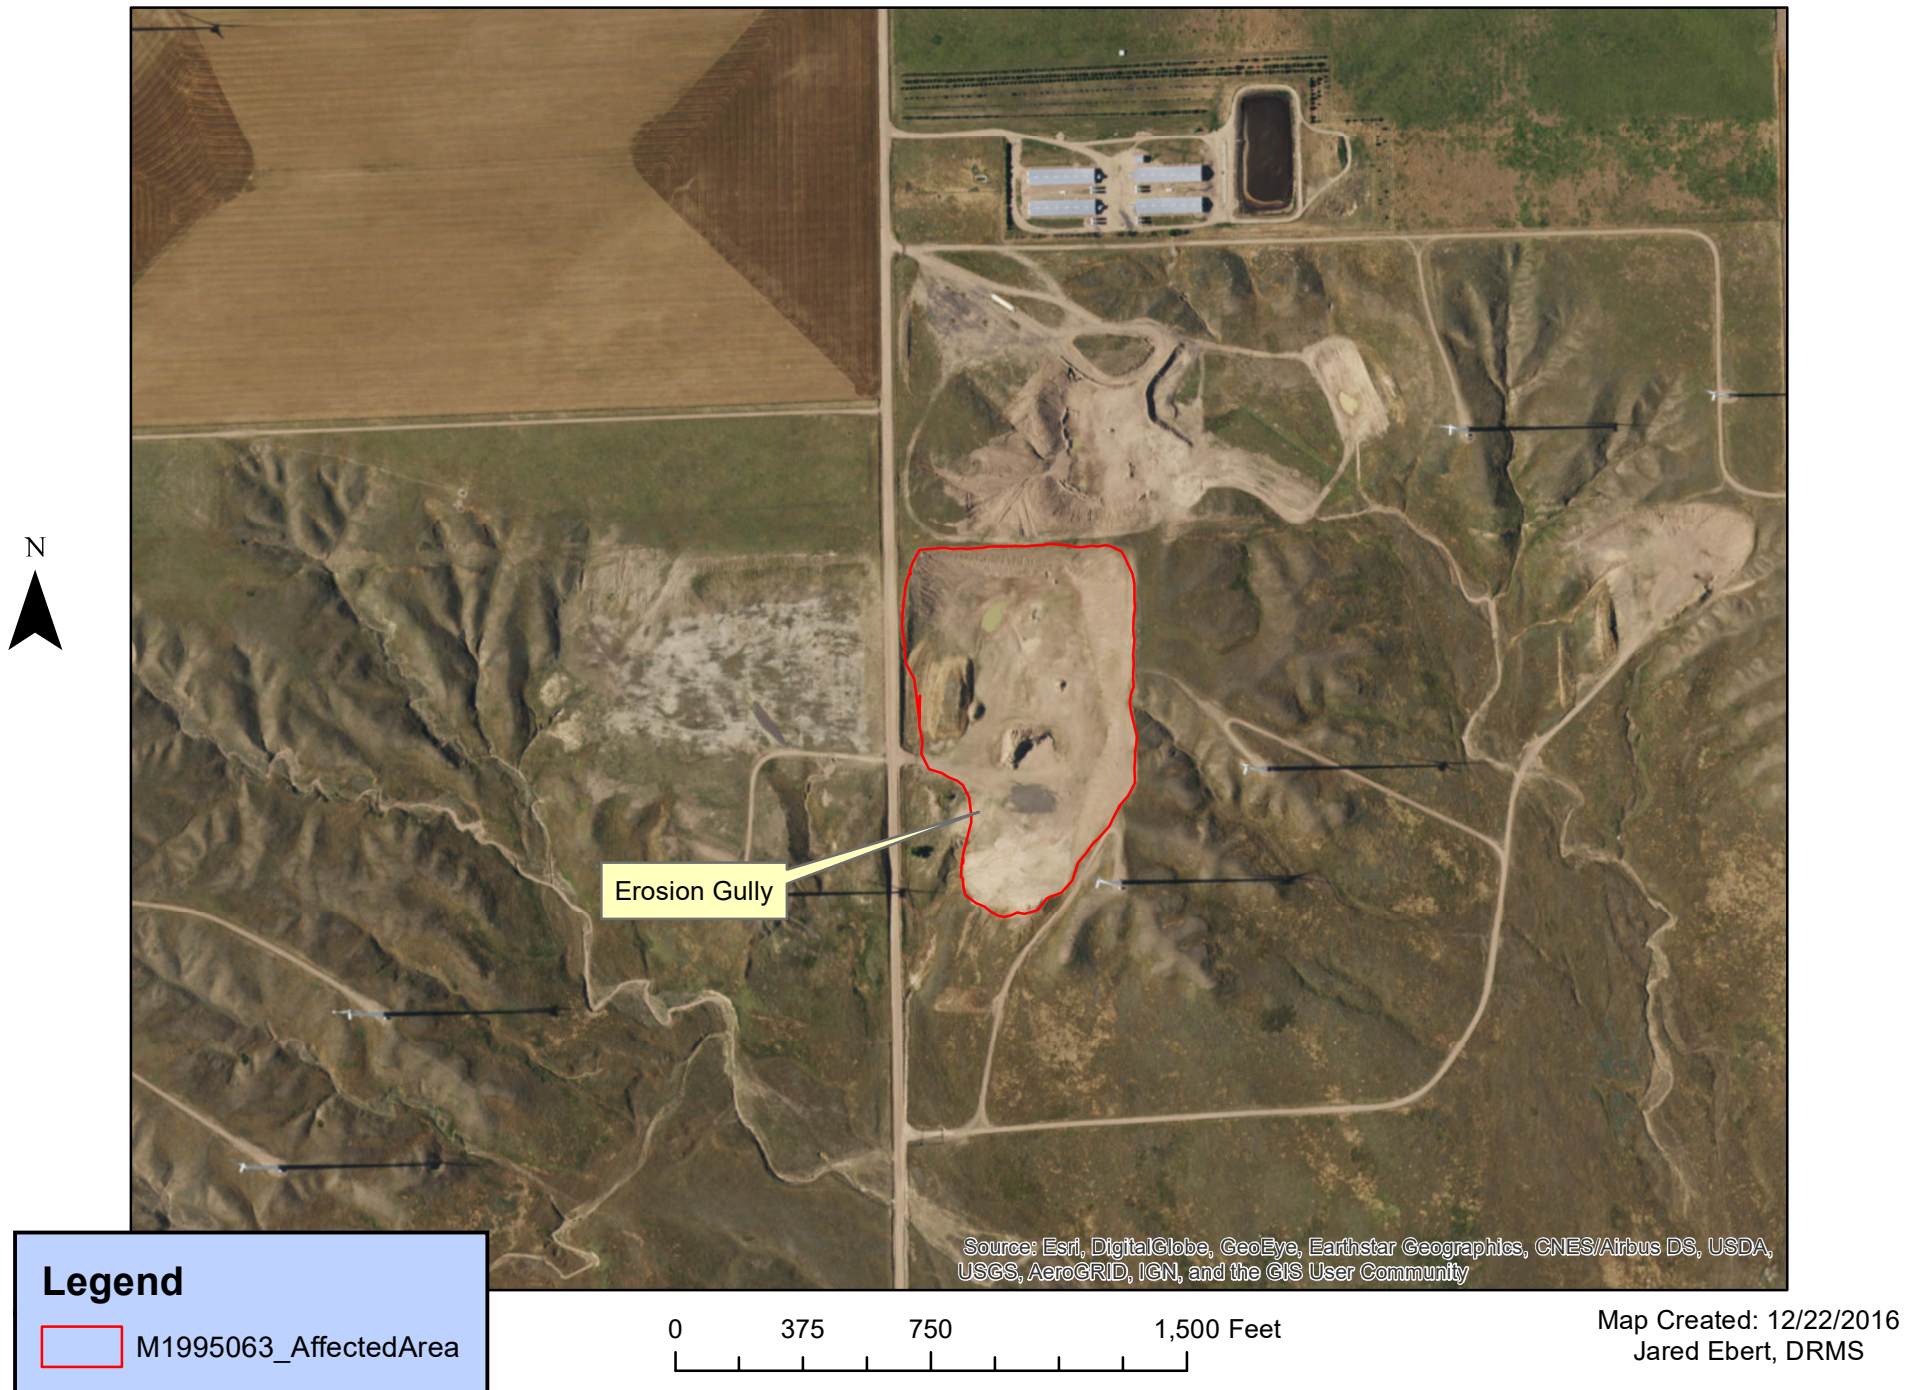
This was a monitoring inspection of the Schumacher Pit, DRMS Permit No. M-1995-063, operated by Logan County. I, Jared Ebert of the Colorado Division of Reclamation, Mining and Safety conducted the inspection. The weather was cloudy and cold at the time of the inspection. Mr. Rob Quint and Betty Green with Logan County accompanied me during the inspection. Using the ArcCollector Application, I measured the affected area to be 13.34 acres. Please see the attached map.
